WPR24LA102

## INVESTIGATION PHOTOGRAPHS

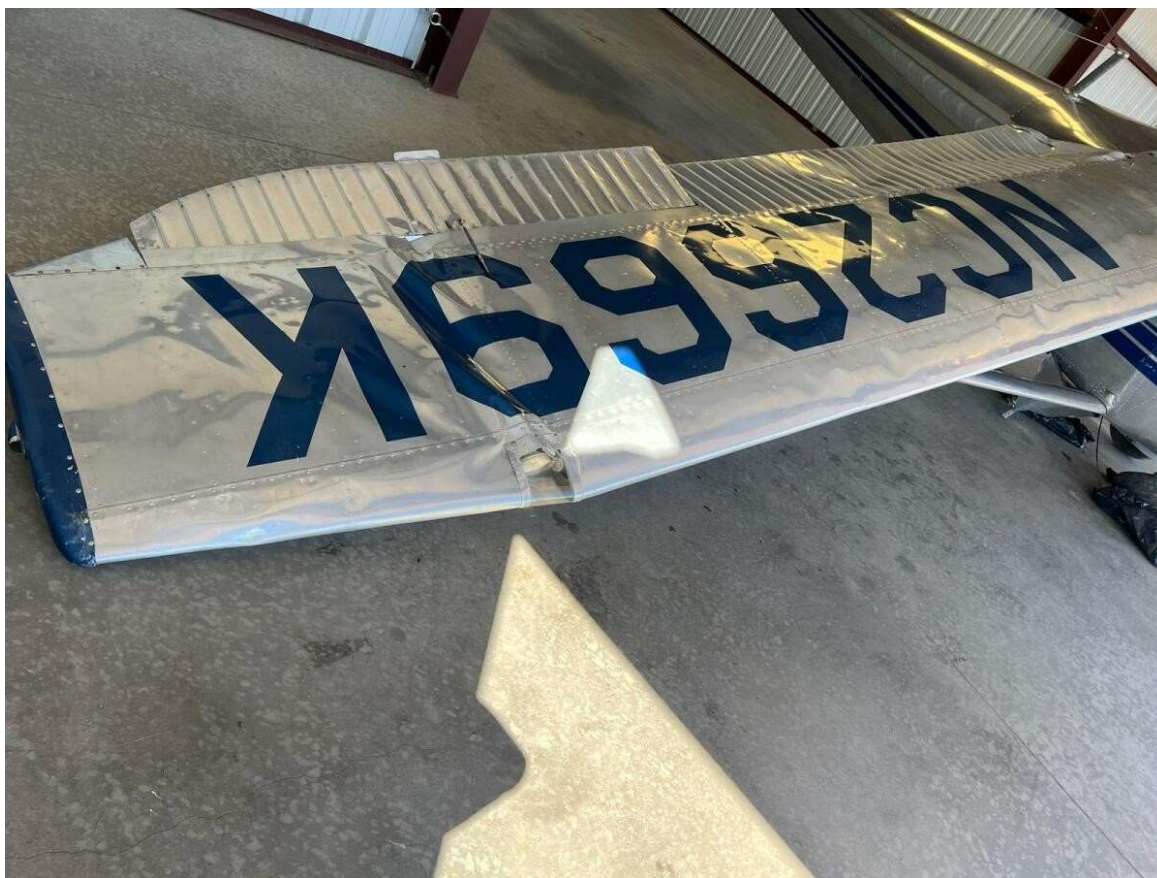
**Photograph 1 - View of Damaged Wing (Courtesy of FAA)**

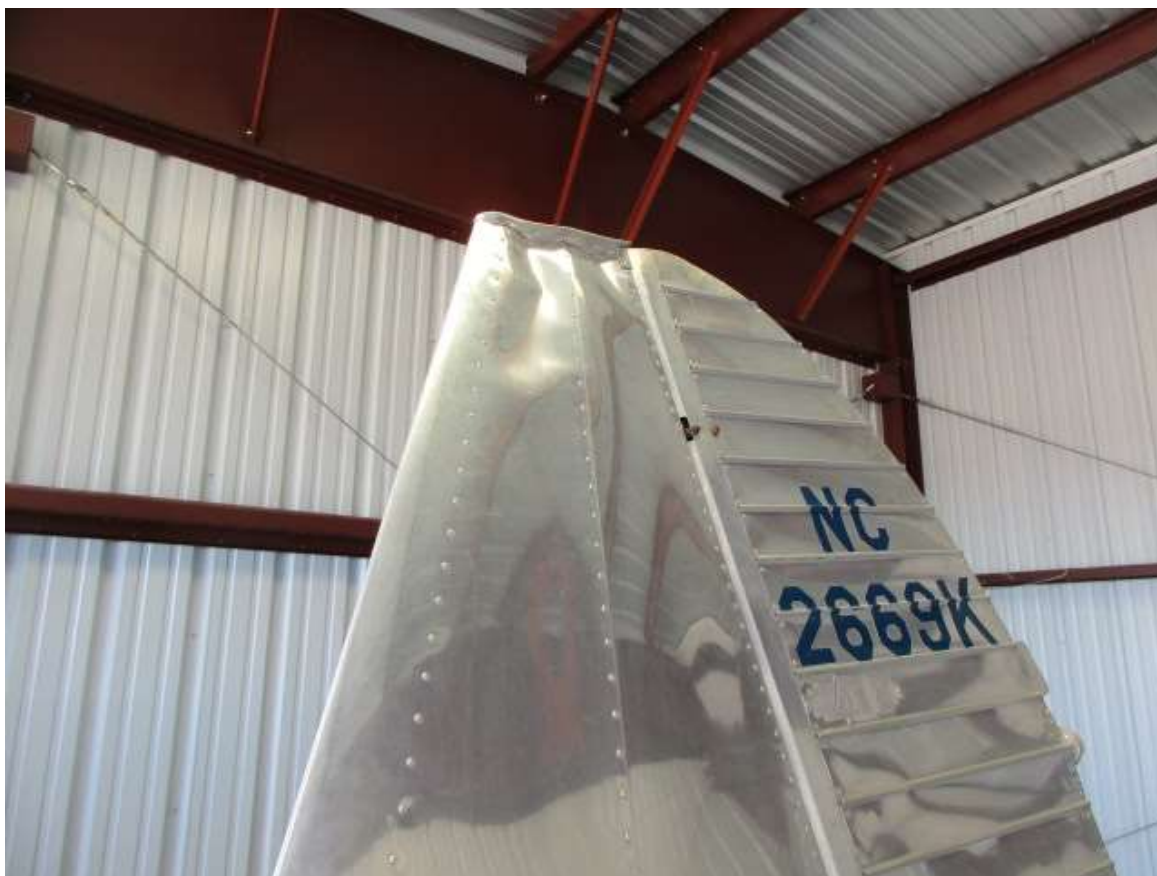
**Photograph 2 - View of Damage to the Tail (Courtesy of FAA)**
