# National Transportation Safety Board

WPR24LA106

## **AIRFRAME & ENGINE EXAMINATION**

Location: Whitethorn, California  
Date: March 8, 2024  
Time: 1325 Local  
Airplane: Cirrus SR22, N2824M

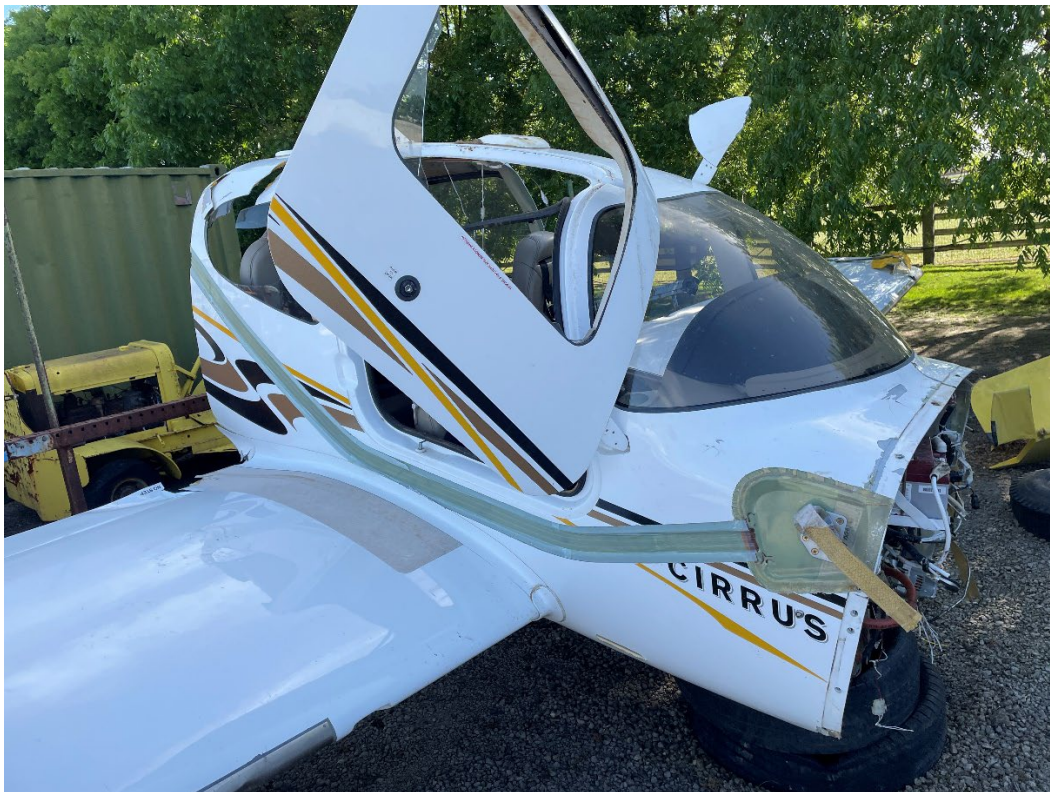
Examination of the recovered wreckage revealed that the engine, engine mount and nose landing gear had been separated from the fuselage by recovery personnel. The firewall exhibited crushing and bending aft. The left side door was fracture separated from the door hinges. The fuselage, aft of the rear seats was separated by recovery personnel to facilitate wreckage recovery.

**Figure 1: View of fuselage during examination.**

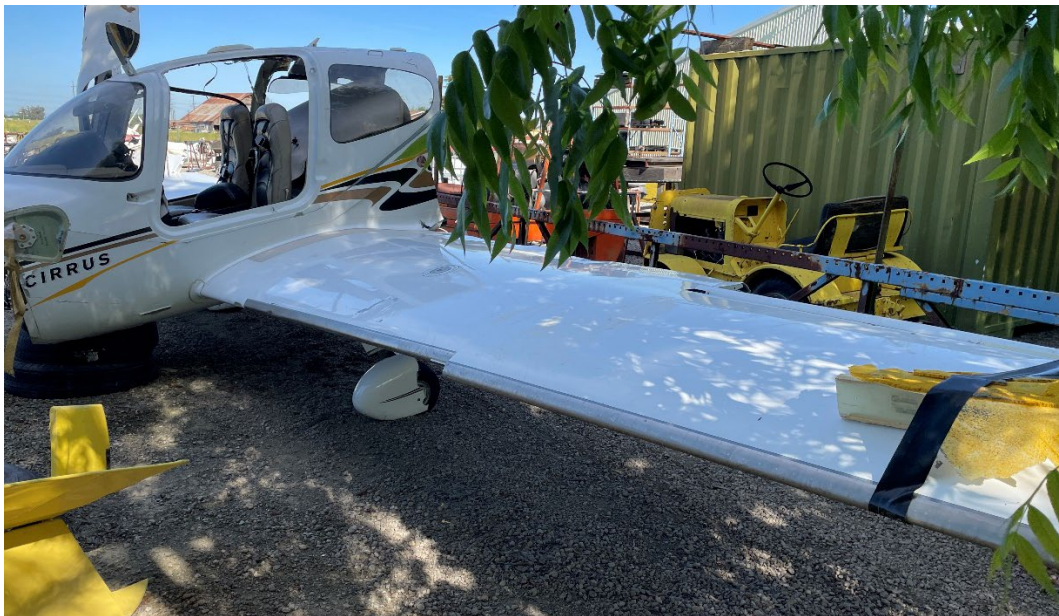
The left wing remained attached to the fuselage. Crushing was observed on the leading edge from the wing root to about mid span. An additional section on the leading edge about 6 inches in width of crushing was observed near the wing tip. The left flap and aileron remained attached via their mounts. Crushing and bending was observed to the left flap and aileron. The main fuel tank fuel cap was observed in place and secure. The left landing gear remained attached to the wing.

**Figure 2: View of left wing during examination.**

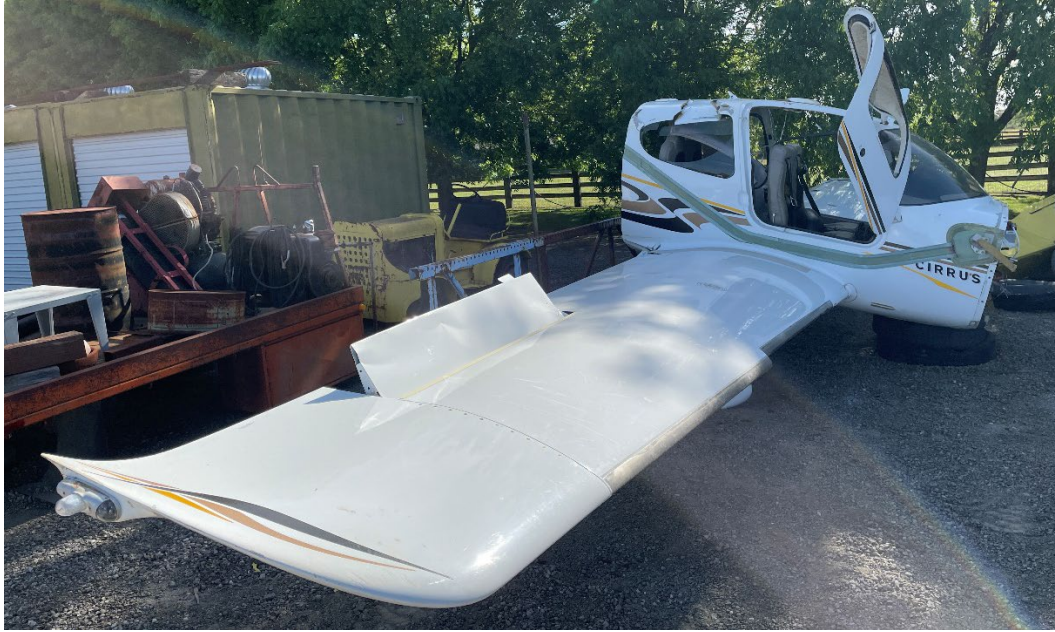
The right wing remained attached to the fuselage. Crushing was observed on the leading edge near the wing root. The right flap and aileron remained attached via their mounts. Crushing and bending was observed to the left flap and aileron. The main fuel tank fuel cap was observed in place and secure. The right landing gear remained attached to the wing.

**Figure 3: View of right wing during examination.**

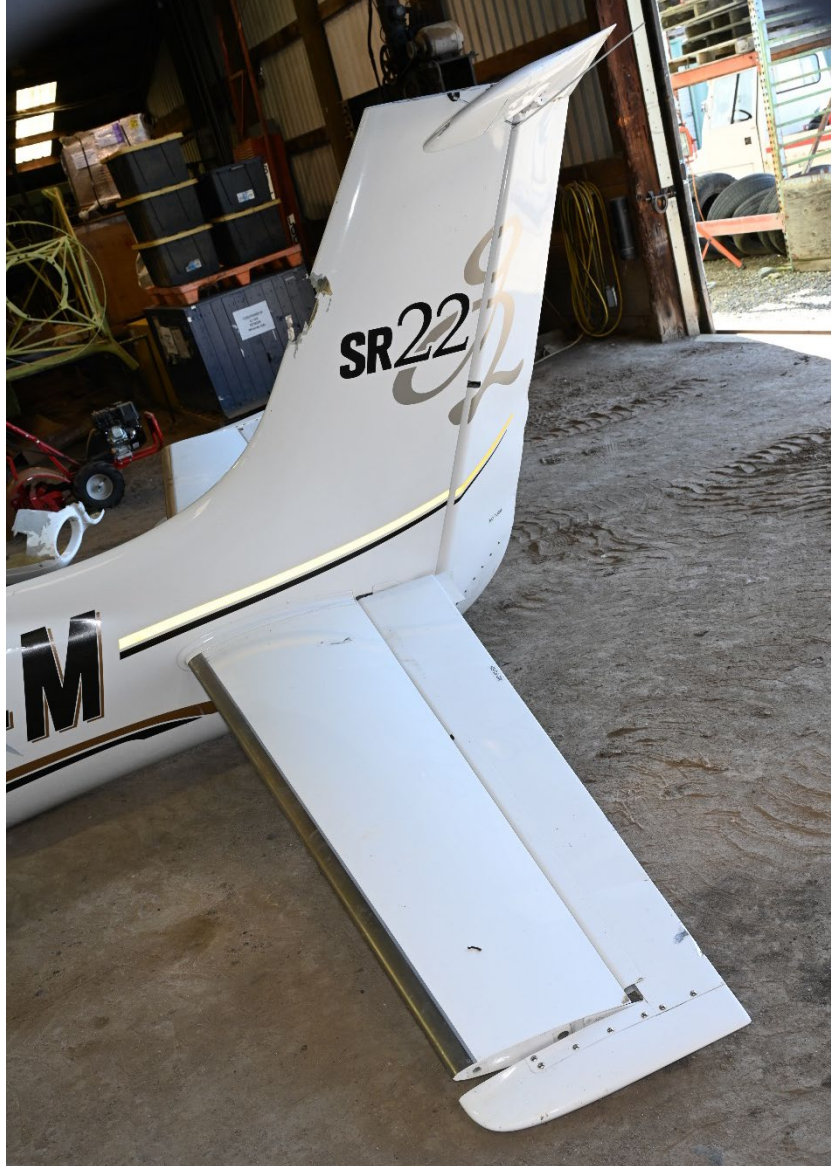
The empennage, forward of the horizontal stabilizer was fracture separated from the fuselage. The vertical stabilizer, rudder, rudder trim, horizontal stabilizers, elevator, and elevator trim tabs remained attached and secure to their respective mounts. Crushing and bending was observed to the rudder.

**Figure 4: View of empennage during examination.**

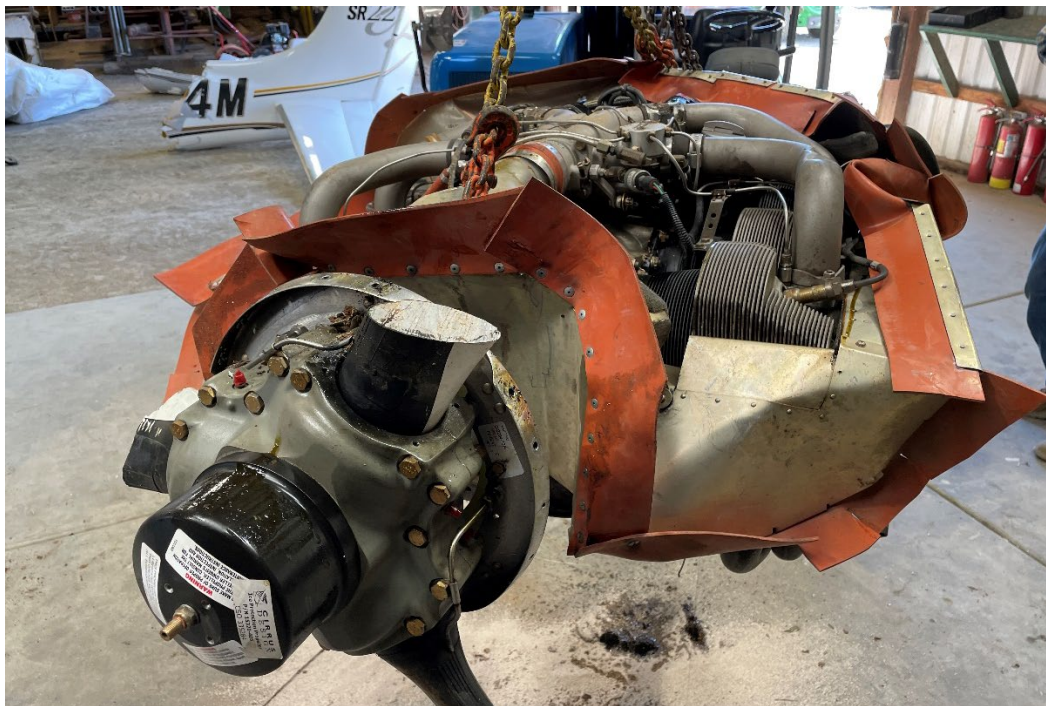
Examination of the recovered engine revealed that it was separated from the engine mount and nose gear assembly. No evidence of any external mechanical damage was observed to the engine crankcase. All six cylinders and all engine accessories remained attached. All fuel and oil lines appeared attached to their respective fittings and were tight.

**Figure 5: Front view of engine during examination.**

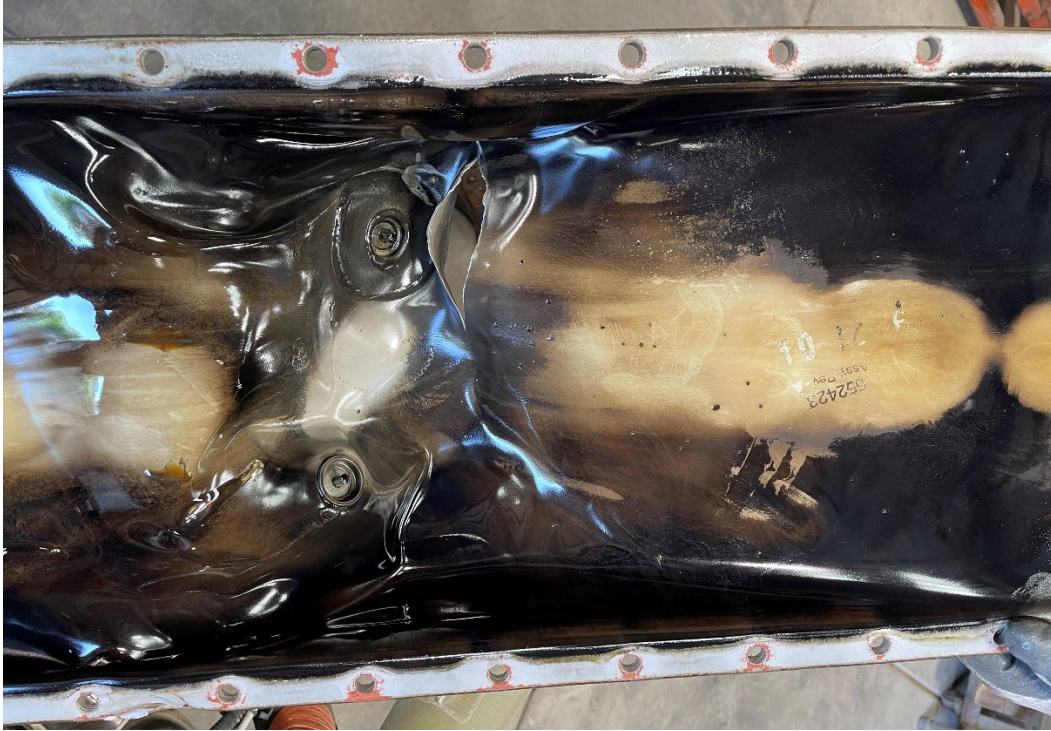
The oil sump remained attached to the crank case. Crushing and a 4 inch puncture was observed near the oil drain. About 1 quart of engine oil was drained from the oil sump. The oil sump was removed, and the oil pickup screen and oil sump were free from debris.

**Figure 6: View of puncture in oil sump.**

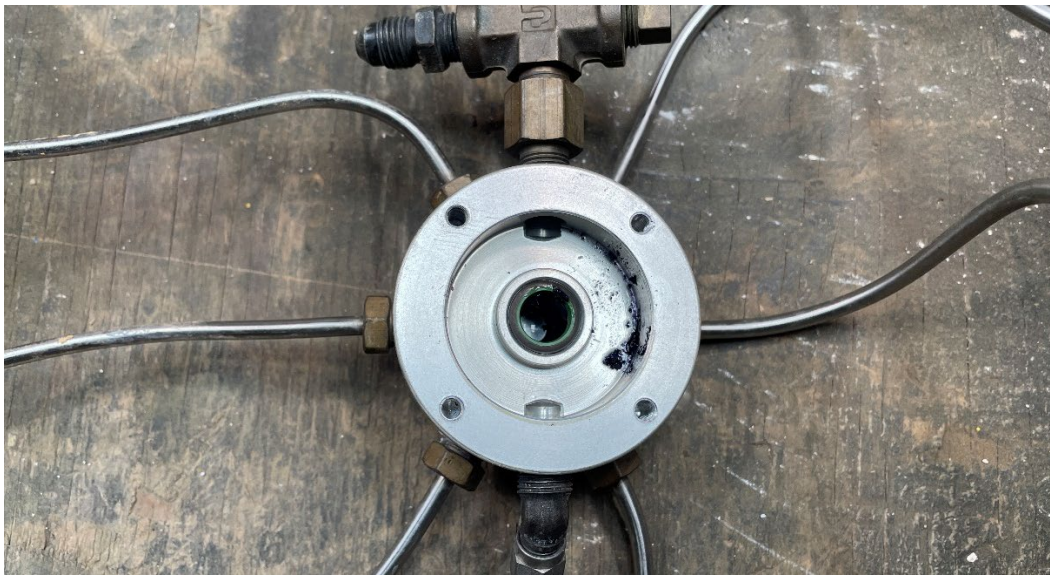
The fuel flow manifold remained attached to its respective mount and was undamaged. The fuel manifold assembly was removed and subsequently disassembled. The internal diaphragm and spring were undamaged. The fuel manifold was clear and free of debris. The liquid in the fuel manifold was tested for water using SAR-GEL water finding paste, with positive results.

**Figure 7: View of positive water test.**

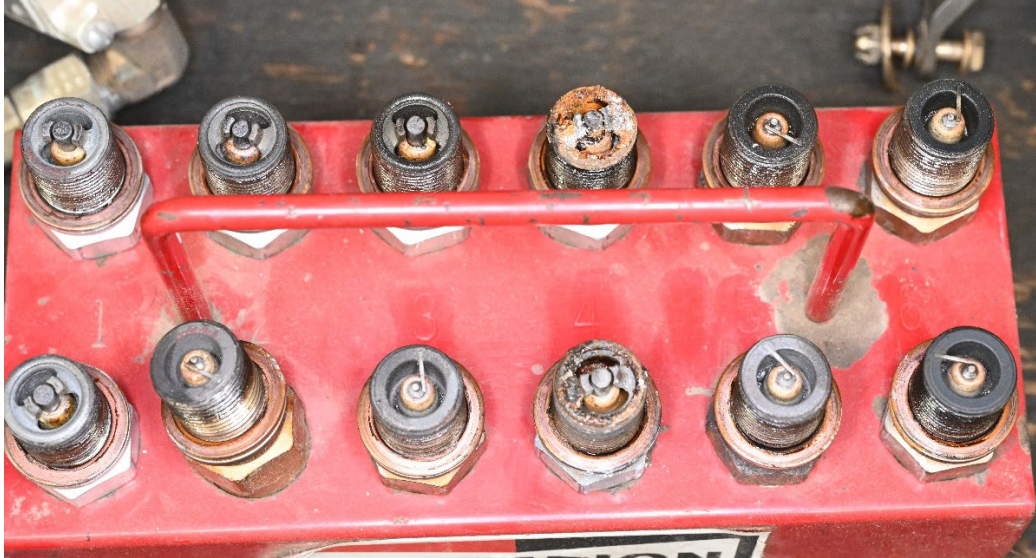
The engine spark plugs were removed from the engine, and they were a combination of massive electrode and fine wire type. The No. 4 cylinder sparkplugs had rust deposit with the electrode area, the remaining sparkplugs exhibited gray deposits within the electrode area. All of spark plugs exhibited signatures consistent with WORN NORMAL when compared to the Champion Check-A-Plug comparison chart.

**Figure 8: View of engine spark plugs.**
