National Transportation Safety Board

WPR24LA109

**INVESTIGATIVE SUPPLEMENTAL MATERIAL**

Location: Billings, Montana  
Date: 04.12.2024  
Time: 0805 mountain daylight time  
Airplane: Beech King Air B200

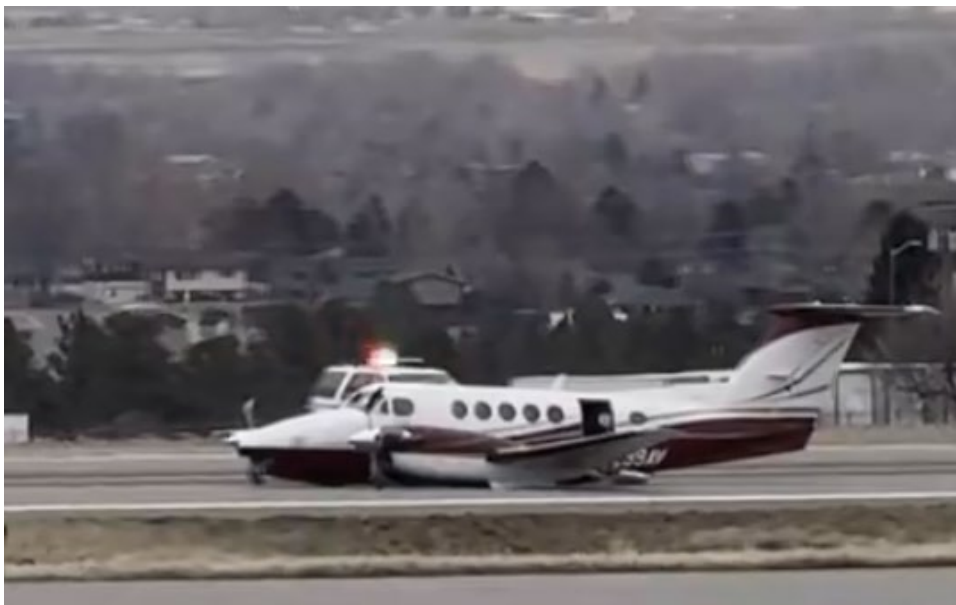
With the flaps retracted, the airplane touched down on the runway 28R. The pilot stated that the main landing gear buckled, followed by the nose gear. The propellers contacted the runway as the belly slid across the surface, damaging both engines.

*Figure 1: Airplane landing with the gear retracted*

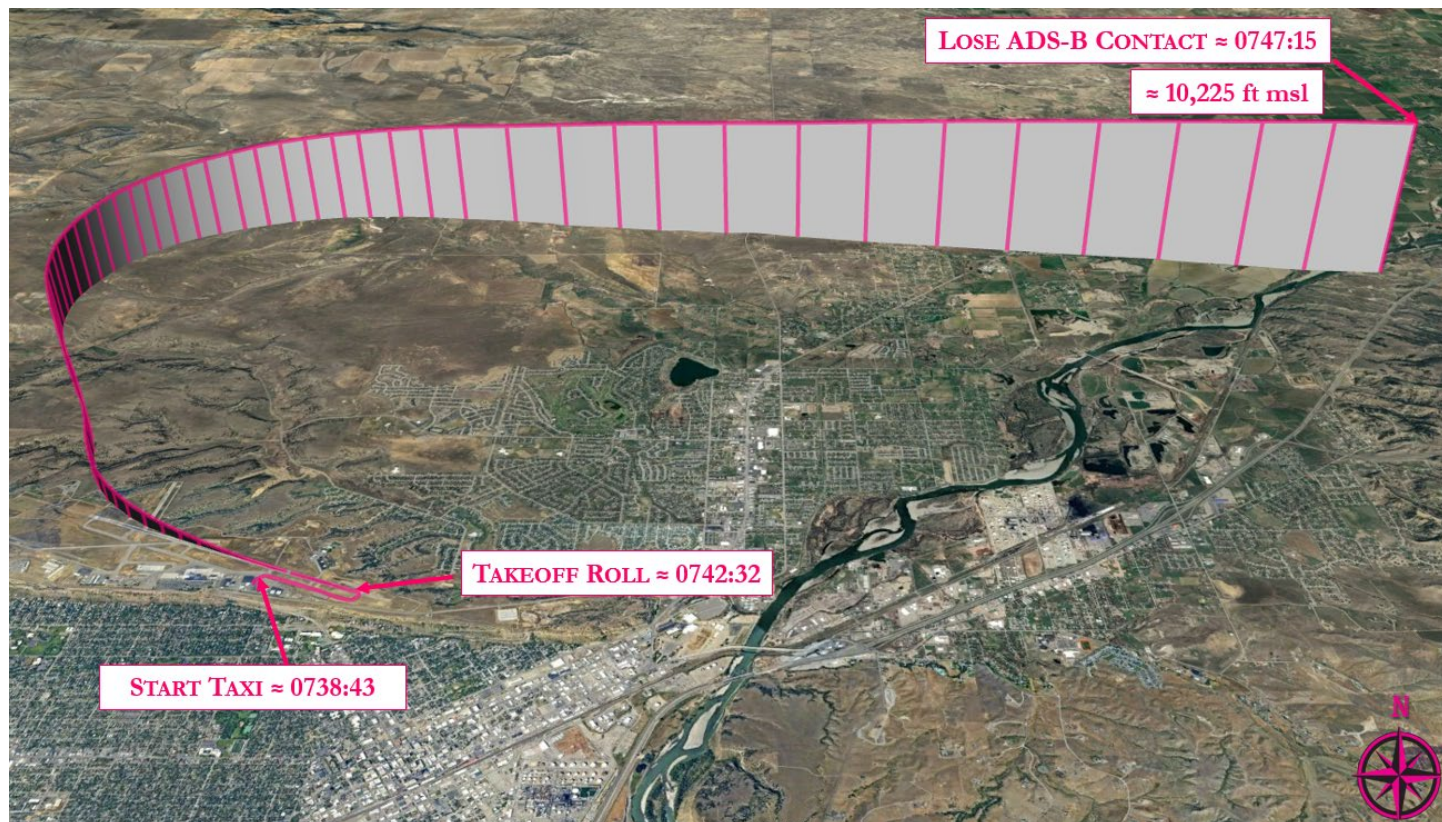
Investigators reviewed the Federal Aviation Administration (FAA) provided Automatic Dependent Surveillance-Broadcast (ADS-B) data for the accident flight (see Figure 1 below). The data disclosed that the airplane departed from runway 28R about 0742 and made a gradual, right-climbing turn to the east. The track ended about 0747.

Figure 2: ADSB data showing the flight path until the loss of electrical power

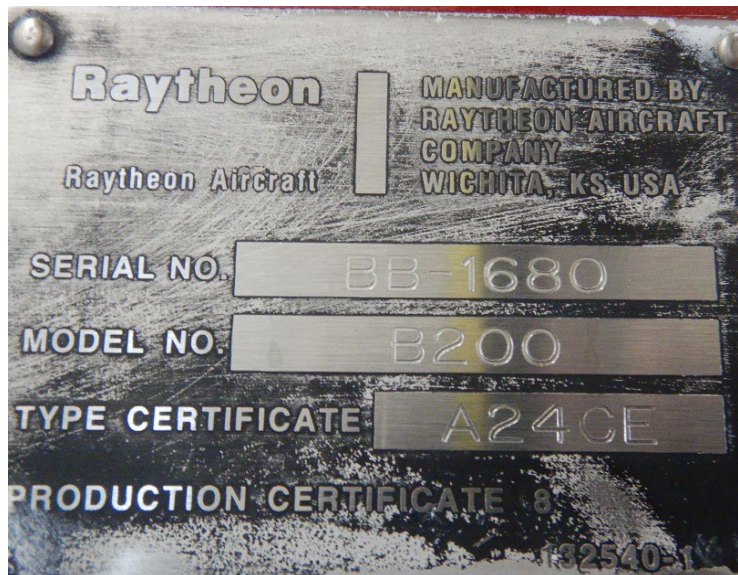
Figure 3: Data plate from the airplane

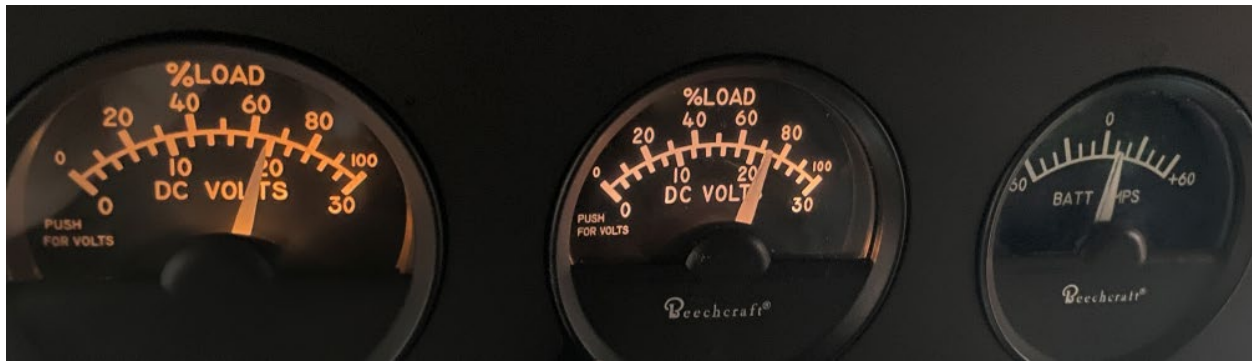
Figure 4: Generator load gauges in overhead panel

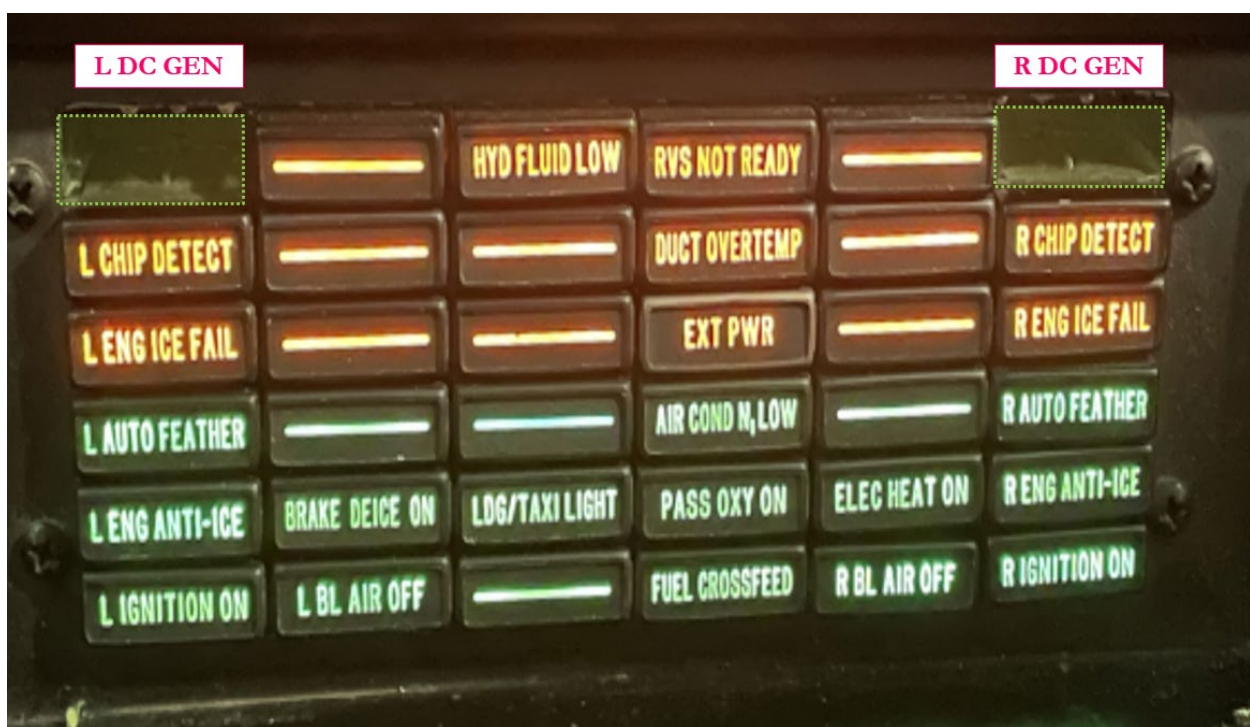
The test for the caution-advisory annunciation panel revealed that all the lights illuminated with the exception of the left and right generator lights (L DC GEN and R DC GEN). When the left light was reset, the light was dimly illuminated, consistent with one bulb not working. An illuminated light was removed and placed into the receptacle for the generator lights. It illuminated in both slots, indicating that the contacts were not faulty.

Figure 7: Test for the caution-advisory annunciation panel

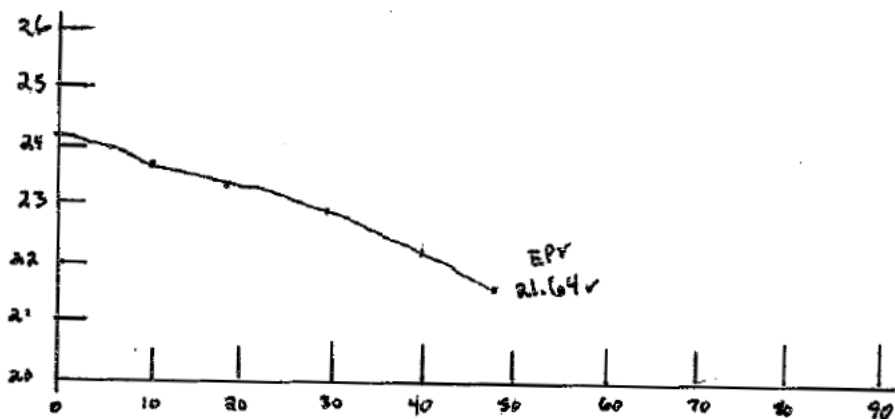
The battery was capacity tested. A 42-amp was applied to the battery and the load dropped to 22.2 volts after 30 secs; to 21.3 volts after 6 minutes; and it failed at 19.99 volts after 8.2 mins. The mechanic testing the battery stated normal batteries will be 23.8-24.2 after 30 secs.

Figure 9: Test results for the battery

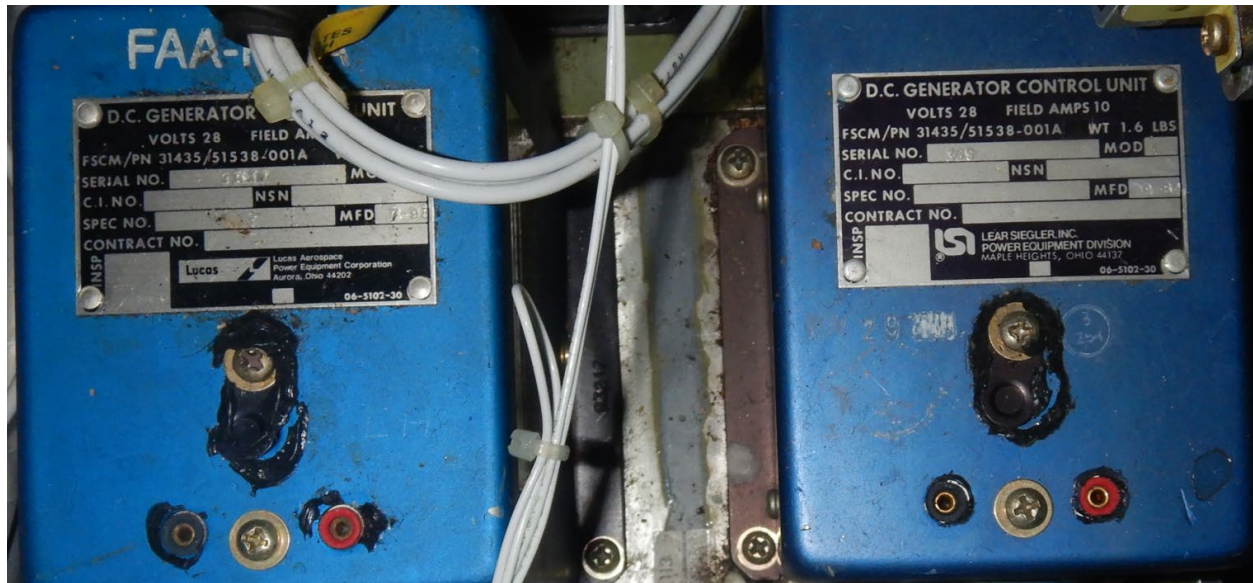
The starter generators and generator control units (GCUs) were removed and sent for functional testing. All components tested within the required operational parameters. The No. 2 engine starter generator was identified as part number 101389007-1, serial number 14288. The No. 1 engine starter generator was part number 10189007-1, serial number 12573. The GCUs tested included the right-position unit, part number 31435/55138-001A, serial number 93217, and the left-position unit, part number 31435-51538-001A, serial number 369.

Figure 10: Starter-Generators
