# National Transportation Safety Board

WPR24LA110

## **MATERIALS LABORATORY**

Factual Report 24-037

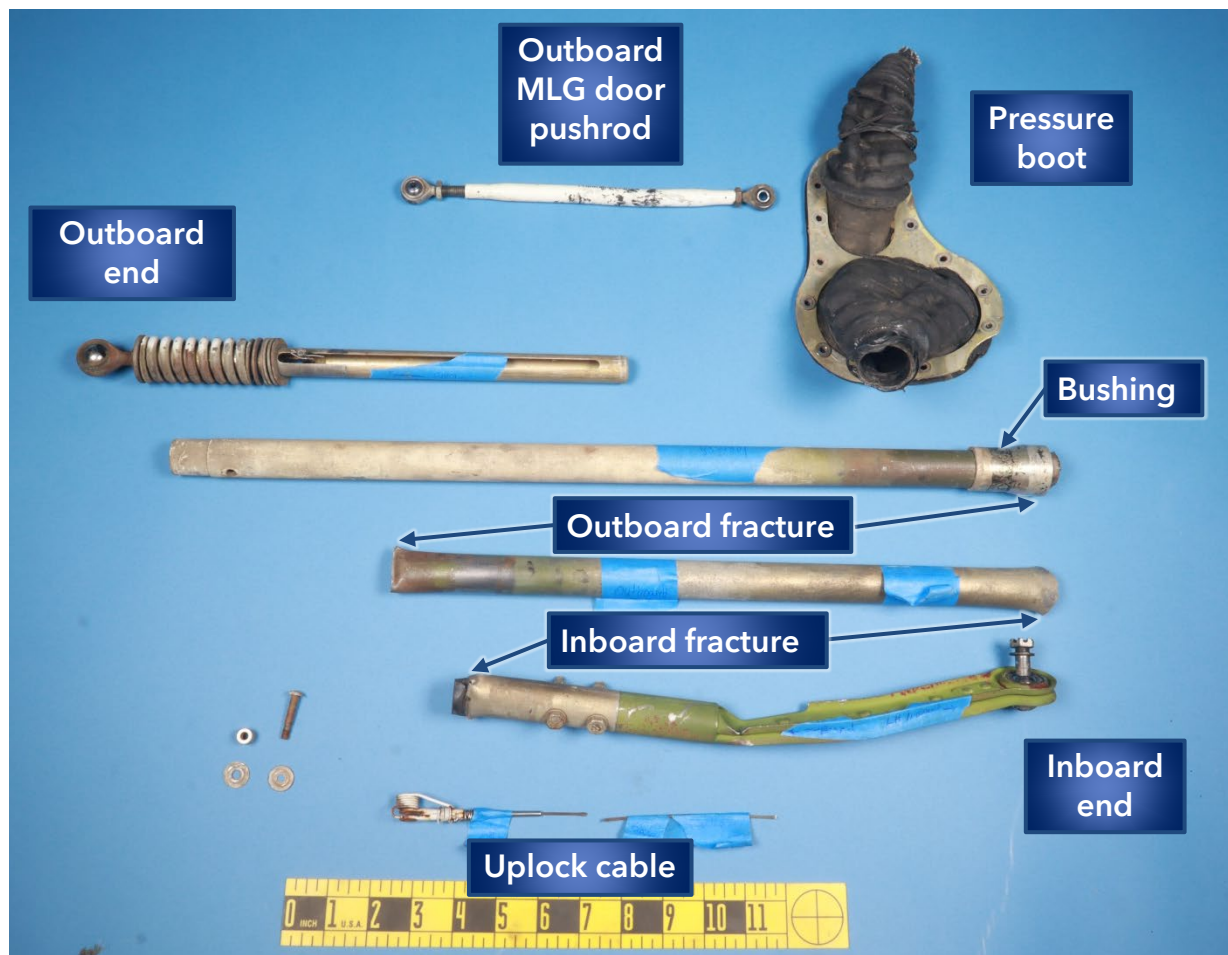
An overall view of the submitted components associated with the left main landing gear (MLG) is shown as received in figure 1. The left main landing gear pushrod assembly was fractured at two locations, and the inboard piece was bent upward near the middle of the piece. The uplock cable was fractured, and the outboard MLG door pushrod was slightly bent.

The inboard and outboard fractures in the left MLG pushrod were located approximately 14 inches and 31 inches from the inboard attachment, respectively. The tubular cross-section of the pushrod was collapsed at both fracture locations, consistent with local bending. At the outboard fracture location, the tube was bent consistent with the inboard end moving aft relative to the outboard end. At the inboard fracture location, the tube was bent consistent with the inboard end moving forward relative to the outboard end. Fracture features at each location were on slant angles consistent with ductile overstress fracture. The overall deformation and fracture pattern was consistent with buckling from compression loading.

The pressure boot had been disassembled from the bushing on the left MLG pushrod before the parts were received as shown in figure 1, and the clamp for attaching the boot to the bushing was not included in the submitted components. The bushing was positioned on the outboard piece of the pushrod tube adjacent to the outboard fracture location as indicated in figure 1. The bushing did not move when hand forces were applied to slide the bushing outboard from its as-received position.

**Figure 1.** Overall view of the submitted components. The inboard end, outboard end, and fracture locations on the left MLG pushrod assembly are indicated.
