**RE: Duke gear swing and cable removal**

**From** Knox, Jeremy D (FAA) <[REDACTED]>

**Date** Tue 6/4/2024 11:38 AM

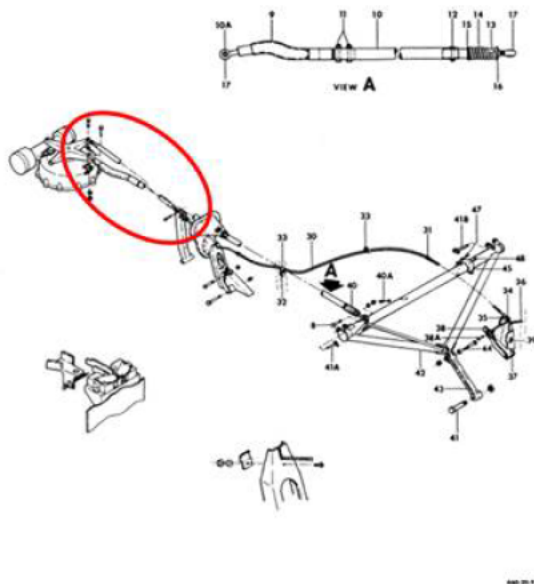
1. LMLG pushrod (1 of 3, item 9-12 from image below)
2. LMLG pushrod (3 of 3, item 9-12 from image below)
3. LMLG pushrod (3 of 3, item 9-12 from image below)
4. LMLG pushrod insert/spring (item 13-17 from image below)
5. Down lock cable from fuselage side
6. Down lock cable from LMLG side with attached torsion spring

I do need to identify where that push tube is in the IPC. Was that push tube the one circled in red below?
