# National Transportation Safety Board

WPR24LA117

## **ENGINE AND AIRFRAME EXAM SUMMARY REPORT**

Location: Acton, CA  
Date: March 22, 2024  
Time: 18:04 Pacific daylight time  
Airplane: N1695H, Piper PA-28-140

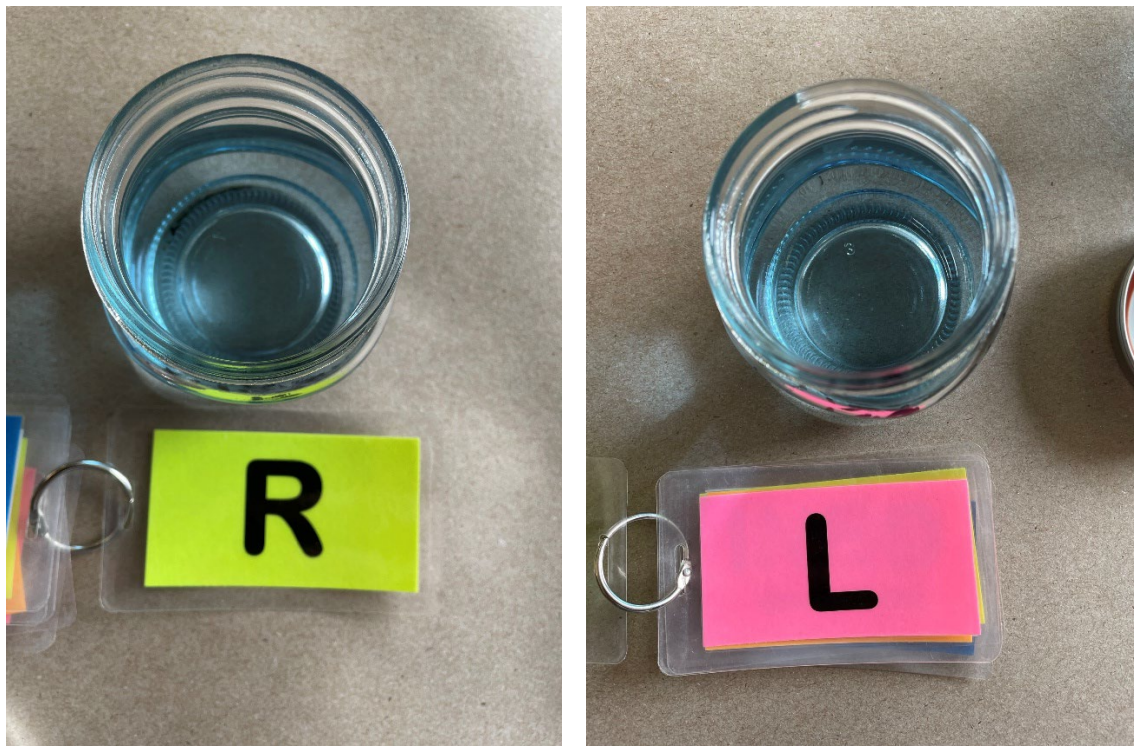
The right wing was cut at the wing root during wreckage recovery. Fluid consistent with 100LL aviation fuel was drained from the right wing fuel tank by wreckage recovery personnel (see figure 1). The underside of the right wing displayed denting and crushing throughout. The right aileron had gouging damage consistent with

The left wing was cut at the wing root during wreckage recovery. Fluid consistent with 100LL aviation fuel was drained from the right wing fuel tank by wreckage recovery personnel (see figure 2). The left wing displayed denting and crushing along the length of the leading edge. The left aileron displayed bending and creasing consistent with impact with terrain. The left wing fuel cap was found in place and secure.

Figure 1: View of sample drained from right fuel tank. Figure 2: View of sample drained from left fuel tank.

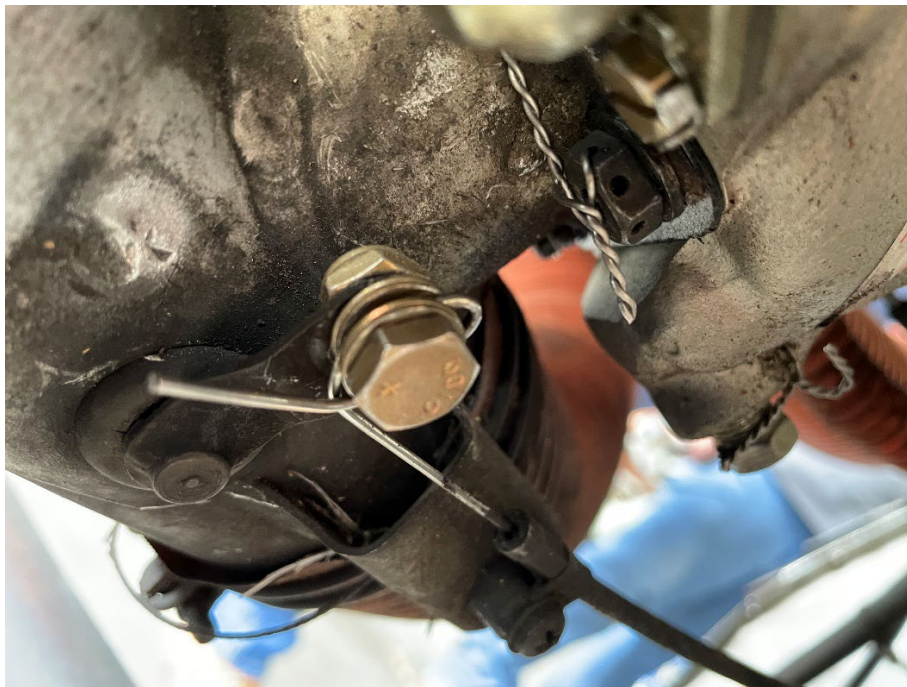
The cable attachment at the airbox mounted control arm was wrapped around the attachment bolt, sandwiched between washers, and loose (see figure 3). The cable was not threaded through the attachment bolt and safety wire was not observed at the attachment. The arm attachment to the airbox wall was loose within its housing and displayed travel in multiple directions when the carburetor heat control cable was moved within its range of travel. The heat door inside the airbox appeared undamaged. Its rubber gasket edging appeared intact. The pivot joint/axle of the heat door displayed vertical travel within the airbox, when the arm attachment traveled inside its housing. Visible grooves were found within the airbox where the heat door had seated previously, representing previous seatings of the carburetor heat "ON" and "OFF" actuation positions.

Figure 3: View of cable attachment at airbox.

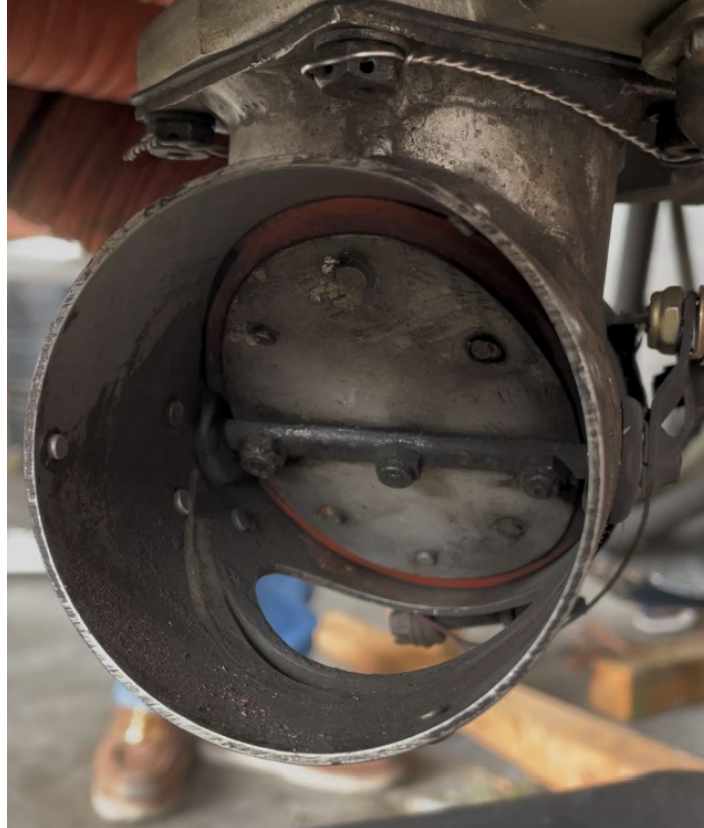
When the carburetor heat was actuated using the cabin mounted carburetor heat knob, travel was found to be restricted. Specifically, the cabin control range was

limited to between the midway point and the OFF position. When the cabin control was moved to the midway limit (in the ON direction), the carburetor heat door closed, blocking the filtered air inlet, and diverting the air from the muffler shroud (see figure 4).

Fig. 4: View of heat door closed in ON position, and cabin control knob at midway limit.

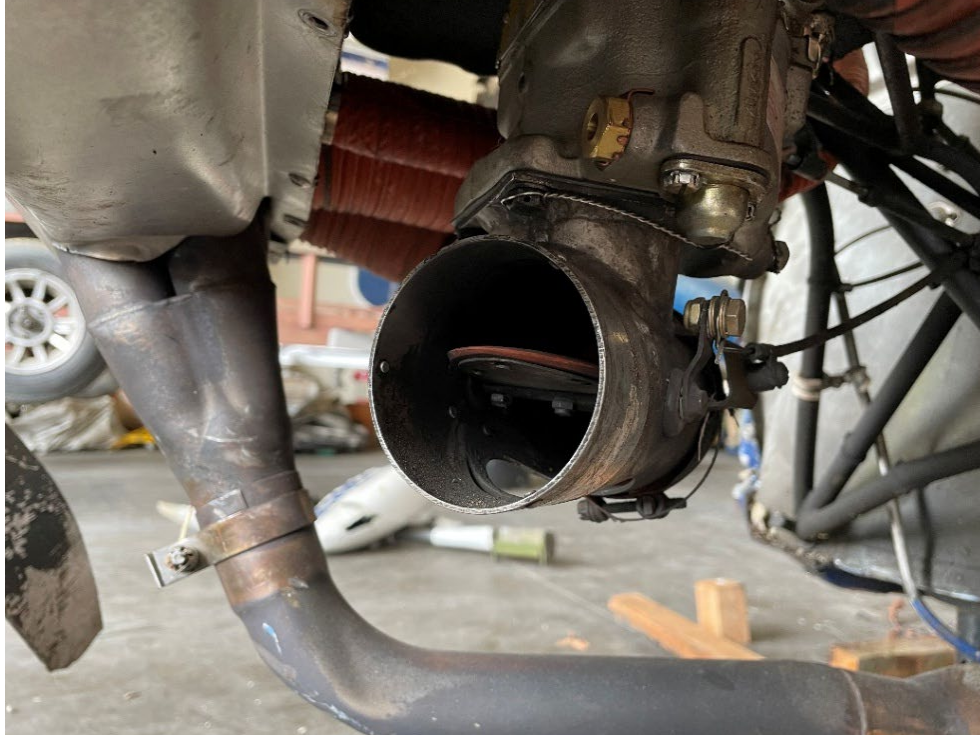
However, when the cabin control was moved to its OFF position, the carburetor heat door stopped at the midway point, such that both filtered and hot air from the muffler shroud were simultaneously entering the carburetor inlet (see figure 5).

Fig. 5: View of cable attachment at airbox and heat door with the carburetor heat at its full OFF position.

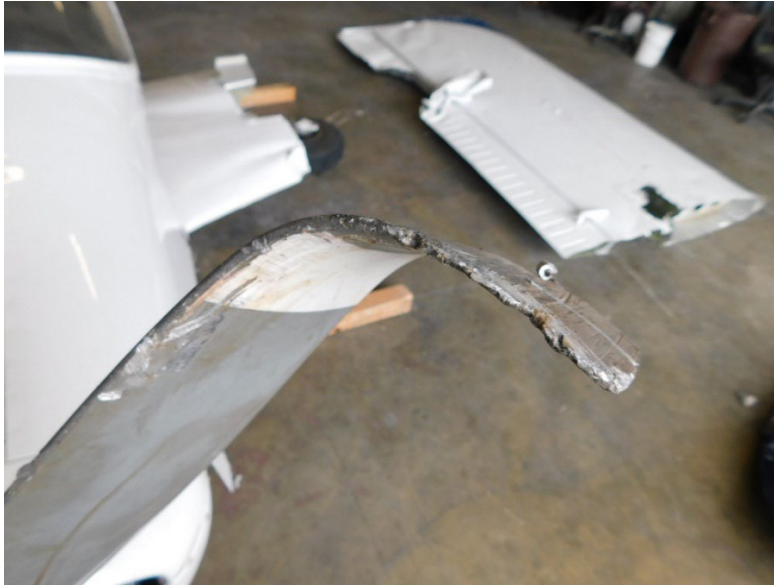
Fig. 6: View of blade A.

The fixed pitch, two bladed propeller remained attached to the crankshaft flange. Blade A was bent forward near the blade tip and displayed chordwise striations and leading edge gouging (see figure 6). Blade B was bent aft at mid span, and bent forward near the blade tip, with chordwise striations and gouging at the blade tip (see figure 7). The propeller spinner remained attached and undamaged.

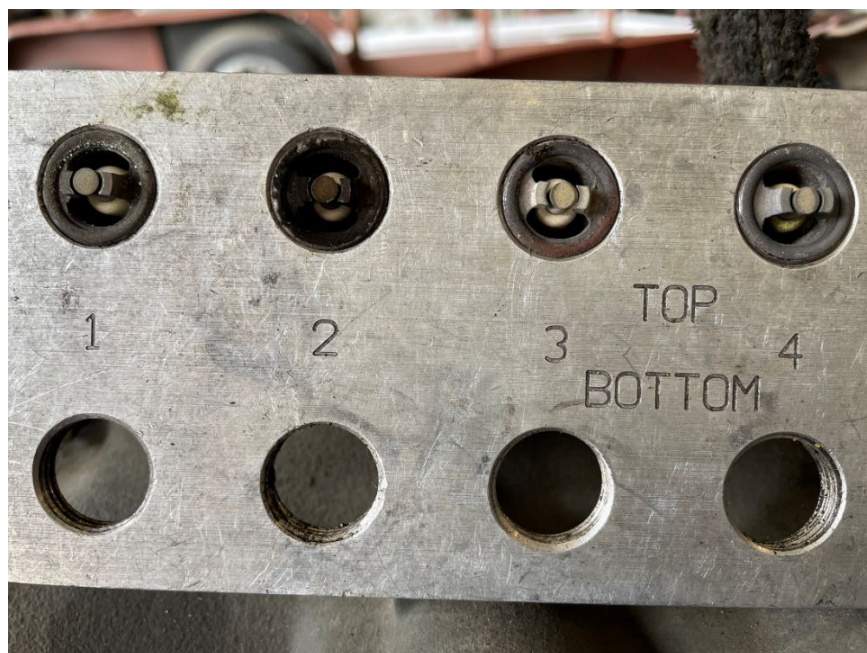
The Champion REM40E park plugs were removed. All electrodes displayed 'Normal' wear signatures consistent with low service life, when compared to the Champion AV-27 Check-A-Plug guide, and were grey in color. Spark plug no 2 displayed black sooting. (See figure 8).

Fig. 8: View of upper spark plugs.

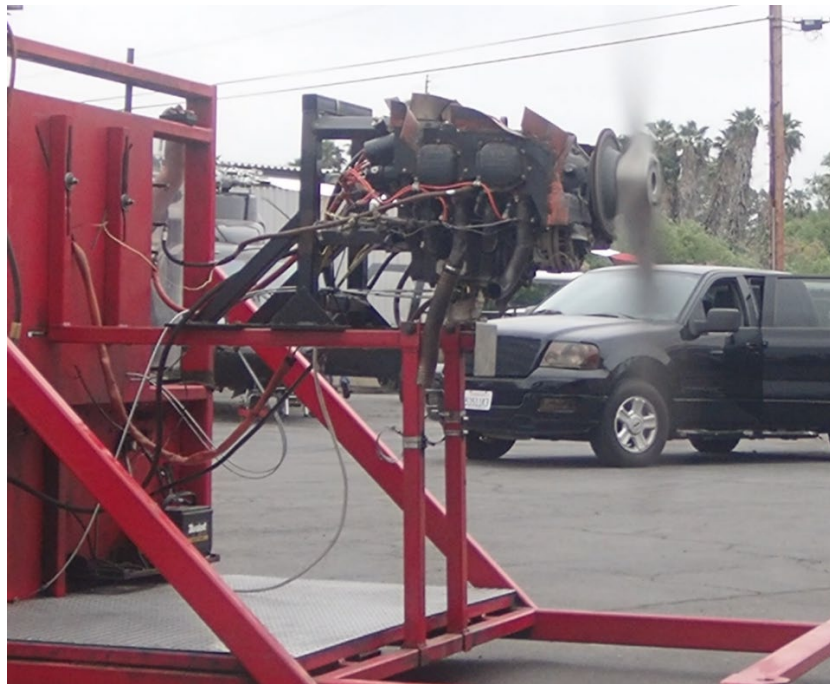
advanced to the full forward position, then decreased to 1700 rpm, increased to full, then decreased to idle, and cycled. The right magneto drop check was 100 rpm, the left magneto drop check was 65 rpm. The idle rise was 25 at 1000 rpm. Full static power was noted at 2,100 rpm. Total engine running time on the test stand was 11 minutes (see figure 9).

Fig. 9: View of engine on test stand during test run.
