# National Transportation Safety Board

WPR24LA121

## **ENGINE EXAM**

Location: Yucca Grove, California  
Date: April 4, 2024  
Airplane: Kitfox Series 5, N743JT

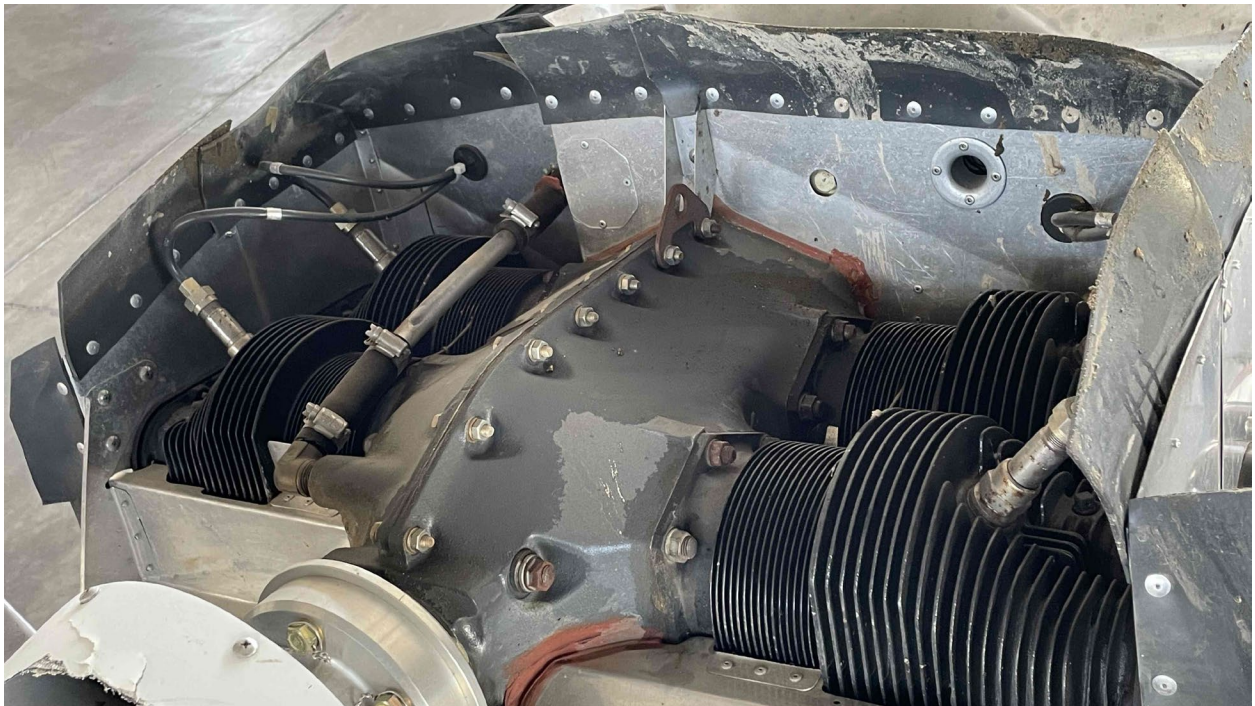
The upper engine cooling deck was mostly dry, with evidence of oil drainage from the engine when it was inverted, but no evidence of oil leak (see figure 1). The carburetor, starter motor, alternator, and both magnetos remained firmly attached to their respective pads. The oil pressure and oil temperature senders were intact and did not appear to be leaking. All remaining oil fittings and lines were intact with no evidence of leak.

**Figure 1 - Top of the engine.**

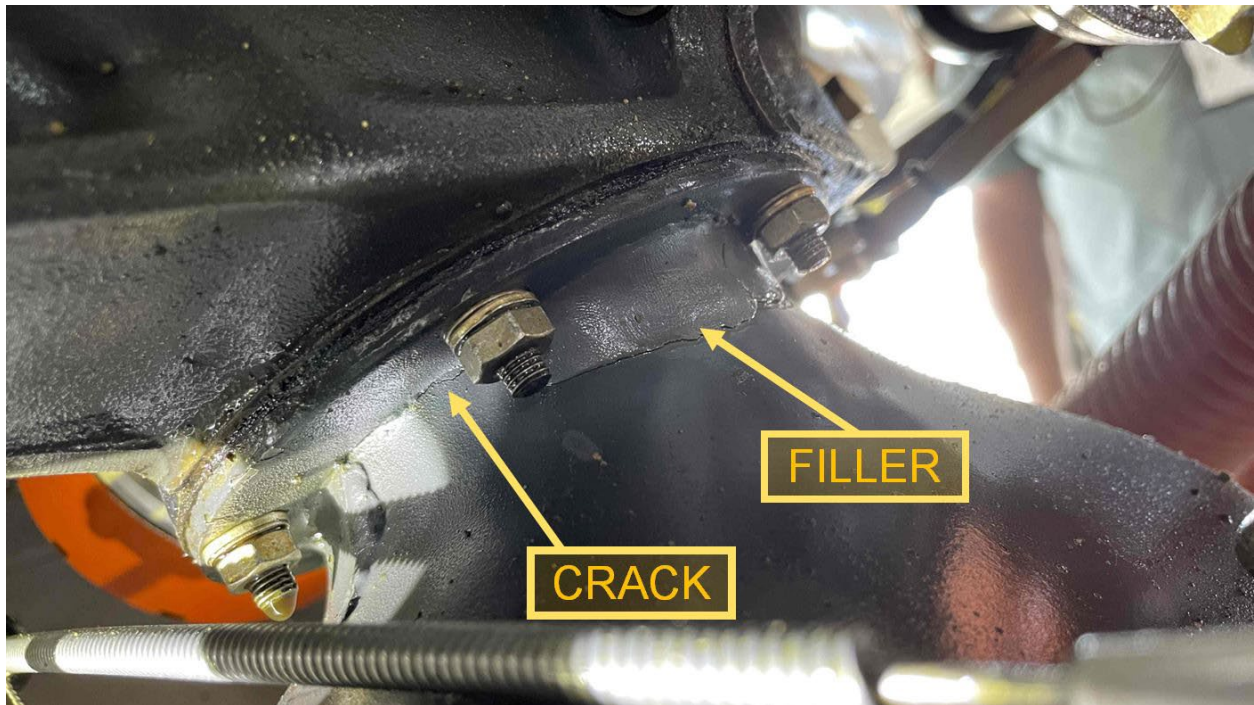
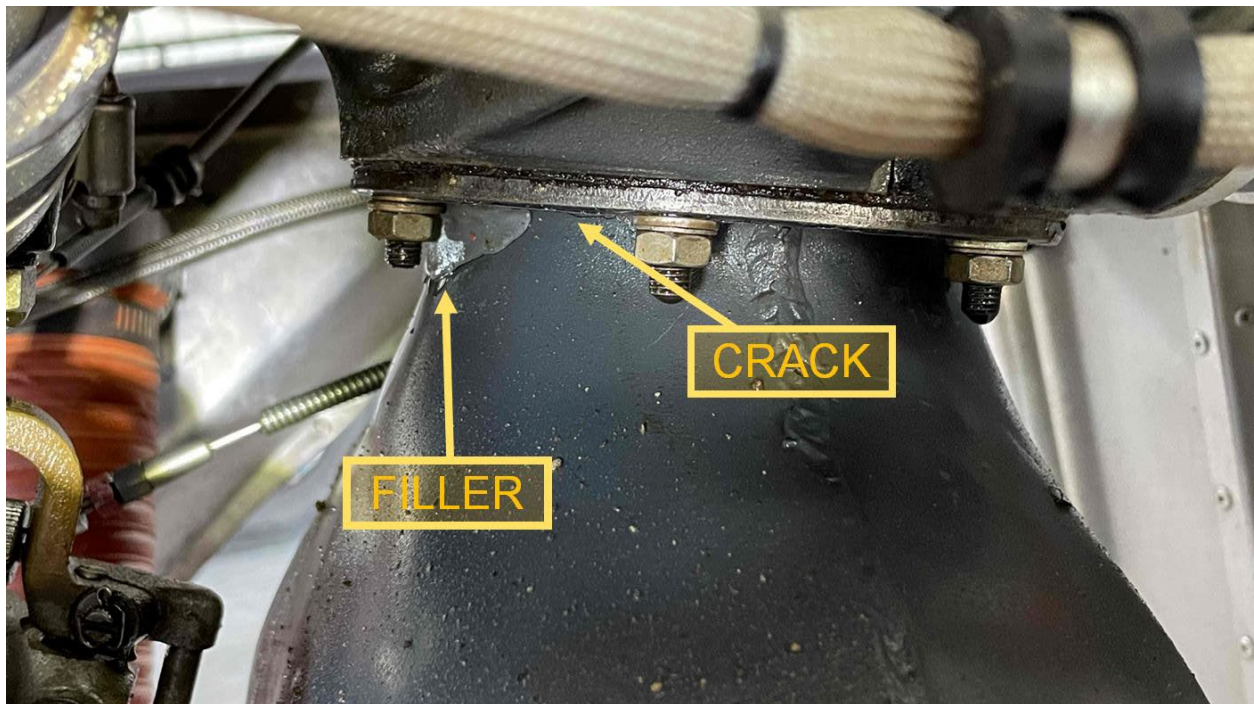
The engine of the experimental amateur-built airplane appeared to have lost most of its oil through a crack in the oil sump mounting flange. The flange showed evidence of a preexisting crack which had been inappropriately sealed with an epoxy putty by the pilot. The accident flight was the first since the repair.

Closer examination revealed that the oil sump and surrounding components and fittings, including the back side of the carburetor, were coated in oil. A 3-inch-wide bead of grey filler material had been applied to the forward neck of the sump mount flange (see figures 2, 3). The bead had unbonded from the sump and the crack opened and closed when the sump was pushed forward and aft by hand (see video attachment 1).

The pilot later confirmed the material used was "Steelstik" epoxy putty, manufactured by J-B Weld. He stated that the crack had been there since December 2023, but the leak was a "nuisance" and not significant with a total oil consumption of about 1 qt every 4-6 hours. He reported, "I performed multiple, lengthy, high power engine runs after the repair although the accident flight was the first flight after the repair".

**Figure 2 - Filler and crack at sump flange.**

**Figure 3 - Filler and crack at sump flange.**

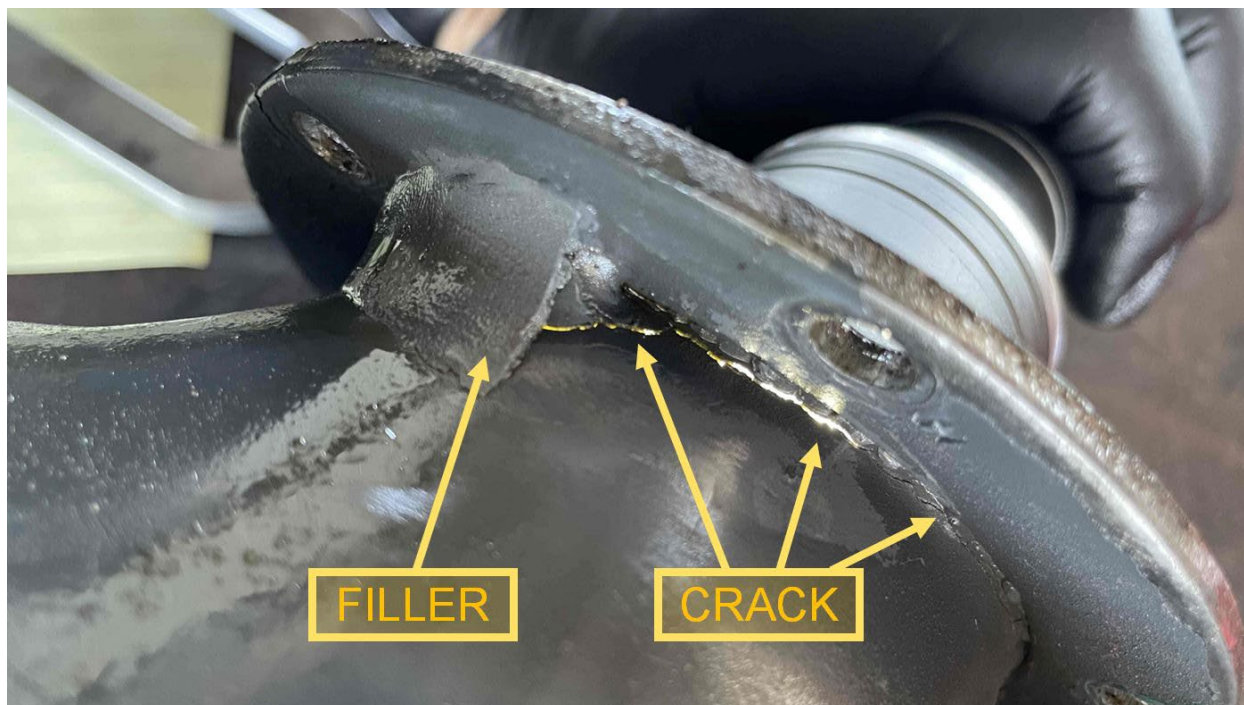
The sump was removed, and a 4 inch long crack was found in the case on the other side of the filler bead. The bead was dark grey in color and could be easily pried off with a screwdriver revealing that the crack had propagated to the outside (see figure 4). The area of the sump where the filler had been installed showed evidence of sanding marks consistent with preparation, but most of the paint remained (see figure 5).

**Figure 4 - Removed filler exposing crack at sump flange.**

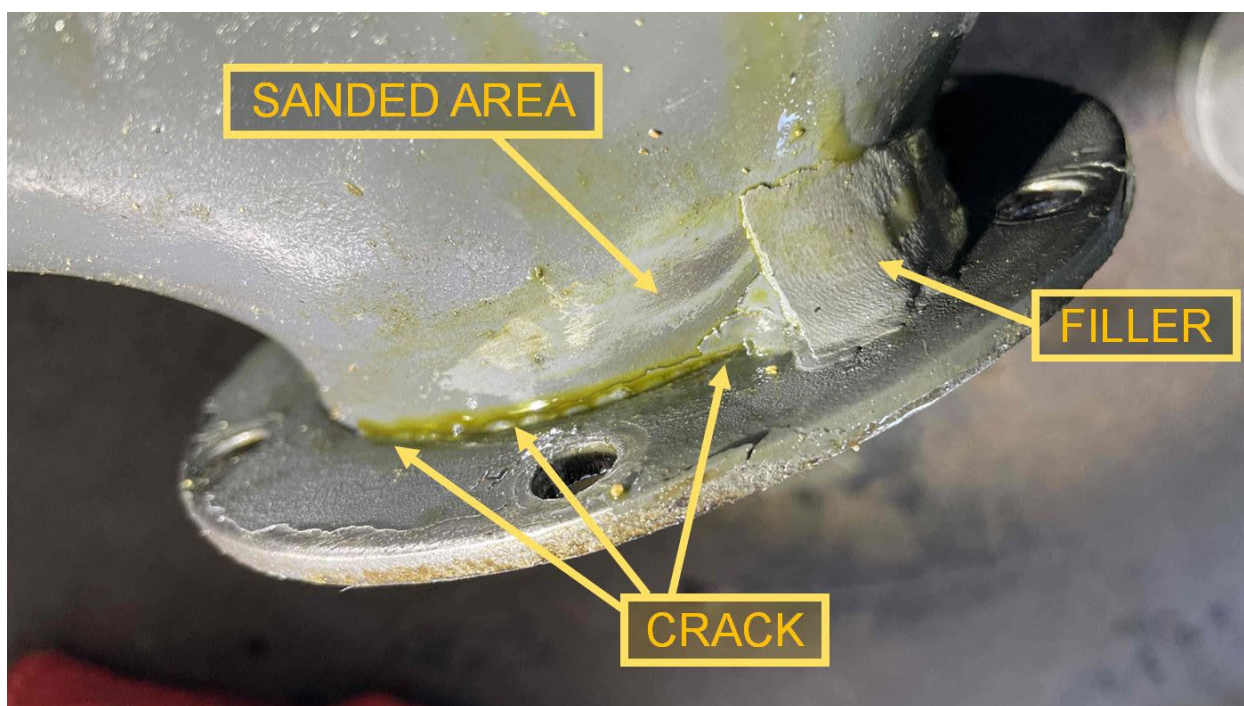
**Figure 5 - Removed filler exposing crack at sump flange and sanded area.**
