# National Transportation Safety Board

WPR24LA122

## **MATERIALS LABORATORY**

Factual Report 24-059

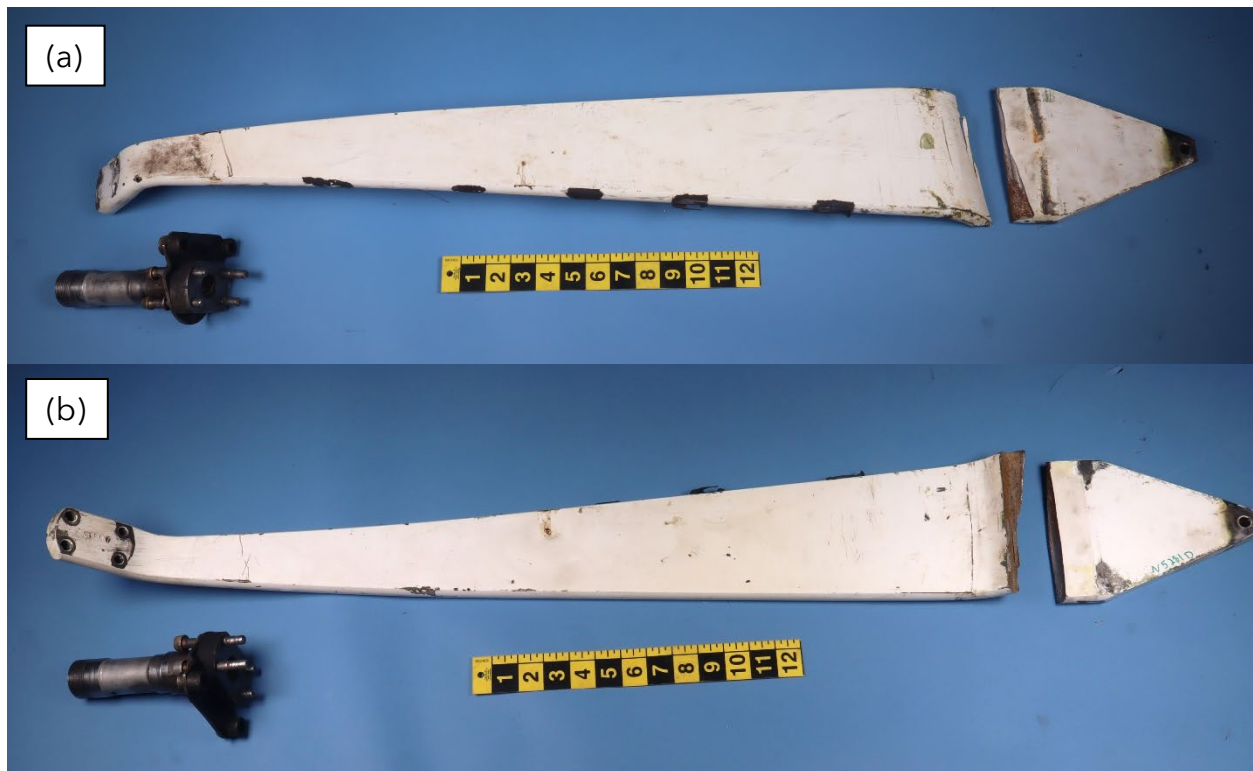
Figure 1 shows the landing gear leg pieces and the axle with attachment bolts as received. The landing gear leg, painted white, had fractured transverse to the longitudinal direction, as shown in the figure's right. The fracture was located about

6.5 inches from the inboard end and about 36.4 inches from the outboard end of the leg.

Figure 1. The pieces of the left landing gear leg, as received from (a) outboard and (b) inboard faces.

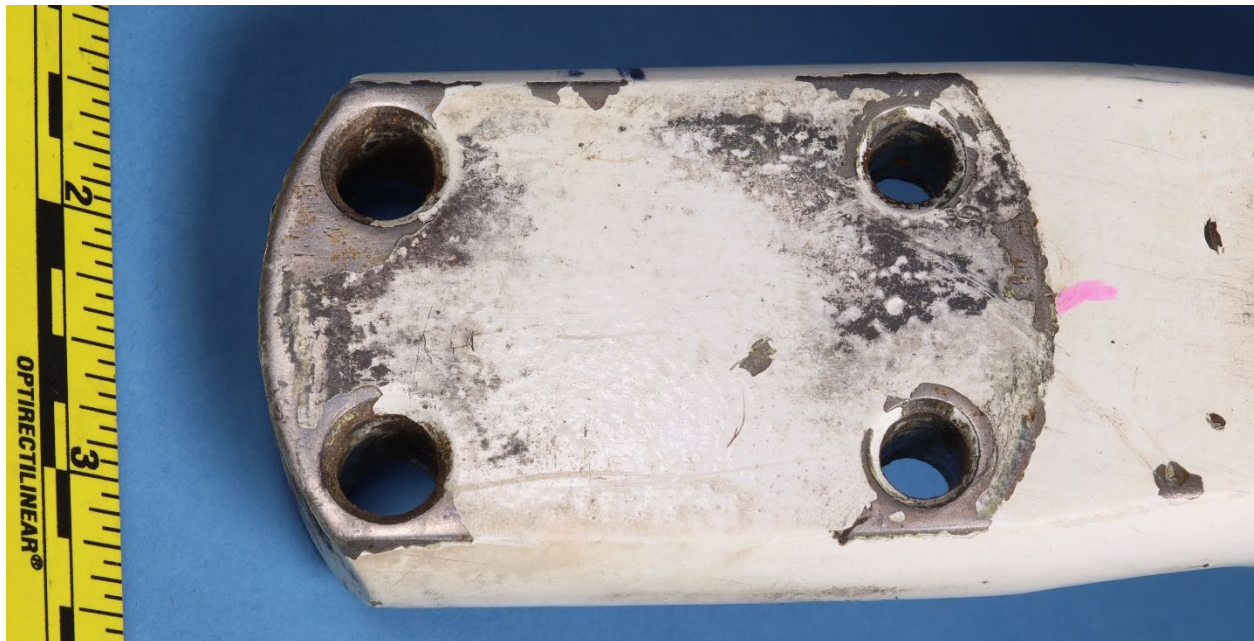
The outboard face at the outboard end of the landing gear leg, shown in Figure 2, exhibited some loss of white paint, consistent with rubbing against the mating axle assembly face, shown in Figure 3. The bolt holes exhibited areas of paint loss.

Figure 2. The outboard face of the leg from Figure 1a with the attachment bolt holes.

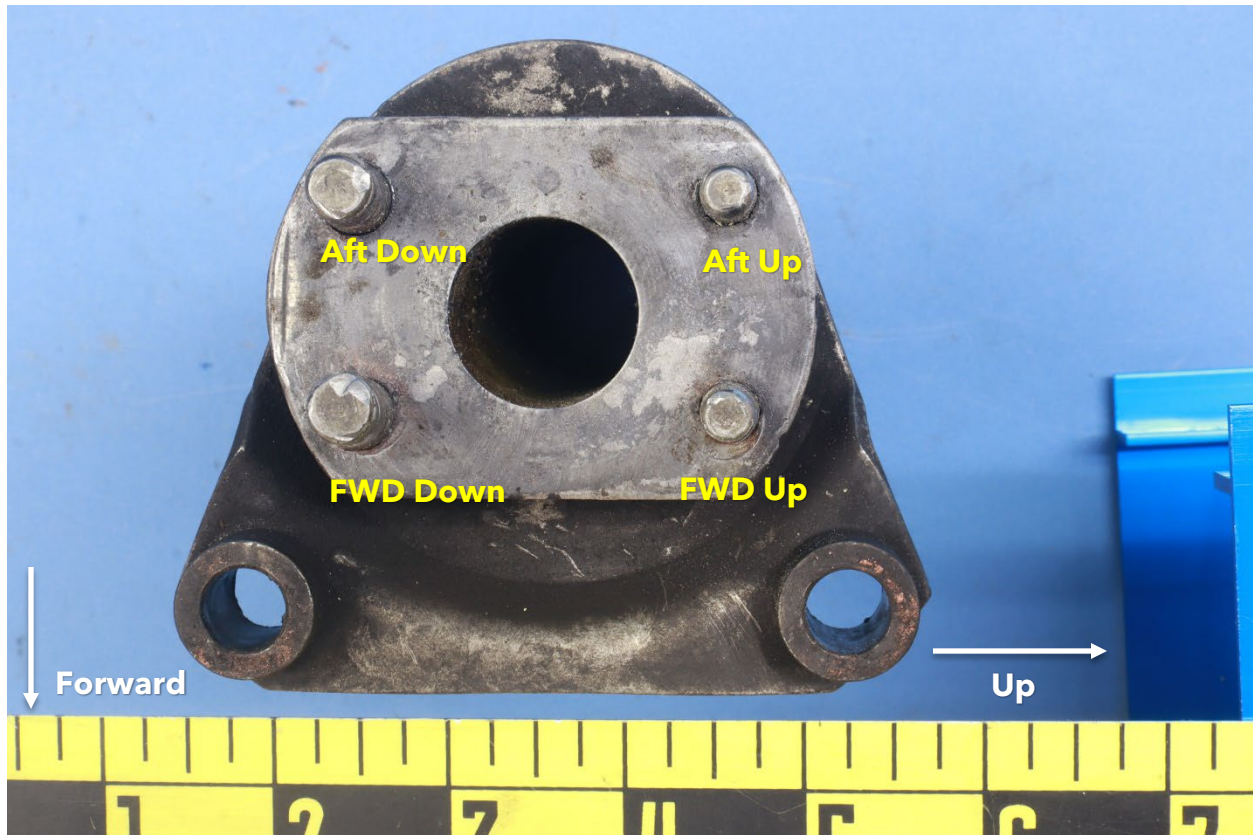
Figure 3. View of the bolts from the bolt side of the axle assembly toward the outboard direction.

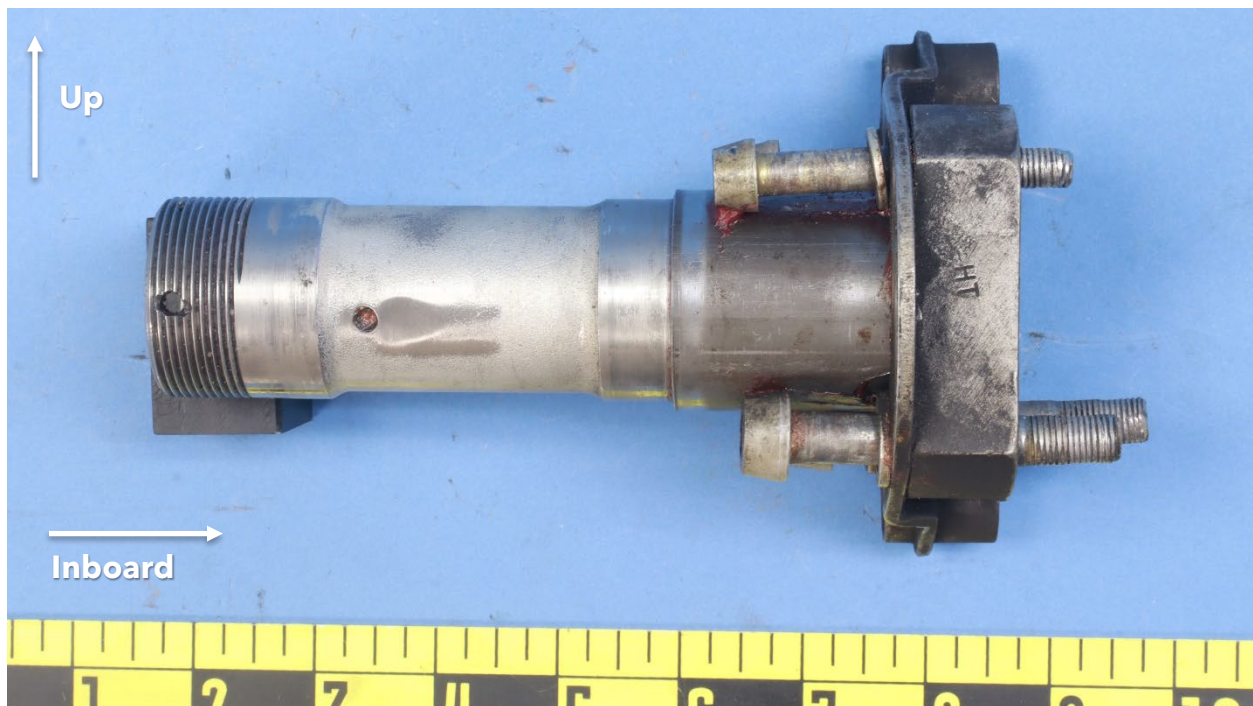
Figure 4 through Figure 9 show views of the conditions of the bolts from the axle assembly, as received. All four attachment bolts were still installed through the flange that mated with the leg, though, as shown in Figure 6, the two lower bolts protruded through the mounting flange more than the upper bolts. An angled view of these bolts, shown in Figure 7, shows that the lower attachment bolts had also bent upward. This deformation is exemplified in Figure 8, with deformation on the lower forward attachment bolt edge. There was also some inward deformation to one of the upper attachment bolts, shown in Figure 8.

Figure 4. Aft-looking forward view of the axle assembly, as received.

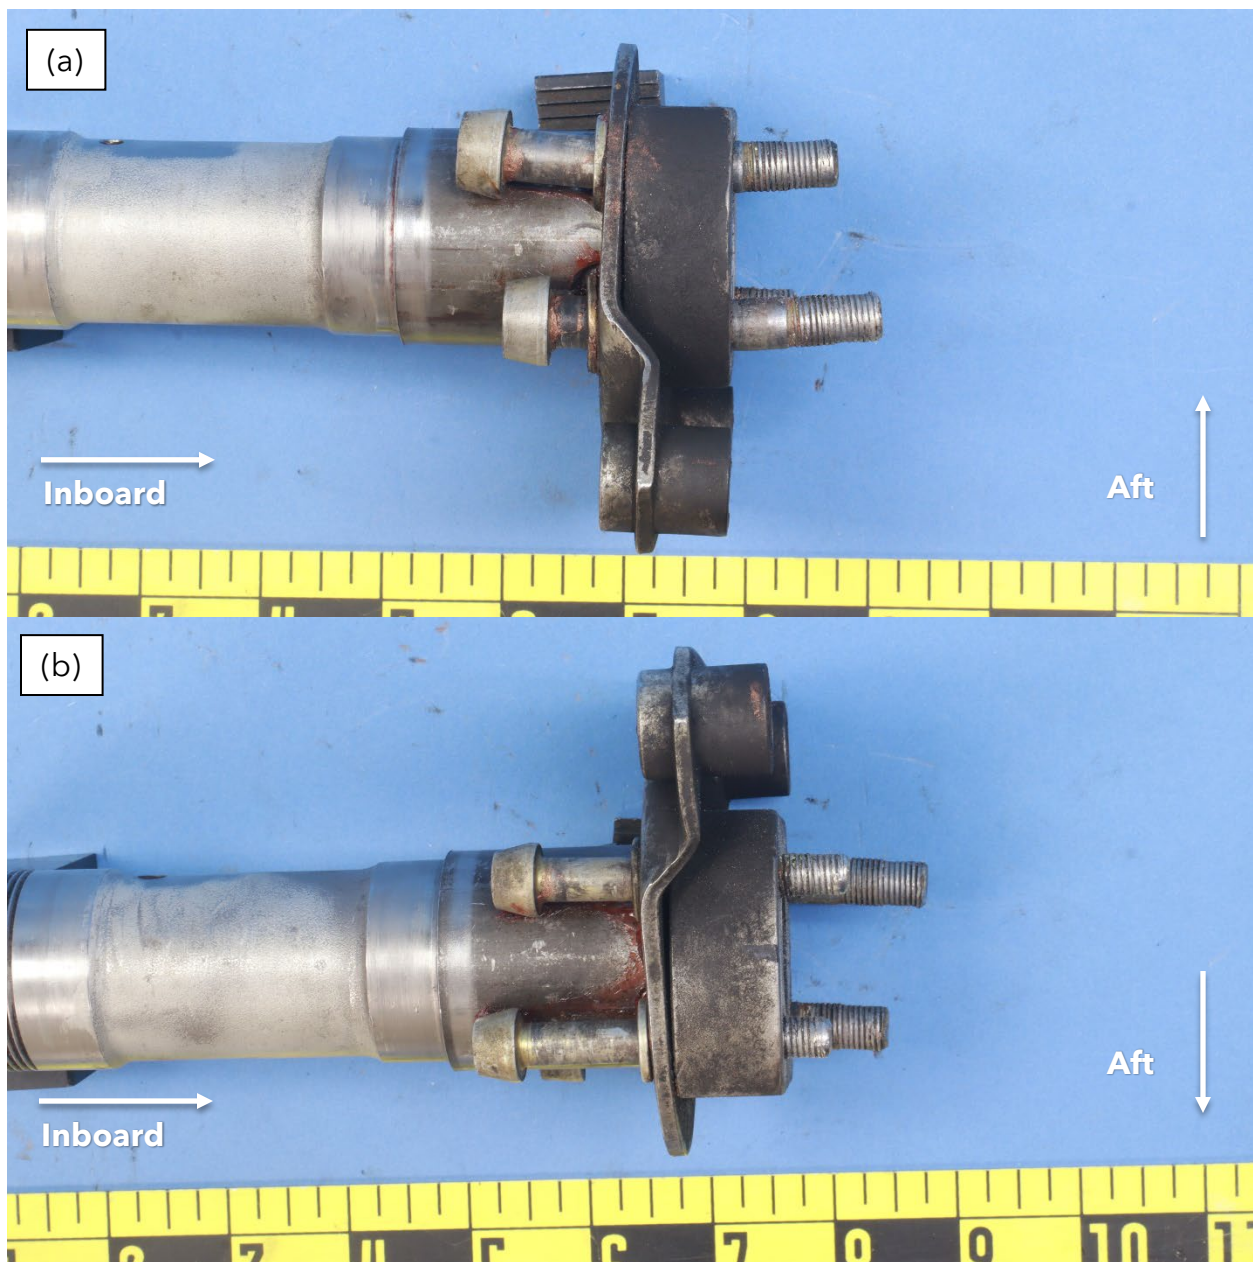
Figure 5. Opposite side views of the bent bolts from the axle assembly: a) lower or bottom side view and b) top or upward view.

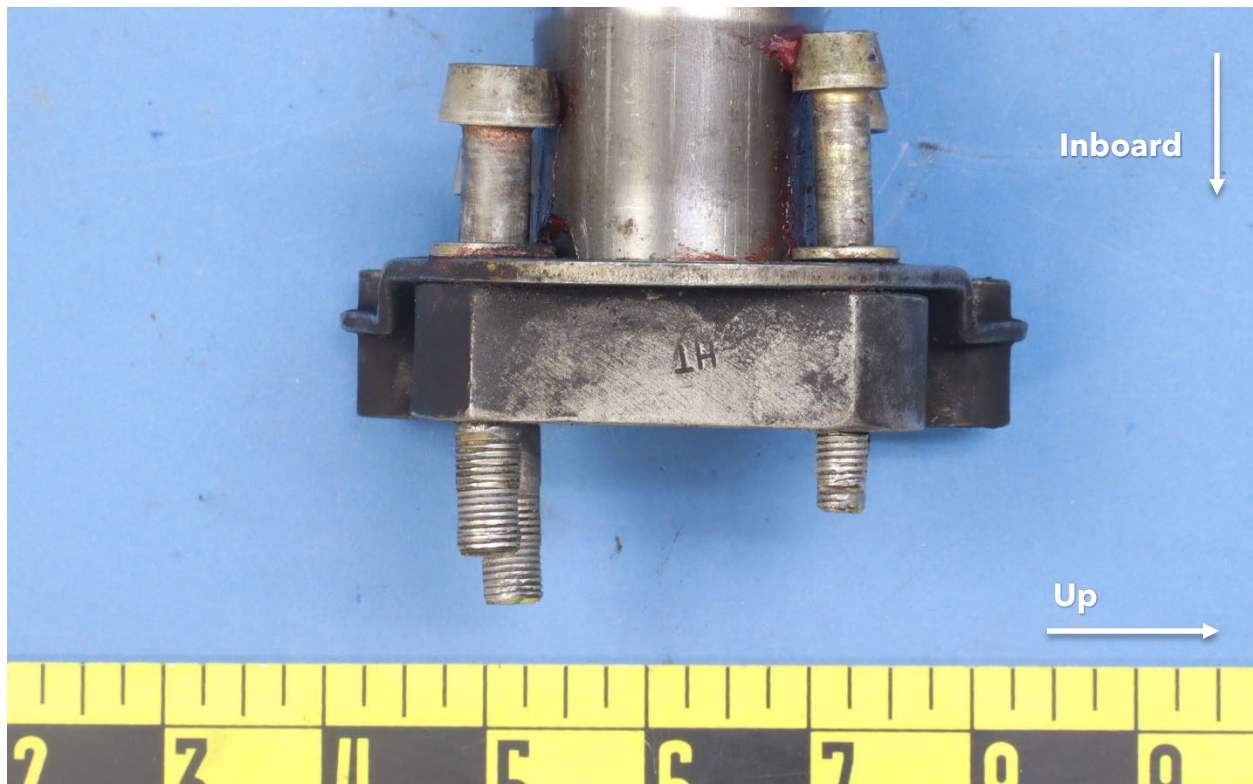
Figure 6. Aft view highlighting the bolt threads for the axle assembly.

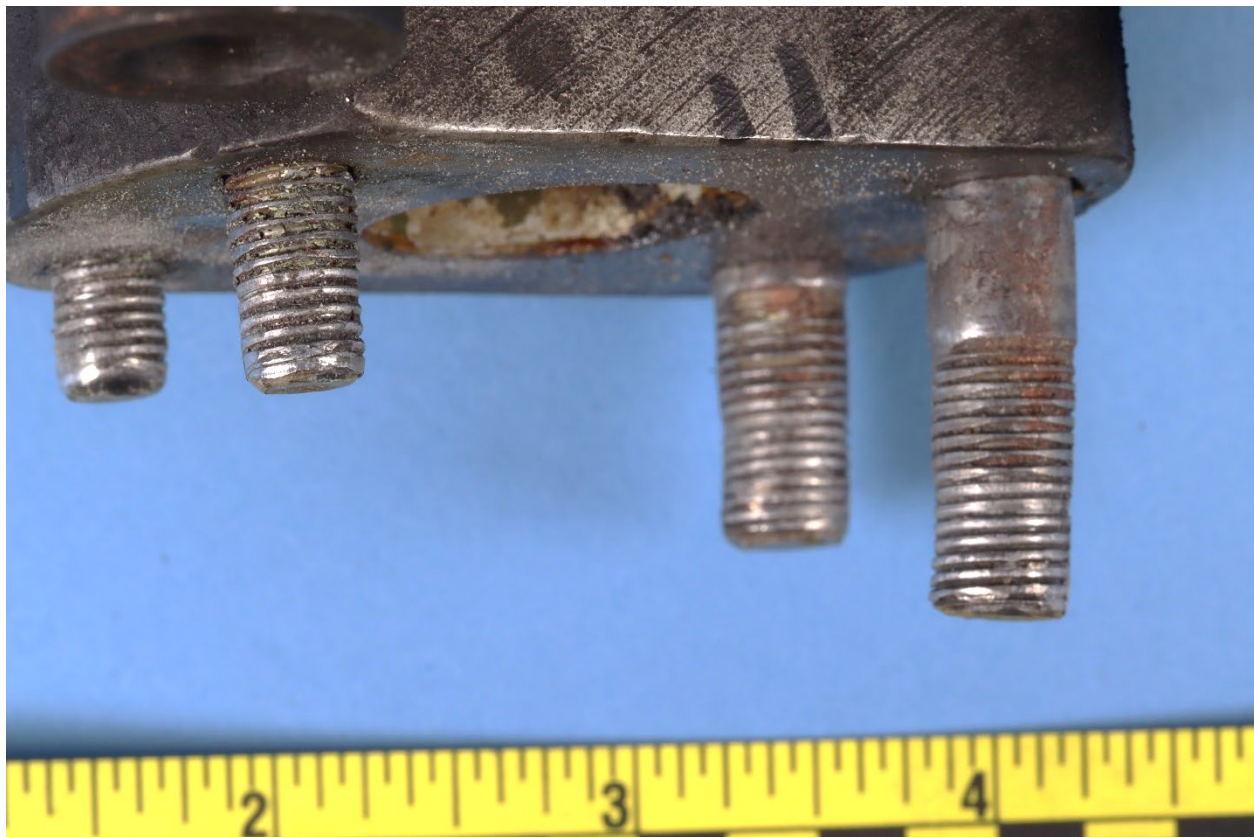
Figure 7. Closer aft view of the bolt threads in Figure 6, showing deformation.

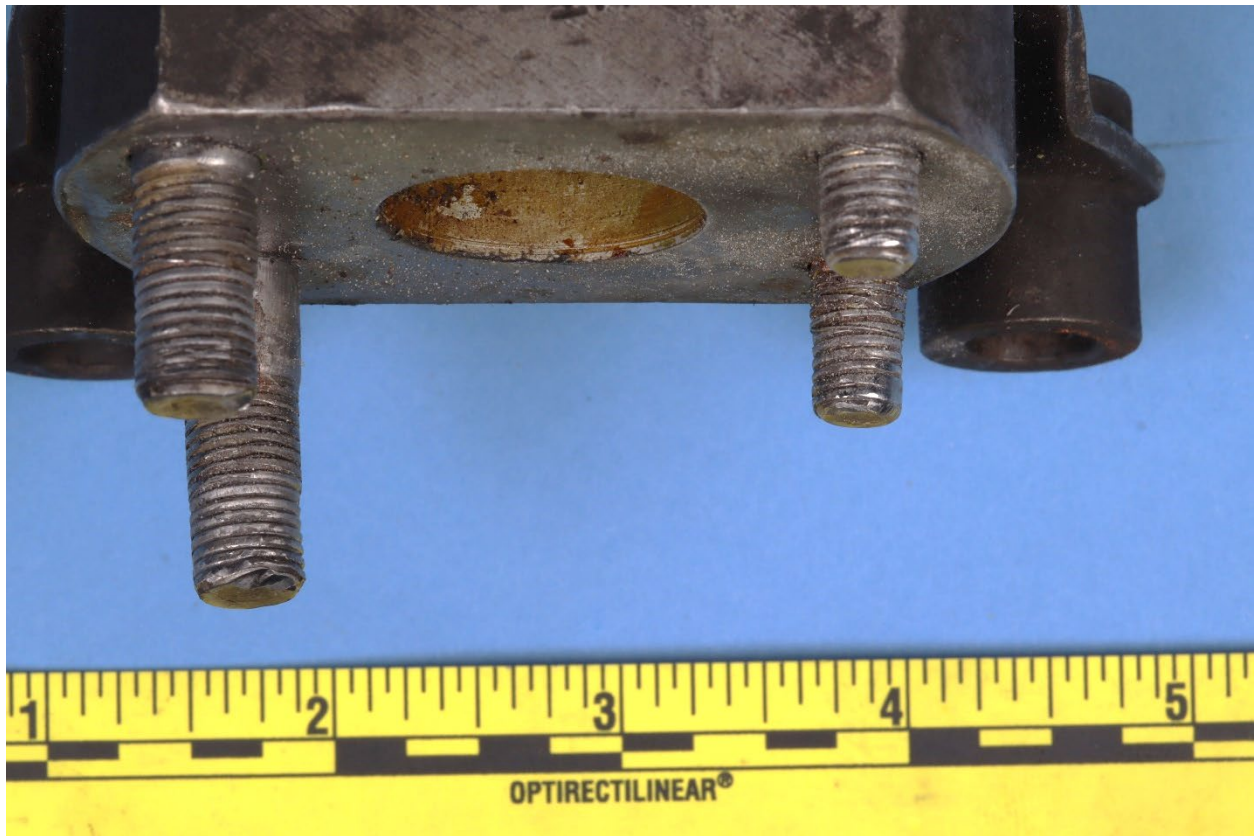
Figure 8. Rotated view (aft looking forward) of the bolts in Figure 7.

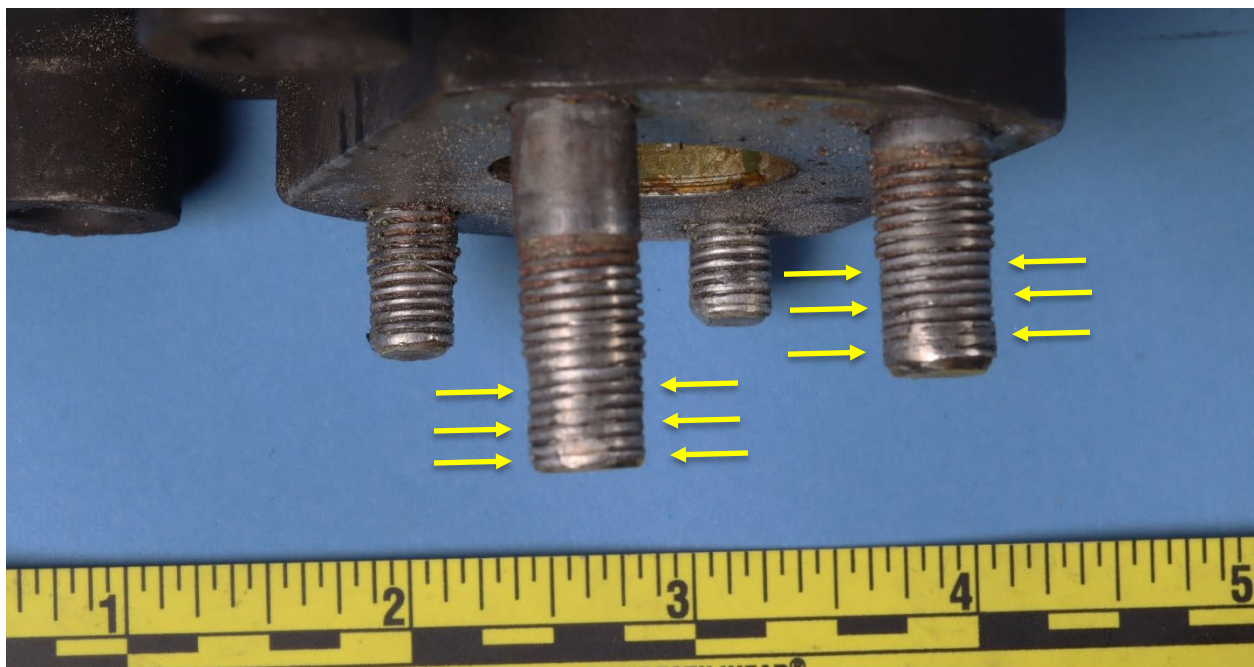
A portion of the threaded regions of the bolts from the axle were damaged. Figure 9 shows this damage to the lower attachment bolts, illustrated by the arrows. Most of the thread crests were missing in these areas, and the faces exhibited longitudinal streaks and smearing, consistent with having been pulled from an engaged position. There were also indications of deformation and impacts on other threads, but not as pronounced as those identified in Figure 9.

Figure 9. Lower side view looking upward of the bolts in Figure 8, showing thread deformation and shear of the lower bolts (arrows).

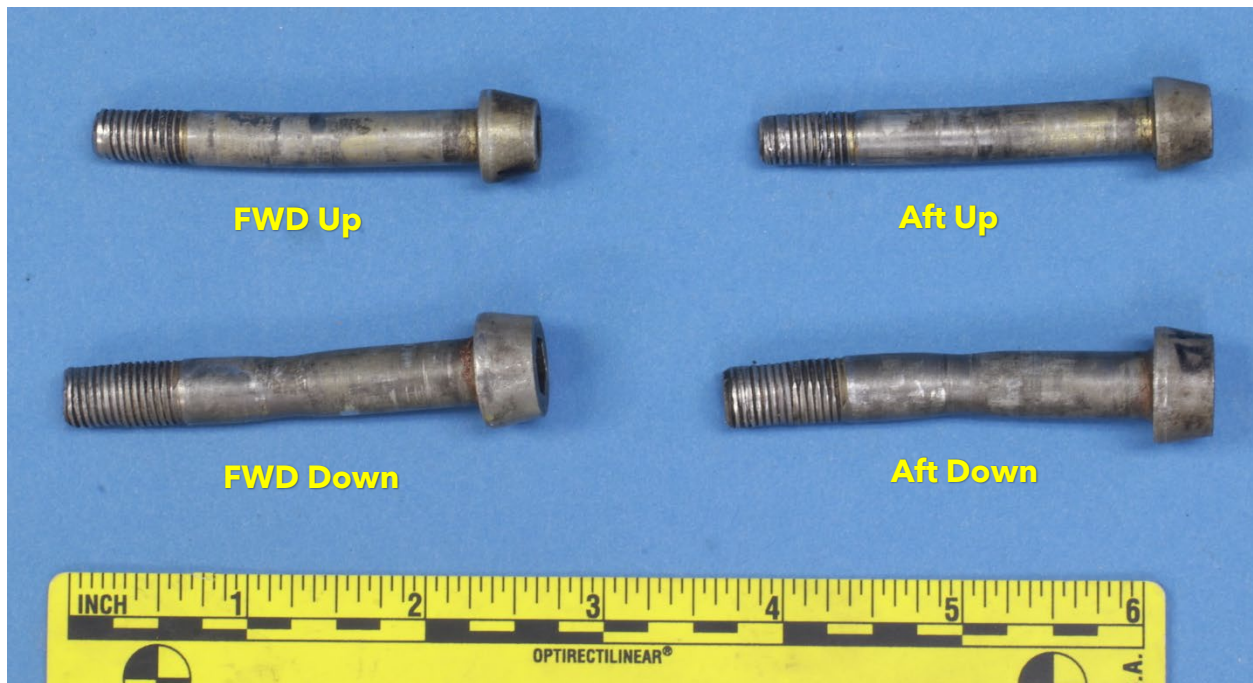
The bolts were measured using digital calipers, focusing on the amounts positioned inboard and outboard of the axle face. These dimensions, along with the dimensions of the bolts after removal, are listed in Table I. Figure 10 shows the bolts from the side after removal from the axle. The upper bolts and lower bolts exhibited different dimensions, with the lower bolts being longer and with wider shank and head diameters.

These dimensions were compared with the stated dimensions from the drawings for the bolts and nuts, listed in Table II. For the bolts, the shank dimensions were within the range prescribed, but the lengths of all the bolts exceeded the stated length of 2.25 inches. These lower bolts also exhibited necking (localized thinning) along the midpoint of the shanks. The aft lower bolt exhibited necking from 0.373 to 0.332 inches, and the forward bolt had thinned to 0.338 inches. This necking and elongation would be consistent with plastic deformation from tensile stresses of the bolts.

Figure 10. The attachment bolts after removal from the axle and cleaning.

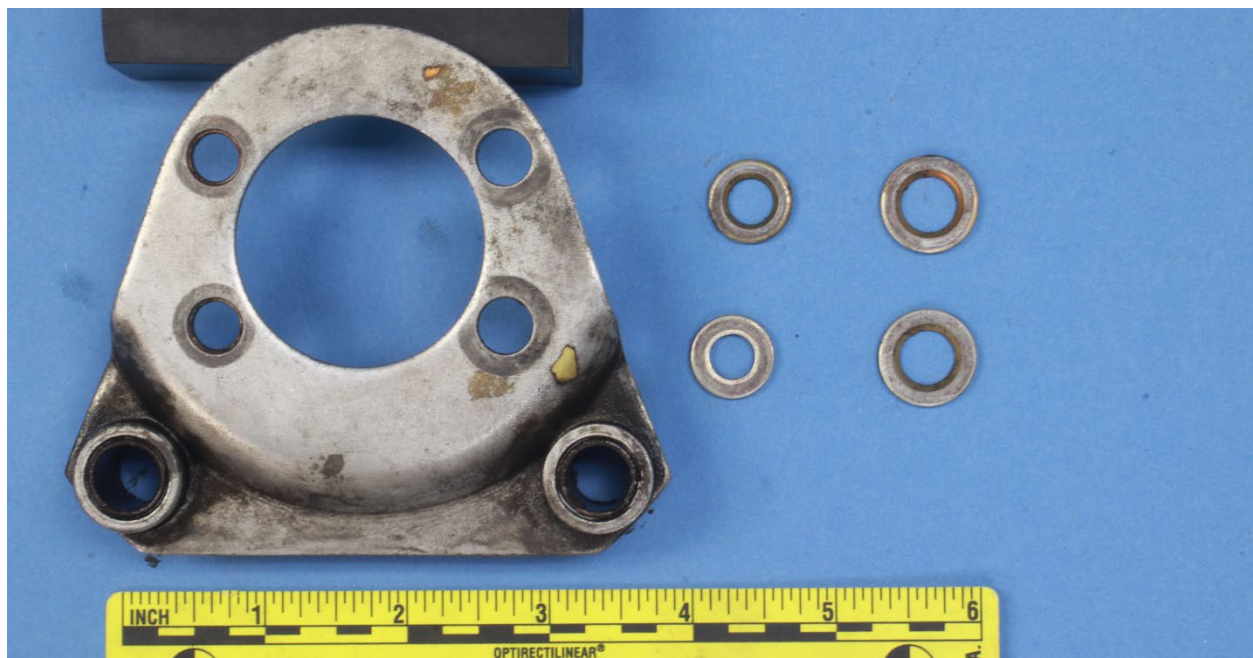
Figure 11 shows the faying surfaces of the axle face and corresponding washers after bolt removal. A halo, consistent with the size and shapes of the corresponding washers faces, was present around each bolt hole on the axle face. These areas on the axle face exhibited rougher surfaces, discoloration, and matted debris particles, consistent with fretting wear.

Figure 11. View of the washers and faying surface of the axle, showing annular areas of fretting.

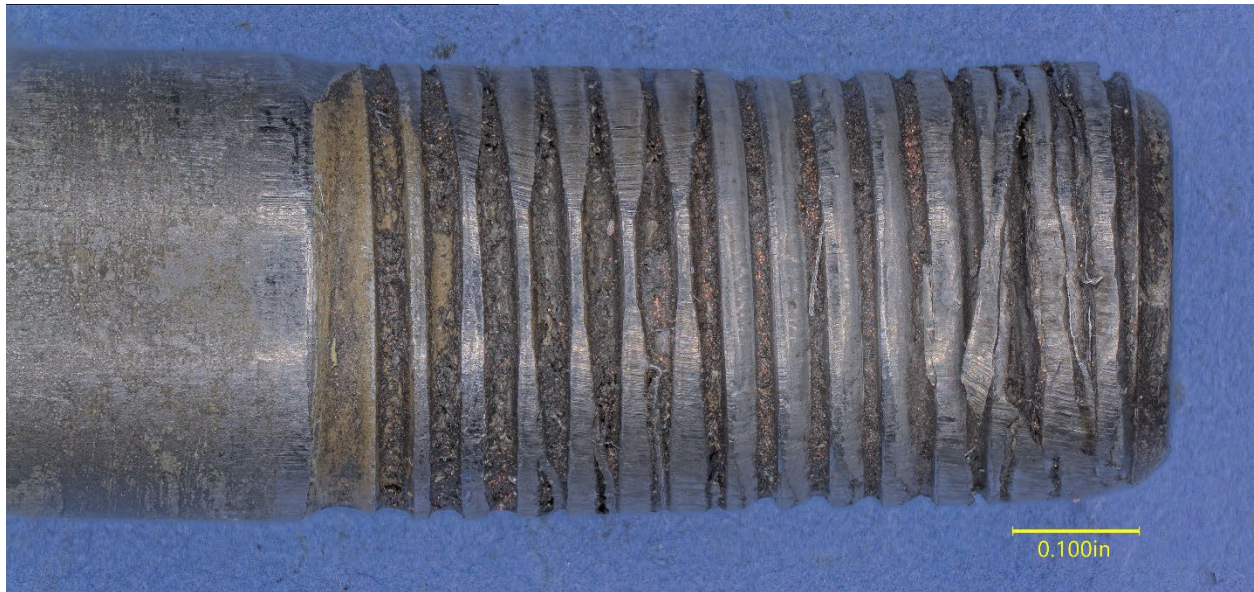
Figures 12 and 13 show closer views of the threads of the aft upper and aft lower bolts, respectively. In each figure, most of the threads had been sheared off, as indicated by gouge marks on the flattened surfaces parallel to the bolt shank direction. In each case, as deformed and battered remnant of a partially separated bolt thread was still present withing a root. Material from the root had deformed to the right in the figures, consistent with shearing in the direction of the absent nuts.

Both these bolts demonstrate the length of more severe thread removal and wear, consistently measured as approximately 0.3 inches long on all four bolts (detailed in Table I). The lengths of the prescribed nuts are listed in Table II, which were used to approximate the thread engagement lengths on the bolts. The nut lengths were greater than the measured areas of most severe thread shearing.

Figure 12. Side view of the damaged threads from the aft lower bolt.

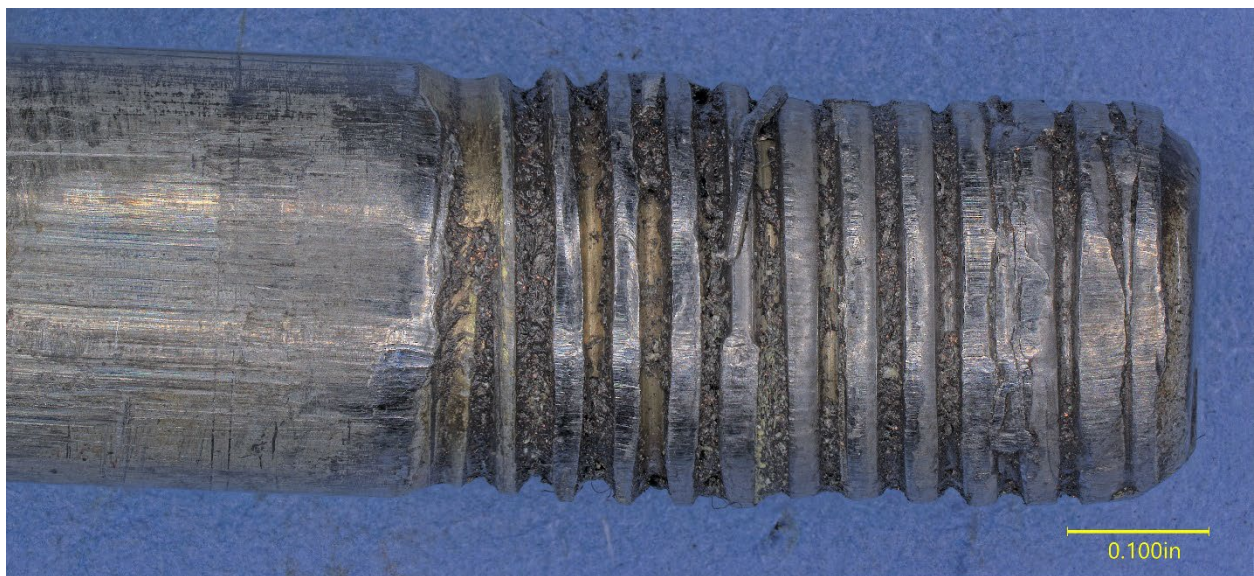
Figure 13. Side view of the damaged threads from the aft upper bolt.

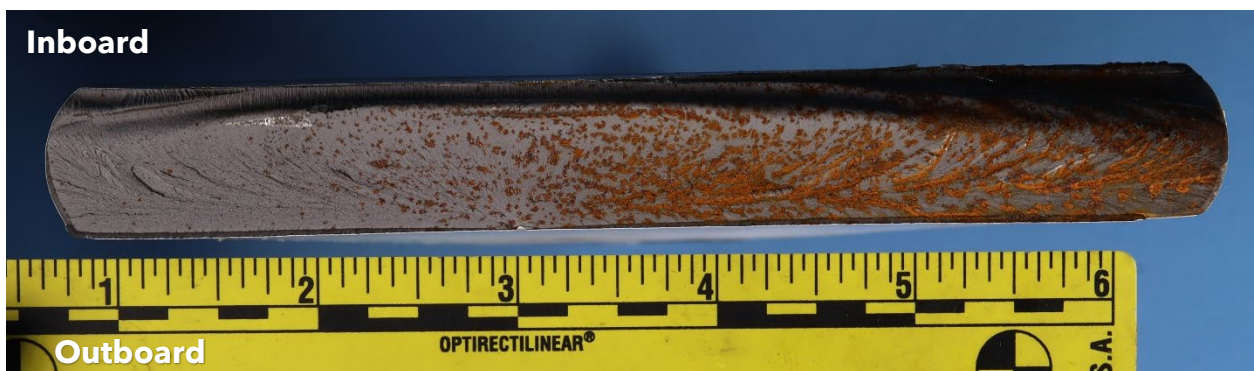
The fracture surface at the inboard end of the landing leg segment in Figure 1 is illustrated in Figure 14. Most of the surface exhibited a dull luster with a rough, fibrous texture. There were sporadic areas of maroon color, consistent with ferrous oxides (i.e., rust; see Figure 15). The outboard portion of the fracture surface was relatively flat, with the inboard side protruding towards the reader. The fracture surface exhibited radiating river patterns, which curved back inward towards the bottom of the surface in shown in Figure 14. These features were consistent with the inboard bending of the landing gear leg during fracture.

Figure 14. View of the outboard fracture surface of the landing gear leg, as received.

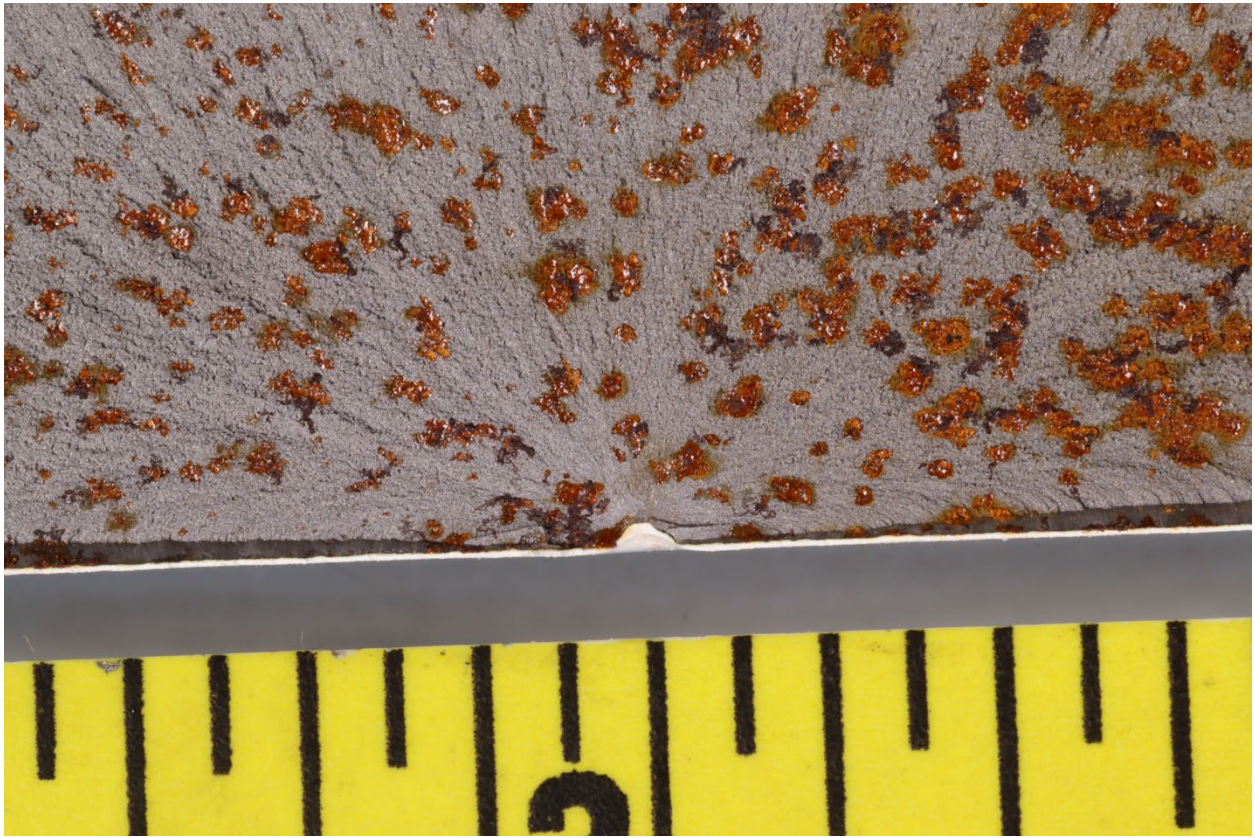
Figure 15 shows an area from where all the river patterns, along with chevron marks, had emanated. The location was represented by the semi-ovoid white region along the bottom edge. After cleaning in an ultrasonic bath with acetone, some of the surface contamination had been removed. Figure 16 shows a closer view of the initiation region of the fracture, showing a dimple that contained white paint from the outside surfaces of the landing gear leg.

Figure 15. Closer view of the initiation region of the fracture surface, showing an area of white paint within a surface pit on the lower surface of the landing gear leg.

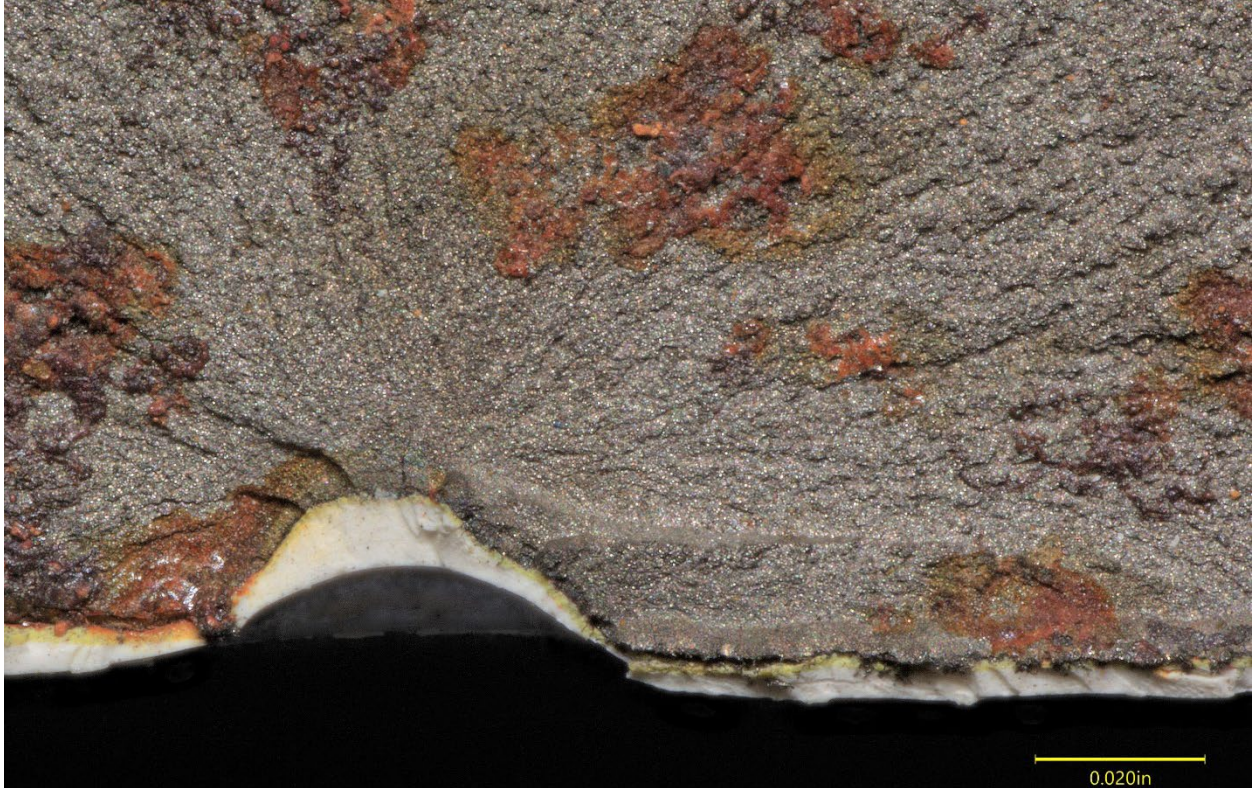
Figure 16. Closer view of the pit and fatigue cracking at the initiation of the leg fracture.

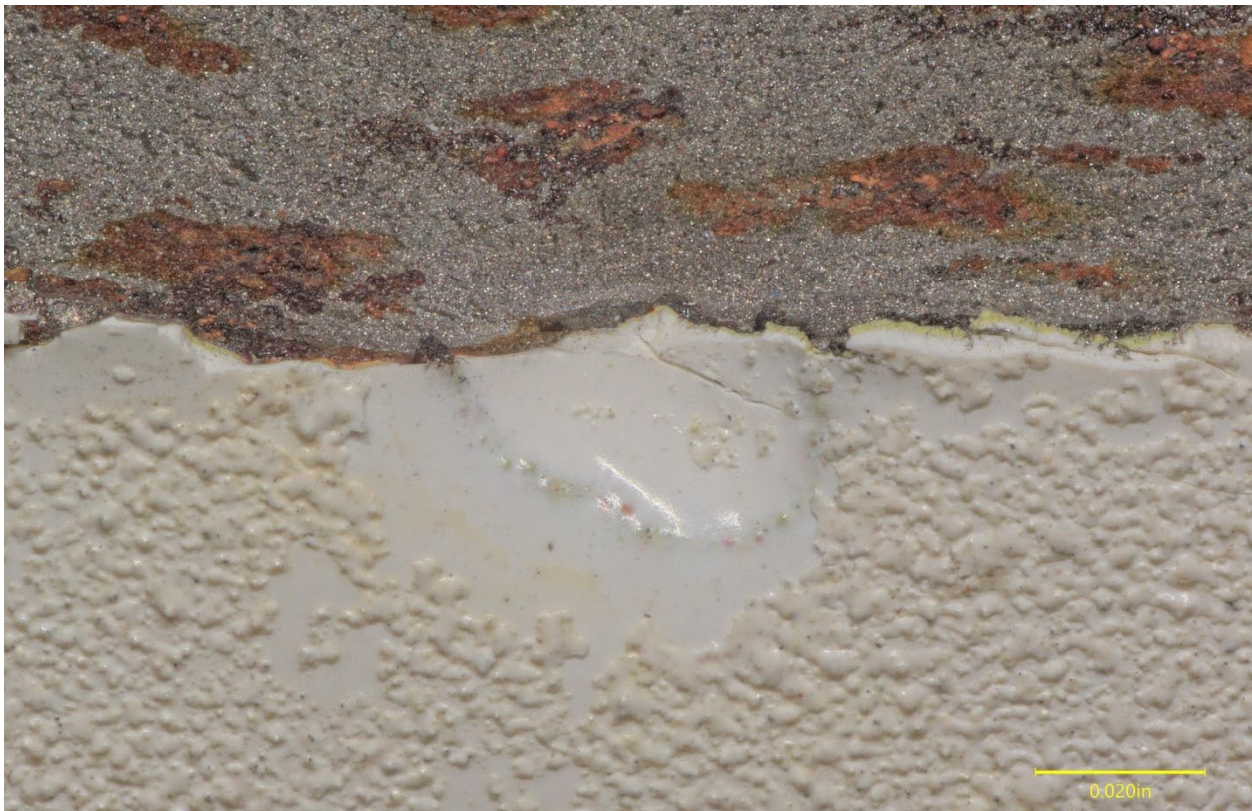
Figure 17 shows an angled view of the painted divot at the fracture initiation region of the landing gear leg. The paint exhibited small blisters from the acetone cleaning but still adhered to the leg surface overall. The paint within the divot lacked such blisters, which was consistent with good adherence. The paint was chemically removed with a chemical stripping mixture of dichloromethane, methanol, and toluene. The angled surface of the divot is shown in Figure 18. The interior contained corrosion compounds, indicated by the maroon color. The outboard-facing surface of the leg also contained depressions, though their depth was less. These features were consistent with corrosion pitting.

Figure 17. Angled view of the pit in Figure 16, showing paint adhering to the pit surface.

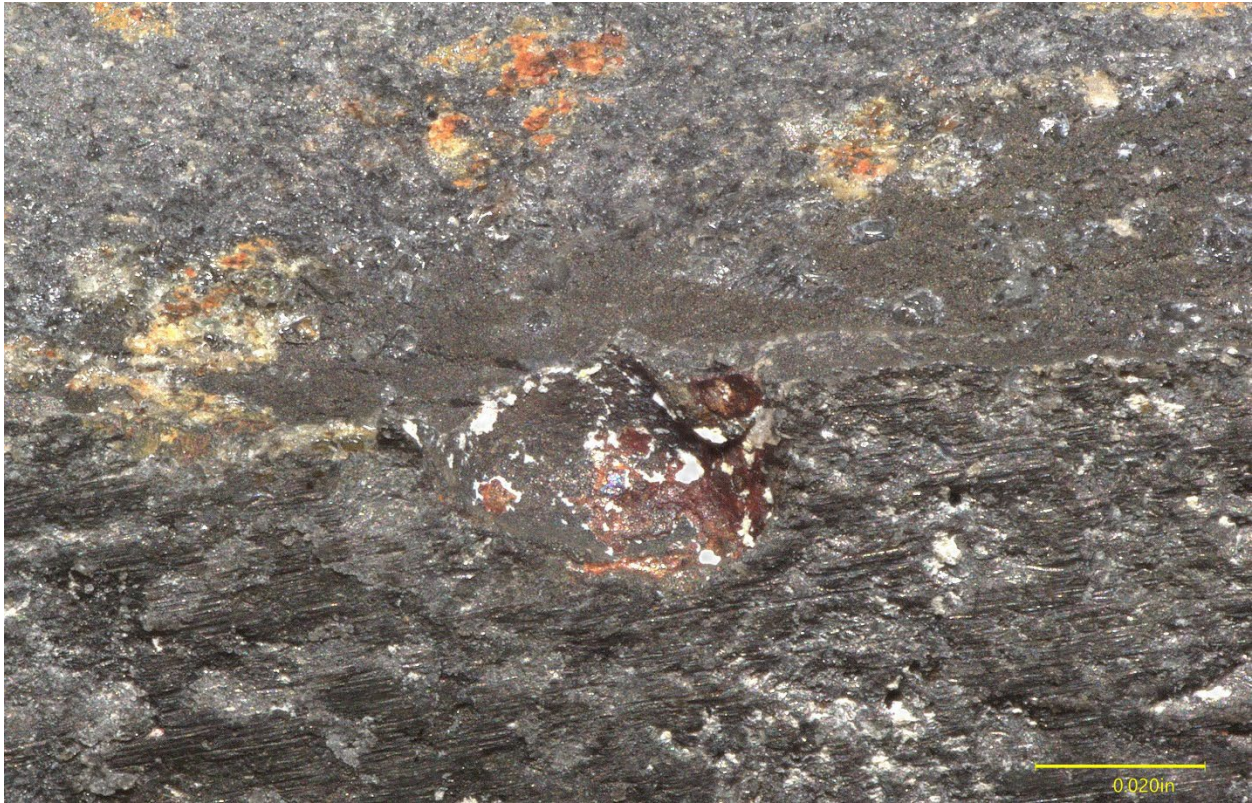
Figure 18. View of the corrosion pit in Figure 17, after chemical stripping of paint.

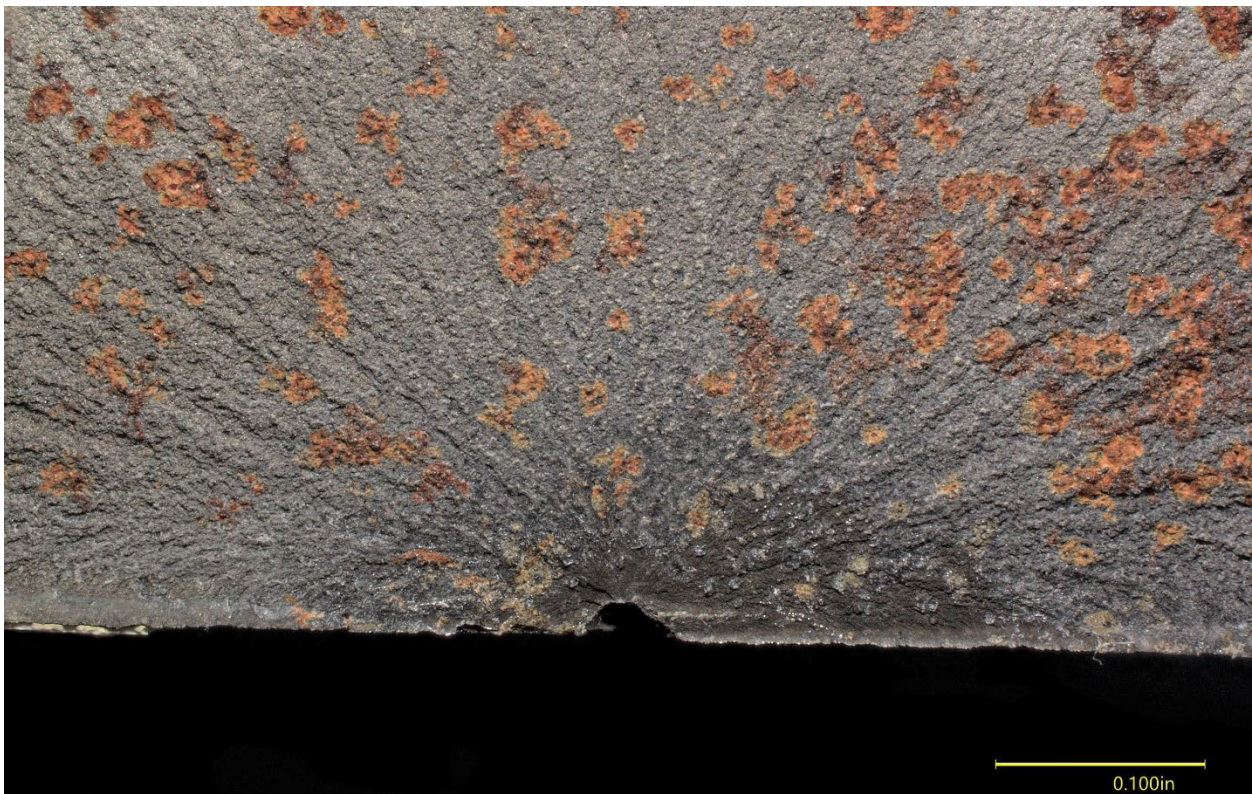
Figure 19 and Figure 20 show closer views of the fracture initiation area at the large pit on the leg after paint removal. The figures demonstrate river patterns emanating from the pit area. There were also several small thumbnail-shaped cracks along the edge of the pit surface. These are annotated in Figure 20.

Figure 19. View of the initiation area of the fracture surface after chemical paint stripping.

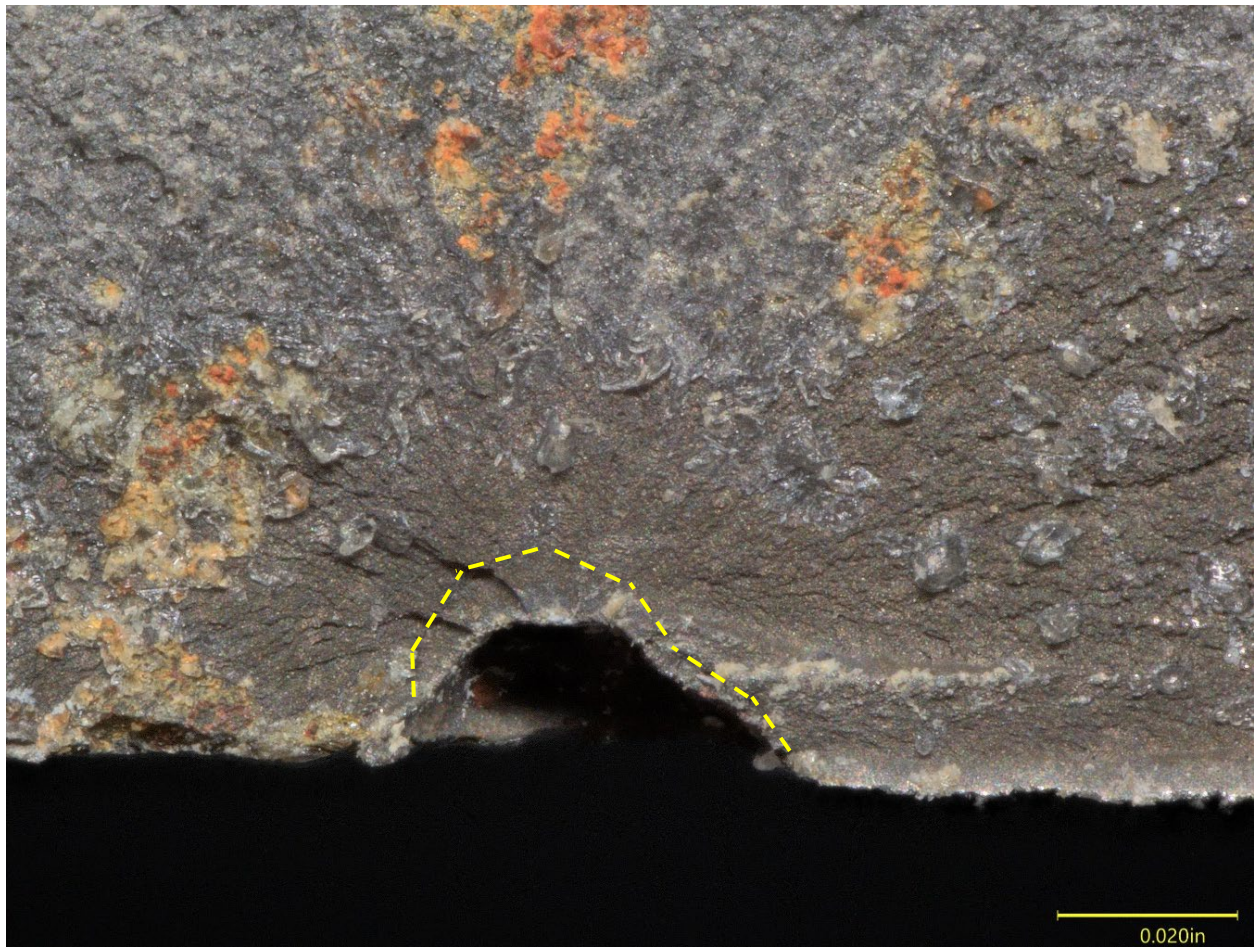
Figure 20. The crack initiation region and the corrosion pit, after chemical stripping and removal of paint and some surface corrosion. The area of fatigue cracking next to the pit is delineated by the yellow dashed lines.

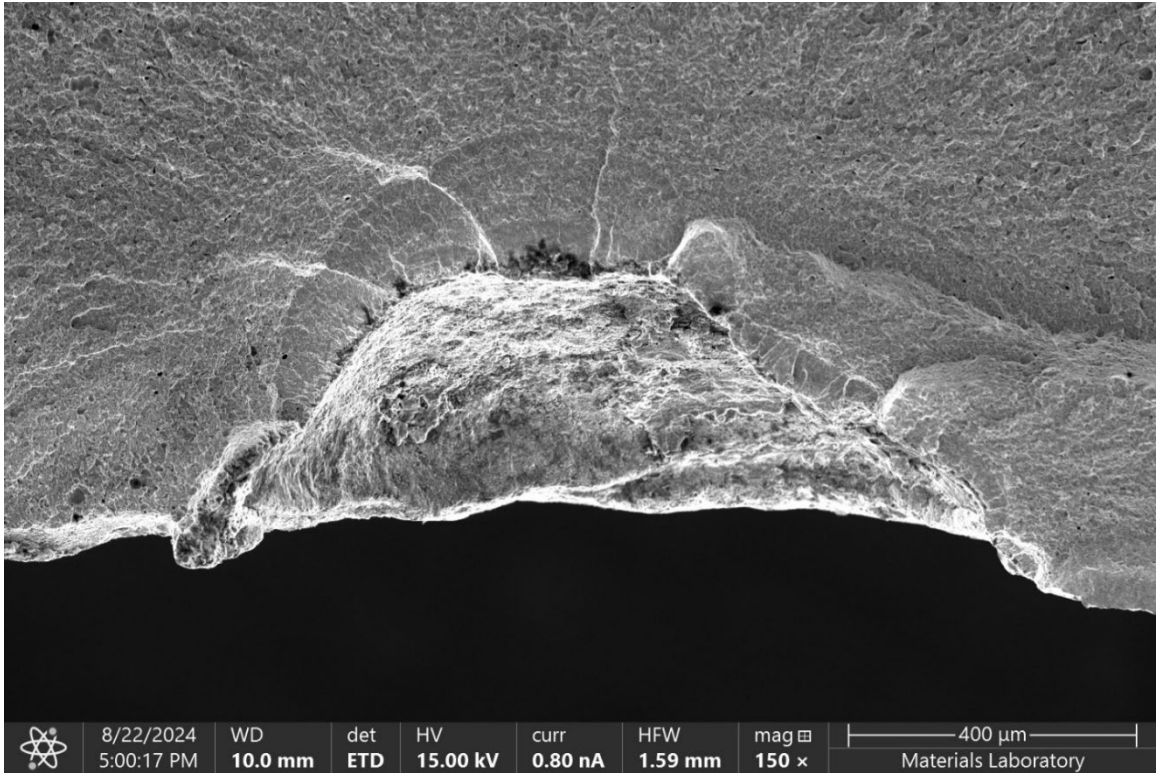
The fracture surface was examined using a field-emission scanning electron microscope (SEM). Figure 21 and Figure 22 show the corrosion pit and thumbnail cracks at the initiation region. The cracks exhibited crack arrest marks and five prominent ratchet marks, indicative of multiple crack initiation sites. The backscattered image shows some darker-colored areas along the edge of the pit.<sup>2</sup> The depth of the pit and crack were measured as being 0.56 mm (0.022 inches) deep and 1.16 mm (0.046 inches) long.

Figure 21. Secondary electron (SE) micrograph of the fatigue cracks around the corrosion pit.
