# National Transportation Safety Board

WPR24LA122

## **MATERIALS LABORATORY**

Factual Report 24-059

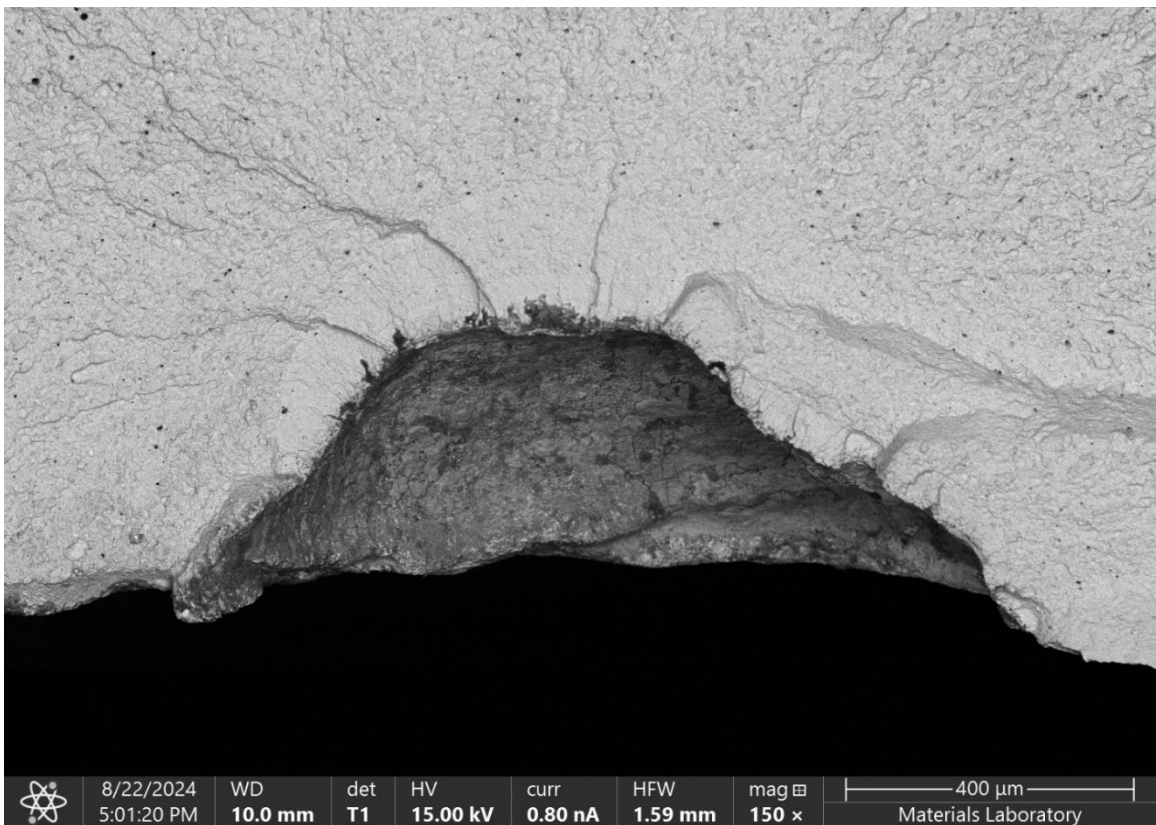
The fracture surface was examined using a field-emission scanning electron microscope (SEM). Figure 21 and Figure 22 show the corrosion pit and thumbnail cracks at the initiation region. The cracks exhibited crack arrest marks and five prominent ratchet marks, indicative of multiple crack initiation sites. The backscattered image shows some darker-colored areas along the edge of the pit.<sup>2</sup> The depth of the pit and crack were measured as being 0.56 mm (0.022 inches) deep and 1.16 mm (0.046 inches) long.

Figure 22. Backscattered electron (BE) micrograph of the fatigue cracks around the pit.

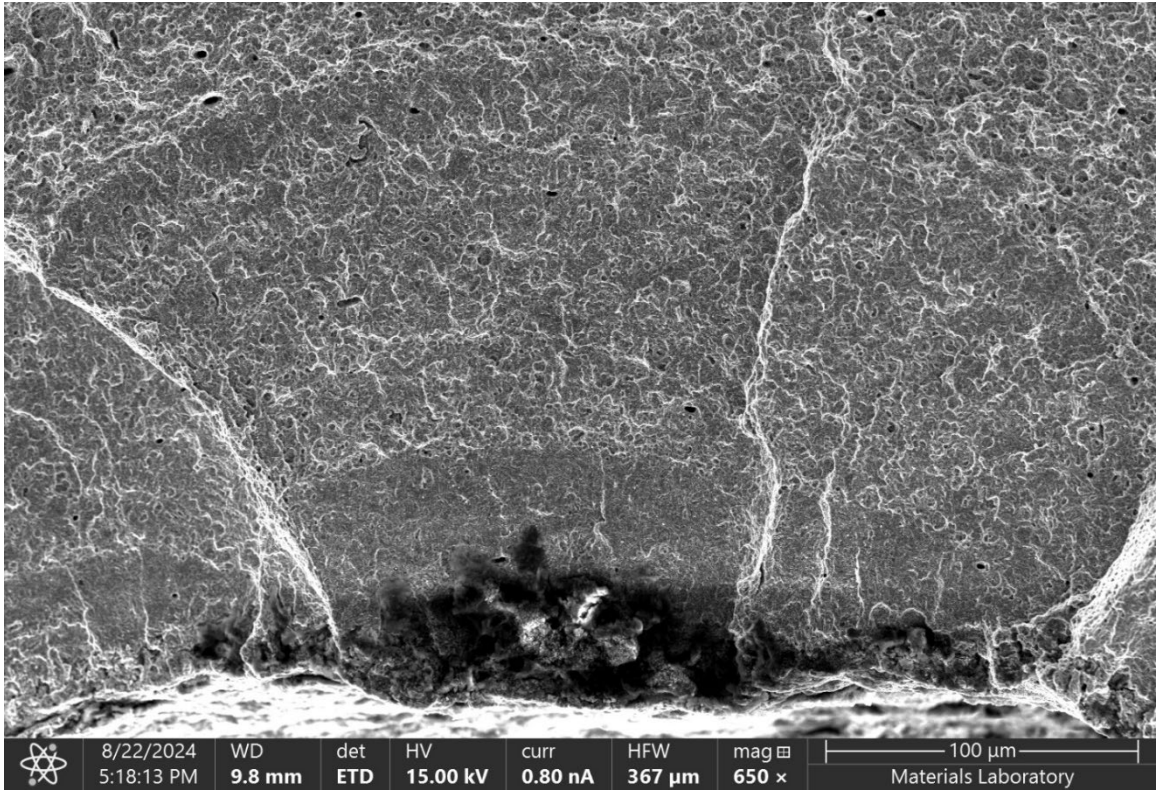
Figure 23 and Figure 24 show closer views of the largest thumbnail-shaped cracks. Figure 25 shows a closer view of a typical region in these cracks, revealing faint fatigue striations. These features were consistent with fatigue crack propagation, which had initiated at multiple sites along the pit surface. The surface exhibited dimpled rupture outside the fatigue cracking, as typified in Figure 26.

Figure 23. SE micrograph of the regions of the fatigue cracking, showing ratchet marks and arrest marks.

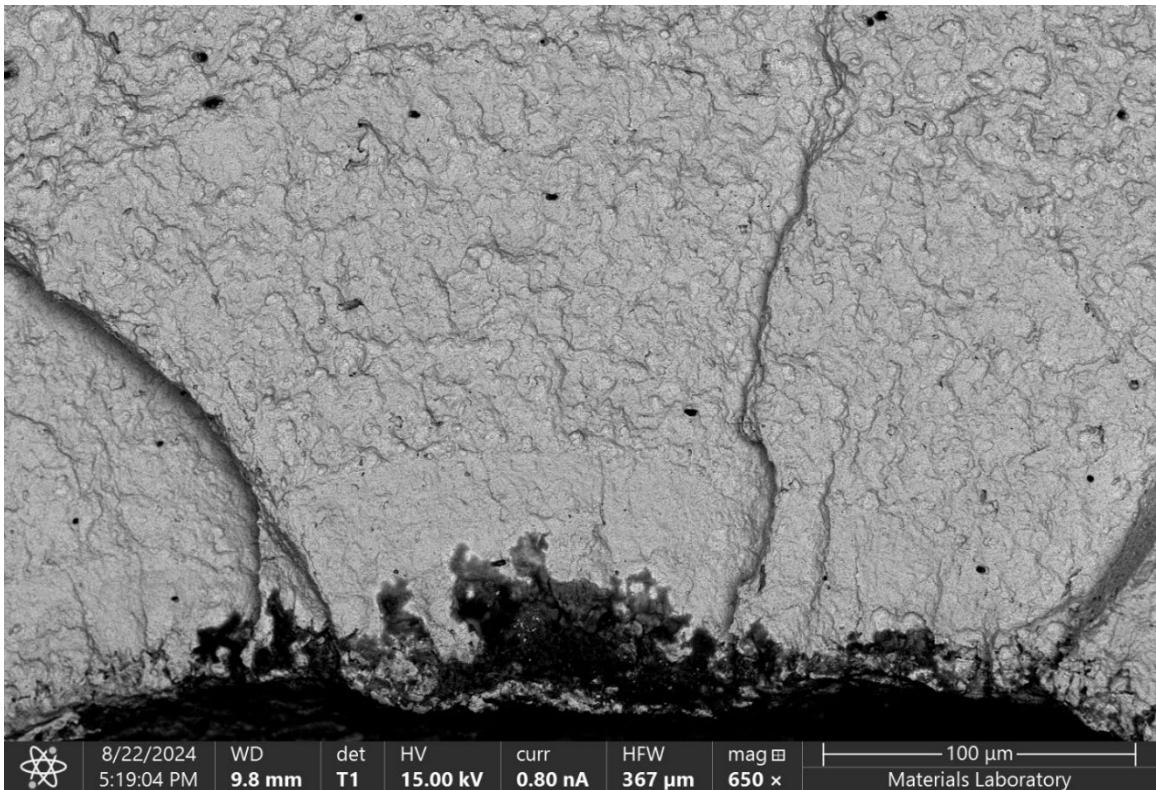
Figure 24. BE micrograph of the fatigue crack area in Figure 23.

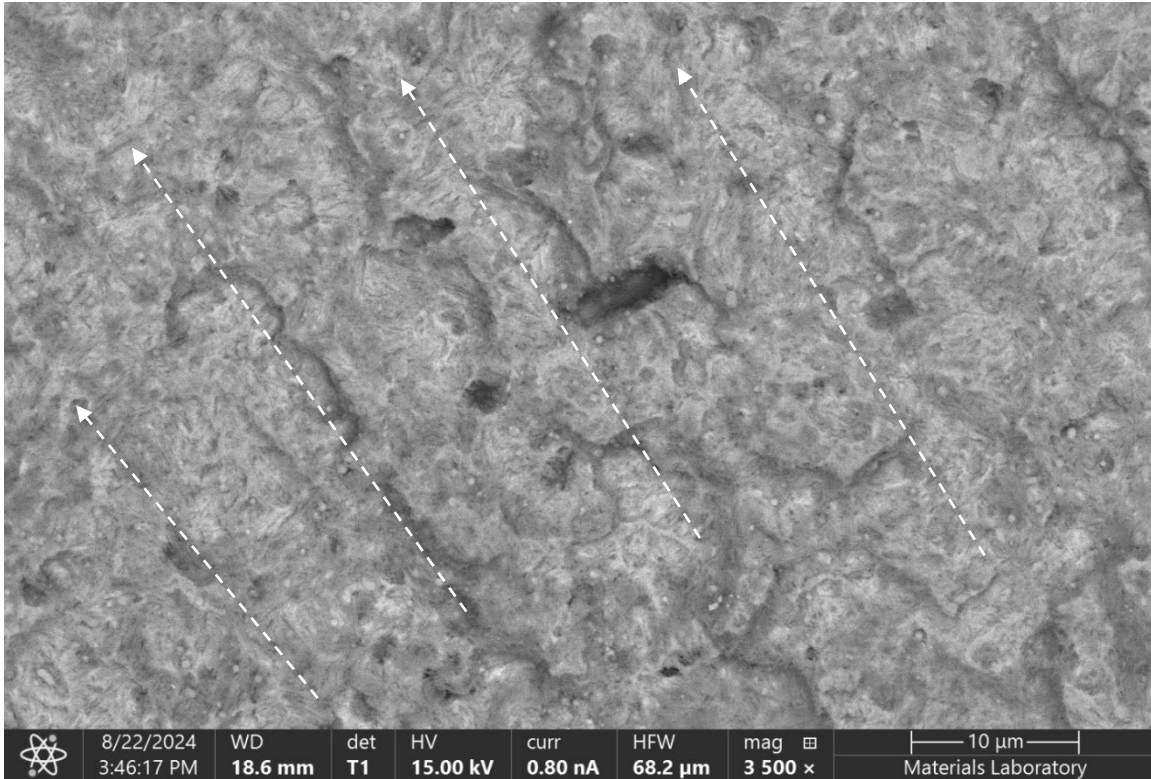
The initiation sites in Figure 25 showed darker material, consistent with oxides of the corroded metal. Chemical composition examination using energy-dispersive x-ray spectroscopy (EDS) examination of this material found it consistent with iron oxides, and detectable amounts of sulfur, sodium, and phosphorus.

Figure 25. BE micrograph of a typical area of the fatigue region, with the crack growth direction annotated with dashed white arrows.

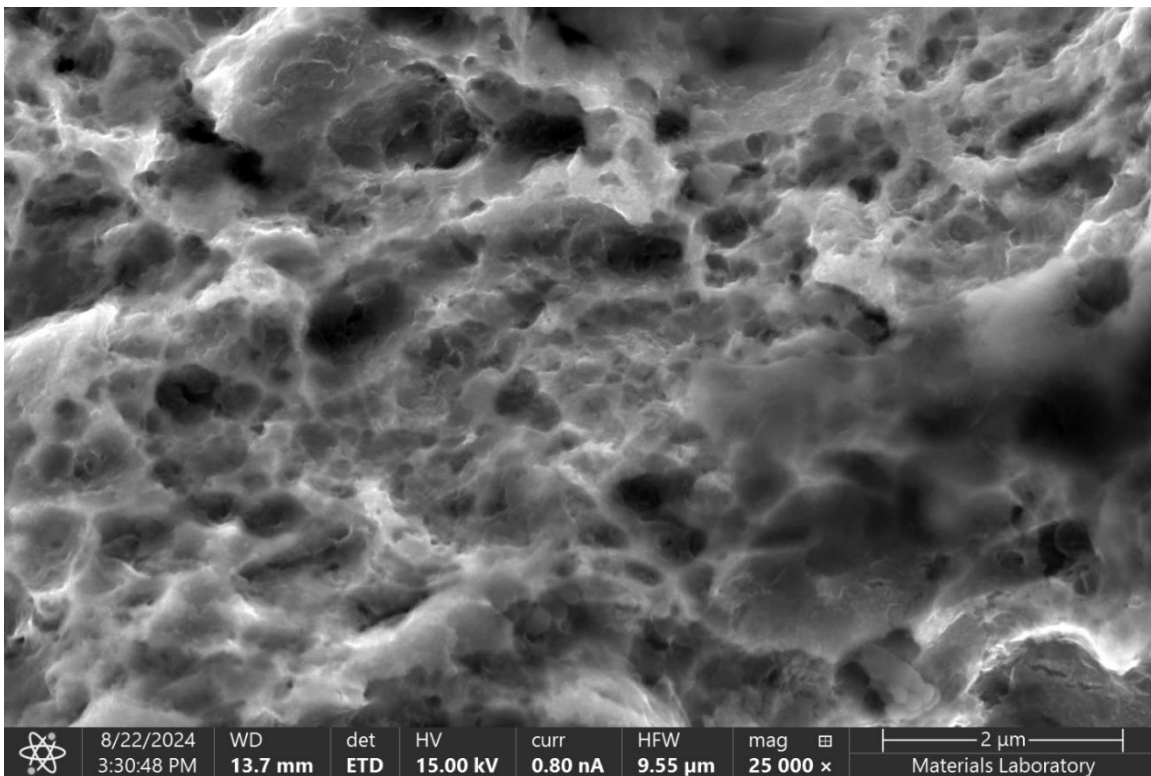
Figure 26. SE micrograph of dimpled rupture outside of the fatigue crack (after cleaning).

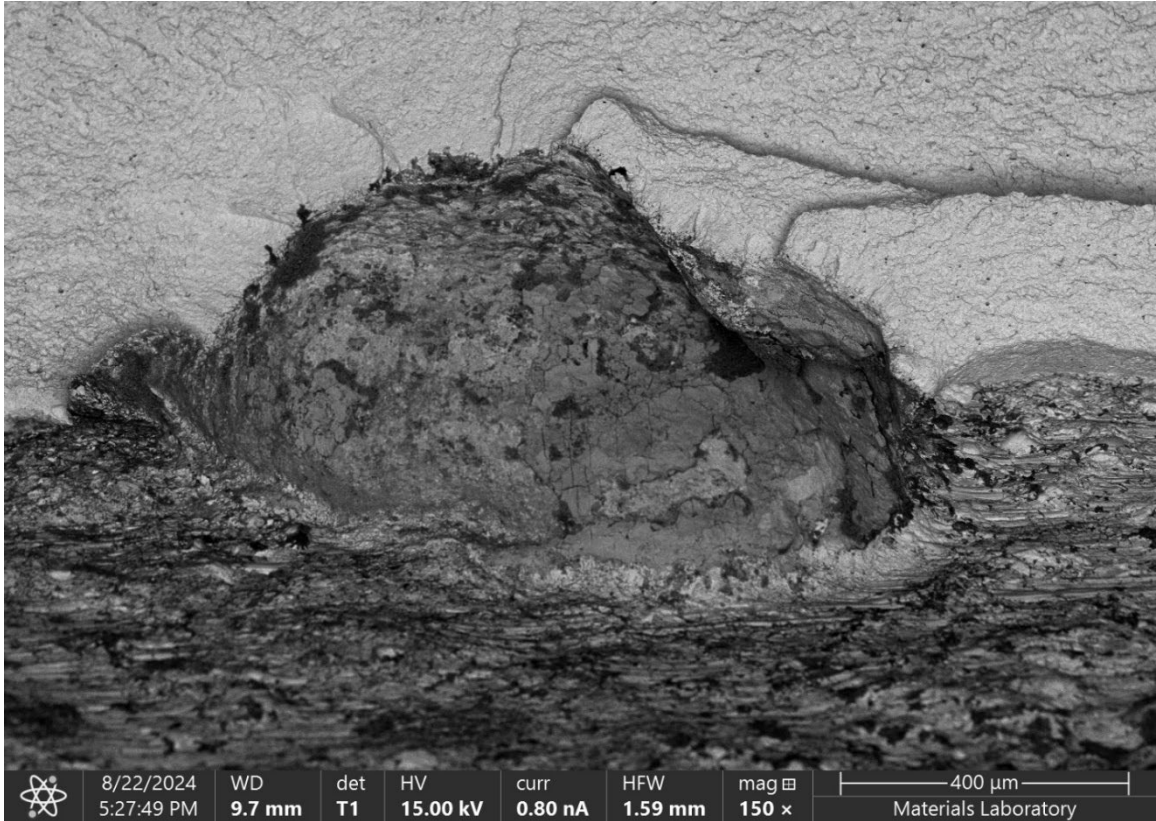
Figure 27 shows an angled view of the corrosion pit and crack initiation sites. The exterior edges of the pit exhibited some mechanical rounding, shown in the lower

right of the pit in Figure 27. The initiation sites were located along an area of penetrating corrosion, depicted in Figure 28. These areas of localized attack, delineated by the darker contrast in the figure, served as initiation sites for cracking that coalesced and then coalesced again, joining disparate cracks separated by perpendicular ratchet marks.

Figure 27. BE micrograph of an angled view of the corrosion pit and fatigue crack.

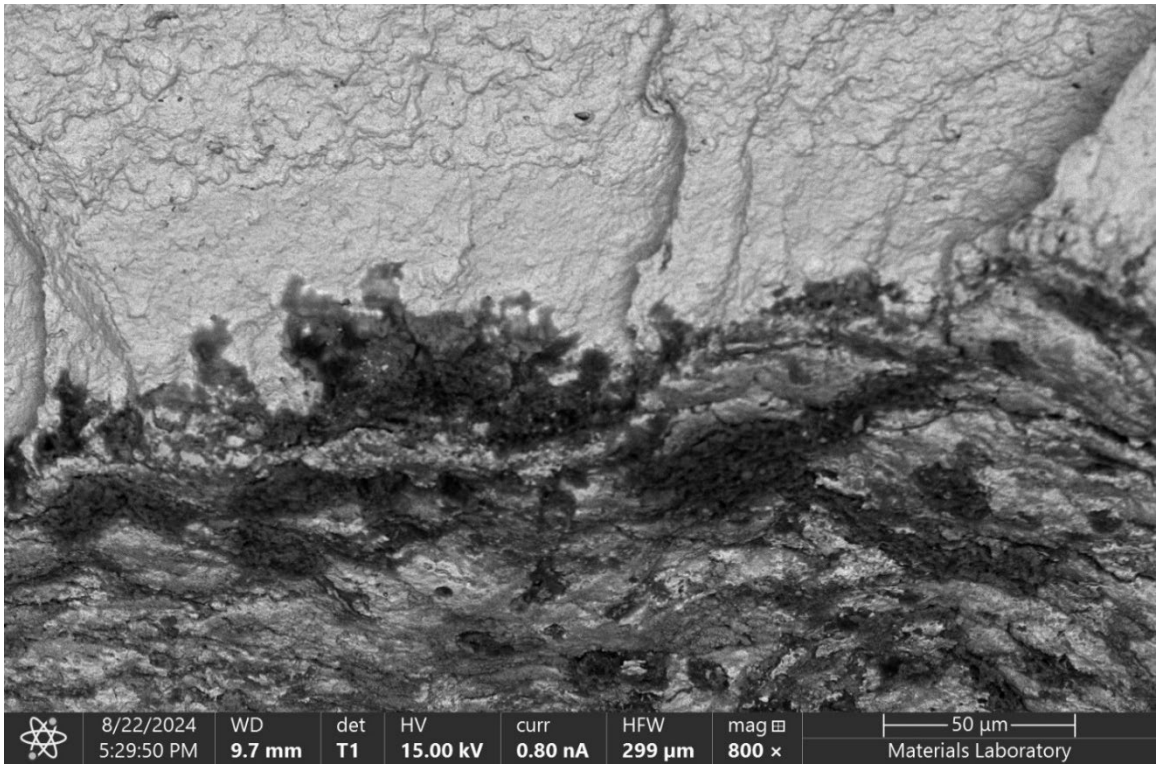
Figure 28. BE micrograph of crack initiation sites along the corrosion pit edge in Figure 27.
