# National Transportation Safety Board

WPR24LA126

## **AIRFRAME EXAMINATION**

Location: Auburn, Washington  
Date: April 11, 2024  
Time: 1345 Pacific daylight time  
Airplane: Cessna P210N, N806RC

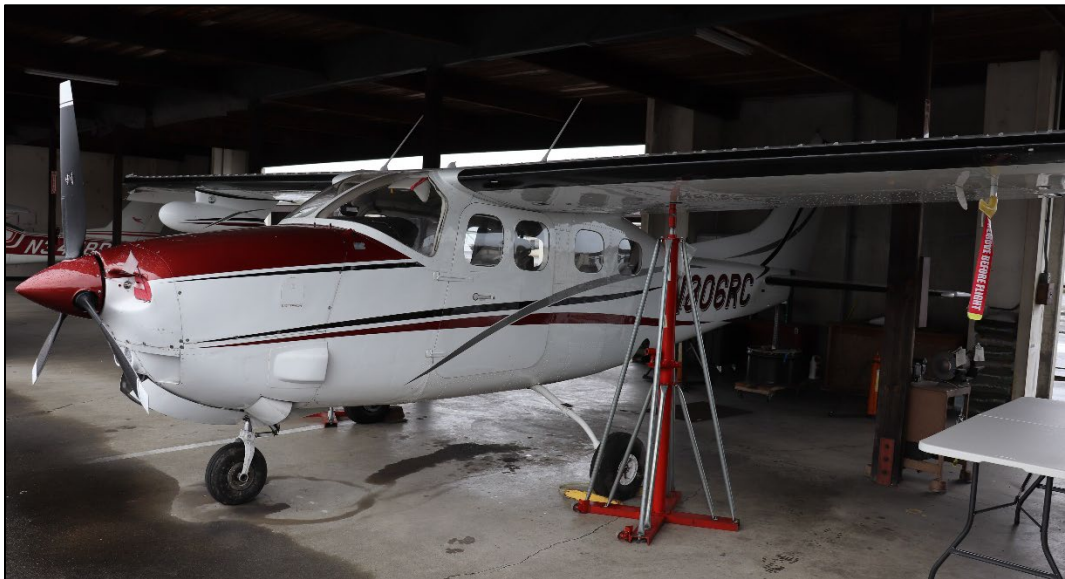
**Figure 1: View of the accident airplane during examination.**

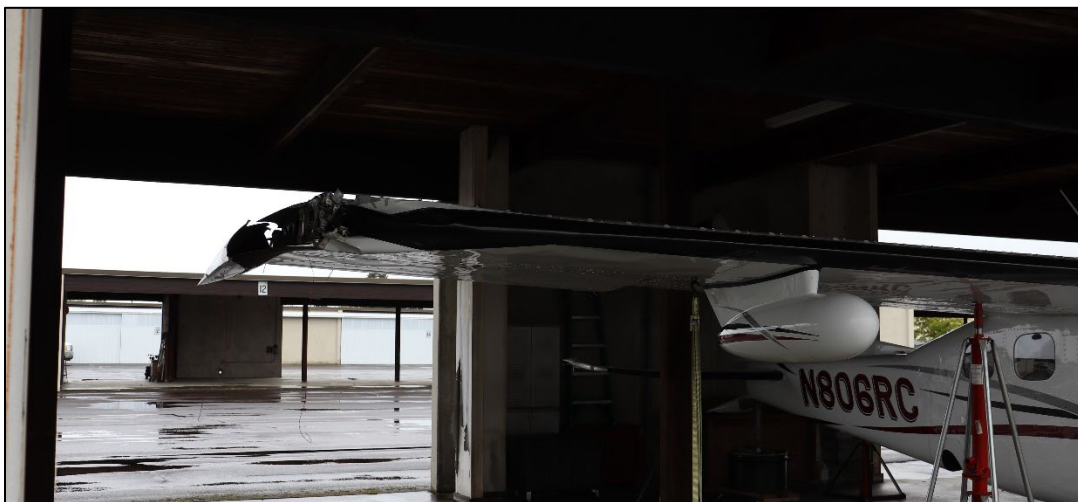
Examination of the recovered airframe revealed crushing and bending of the right outboard wing tip. Damage to the right horizontal stabilizer and elevator, about mid span was also observed. The observed hobbs meter time was 683.3 hours.

**Figure 2: View of right wing tip damage.**

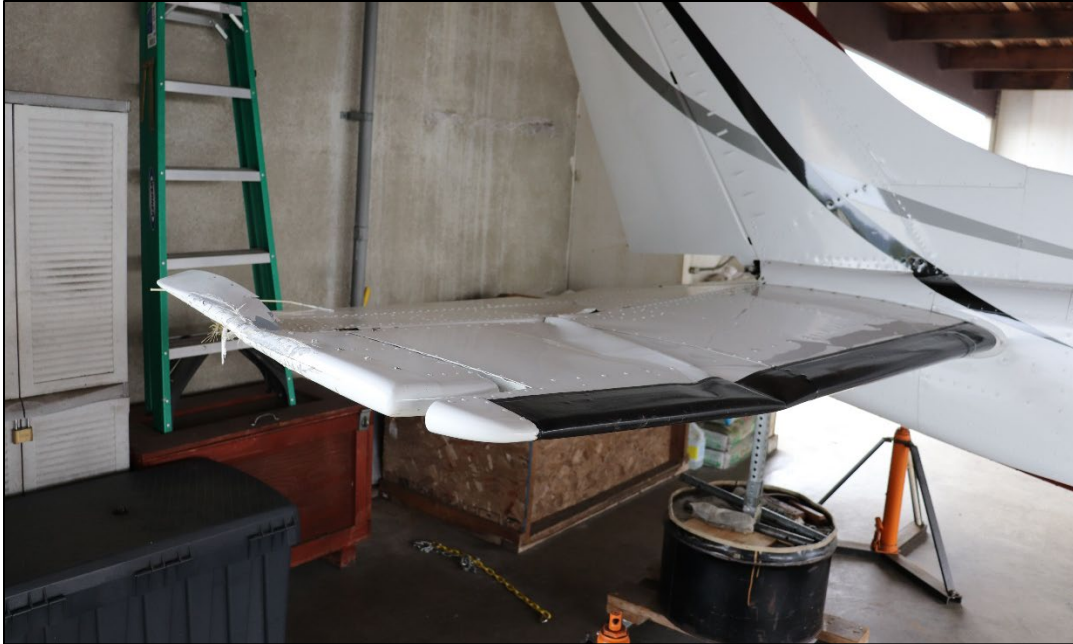
**Figure 3: View of right horizontal stabilizer and elevator damage.**

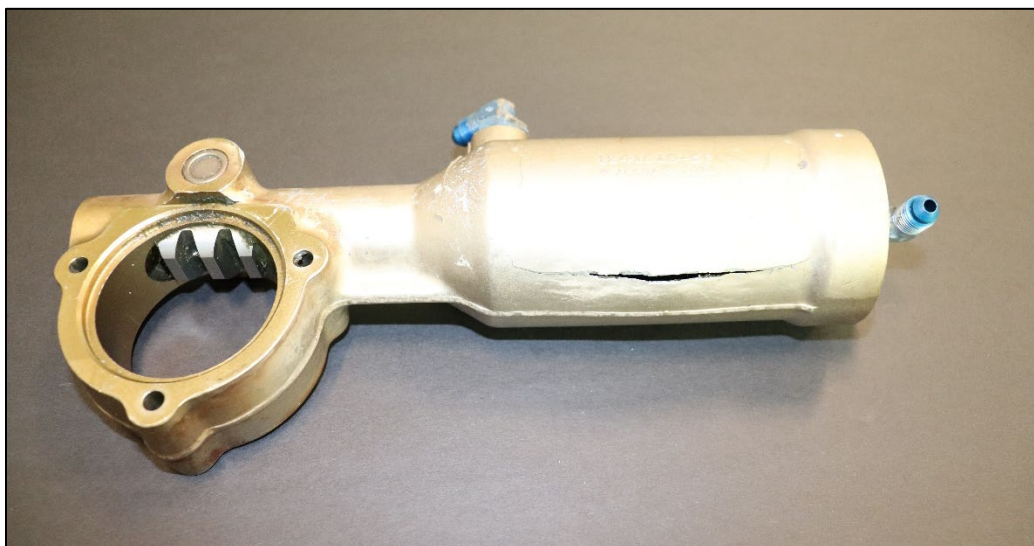
The airplane was stabilized using floor jacks and a tail stand. The seats, interior, and fuselage inspection panels were removed. A visual examination of the landing gear hydraulic system was conducted, no damage was observed. The emergency hand pump was extended and pumped. Red in color liquid, consistent with hydraulic fluid was observed coming from the left main landing gear actuator. The left main landing gear actuator was removed, and crack about 3 ½ inches was observed on the actuator housing. The actuator was retained for further examination.

**Figure 4: View of left main landing gear actuator.**

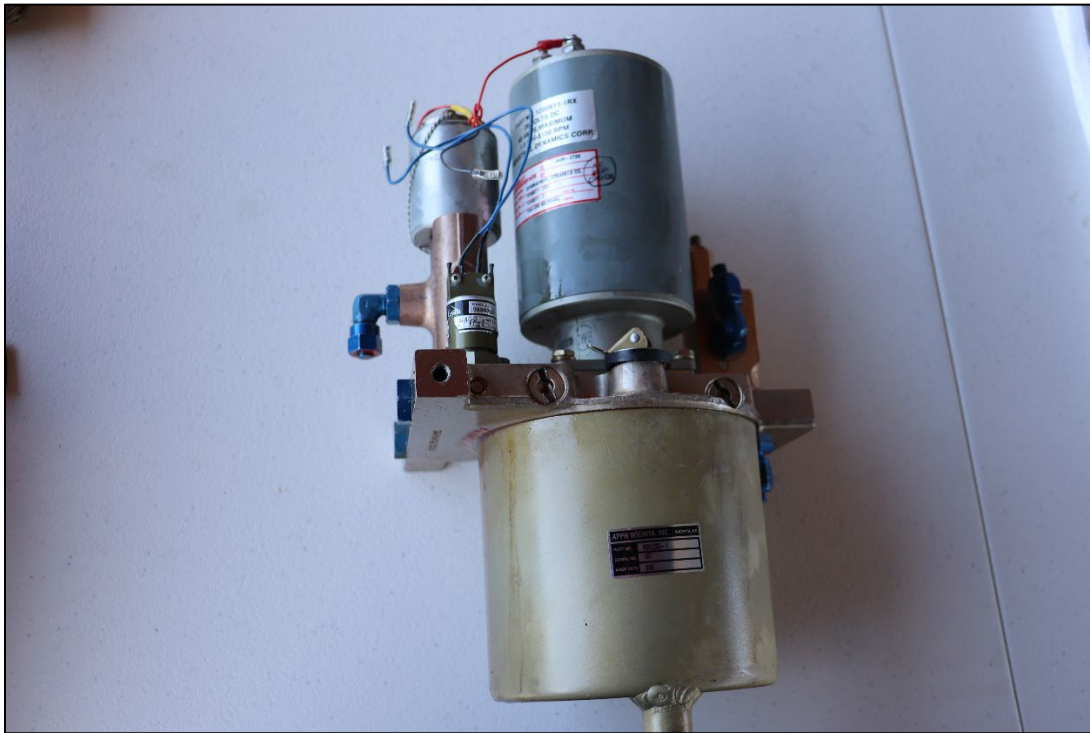
On May 2, 2024 the hydraulic power pack was removed from the airplane and retained for further examination.

**Figure 5: View of hydraulic power pack.**
