# National Transportation Safety Board

WPR24LA127

## **AIRFRAME AND ENGINE EXAMINATION REPORT**

Location: Heber, Utah  
Date: April 21, 2024  
Time: 1530 mountain daylight time  
Motor-glider: Schleicher Alexander GMBH & CO ASH 26 / N644CC

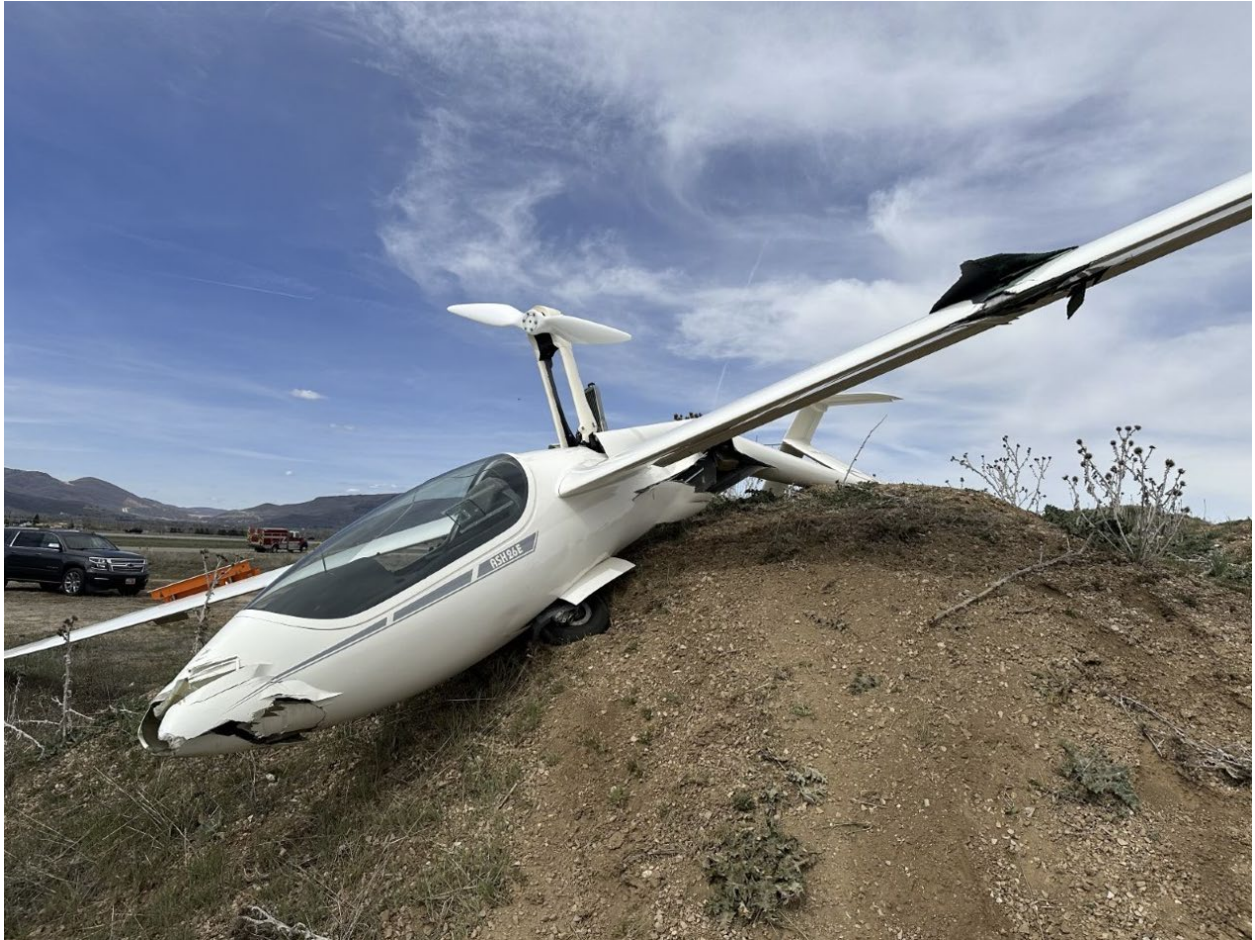
The composite fuselage exhibited multiple fractures just aft of the cockpit. The nose exhibited a fracture. The fuselage was fractured aft of the cockpit area which resulted in the tail cone and empennage partially separating from the fuselage.

Figure 2. Substantial fuselage and wing damage. Photo courtesy of the pilot.

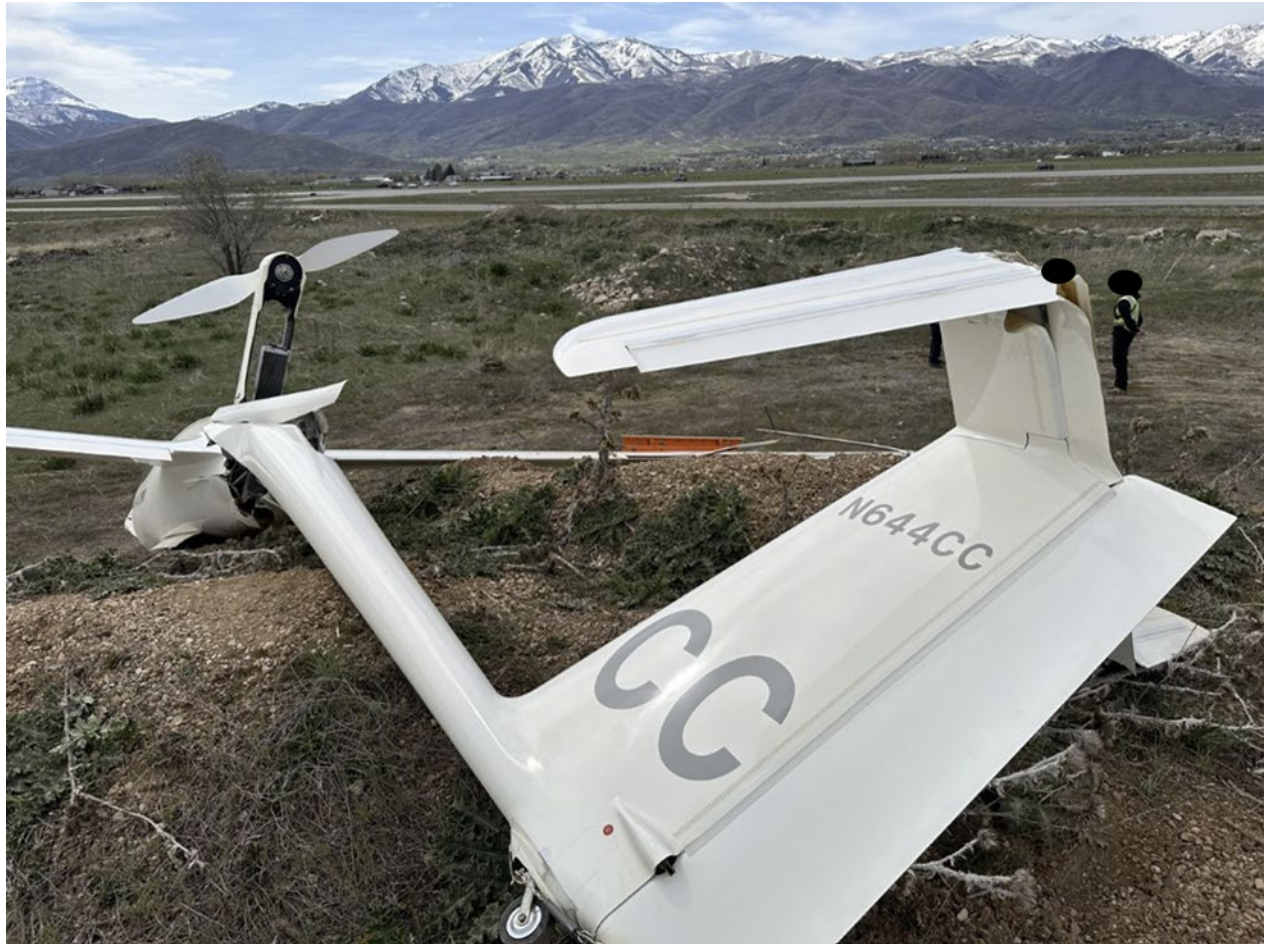
The T-tail remained attached to the top of the vertical stabilizer. The left side horizontal stabilizer exhibited a downward bend about mid-span. The right side exhibited an upward bend about midspan. The vertical stabilizer remained attached to the end of the tail cone and exhibited minor damage. The rudder remained attached to the vertical stabilizer and exhibited minor damage.

Figure 3. Empennage damage. Photo courtesy of the pilot.

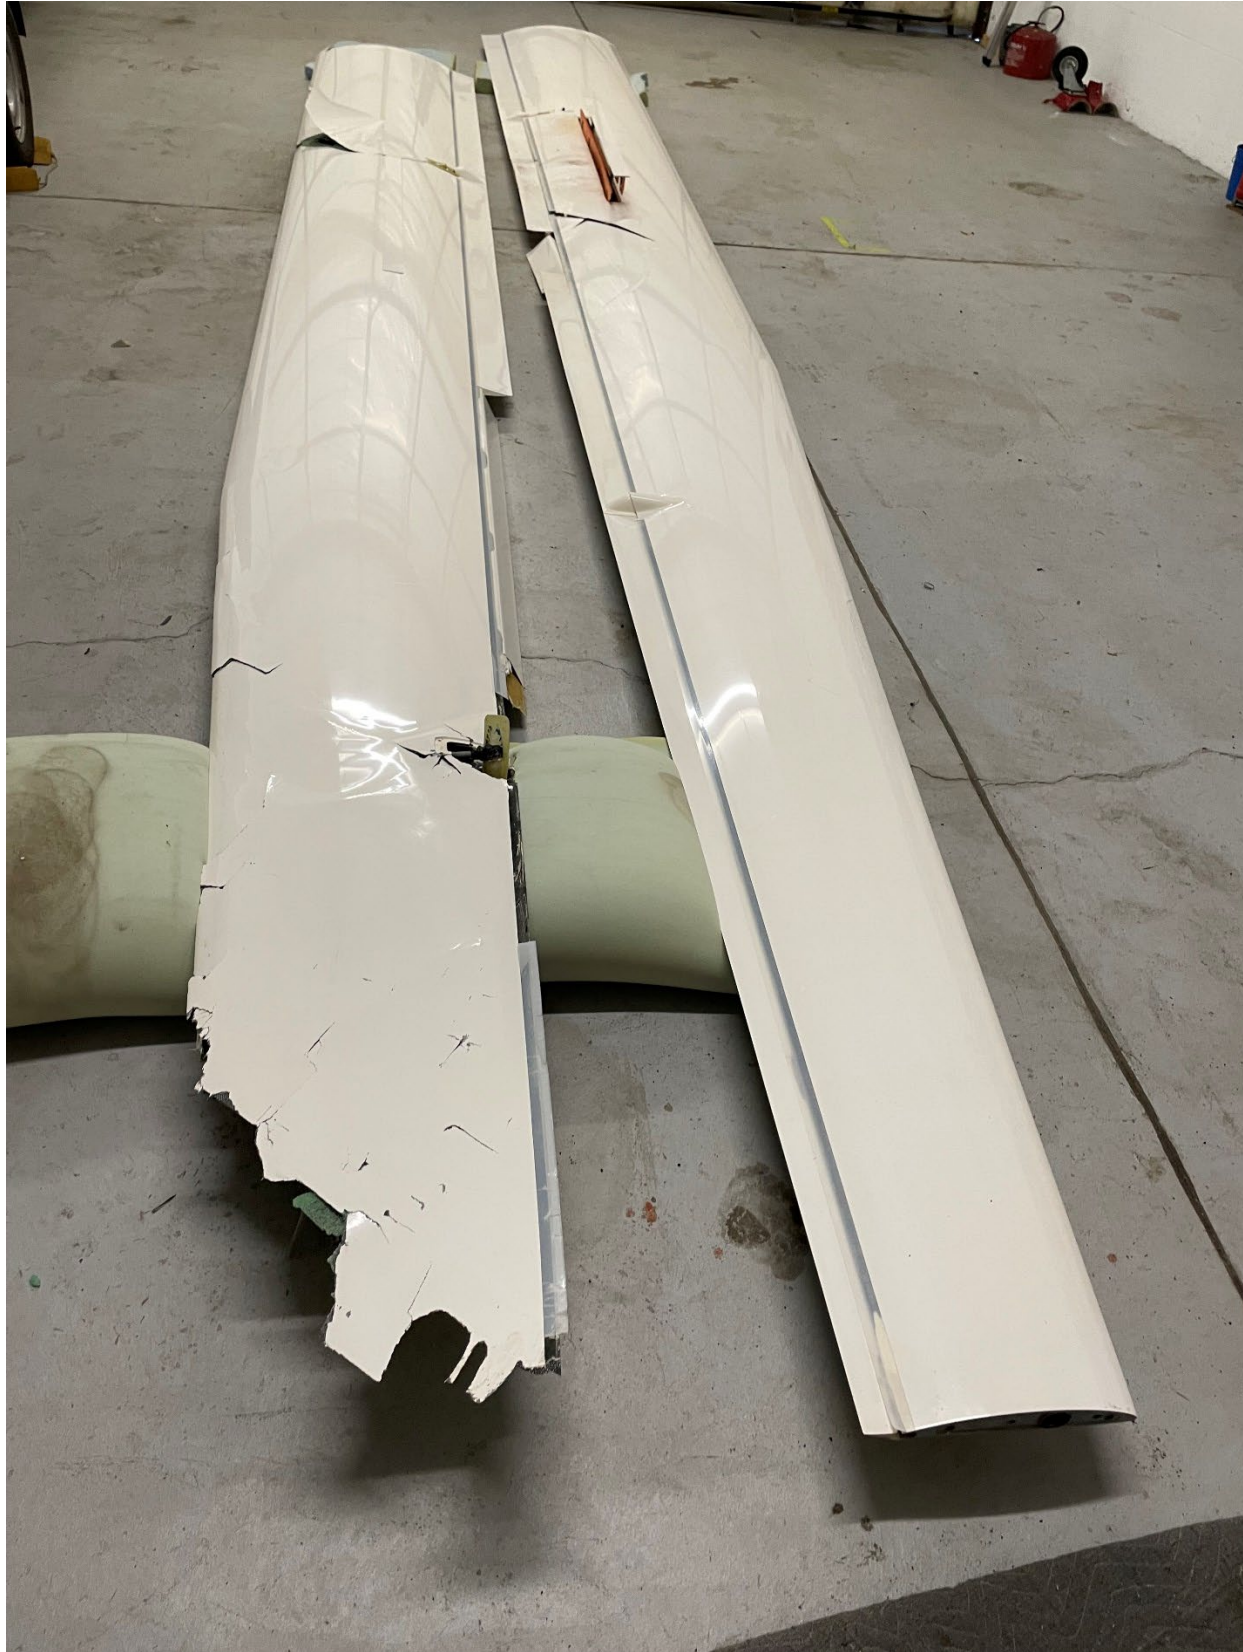
The right wing remained whole and exhibited substantial damage. The right-wing spoiler was extended. According to the pilot, he extended the spoilers after landing. The aileron and flap remained attached to the right wing. The control tubes were cut during the recovery.

The left wing fractured. The winglet and about 3 ft of the wing tip separated from the wing. The aileron and flap remained attached to the left wing. The control tubes were cut during recovery.

Figure 4. Left and right wing, top view.

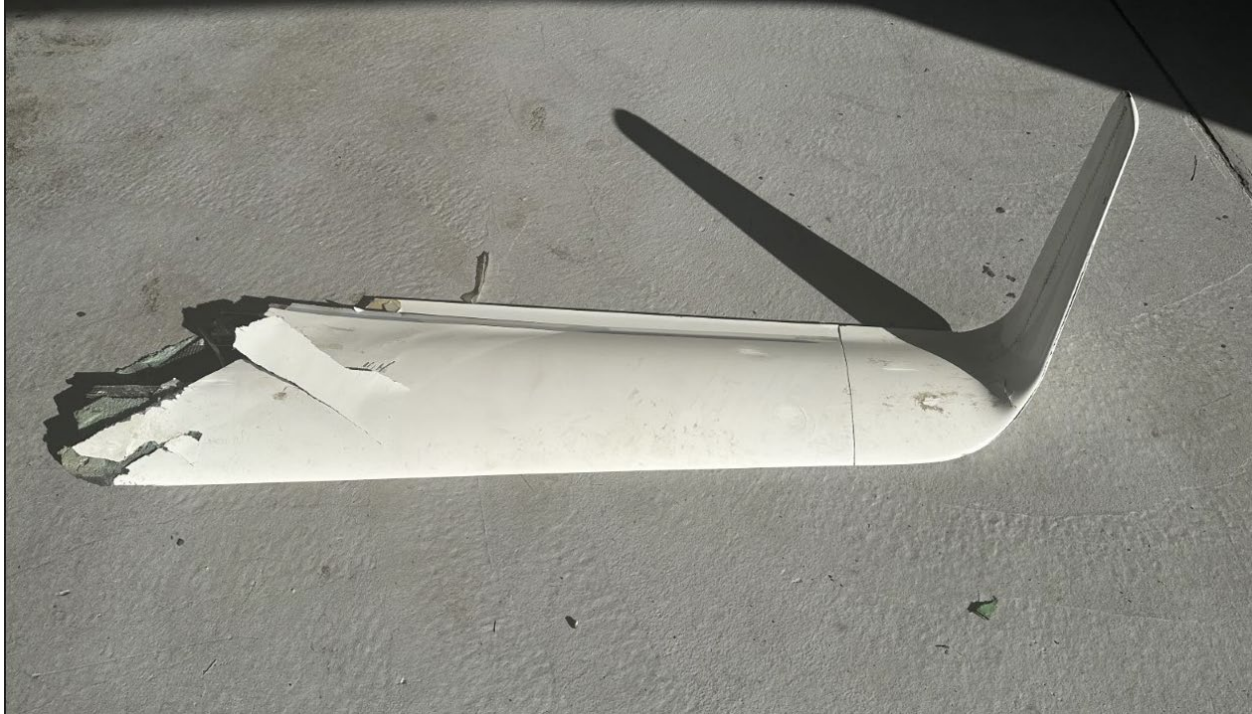
Figure 5. Left wing tip.

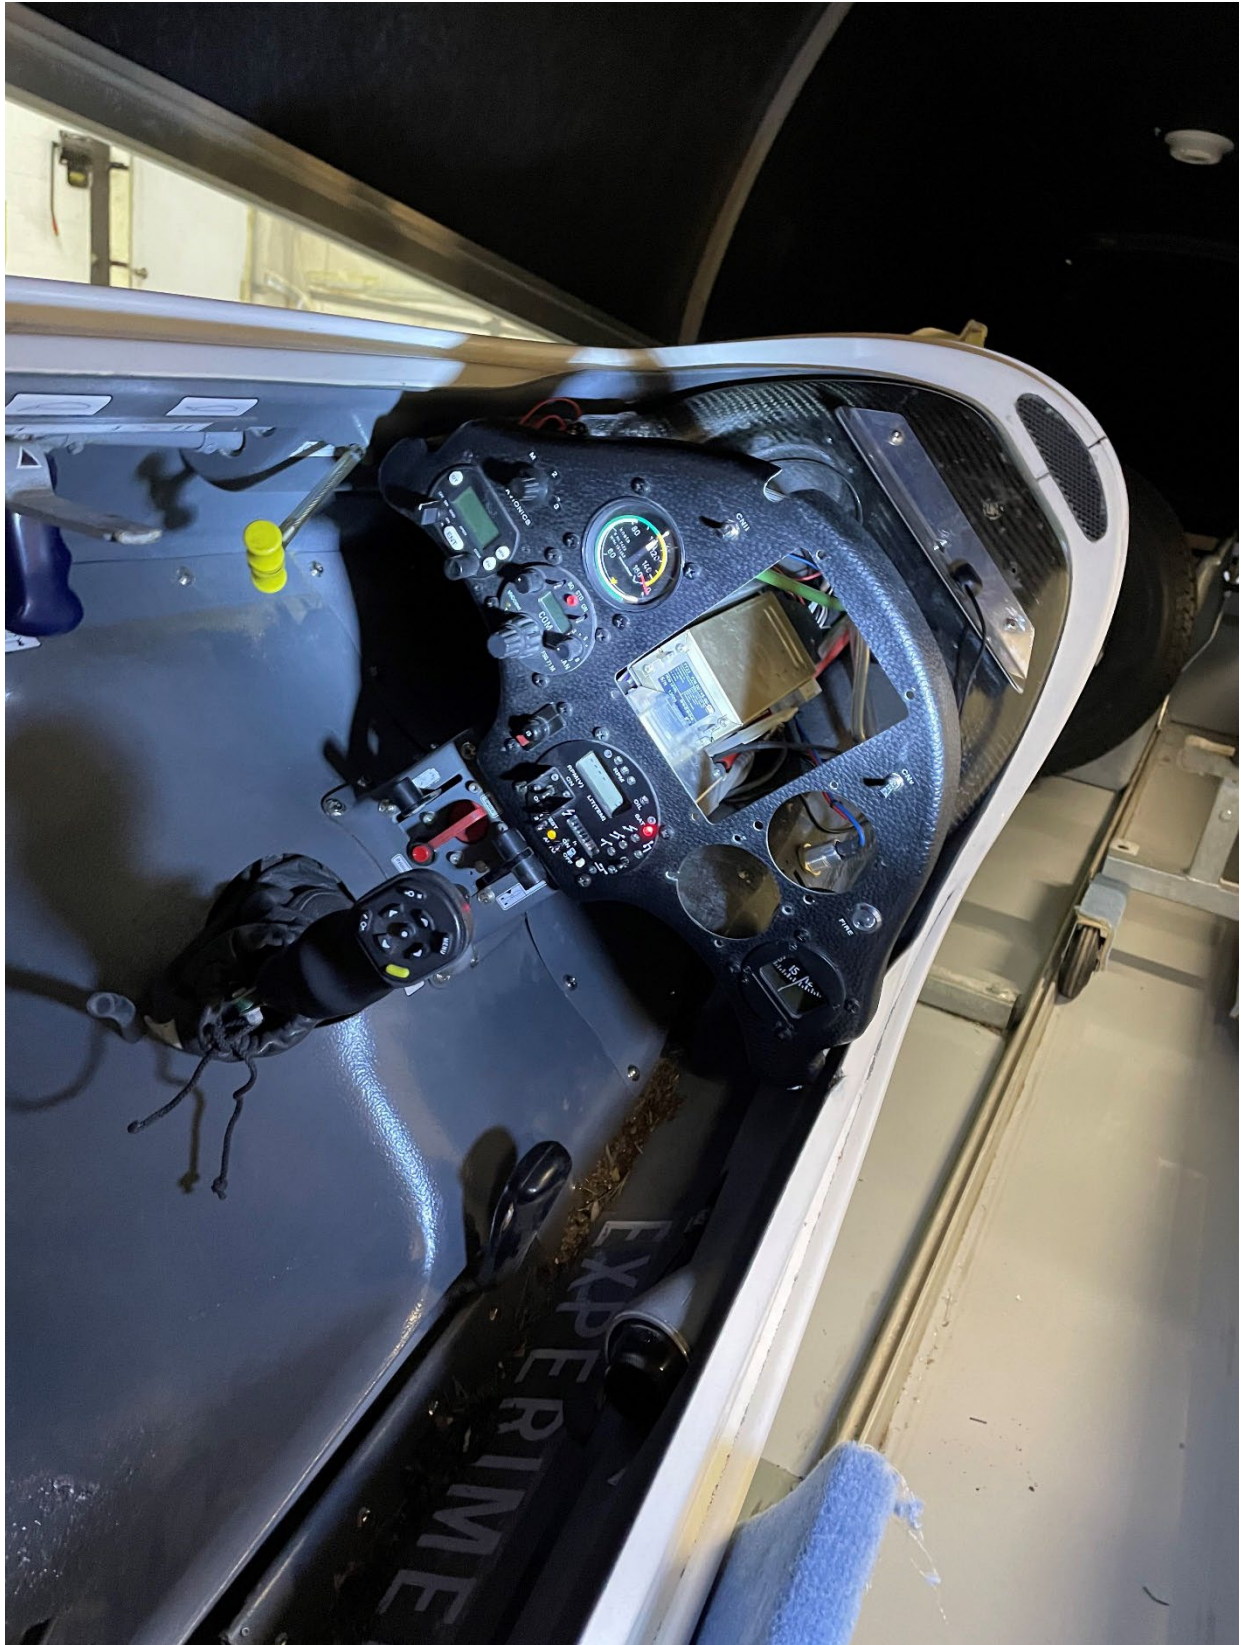
Figure 6. Instrument panel.

The instrument panel remained secured in the cockpit. All instruments were secured in the instrument panel. There was no non-volatile memory available for download. The flap handle, spoiler handle and landing gear handle were present; however, the motor glider was recovered, and the handle positions could not be verified to be in the same position as immediately after the accident.

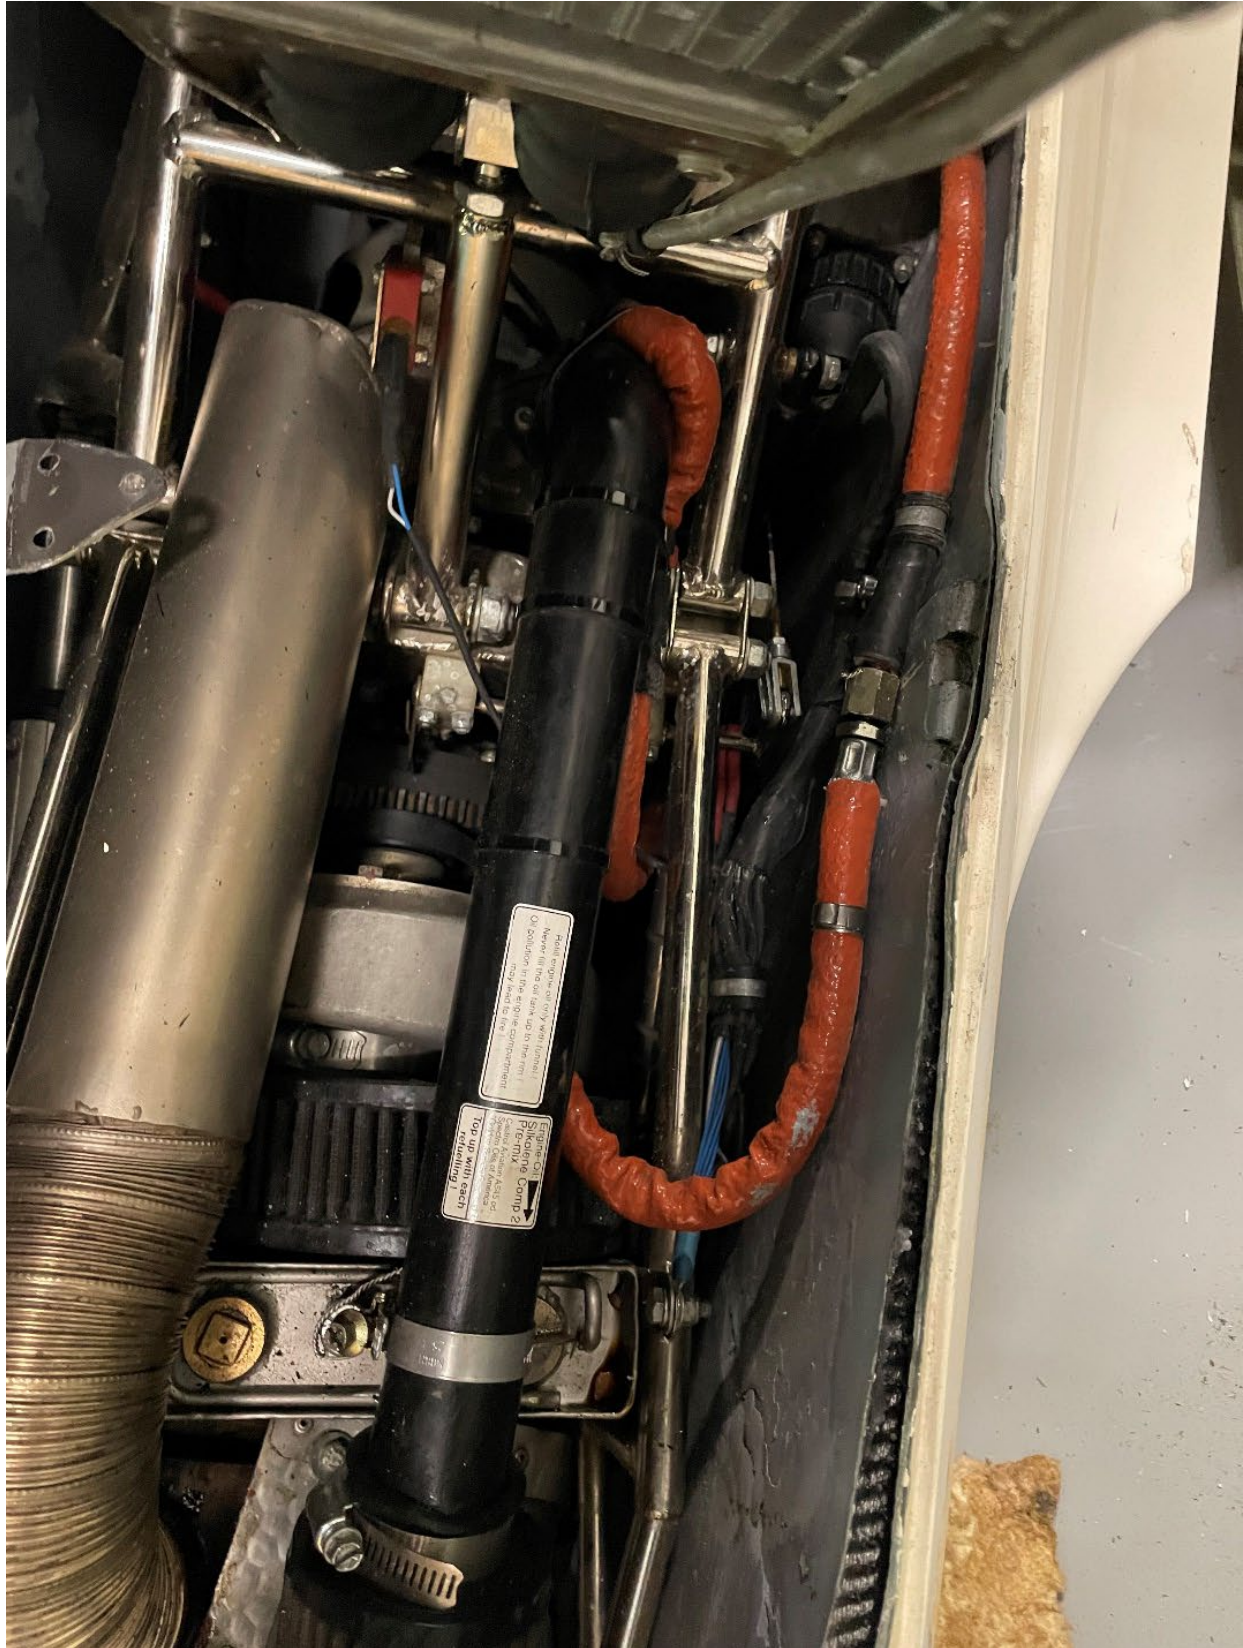
The engine remained secured in the engine bay. The motor mount was damaged at the front-right attachment point.

Figure 7. Engine installed in the fuselage.

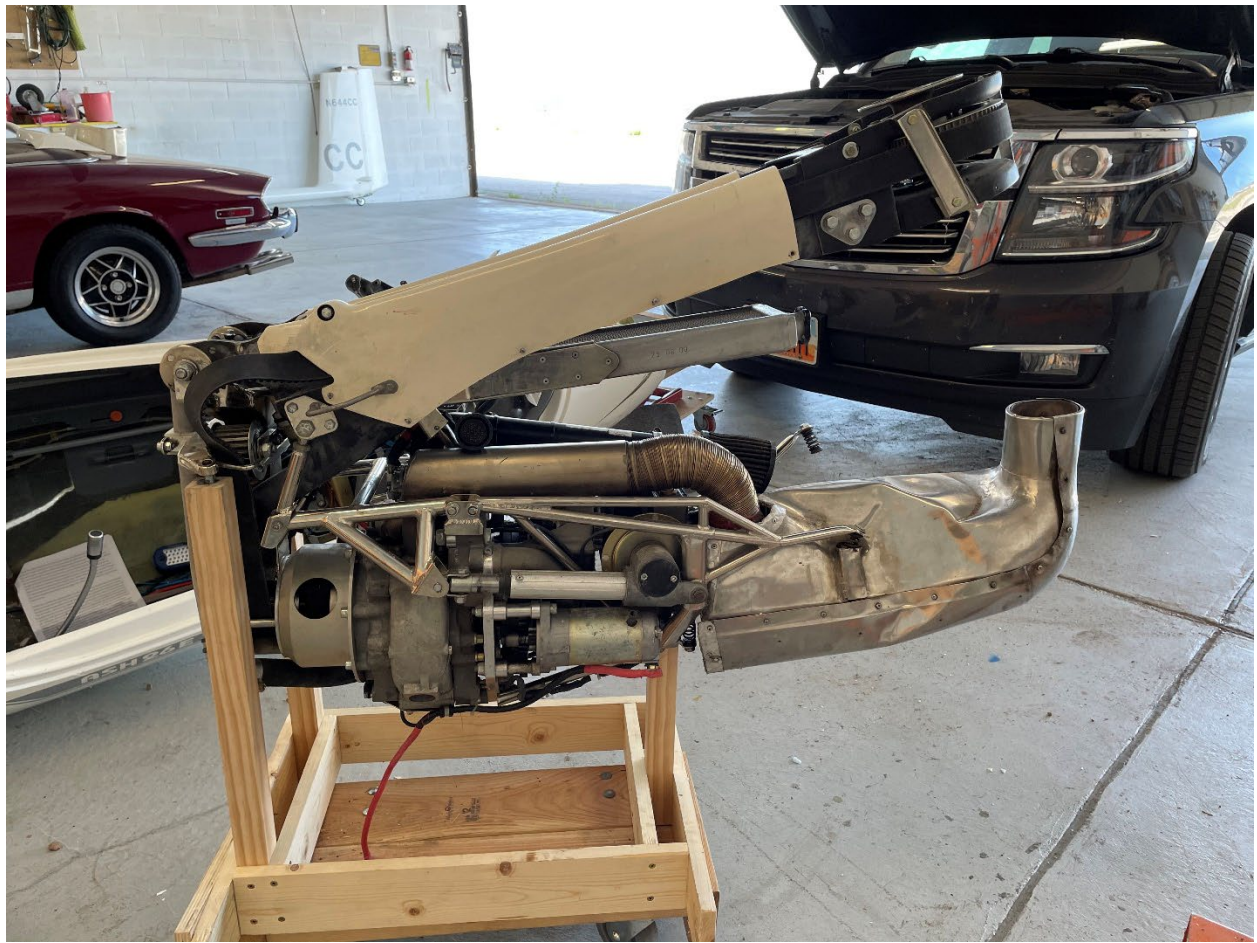
Figure 8. Engine left side.

The engine was removed from the fuselage. A visual examination revealed no visible damage to the engine.

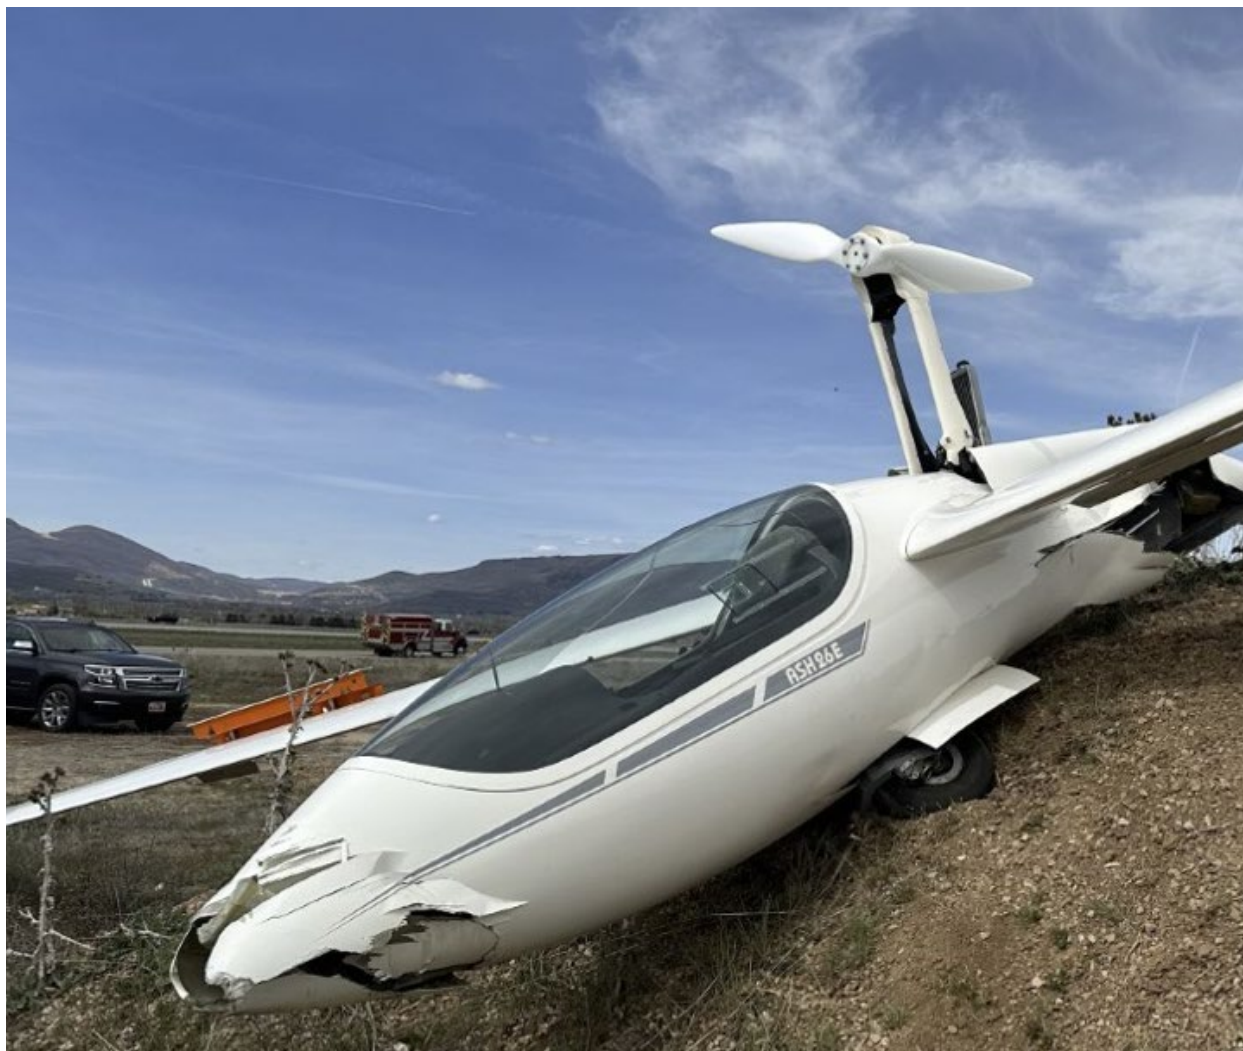
The composite, two-bladed, fixed-pitch propeller remained attached to the mast and exhibited no damage. The drive belt remained in place and exhibited no damage.

Figure 10. Propeller and propeller mast.
