# National Transportation Safety Board

WPR24LA130

## FUEL SUPPLEMENT

Location: Benson, AZ  
Date: April 22, 2024  
Time: 0945 mountain standard time  
Airplane: Rans S-7S

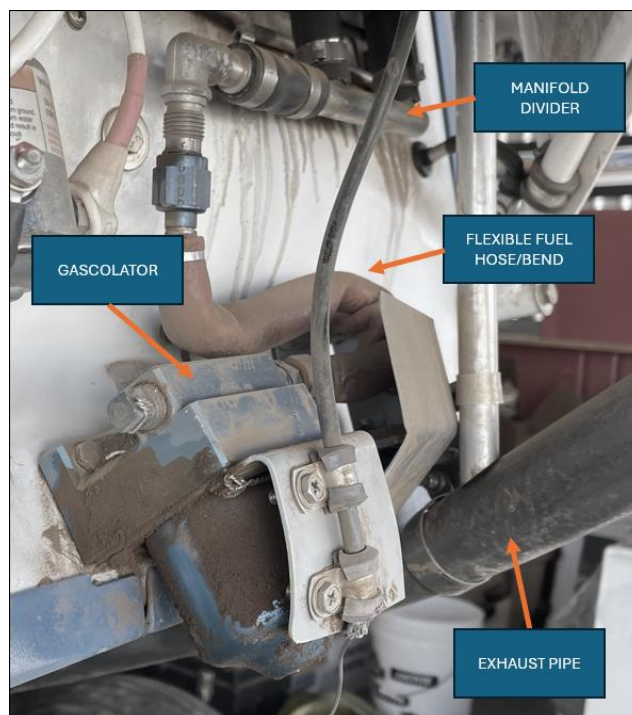
*Figure 1: Firewall-mounted components*

The airplane's fuel system was a combination gravity- and suction-fed design: which gravity-fed fuel flowed from the composite fuel tanks in the inboard section of each wing to a 1.75 gallon "header" tank, located in the lower fuselage behind the back seat. Two electric fuel pumps were mounted to the engine side of the firewall and pulled fuel from the header tank through approximately 10.1 feet of fuel tubing, routing through a shut-off valve near the pilot seat and then through the firewall, where fuel entered an aluminum gascolator attached to the lower left firewall. The engine exhaust pipe was also located along and under the lower firewall near the gascolator.

In post-accident testing, the engine was operated with the cowling removed. The exhaust system transferred significant radiated heat to metallic fuel-system components located on the firewall, close to the exhaust pipe. These fuel system components included (in order of proximity to the exhaust pipe) the gascolator, fuel lines, two fuel filter housings, and two fuel pumps. They were heated by the exhaust pipe during engine tests and retained heat for an extended period: fuel vaporization was observed by investigators when they tested the heat-soaked components 20+ minutes after the engine was stopped. Heating of the fuel by the heat-soaked fuel system components increased fuel vapor pressure locally, raising the likelihood of vaporization within the fuel system.

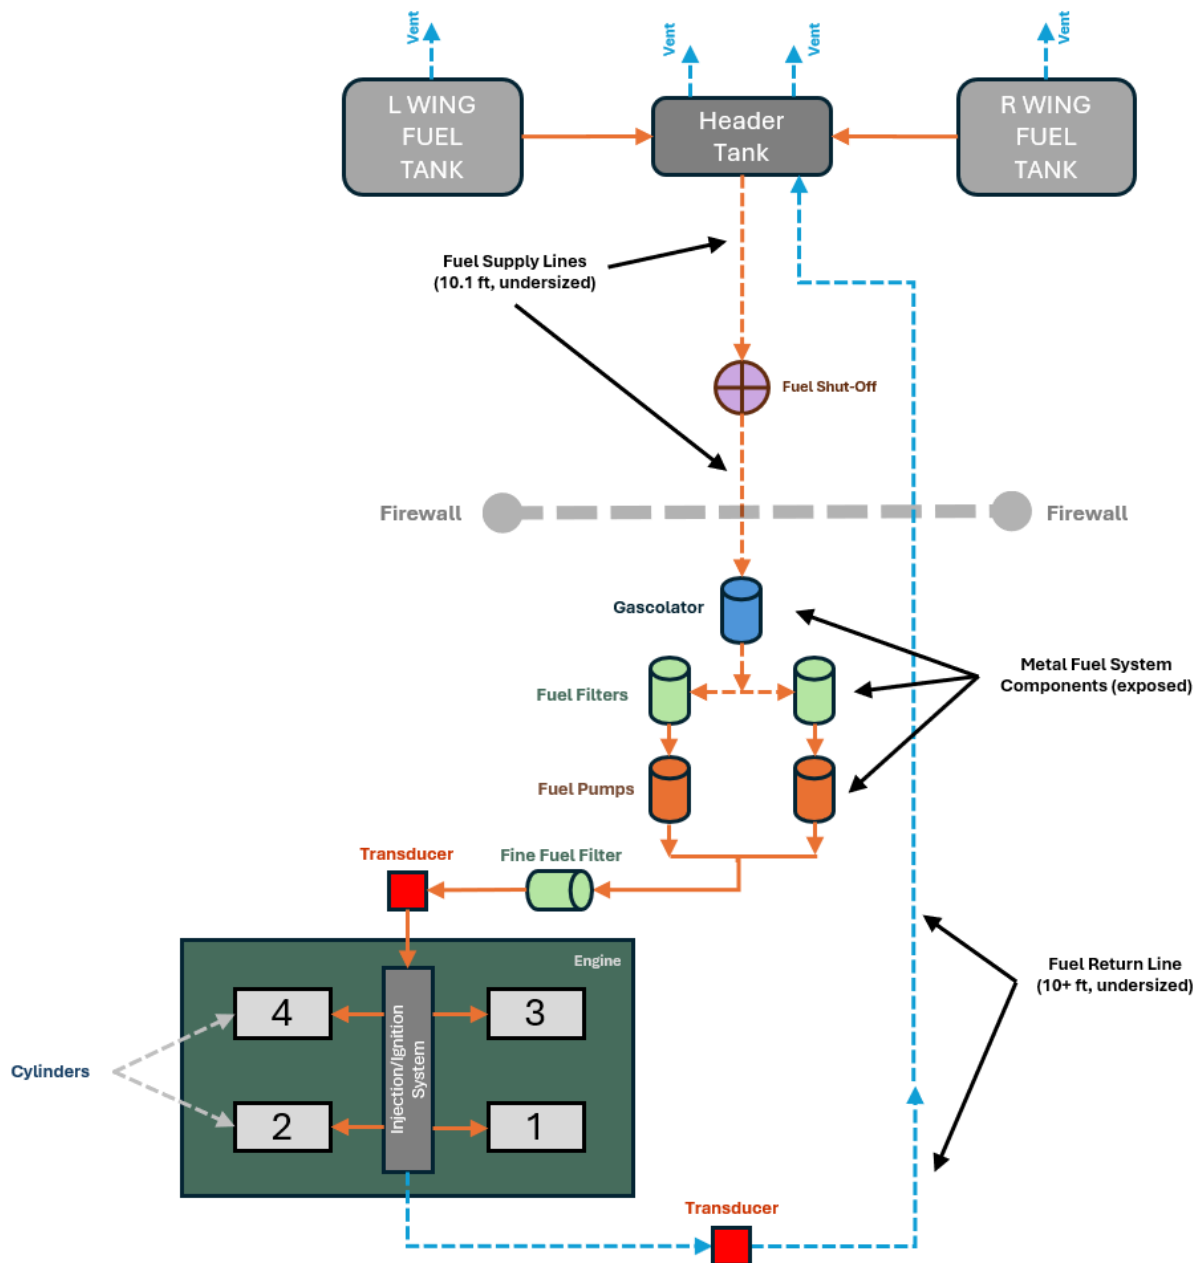
Figure 2: Fuel System Diagram

A representative of engine manufacturer ULPower Aero Engines stated that the fuel supply line was undersized (3/8 inch inside diameter vs. 1/2 inch inside diameter needed for the specific installation, due to the 10+ foot length of the supply line). In addition, the fuel return line was undersized (1/4 inch inside diameter vs. ULPower specified 5/16 inch minimum diameter; and in the case of this installation he would recommend a 3/8 inch inside diameter line, due to the length of the tube). He pointed out that the 1/4 inch fuel return line provides less than half the flow volume of the 5/16 inch line.

Fuel exited the gascolator through an insulated, flexible fuel hose made 180-degree 90-degree bends, with restrictive bend radii smaller than specified in accepted aircraft maintenance practices (refer to AC 43.13-1B Chapter 9, Section 2, Table 9-2). The flexible hose was connected via non-insulated metal fittings containing a 90-degree bend to a non-insulated metal tube manifold/divider, located above the gascolator on the firewall. The manifold divided the fuel path into two non-metallic lines, each of which routed fuel in parallel paths to fuel filters contained in metal canisters and then into corresponding metal fuel pumps, which were mounted to the firewall. After exiting the fuel pumps, pressurized fuel from both pumps entered a banjo fitting and from there a single common fuel line routed fuel through a fine fuel filter and a flow transducer mounted atop the engine, and to the engine's electronic fuel ignition and injection system. Unused fuel was routed through a second fuel flow transducer before entering the return line, which passed through the firewall and aft approximately 10 feet, returning unused fuel back to the header tank located behind the back seat.

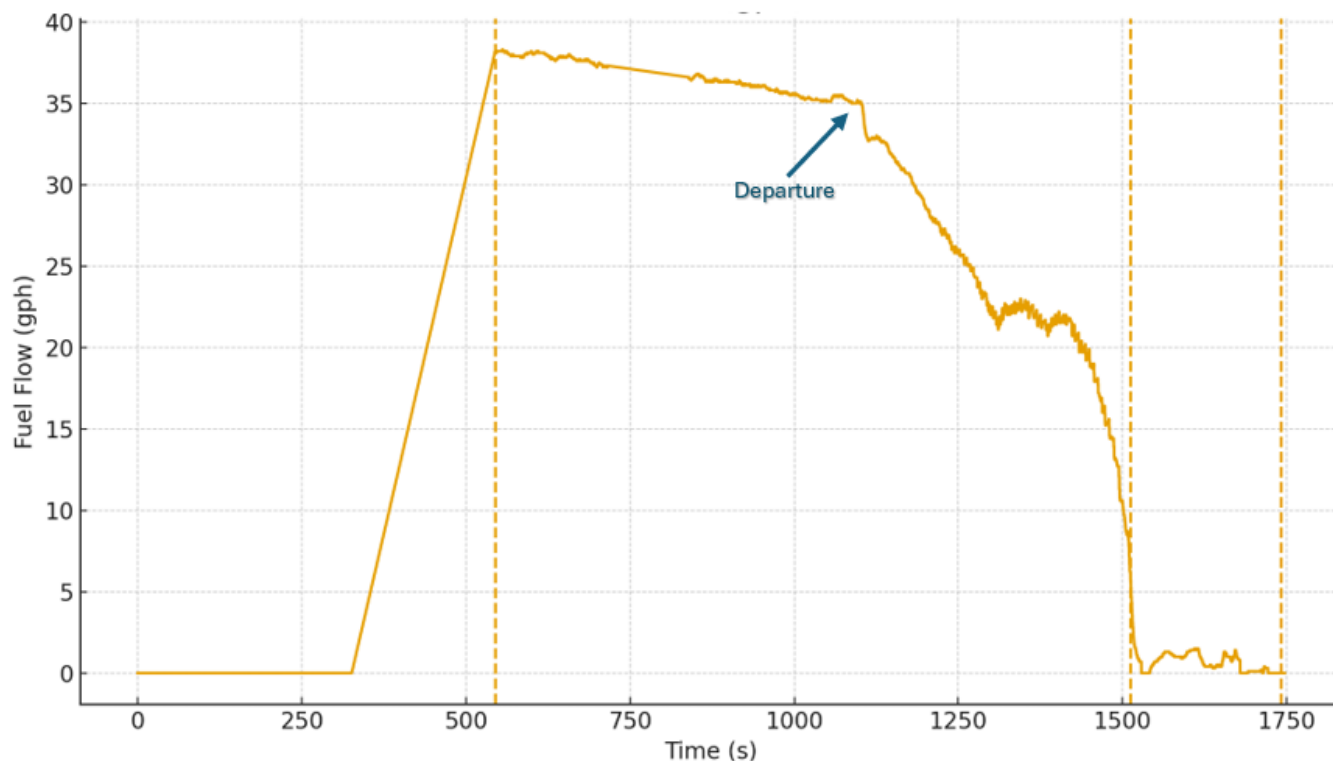
*Figure 3: Recorded Fuel Flow Data – Accident Flight*

A review of the parameters in the downloaded Dynon Skyview tabular data revealed that the engine was running when data recording initiated at 08:23:14 local time (represented by 550 elapsed seconds in Figures 3-7), and operated for approximately 9 minutes during ground operations with normal fuel flow (~40 GPH) and pressure (~40 psi), demonstrating functional operation despite marginal fuel vaporization conditions. Take-off occurred at 08:32:30, followed by just under seven minutes of powered flight, during which fuel flow and pressure progressively degraded. Complete fuel system failure occurred abruptly at 08:39:20, with fuel flow and pressure dropping suddenly and simultaneously to near zero psi. Exhaust gas temperatures spiked to 775-780°C just prior to the sudden fuel pressure/flow drops, indicating engine operation under lean, fuel-starved conditions. The forced landing occurred at 08:42:30.

Based on the recorded data; component heating observed during post-accident engine tests; and fuel flow limitations associated with the restricted fuel lines, which extended the amount of time fuel was in contact with hot fuel system components; it is likely that heating of the fuel as it passed through the airplane’s fuel system was a significant factor contributing to fuel vaporization during the accident flight.

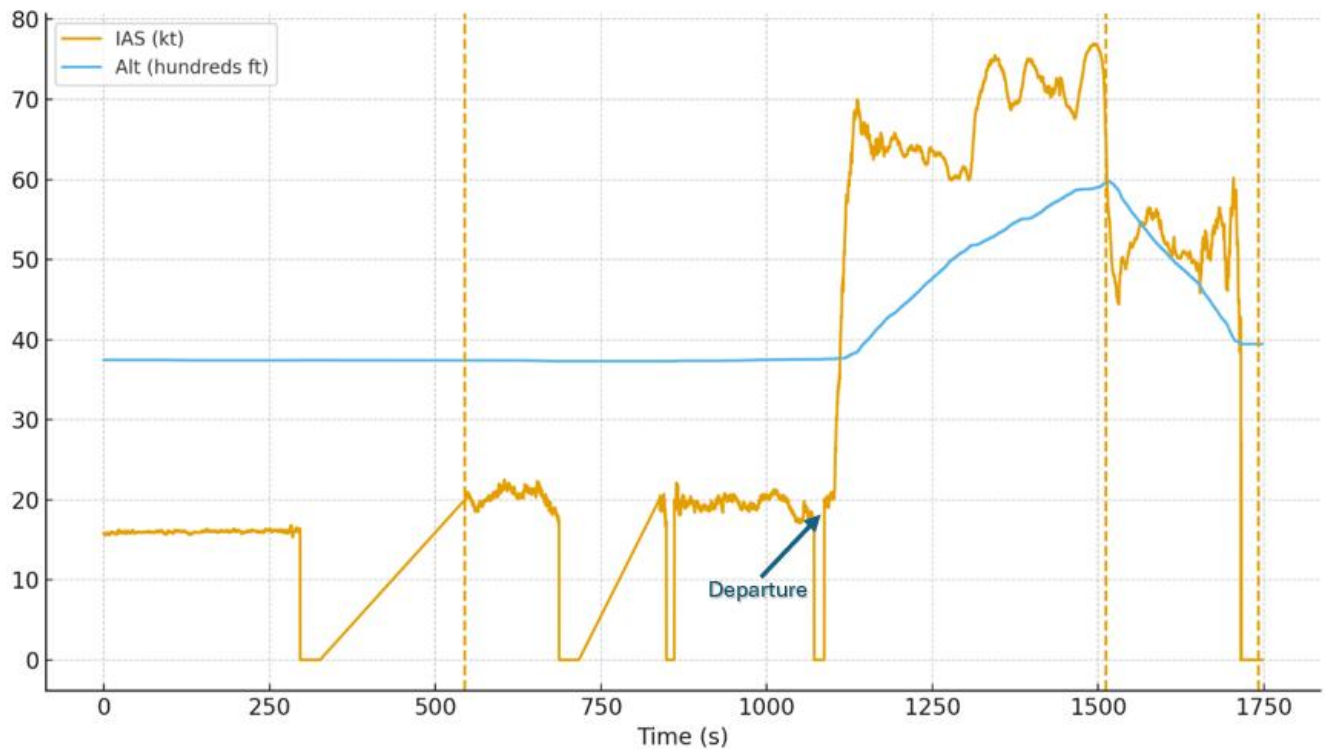
Figure 6: Recorded Airspeed/Altitude Data – Accident Flight

During the airplane's 6.5-minute climb from 3,831 feet to approximately 6,000 feet MSL (2,169 feet altitude gain), the surrounding atmospheric pressure decreased from approximately 14.14 psi to approximately 12.52 psi. In a 12.52 psi environment, RVP 15 fuel will vaporize at any fuel temperature above about 93 degrees Fahrenheit. This reduction of surrounding static air pressure as the airplane climbed created an environment highly conducive to vaporization. When the
