**From:** [Stephen Stein](#)  
**To:** [Tealeye Cornejo](#)  
**Subject:** Fwd: NTSB Investigation: 6120.1 Form  
**Date:** Tuesday, April 30, 2024 8:59:16 AM  
**Attachments:** [99C accident.docx](#)

As you know the National Transportation Safety Board is investigating an accident involving a Cessna 182, registration N2299C, which occurred on April 23, 2024 in Challis, Idaho. You have been identified as the operator of the helicopter at the time of the accident and by the rules pertaining to the notification and reporting of aircraft accidents (Title 49 *Code of Federal Regulations* Part 830), require the operator and/or pilot of an aircraft involved in an accident, or certain incidents, to file a report on NTSB Form 6120.1/2 and furnish other information as required within **10 business days** of the accident.

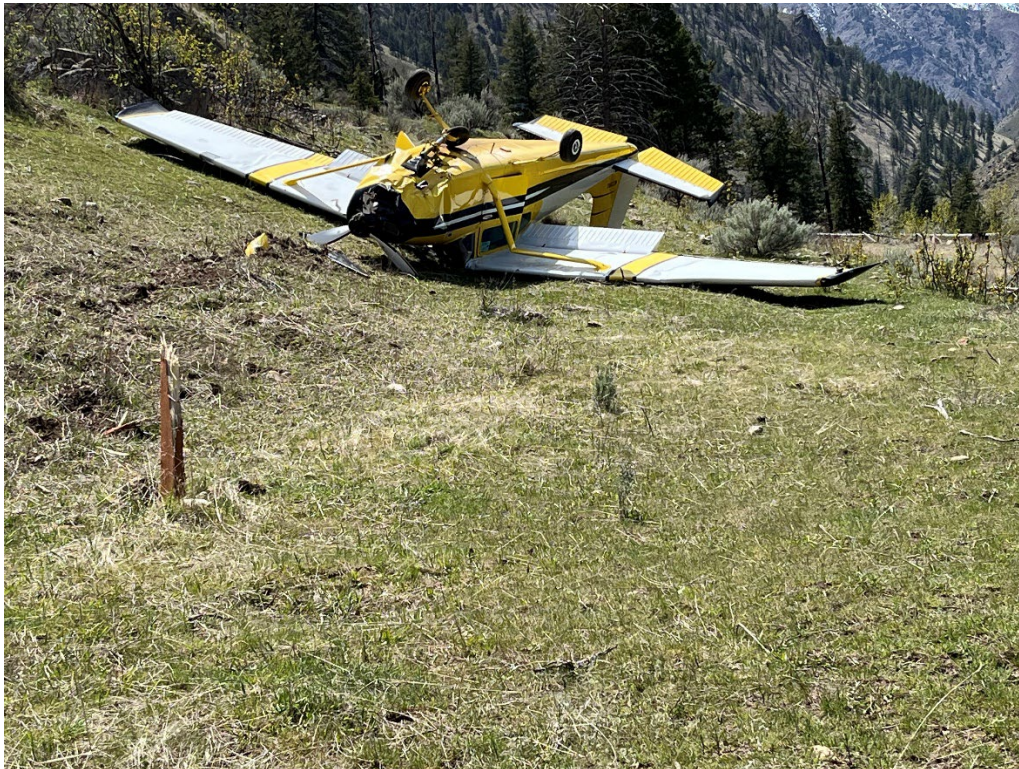
All seemed normal up to this point, and I slowed, lowering 40 degrees of flaps, and descended further aligning with the runway. I was a little higher than normal, and about 70 knots airspeed. I continued the final approach and landed perhaps a couple hundred feet from the end of the runway and began concentrating on keeping the aircraft on the narrow runway. After touchdown as I was approaching the last part of the runway, I saw that there was a large mudhole on the runway, so I eased the aircraft to the right slightly off centerline to avoid the water. The surface there was smooth turf. Realigning as I approached the runway end, I noticed I was travelling too fast and tried to stop, but instead ran off the runway end through some big rocks and onto a small knoll. This is not good, I thought. The nose strut was torn loose, and the nose dug into the hillside, flipping the aircraft onto its back, finally stopping upside down.

The engine was stopped and I was hanging upside down held securely by BAS lap belt and shoulder harnesses. I determined that I was uninjured, so hung there collecting my thoughts.
