# National Transportation Safety Board

WPR24LA134

## **MATERIALS LABORATORY**

Factual Report 25-011

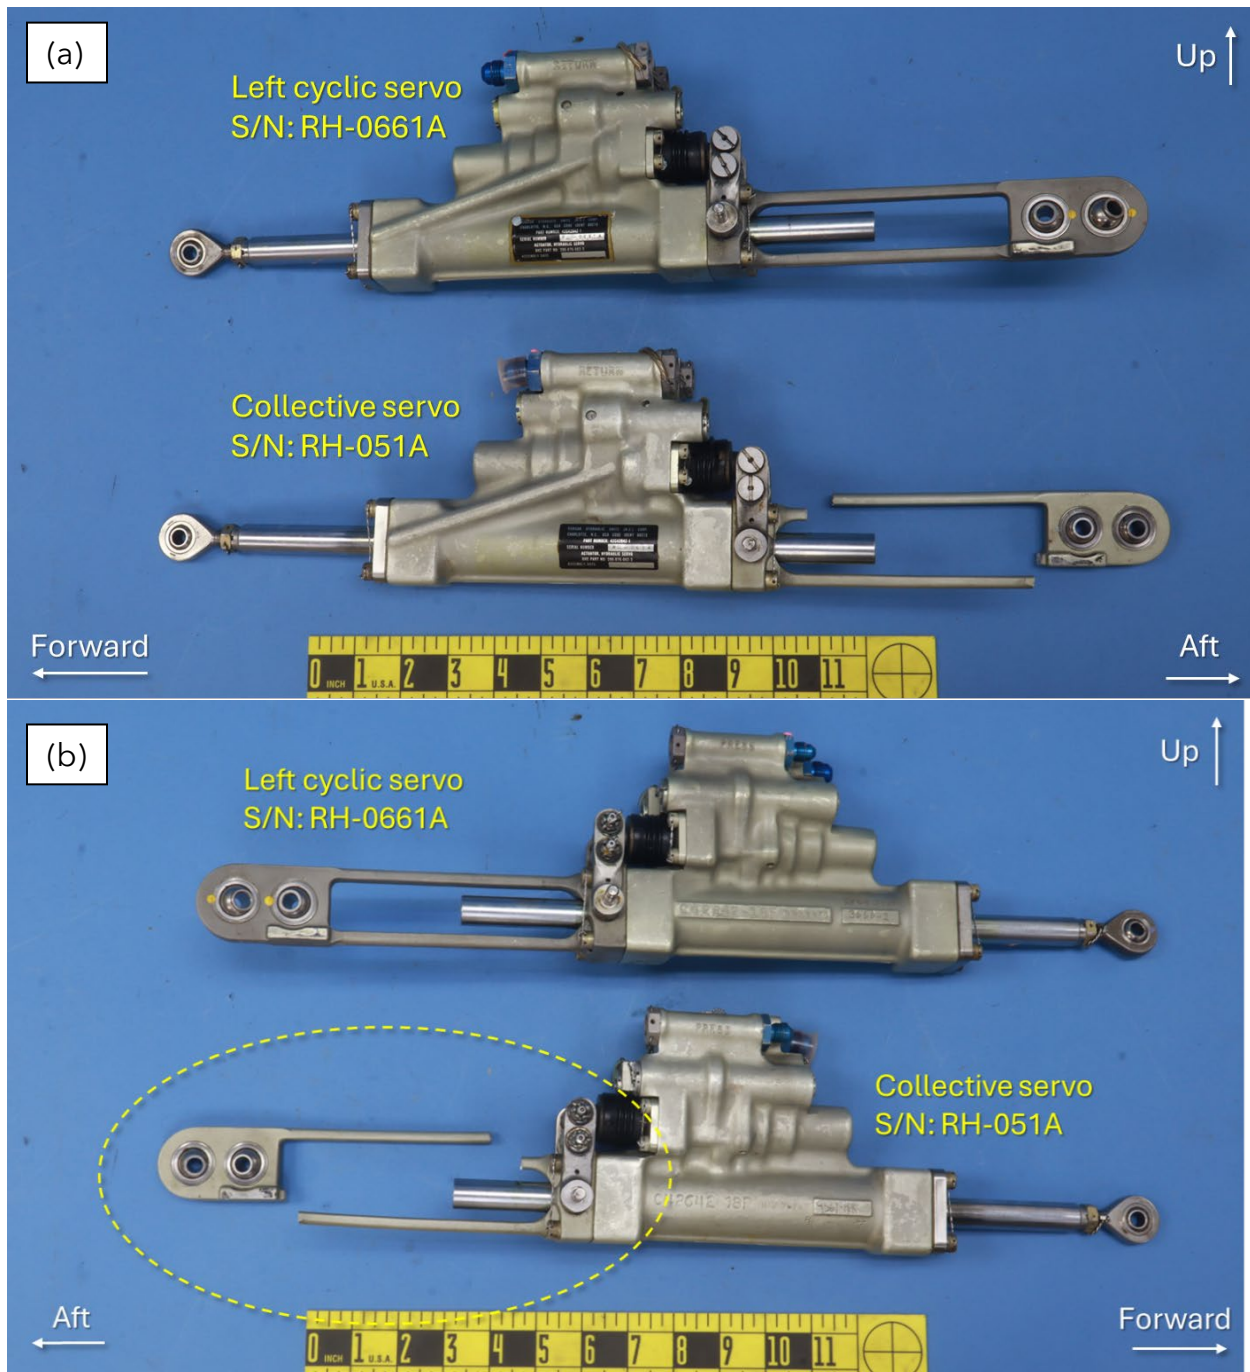
Figure 1 and Figure 2 show the two servos from the accident helicopter, as received. The bottom servo in the figures is connected to the collective system and had fractured in two locations along the upper and lower legs of the arm (see Figure 3 through Figure 5). The top servo in Figure 1 was from the left cyclic control system and was used as an exemplar for the examination. The arm of this servo was intact.

Figure 1. The two servos from the accident helicopter, as received. The circled area in (b) corresponds to the fractured arm legs from the collective servo.

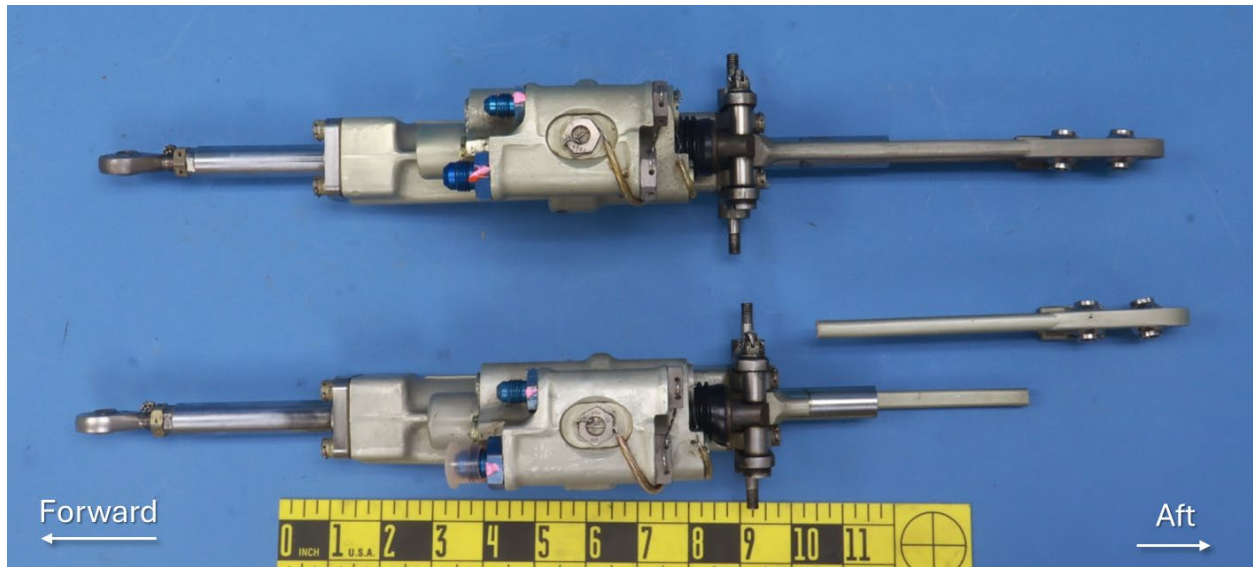
Figure 2. Views of the servos from the upward-facing surfaces, showing the locations of the fractures on the collective servo.

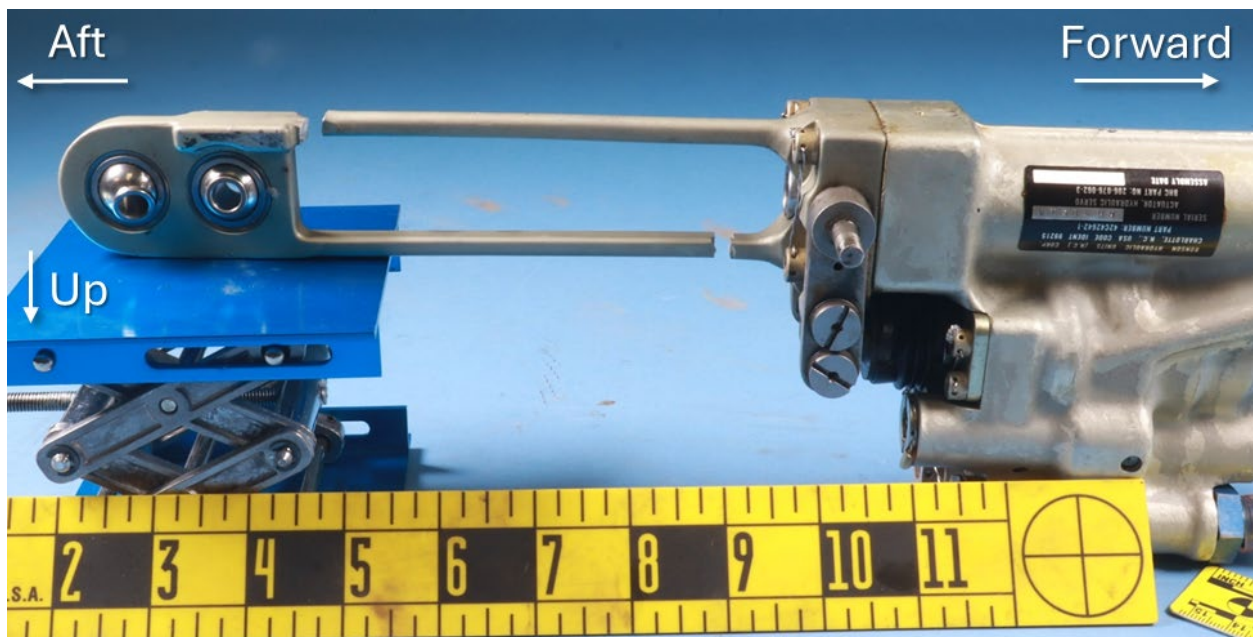
Figure 3 and Figure 4 show the two fracture locations of the collective servo arm. Both fractures were relatively flat and oriented 90° relative to the longitudinal direction of each leg. The fractures were also located near the radii at each end of the opening in the middle of the arm. The bottom leg fracture surface was next to the side with the two aft fisheye bearings (on the left in the figures), whereas the fracture surface on the upper leg was towards the main servo body, approximately 0.5 inches from the arm end, or 0.25 inches from the radius.

Figure 3. The collective servo arm, positioned to show the locations of the fractured remnants at the time of fracture.

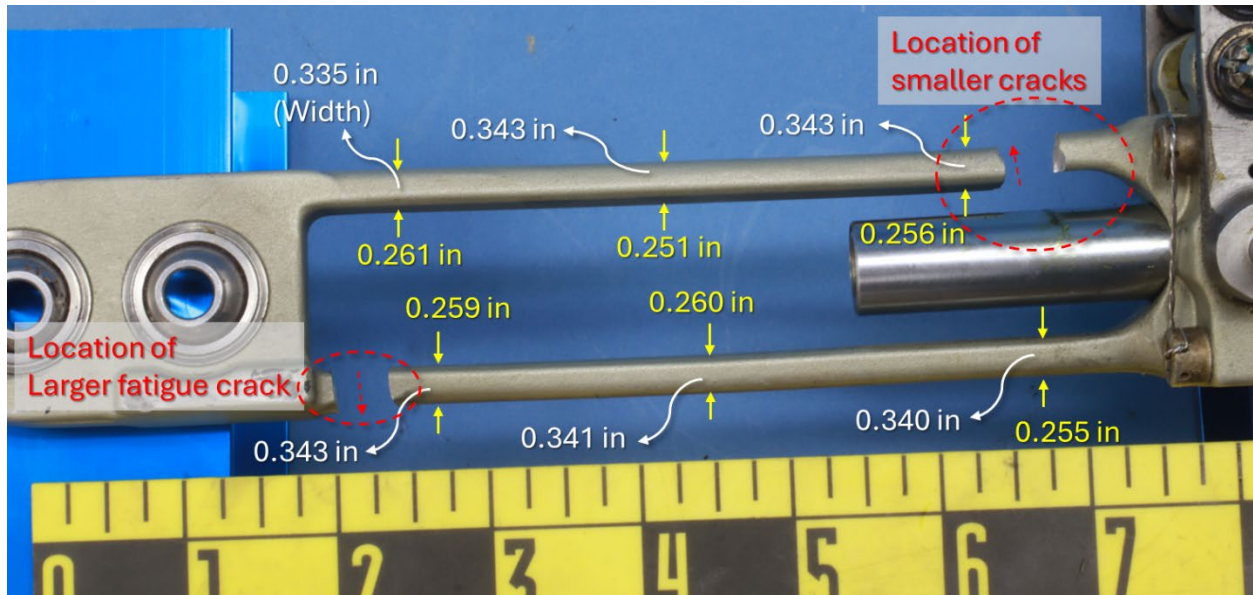
In both cases, the cracks on the fracture surfaces had propagated from the interior surfaces outward, as denoted by the red dashed arrows in Figure 4. Figure 4 also illustrates the various thicknesses of the fractured legs of the arm (in yellow), as well as the widths (in white). The fractured surfaces, annotated in Figure 4, are shown in Figure 5. This figure depicts the fracture surfaces on the aft arm fragment. Figure 6 shows an angled view of the forward fragment of the collective servo arm.

Figure 4. Closer view of the collective servo arm fractures.

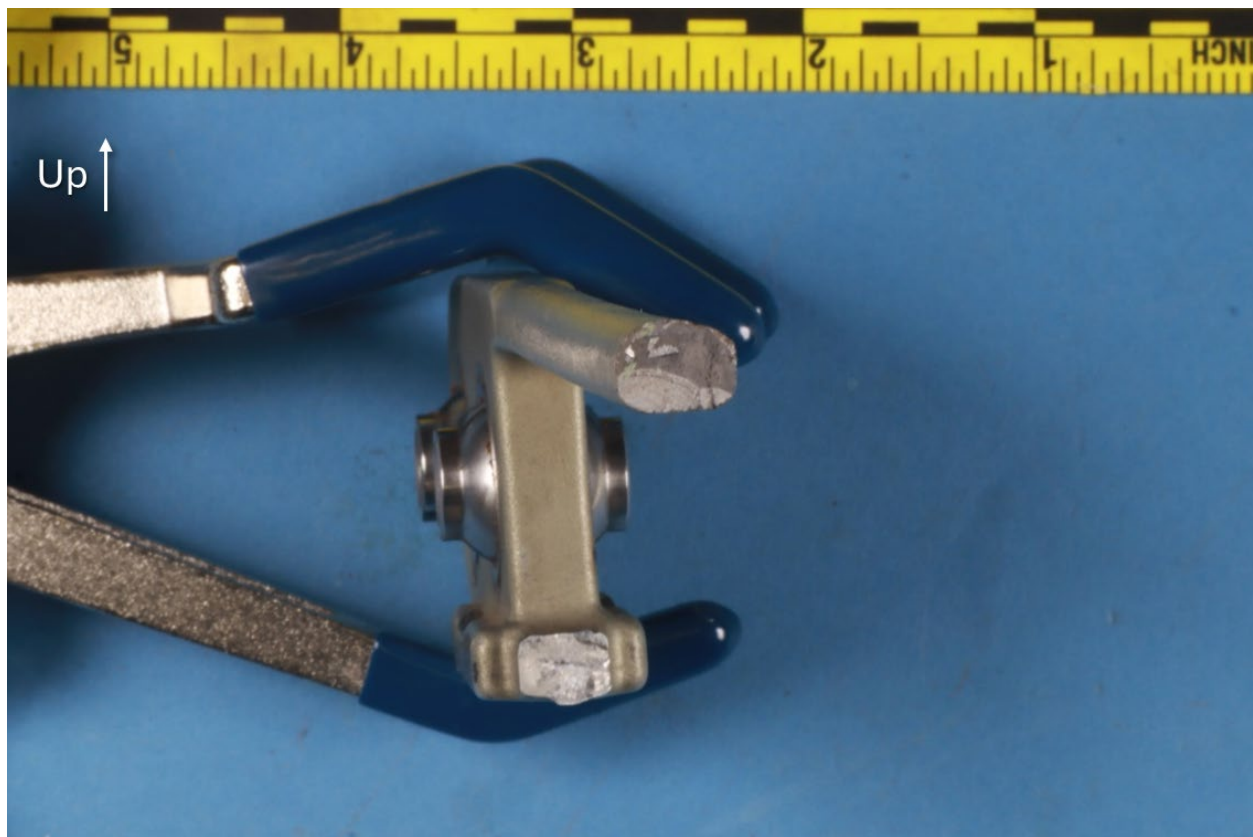
Figure 5. View of the two fracture surfaces of the servo arm, from the forward-looking aft view.

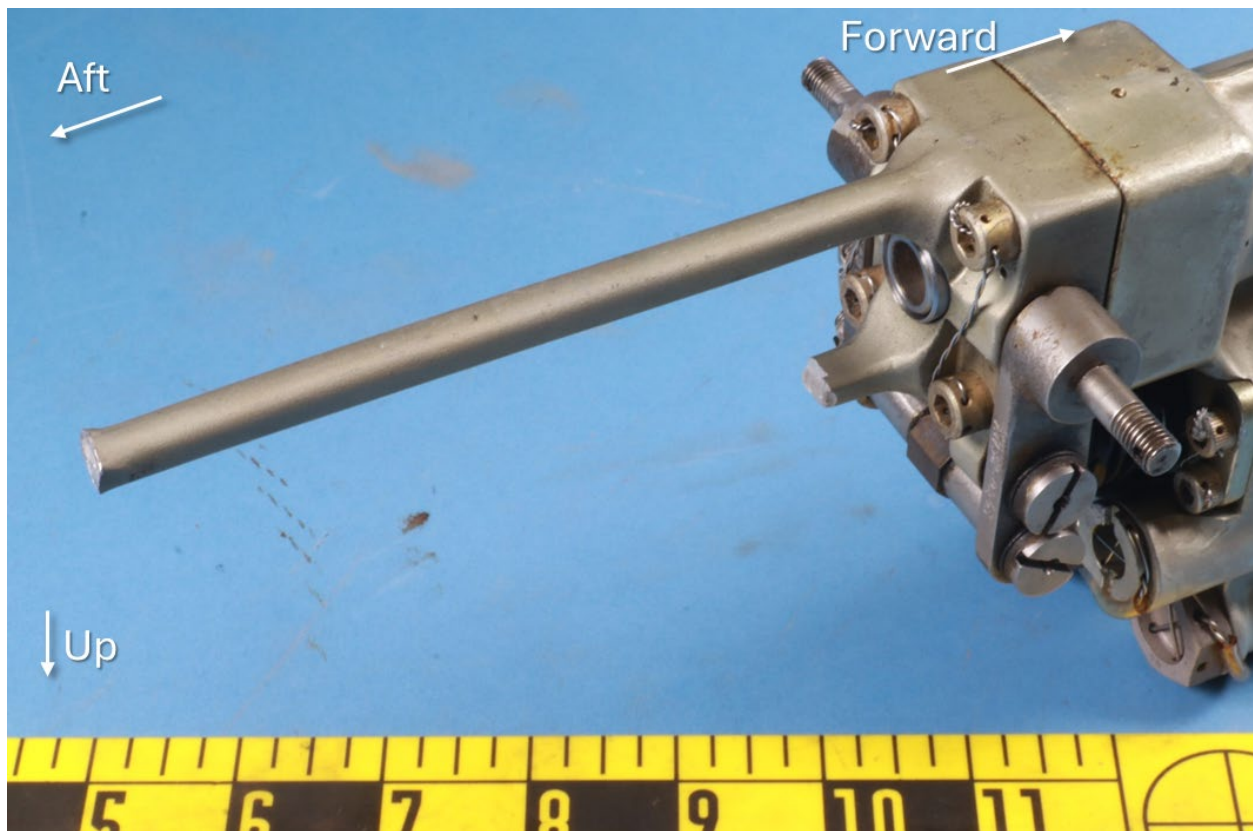
Figure 6. Angled view of the two inboard side fractures of the collective servo arm.

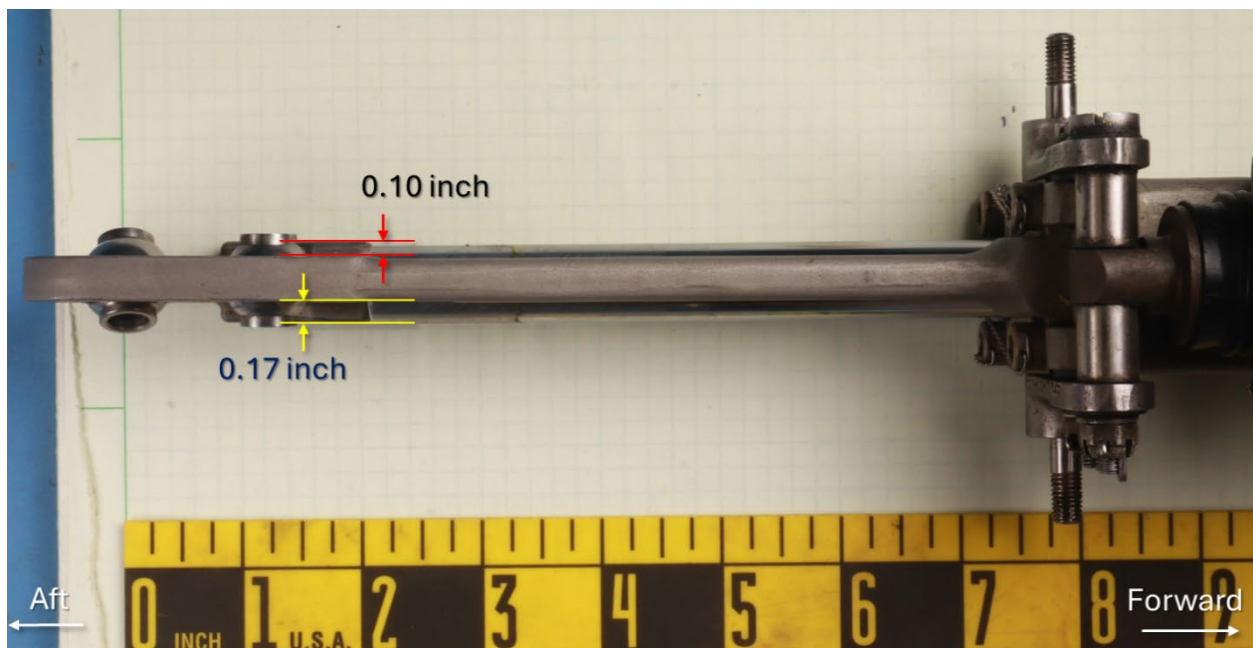
Figure 7 and Figure 8 show the two servo arm fragments positioned in a way that demonstrates out-of-plane displacement or deformation. Figure 7 shows the displacements between the upper and lower legs of the aft arm fragment are also annotated in Figure 7. Figure 8a shows a top-down view of the forward collective arm fragment, showing a bend of approximately 1° or 0.050 inches (towards the up direction on the left in the figure). The side view in Figure 8b also exhibited an upward bend. Figure 8a also shows a vertically oriented linear witness mark located at the edge of the piston in Figure 8b.

Figure 7. Top-down view of the cyclic (exemplar) servo arm.

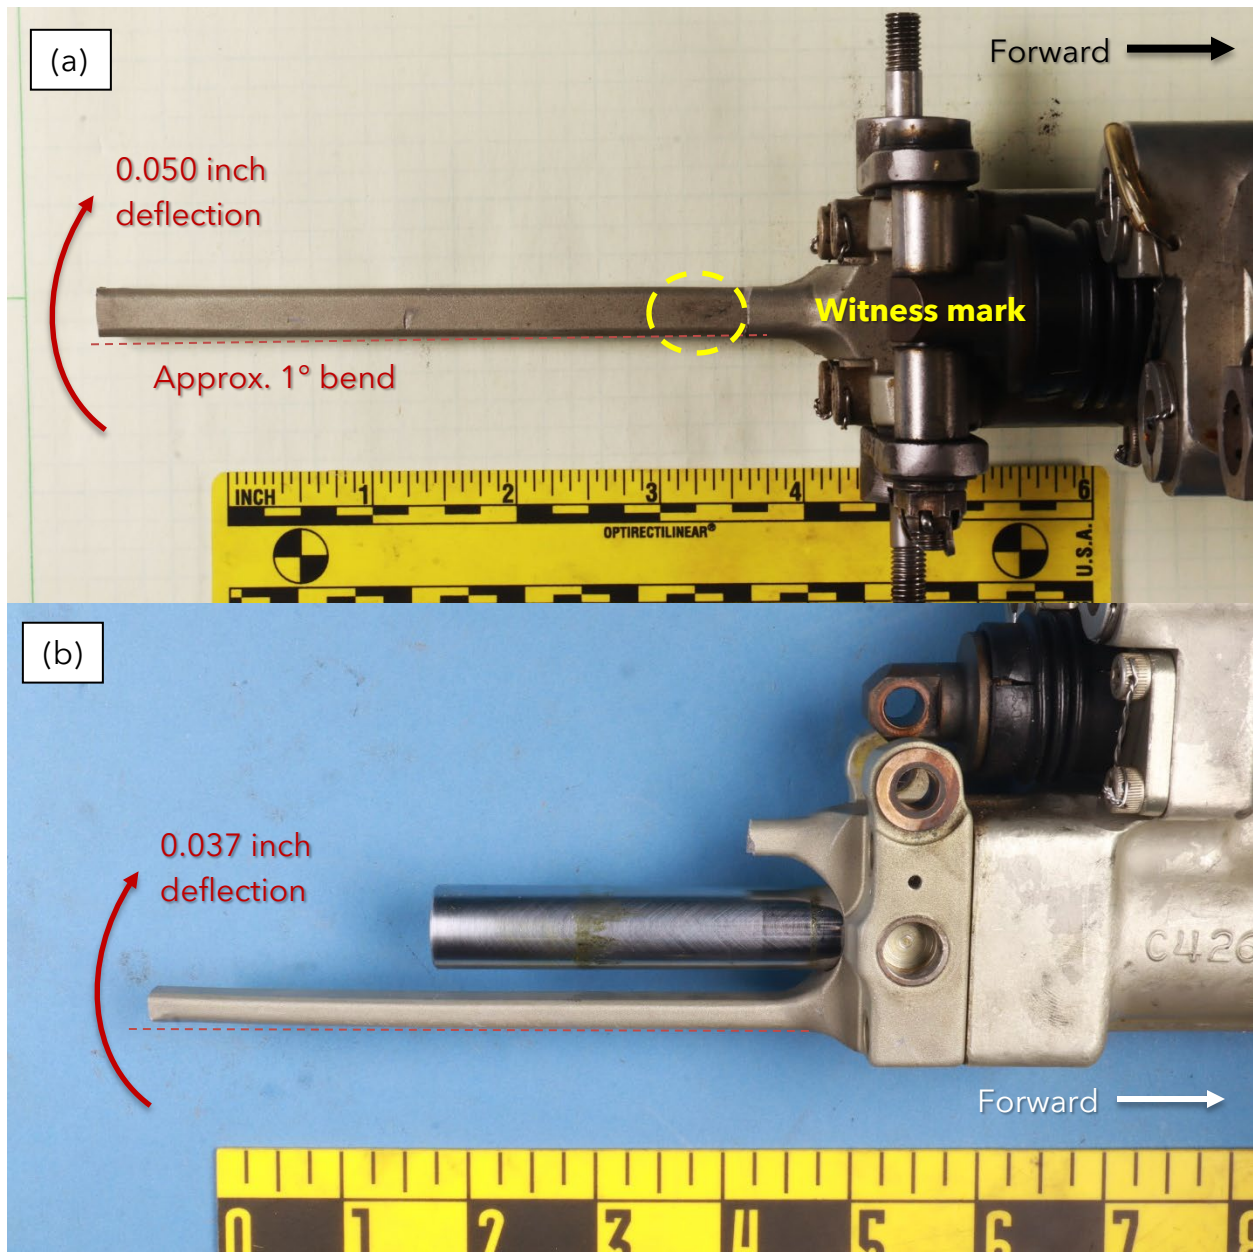
Figure 8. Views of the inboard side of the fractured arm from (a) the top-down view and (b) the side view from the right.

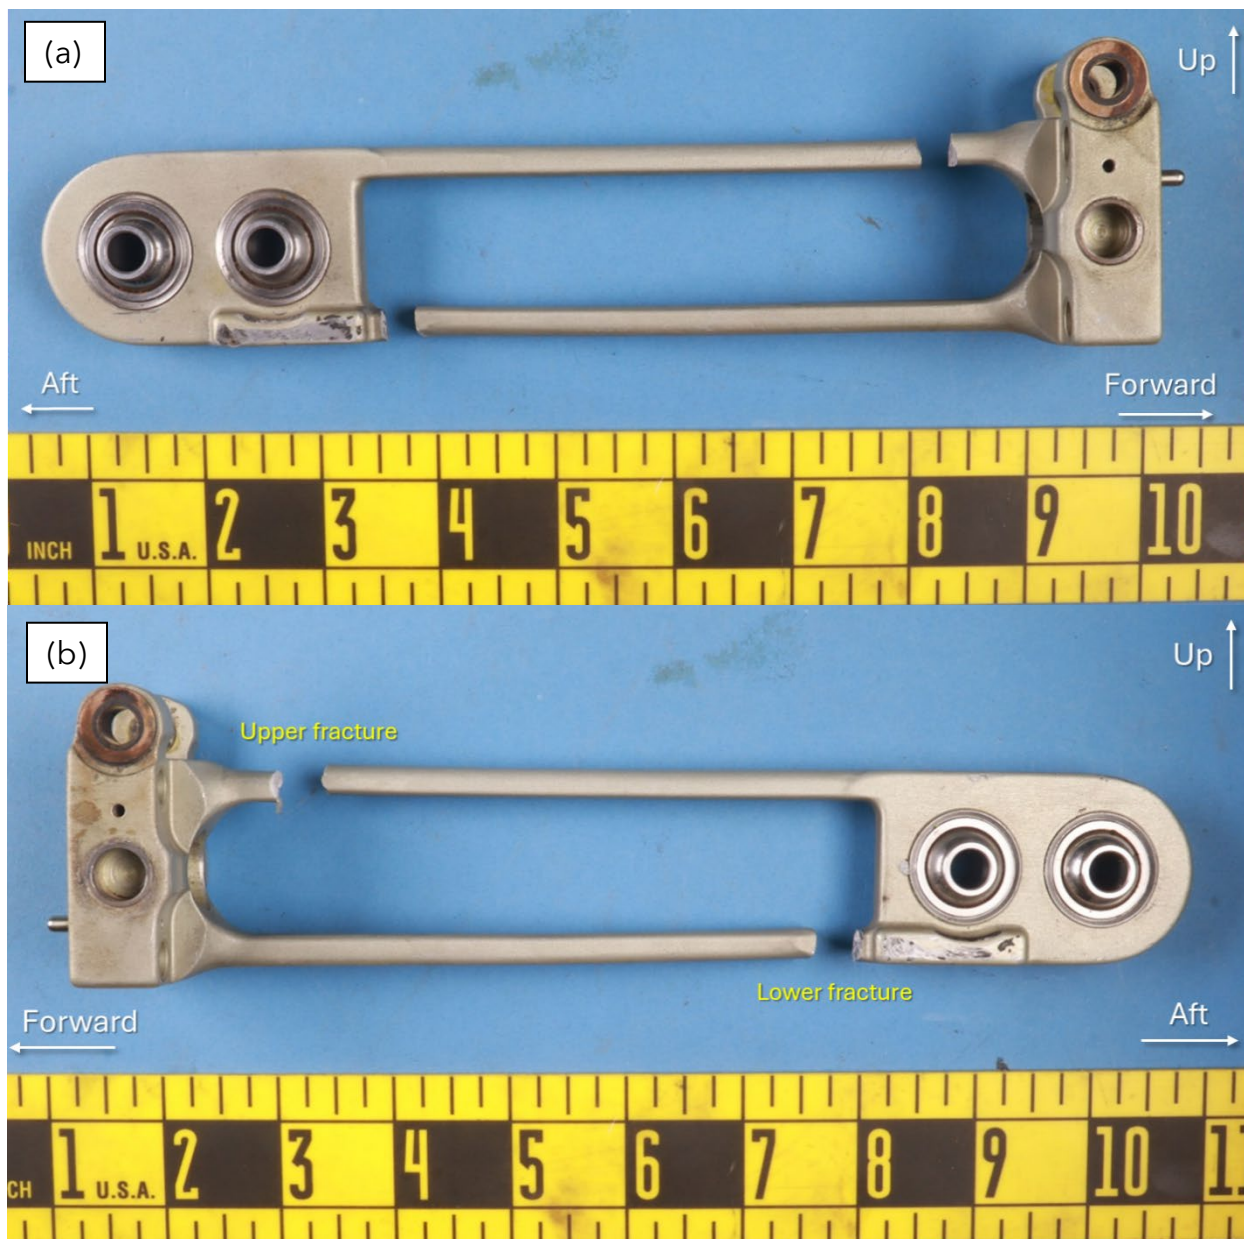
Figure 9 shows the fractured collective servo arm after removal from the rest of the assembly and cleaning in an ultrasonic bath with acetone. Both legs exhibited out-of-plane bending in the upward direction, as shown on opposite sides in the figure. Both arms from the collective and cyclic servos were examined using fluorescent penetrant inspection (FPI). One indication was identified on the upper-facing surface of the lower leg from the collective servo. This indication corresponded with the witness mark shown in Figure 8a. No other indications were observed on the surfaces of either servo arm.

Figure 9. Opposite side views of the fractured servo arm, after disassembly and cleaning with acetone.

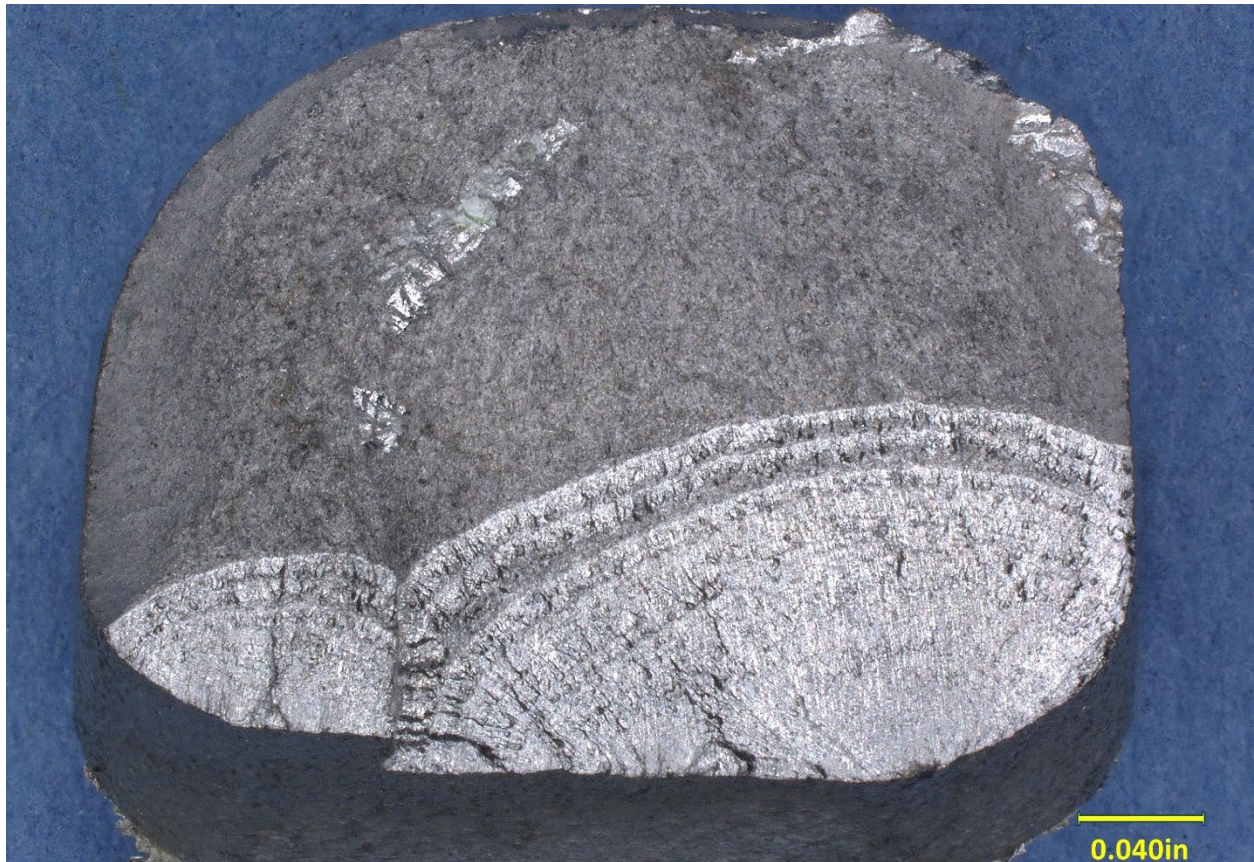
The forward fracture surfaces of the fractured collective servo arm legs were sectioned for microscopic inspection. Figure 10 shows the upper leg fracture surface, which exhibited two thumbnail cracks. These features exhibited crack arrest marks and ratchet marks between each crack. Figure 11 shows the initiation site of the

Figure 10. Upper leg fracture surface from the forward face.

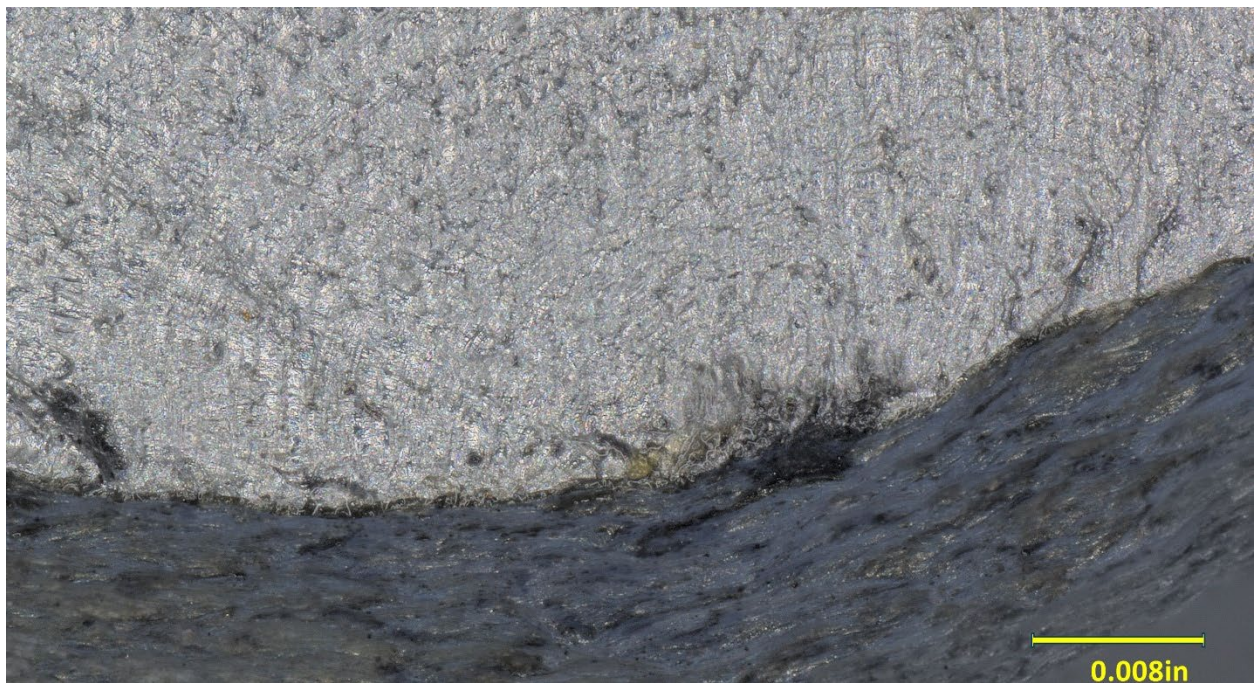
larger of the two cracks. This area exhibited a darker contrast and concave crack arrest marks emanating from the initiation site at the edge corner. The thumbnail cracks comprised approximately 40% of the fracture surface area, whereas the rest of the fracture surface exhibited a rough, fibrous surface texture with a dull luster.

Figure 11. Primary crack initiation site of the larger crack in Figure 10.

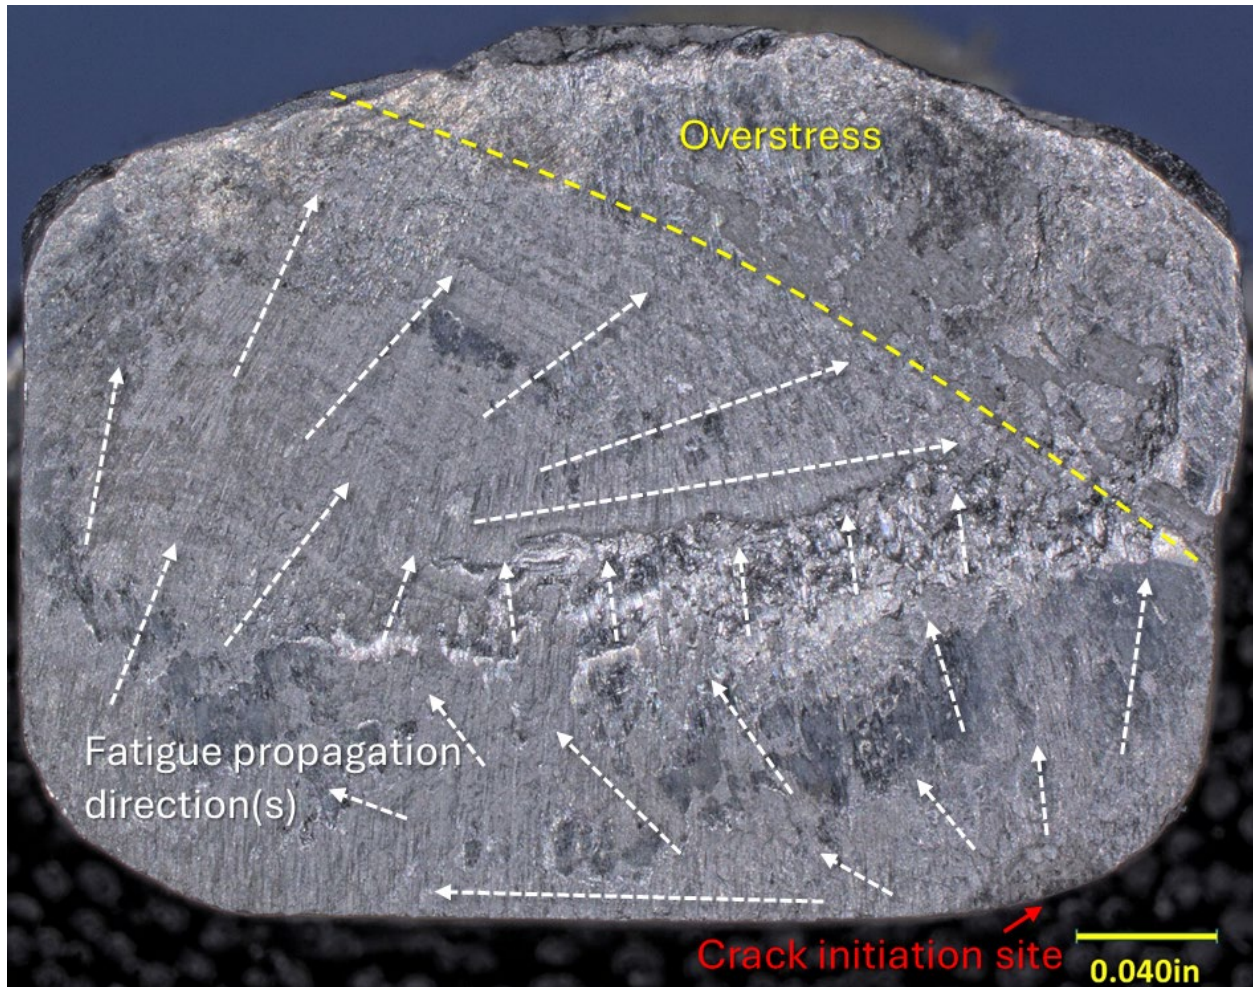
Figure 12 illustrates the lower leg fracture surface. Much of this surface had been damaged by smearing and streaks, consistent with post-fracture damage to the surface. The fracture surface was not entirely destroyed, and it exhibited a larger area (approximately 80%) of features consistent with crack propagation features than the upper leg surface. Figure 12 shows the general crack propagation direction from the lower right corner toward the left and then back toward the upper right. This cracking initiated at the site shown in Figure 13 and Figure 14. This location contained a prominent corrosion pit, distinguishable by the darker color and lack of yellow-tan anodized layer on the surface.

Of note was a partial horizontal ridge about mid-height on the lower leg fracture surface, as seen in Figure 12. Figure 18 shows a closer view of the ridge imaged using an SEM. The area near the ridge, shown in Figure 19, exhibited fine fatigue striations, consistent with crack propagation upward, as depicted by the white dashed arrows in the figure. This propagation direction was consistent with that of the fatigue crack from the primary crack initiation site. The area above the ridge, as illustrated in Figure 20, exhibited more widely spaced fatigue striations, propagating from left to right in the figure. This was consistent with the later crack propagation direction annotated in Figure 12.

Figure 12. View the lower servo arm leg fracture surface from the forward face. The dashed lines represent the general crack propagation direction, with the red arrow showing the primary crack initiation site.

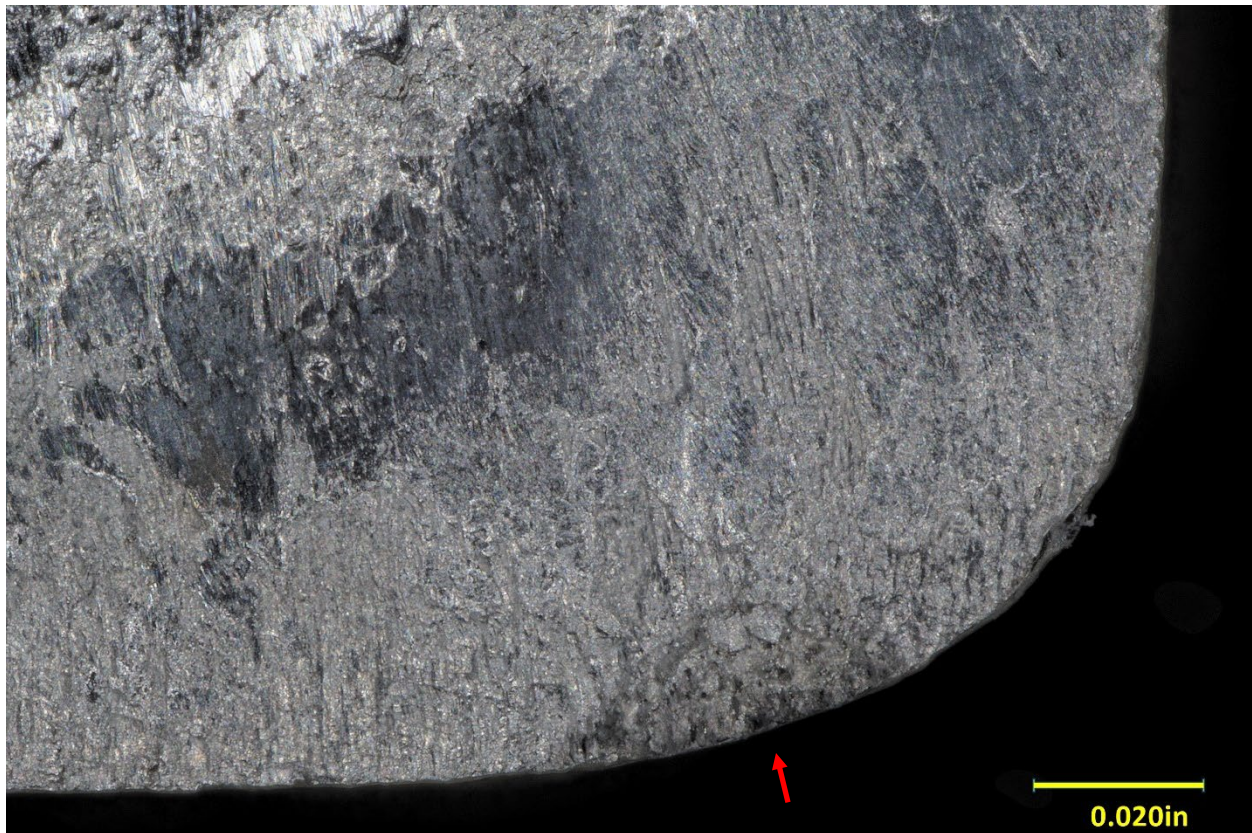
Figure 13. The crack initiation site (red arrow) of the lower leg fracture surface.

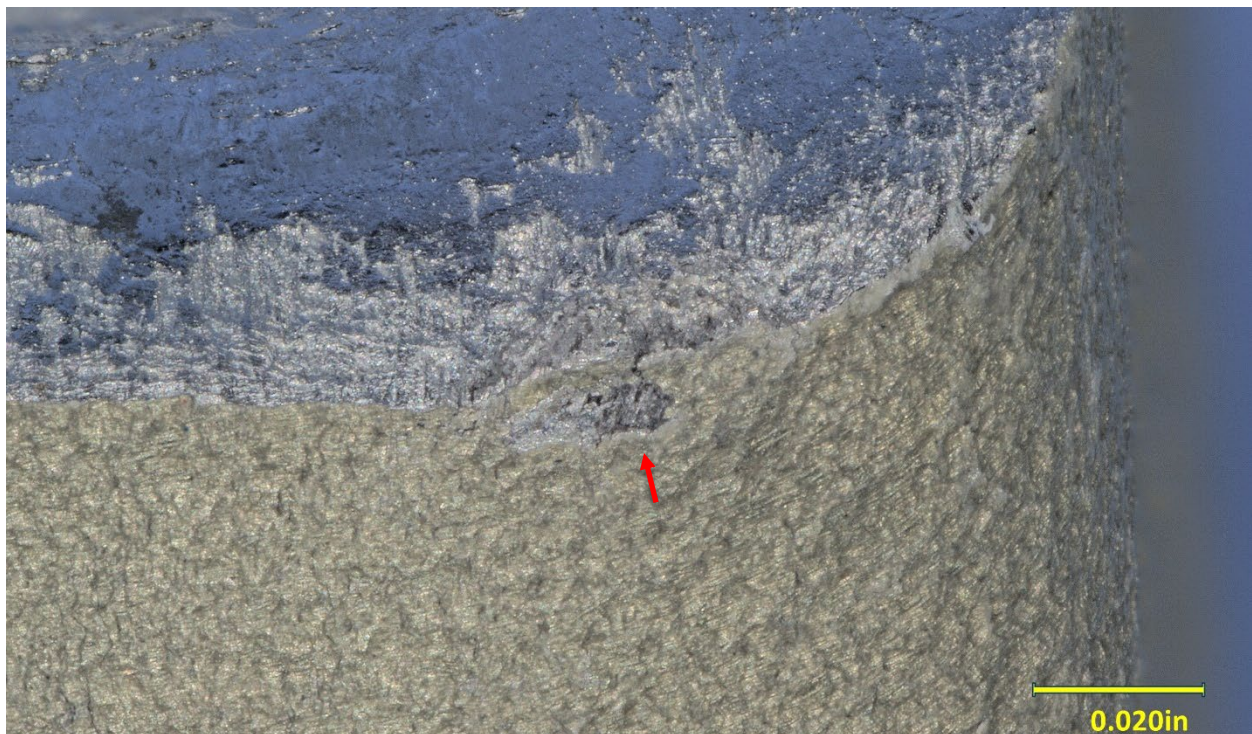
Figure 14. Angled view of the initiation site (red arrow) in Figure 13.

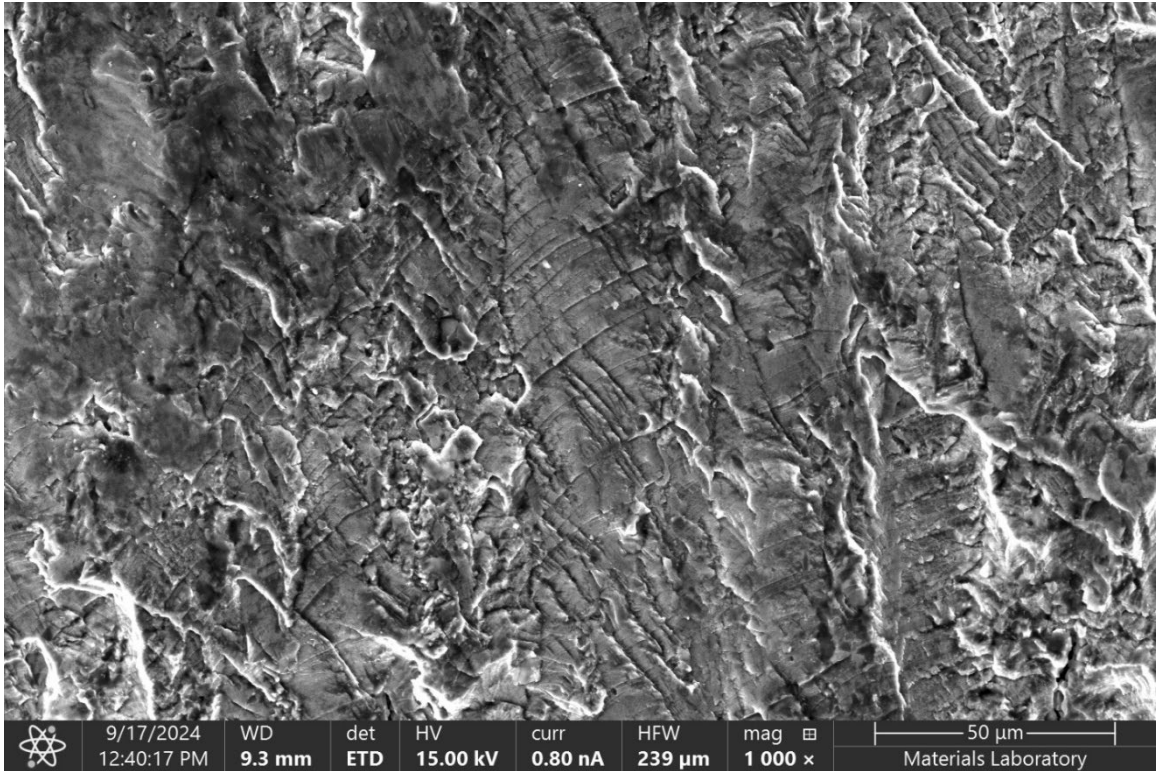
The fracture surfaces were examined using a field emission scanning electron microscope (SEM). The surfaces were observed before and after cleaning with a chromic acid solution. Figure 15 and Figure 16 show typical features within the thumbnail cracks. These fatigue striations were consistent with fatigue crack propagation. Dimpled rupture was observed outside the fatigue cracking regions (Figure 17). These disparate features were consistent with subsequent overstress fractures of the leg following the end of fatigue crack propagation.

Figure 15. Secondary electron (SE) micrograph of fatigue striations on the lower leg fracture surface.

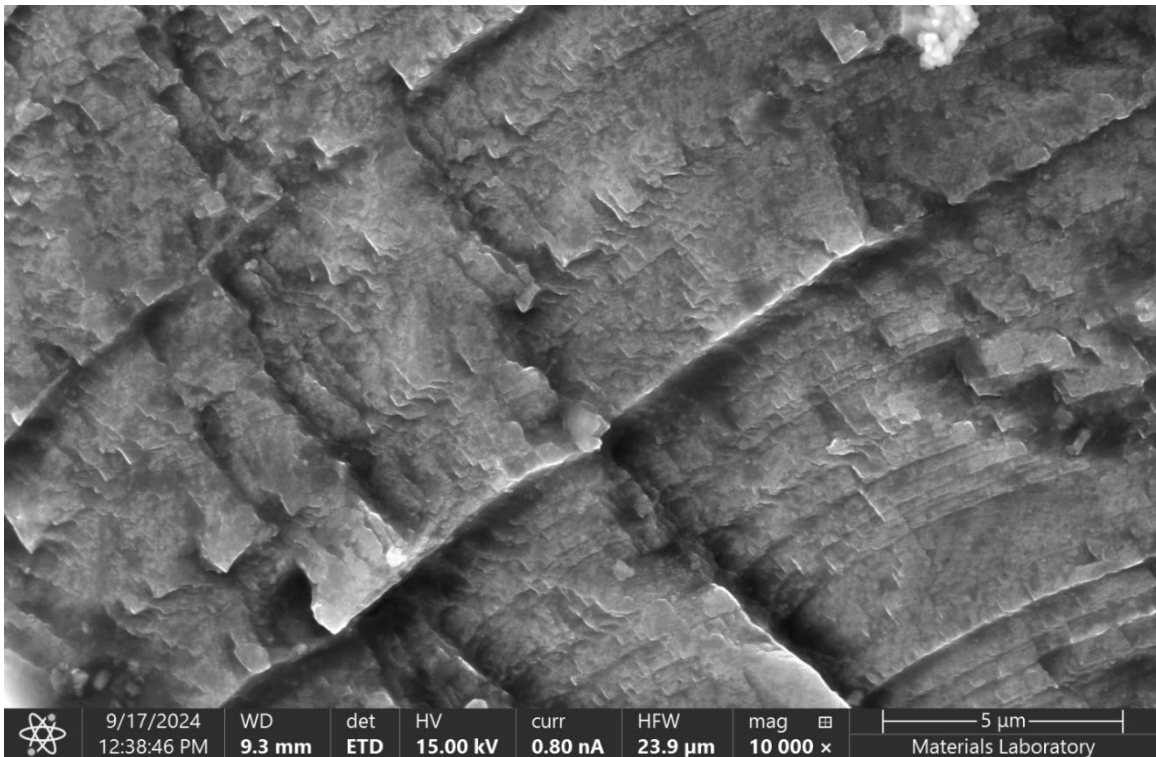
Figure 16. SE micrograph of fatigue striations and larger bands in Figure 15.

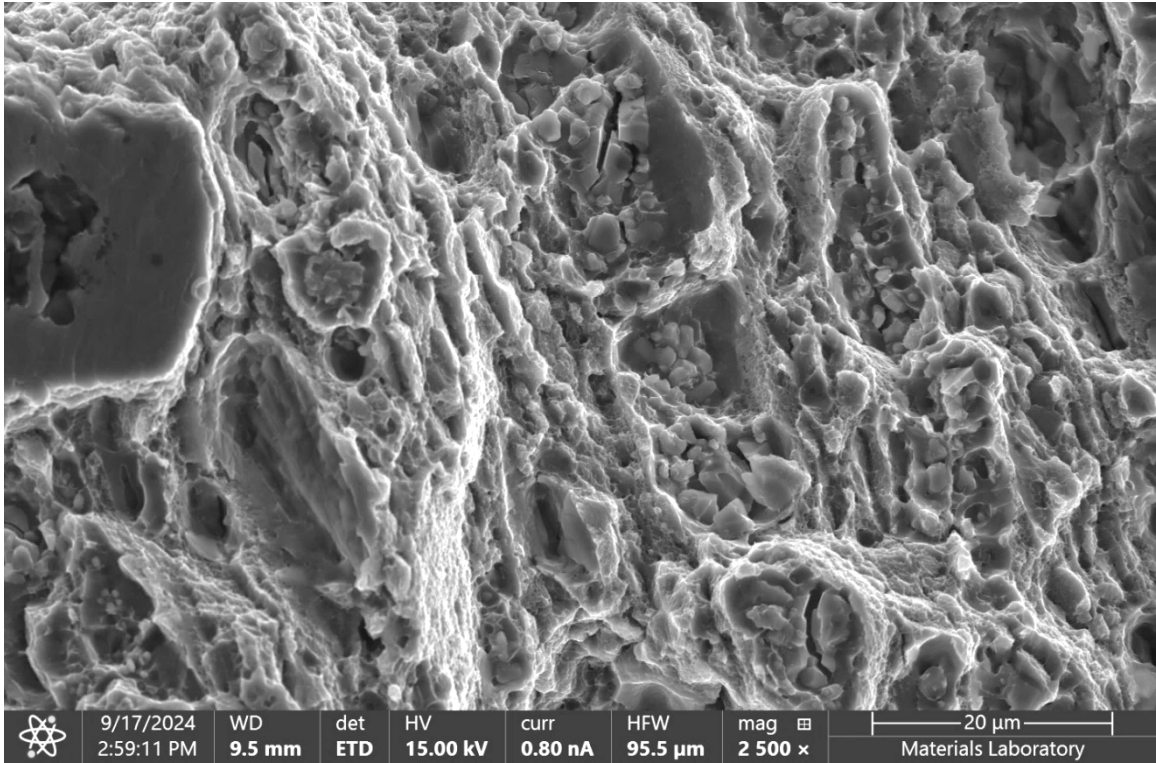
Figure 17. SE micrograph of dimpled rupture outside of the fatigue cracking areas.

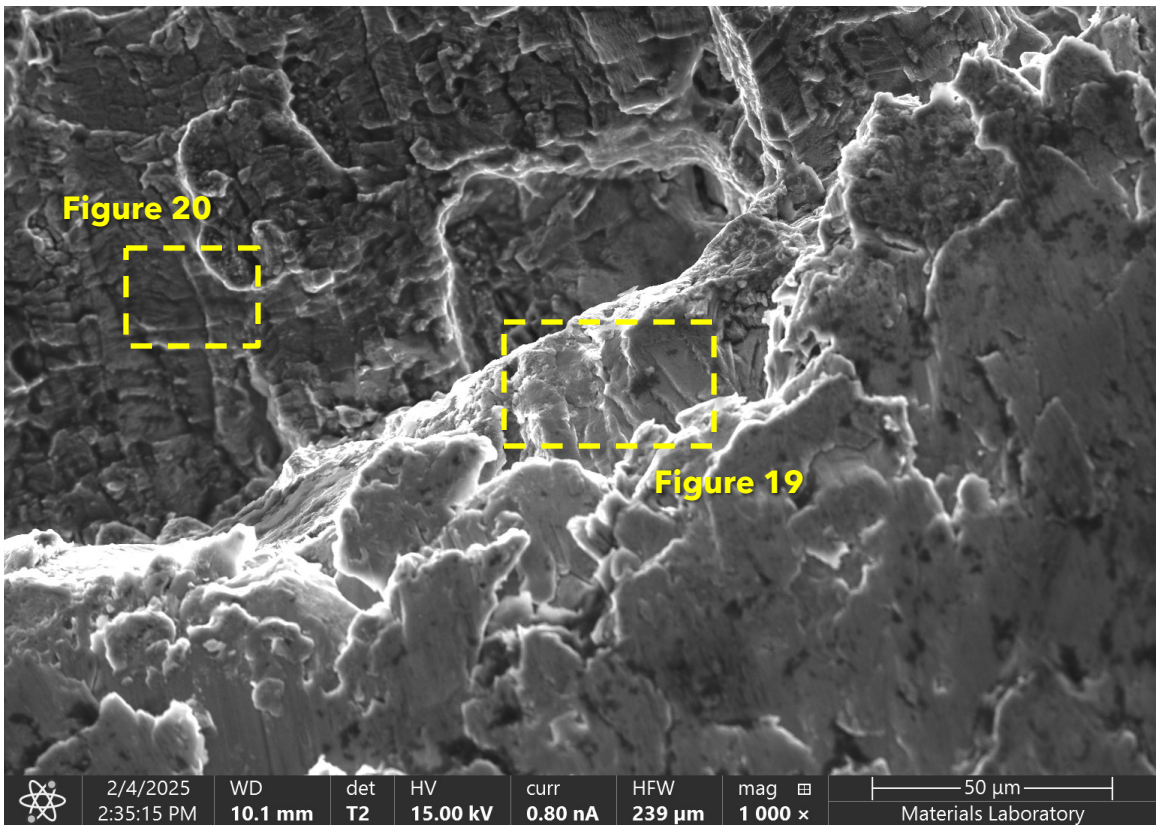
Figure 18. SE micrograph of the ridge in the center of the lower leg fracture surface.

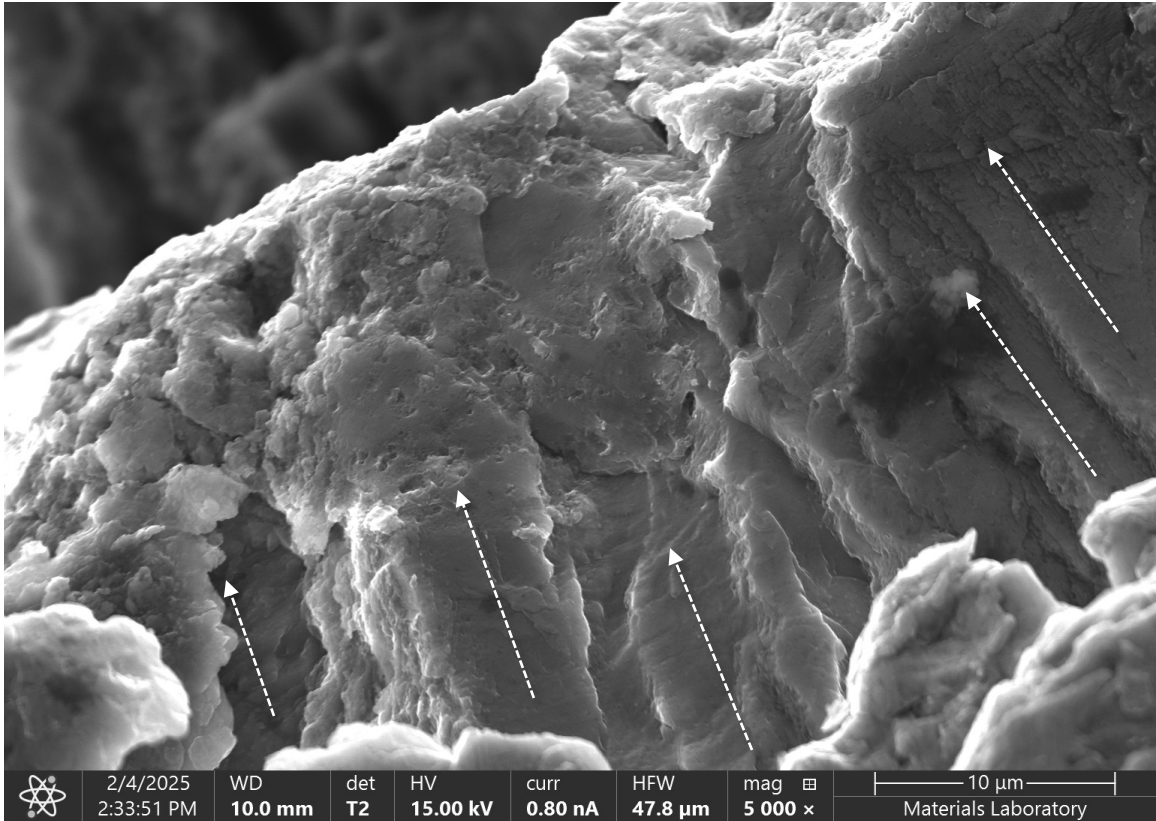
Figure 19. SE micrograph of fine striations near the ridge on the fracture surface.

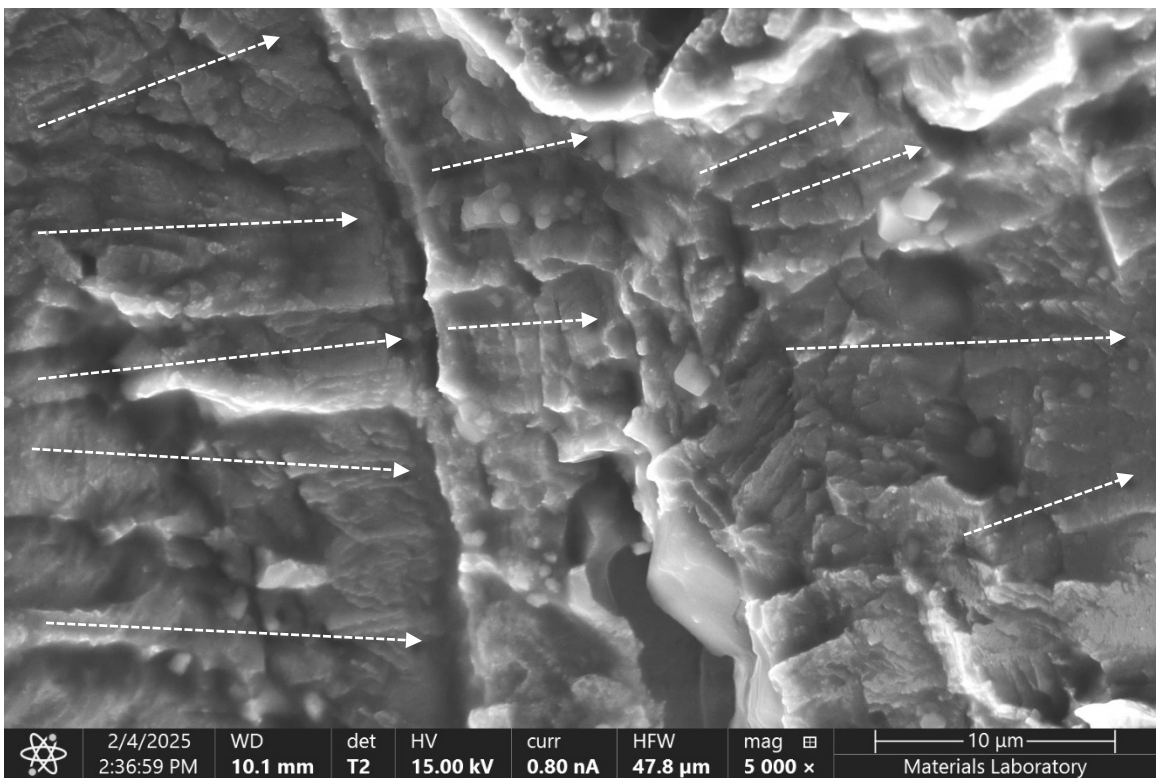
Figure 20. SE micrograph of striations on the upper portion of Figure 18.
