# National Transportation Safety Board

WPR24LA134

## **MATERIALS LABORATORY**

Factual Report 25-011

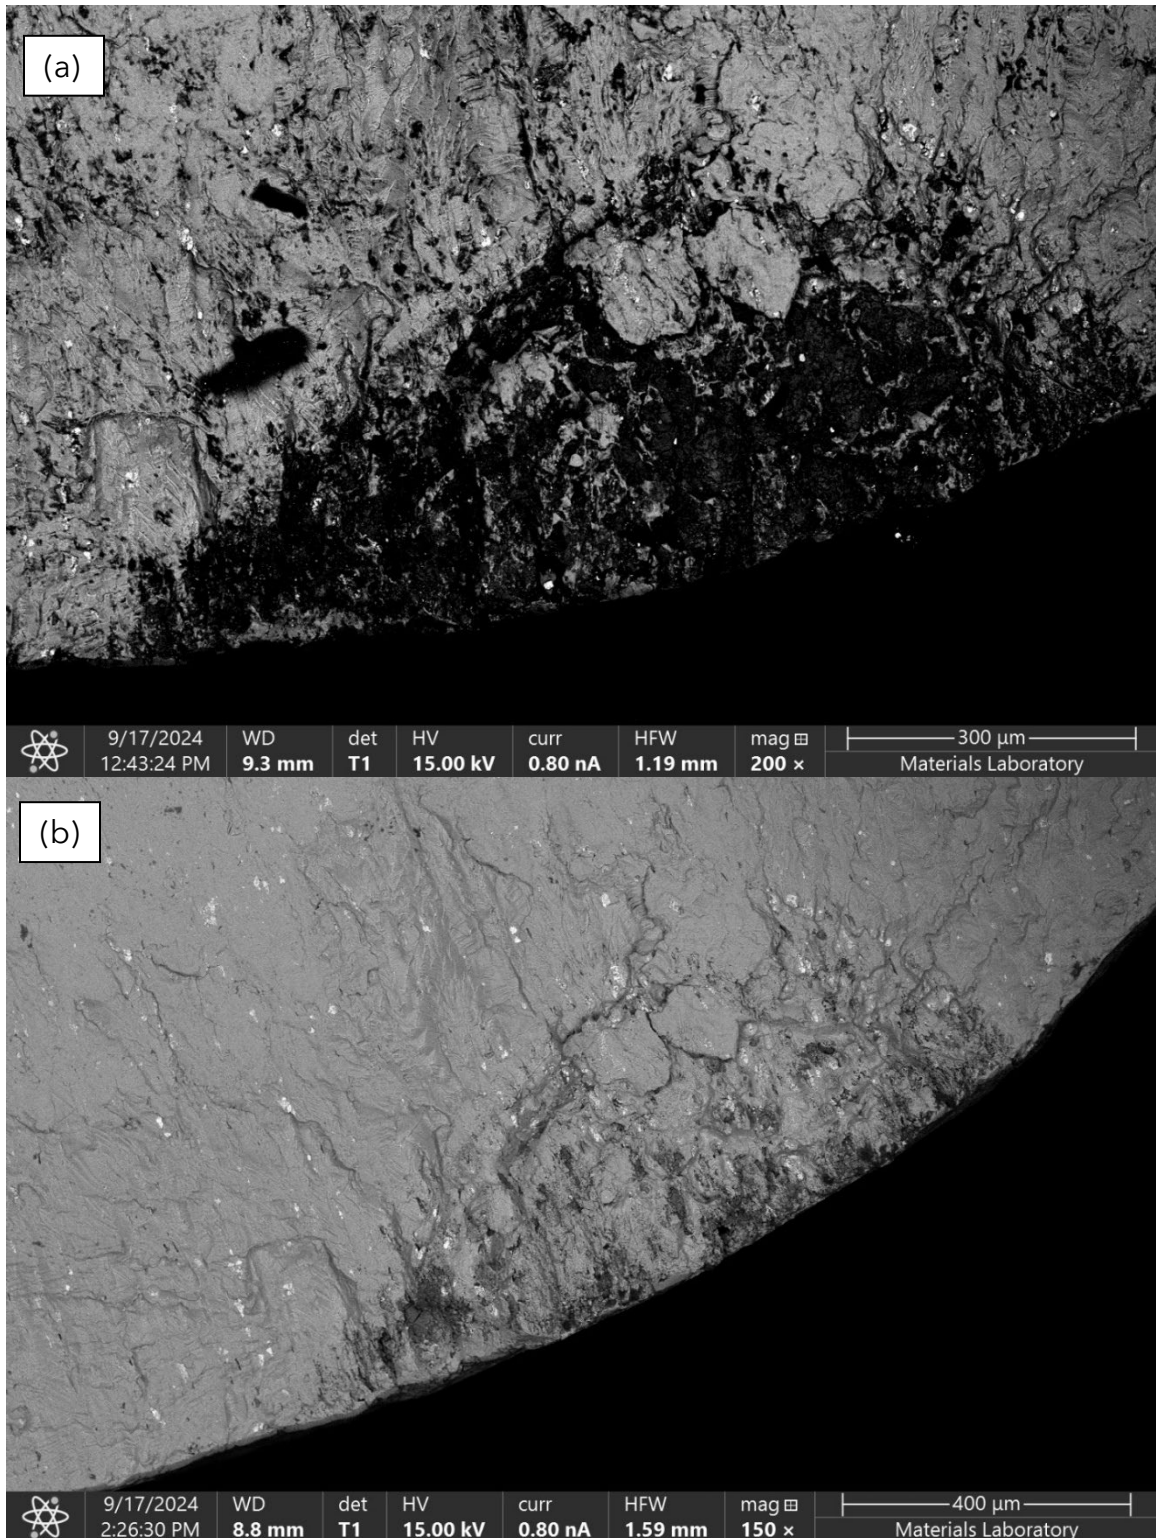
Figure 21 shows the primary crack initiation site on the lower leg fracture surface after subsequently more aggressive cleaning steps. Both figures show the extent to which lower atomic number (Z) compounds were present in this region.<sup>1</sup> Figure 22 shows an angled view, illustrating the darker gray surface anodized layer and a depression at the initiation site, consistent with a corrosion pit. Figure 23 illustrates a closer look at the corrosion pit at the crack initiation site, which exhibited darker-contrasting

Figure 21. Backscattered electron (BE) micrographs of the lower leg crack initiation site (a) after cleaning with acetone and (b) after cleaning with a chromic acid solution.

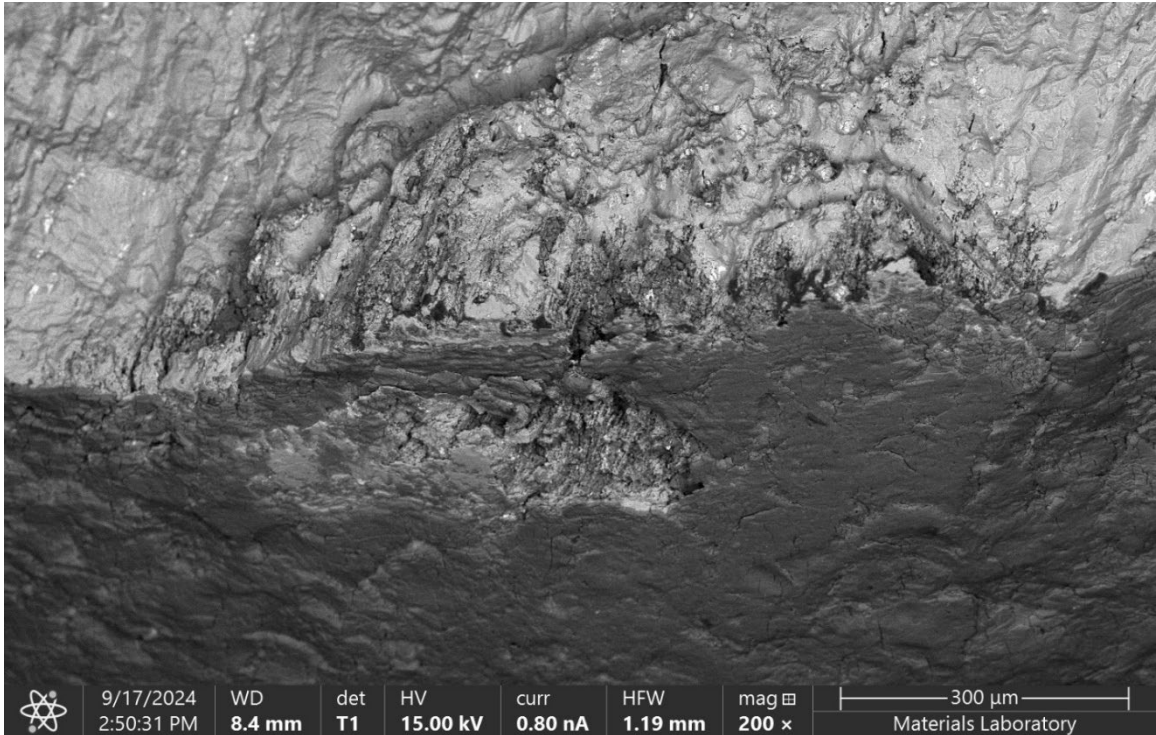
Figure 22. BE micrograph of an angled view of the initiation site, showing pitting.

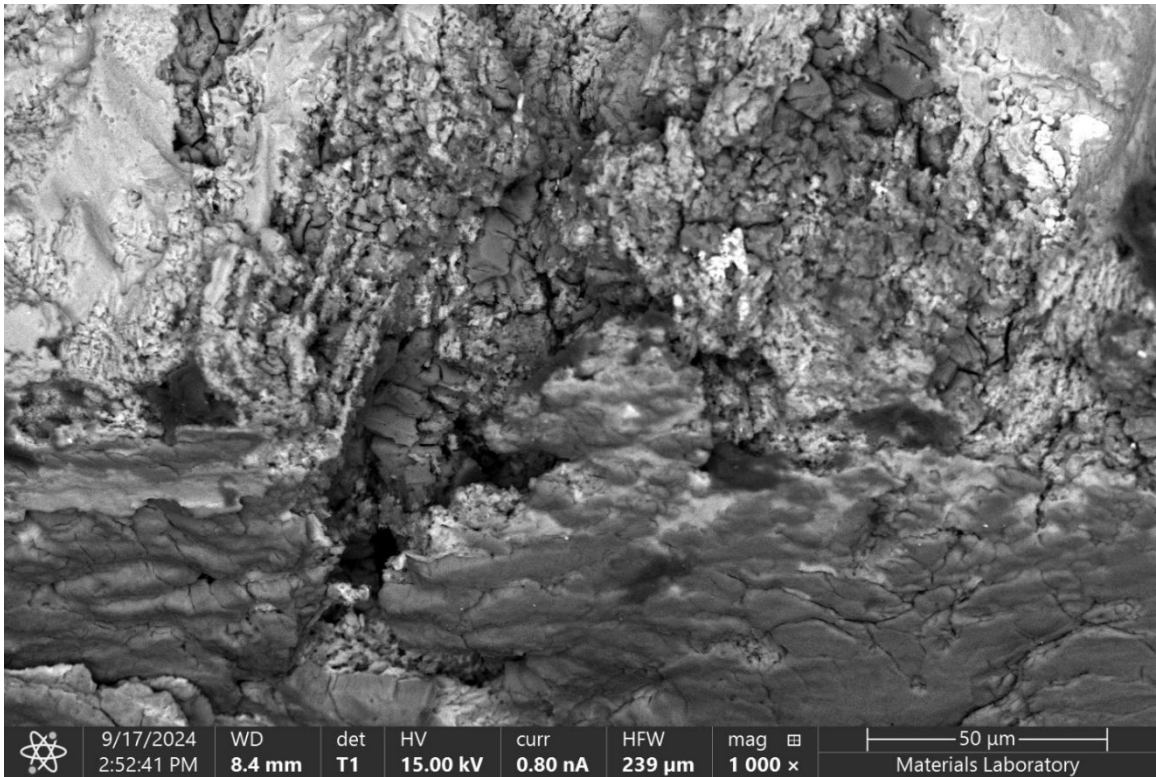
compounds, which were typically blocky in shape with multiple cracks. The corrosion pit measured 1.1 mm wide by 0.34 mm deep (0.043 by 0.013 inches).

Figure 23. BE micrograph showing the fractured brittle compounds within the corrosion pit.

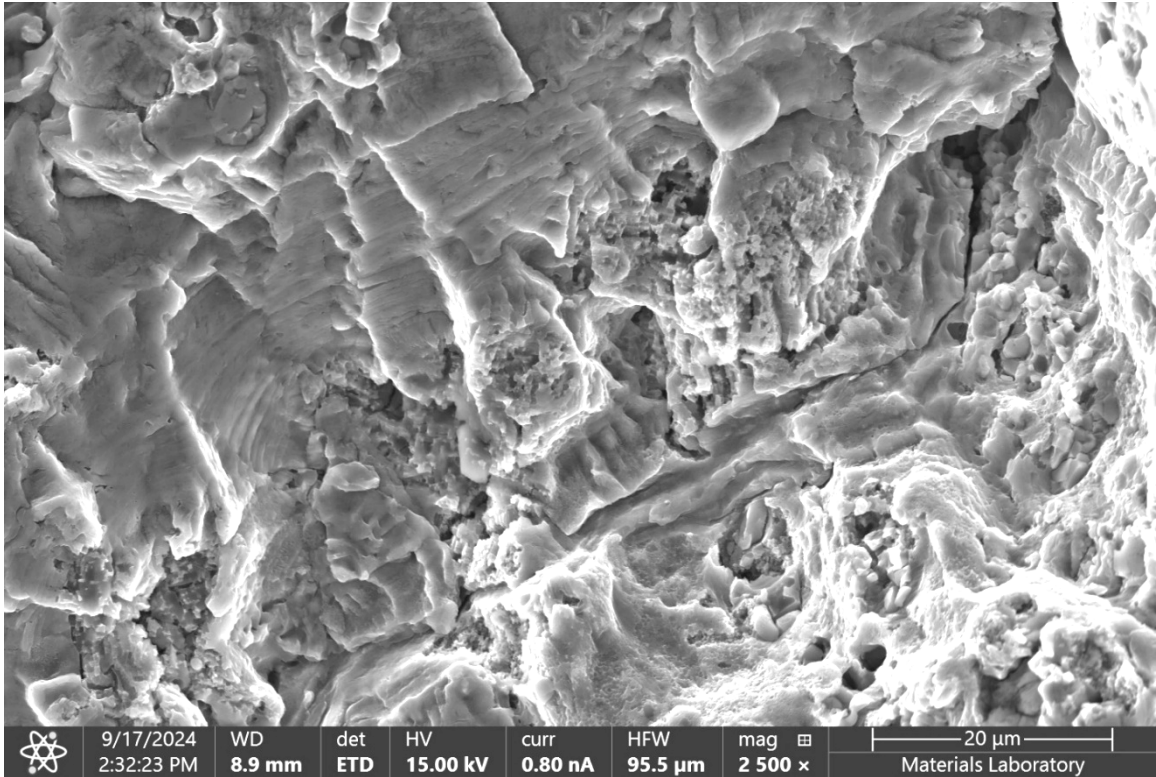
As illustrated in Figure 24 and Figure 25, the blocky features at the edge of the corrosion pit served as individual initiation sites for multiple fatigue cracks, separated by small ratchet marks. These cracks coalesced during the initial propagation stage, exemplified by the striations and termination of the ratchet marks.

Figure 24. SE micrograph of fatigue striations propagating from the edge of the pit tip.

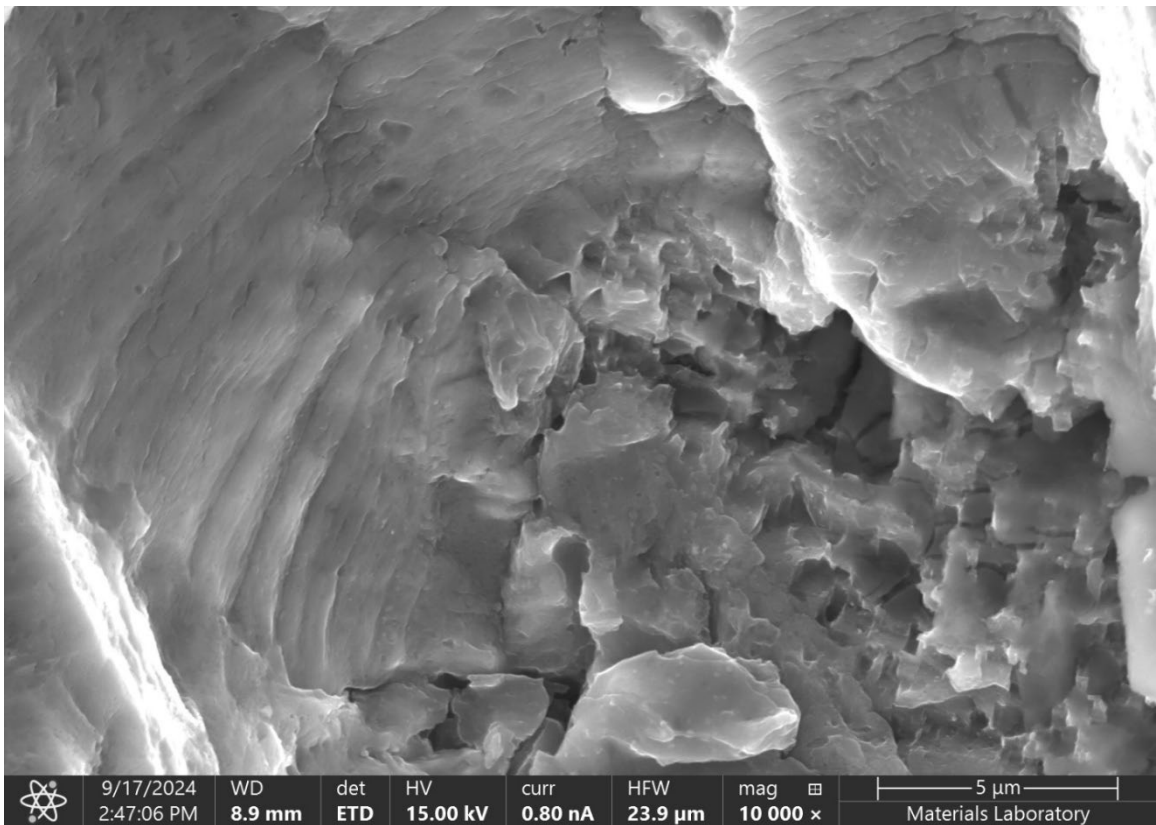
Figure 25. SE micrograph of several initiation sites along the pit tip in Figure 21.

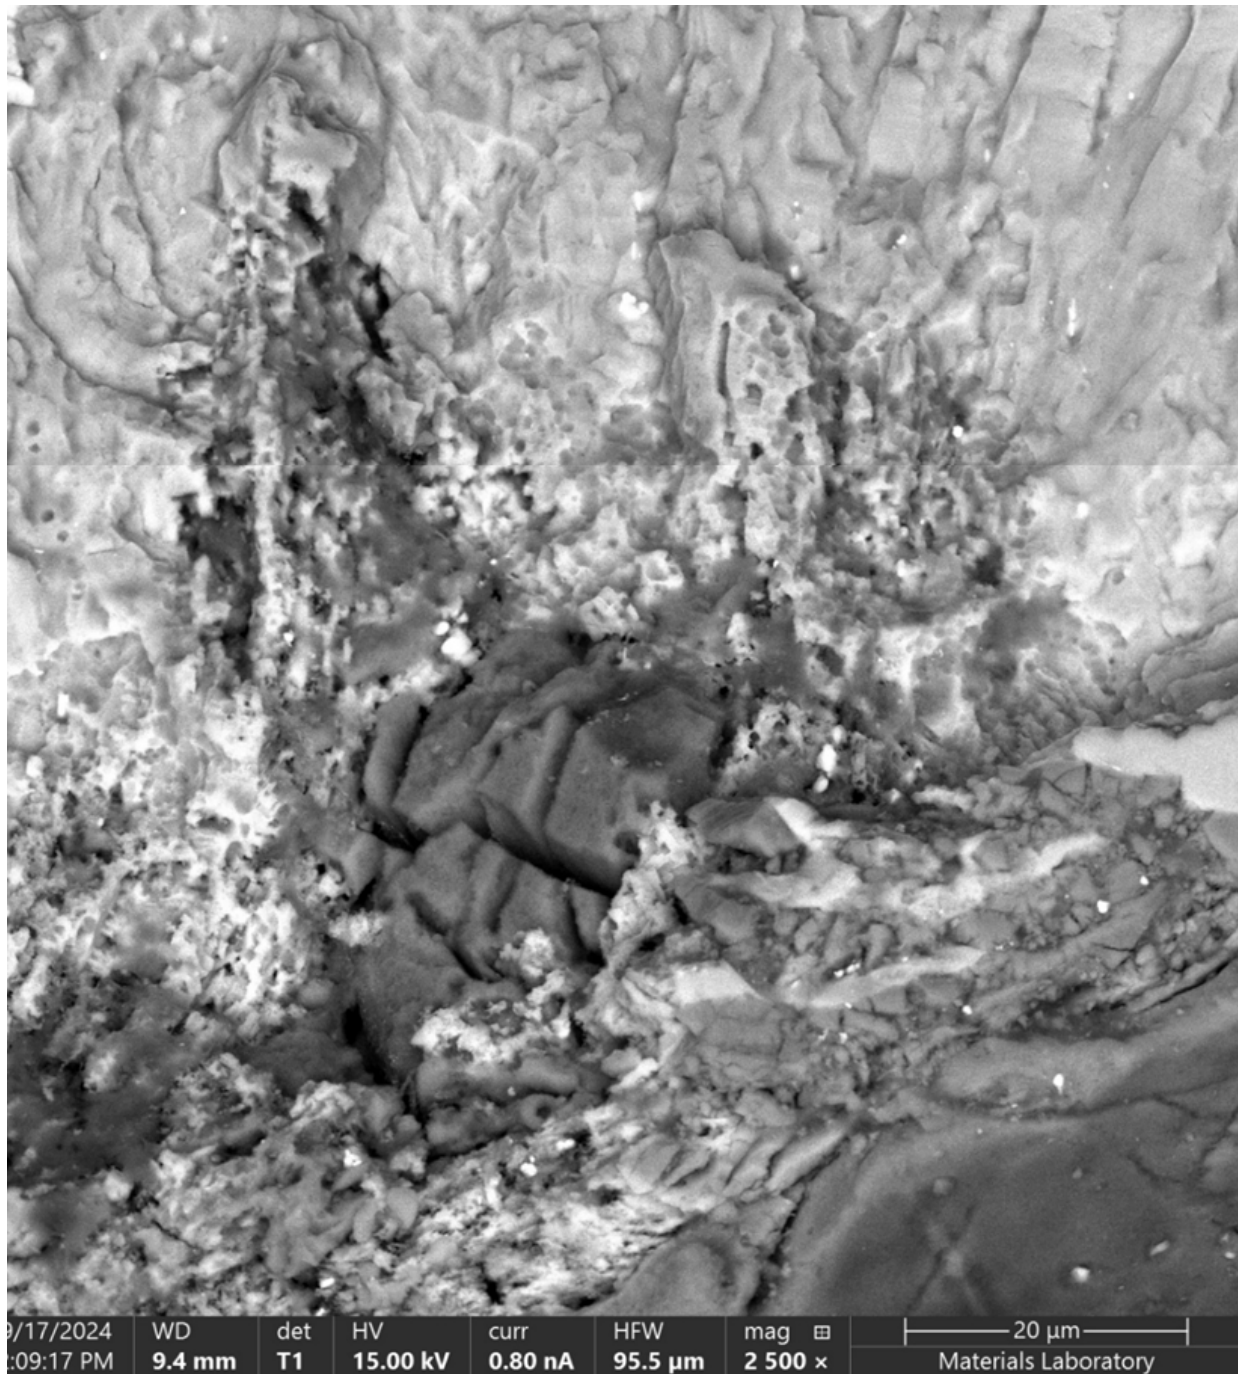
Figure 26 highlights the darker-contrasting blocky compounds at the tip of the corrosion pit in Figure 23. These compounds were examined using energy dispersive x-ray spectroscopy (EDS). As typified in Figure 27, the compounds were consistent with aluminum oxide. There were also elements consistent with corrosion products in a marine environment, namely sodium, potassium, calcium, chlorine, and sulfur. There was an elevated amount of chlorine in the deepest regions of the pit, located in the upper part of the pit depicted in Figure 26.

Figure 26. Montage of BE micrographs of the pit tip, showing contrast between the fatigue crack propagation regions and the pit, which contained lower Z-compounds.

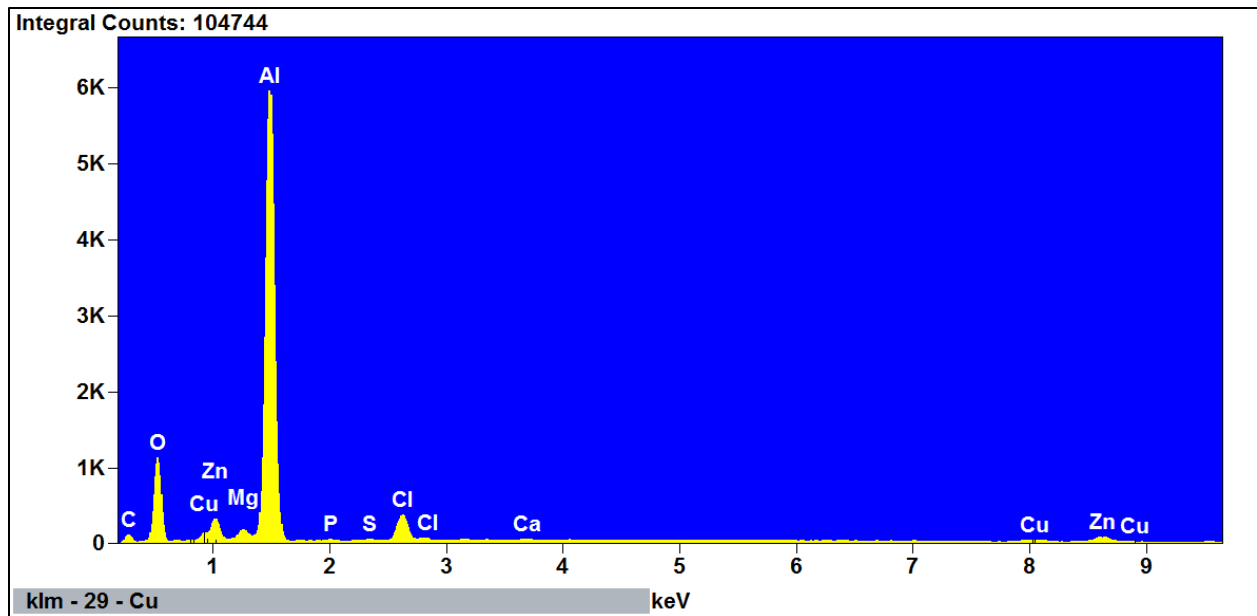
Figure 27. EDS spectrum of the dark area in Figure 23b, showing peaks consistent with aluminum oxide and an elevated chlorine peak.

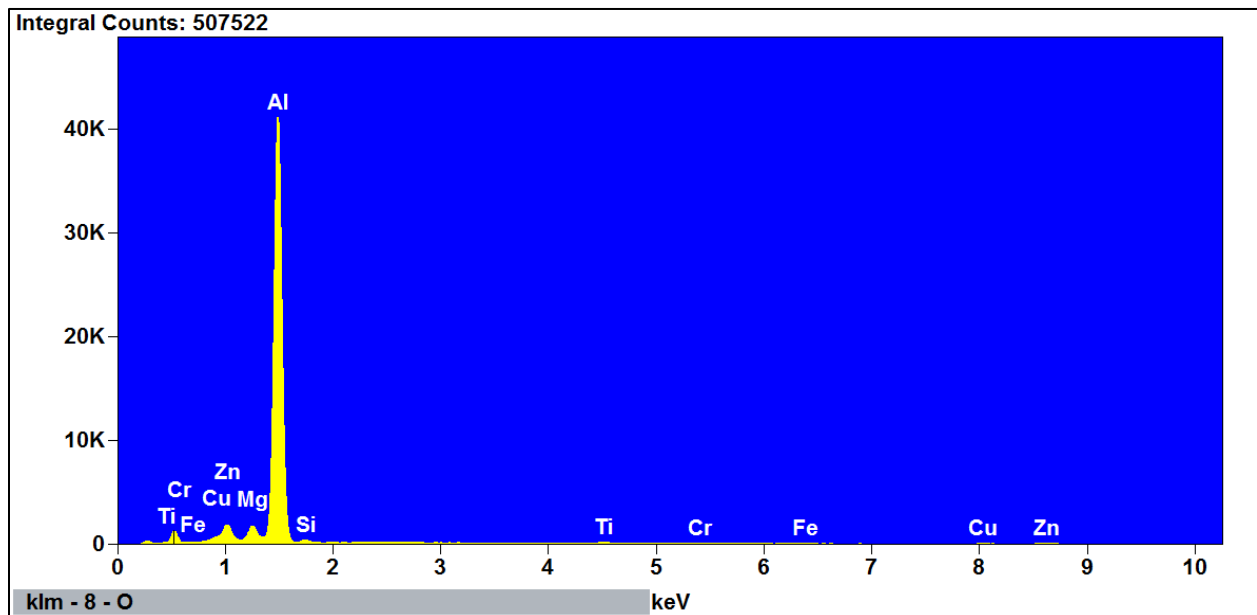
The base material of the servo arm was also examined using EDS, as well as x-ray fluorescence (XRF). Figure 28 shows a typical EDS spectrum of the alloy, which was consistent with a 7075 aluminum alloy composition. Electrical conductivity was examined per ASTM E1004.<sup>2</sup> The conductivity averaged 39.2% IACS. The hardness was inspected per ASTM E18.<sup>3</sup> The hardness averaged 84 HRBW. These data were consistent with a T73 temper for this alloy, per AMS 2658.<sup>4</sup> A 7075-T73 aluminum alloy was the prescribed material for the servo arm.

Figure 28. EDS spectrum of a typical area of the servo arm material from Figure 17, consistent with a 7000-series aluminum composition.

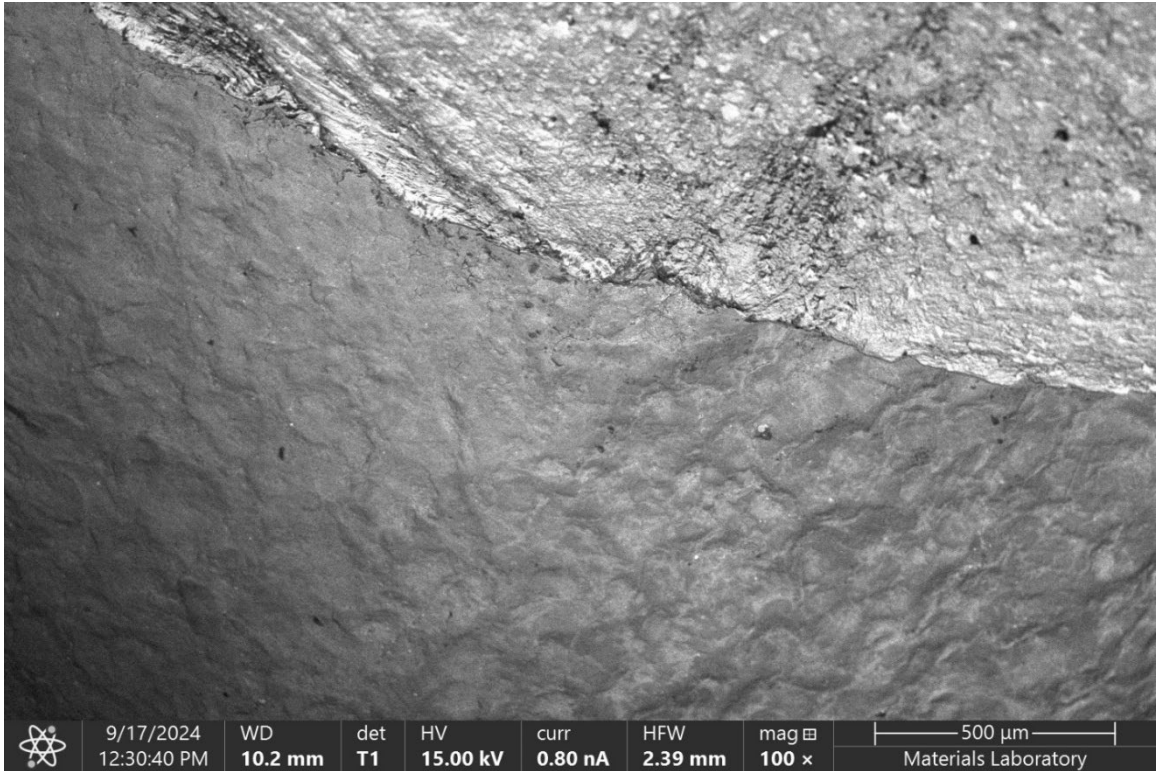
The fracture surface of the upper leg was also examined using an SEM. The two thumbnail cracks exhibited three major initiation regions. Figure 29 and Figure 30 show the crack initiation site for the smaller of the two thumbnail cracks. This site contained a corrosion pit, and fatigue striations were observed emanating from the location (Figure 30).

Figure 29. BE micrograph of an angled view of the initiation site of the smaller fatigue crack on the upper leg fracture surface.

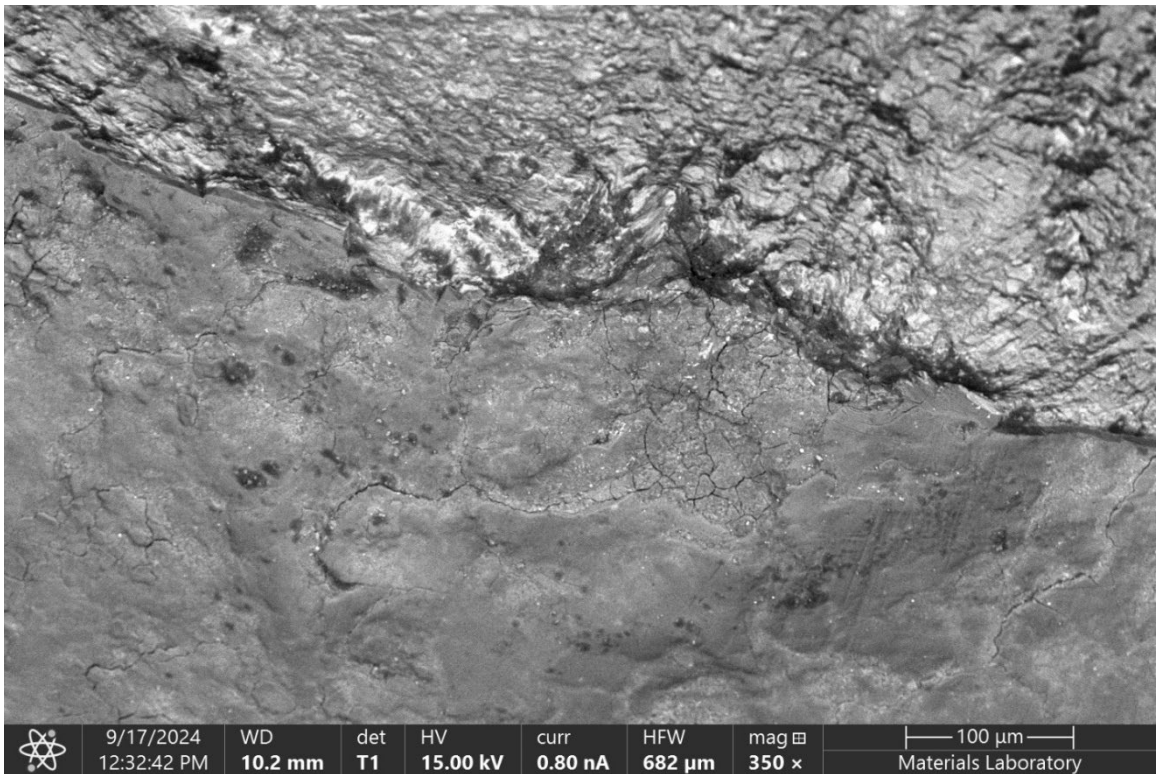
Figure 30. BE micrograph of the pit at the initiation site in Figure 26.

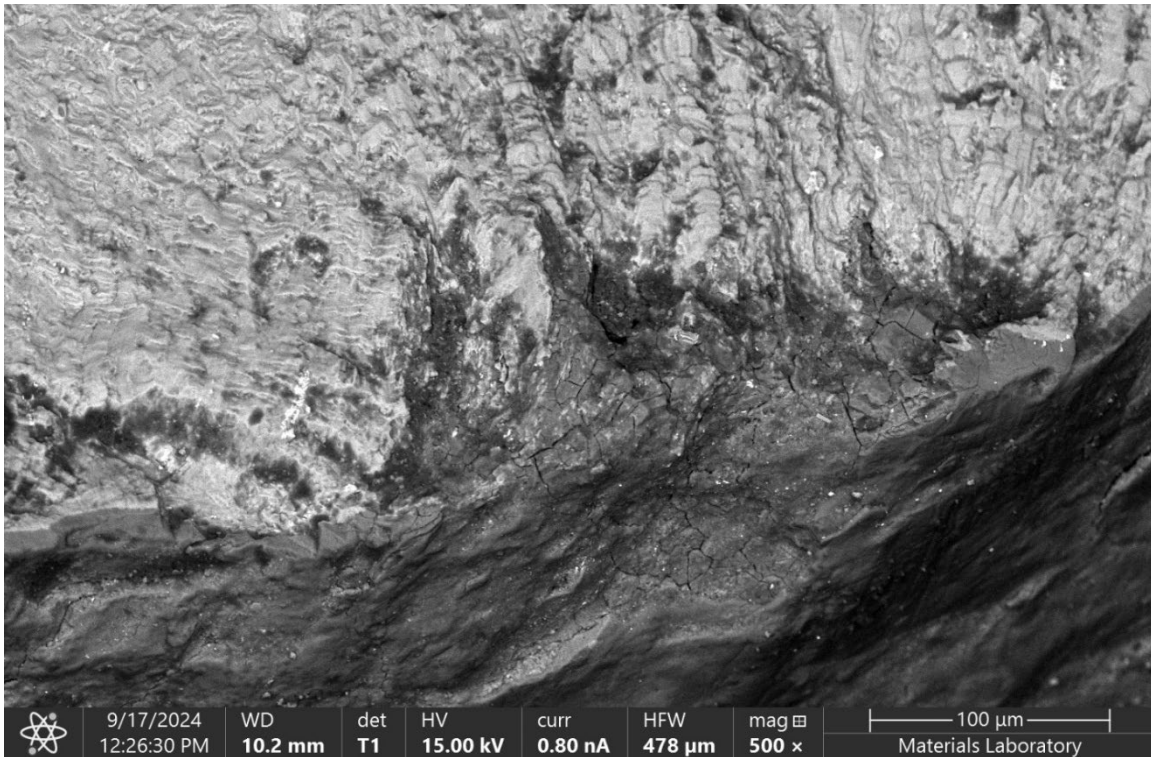
The larger thumbnail crack on the upper leg fracture surface exhibited a wider corrosion pit at the initiation site (Figure 31). This pit measured 0.30 mm wide by 0.14 mm deep (0.012 inch by 0.0055 inch). The pit exhibited blocky compounds that had crack in multiple places, consistent with localized brittle fracture. Fatigue striations were present near the corrosion pit, showing propagation into the leg cross section away from the surface corrosion pit (Figure 32).

Figure 31. BE micrograph of the larger fatigue crack initiation site on the upper leg fracture.

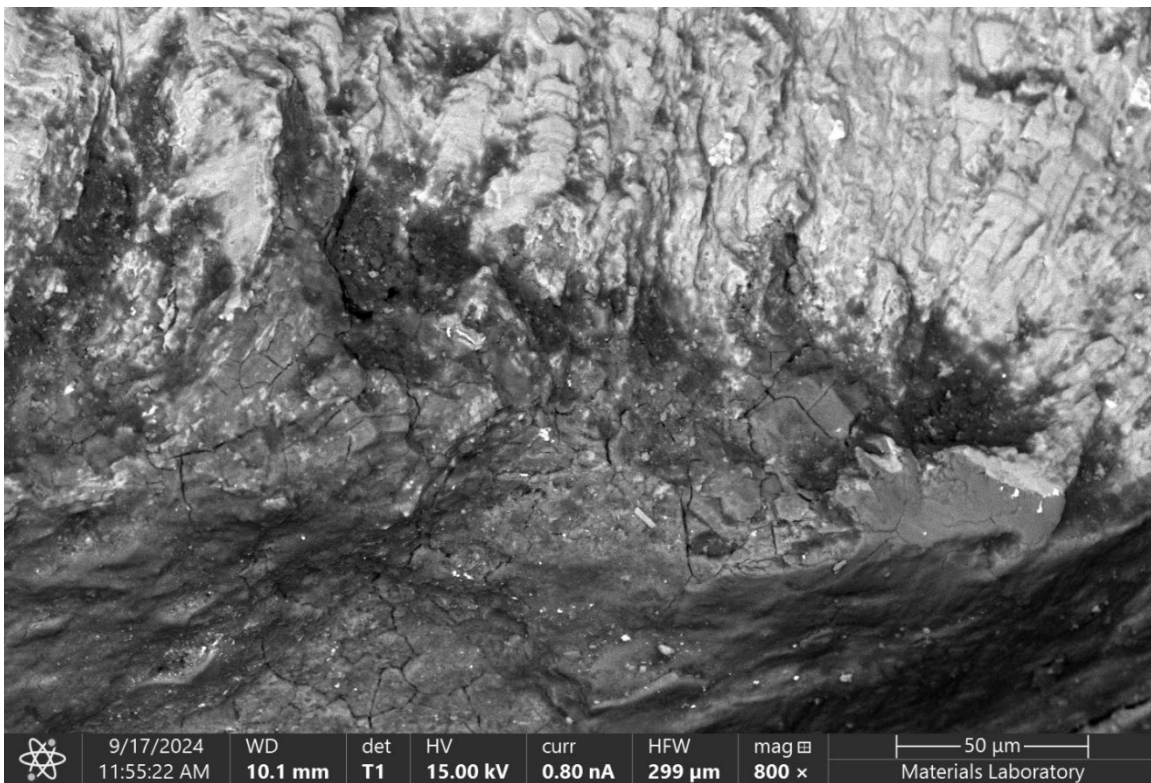
Figure 32. BE micrograph of the pit creating multiple initiation sites in Figure 28.

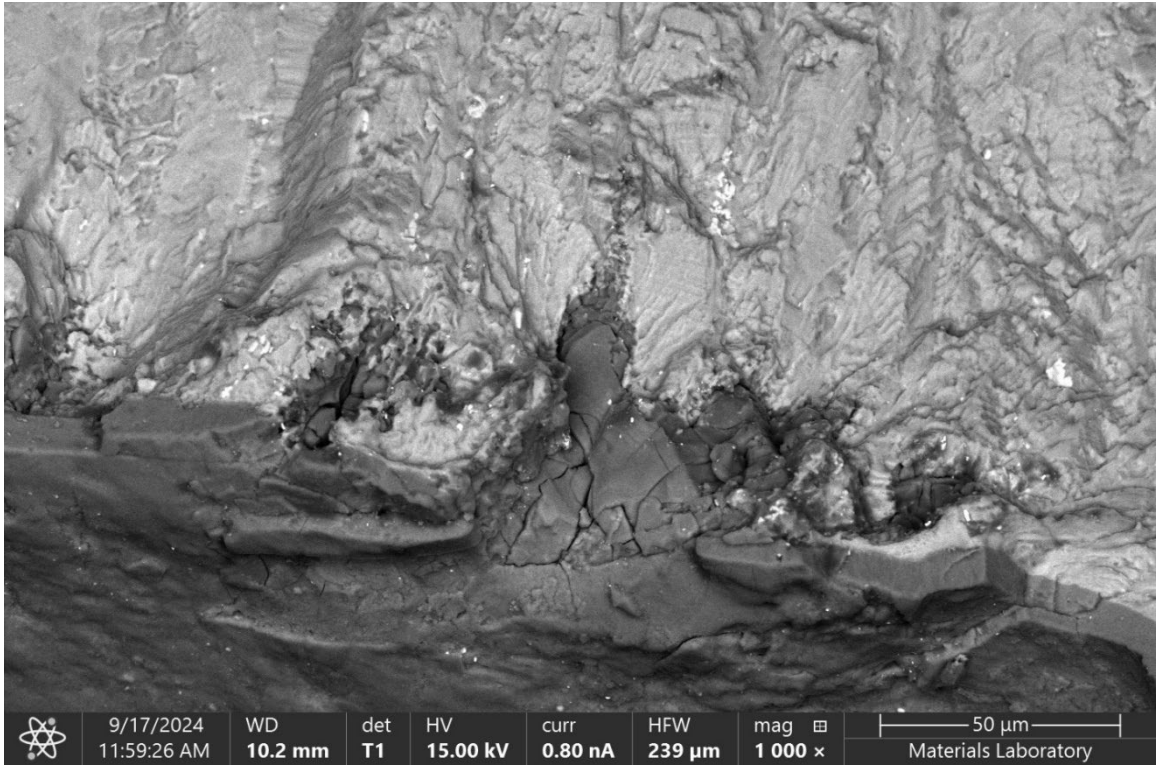
Figure 33 to Figure 35 show the middle crack initiation sites, which consisted of two elongated corrosion pits. This blocky aluminum oxide compound had fractured, as evidenced by multiple cracks. Similar to the initiation site of the lower leg fracture surface, multiple fatigue cracks on the upper leg had initiated along the edges of the blocky corrosion pit tips, creating striations consistent with crack propagation away from the pit on the interior surface (Figure 35).

Figure 33. BE micrograph of two pits at the middle initiation sites of the upper leg fracture surface.

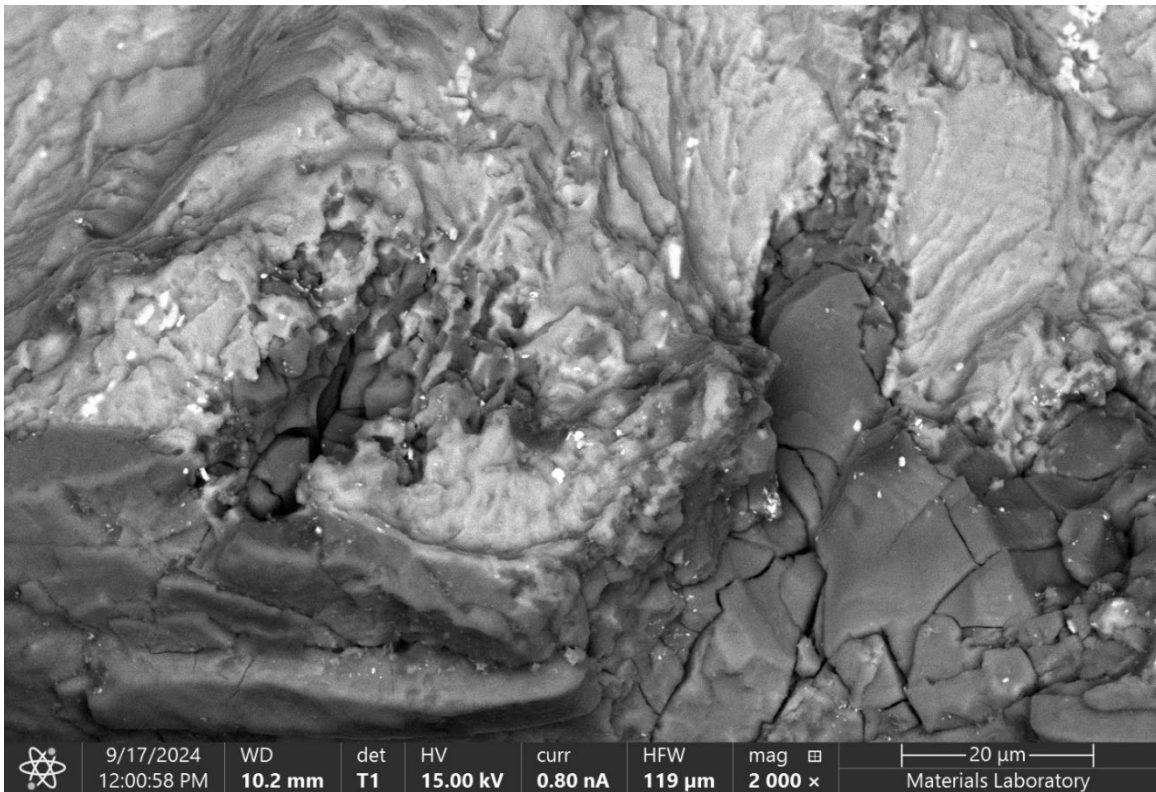
Figure 34. BE micrograph of the pits in Figure 30.

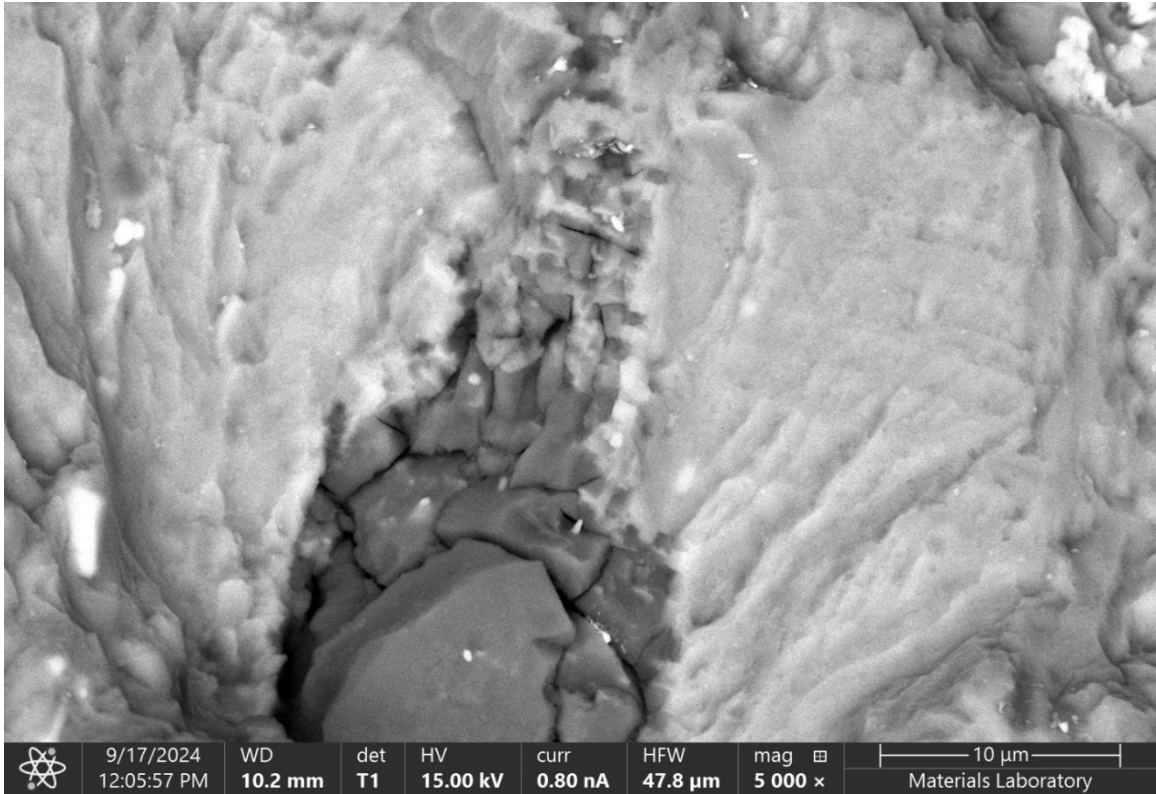
Figure 35. BE micrograph of fatigue crack initiation along the facets of the tip of the corrosion pit to the right in Figure 31, showing striations along the propagation direction.

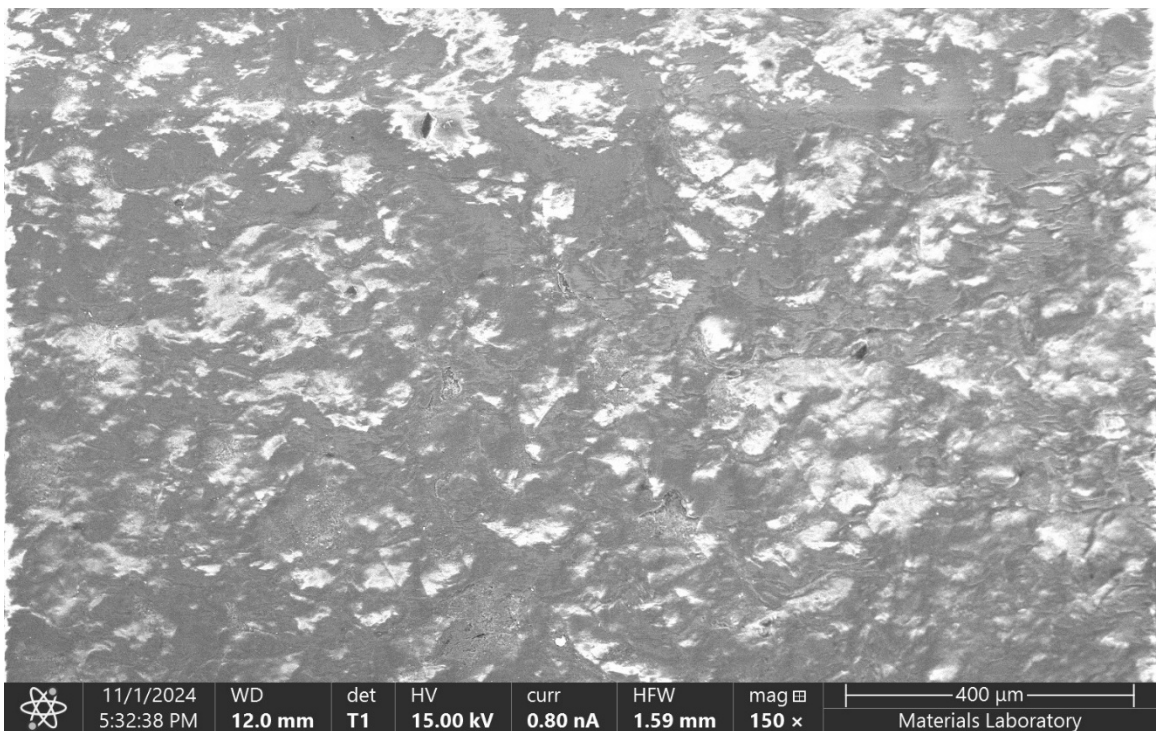
Examination of the interior surfaces of both servo arm legs away from the fracture surface found areas with numerous corrosion pits, as exemplified in Figure 36. These pits appeared as rough depressions within the surface anodizing coating, as shown in Figure 37. Being non-conductive, the anodizing coating generated charging artifacts during SEM examination, except within the pits, which were absent the coating. The chemical composition was consistent with those near the fatigue crack initiation sites, primarily aluminum oxide with elements associated with salt compounds, similar to those shown in Figure 27.

Figure 36. BE micrograph of the surface along the interior collective servo arm surface, showing multiple divots and pock marks.

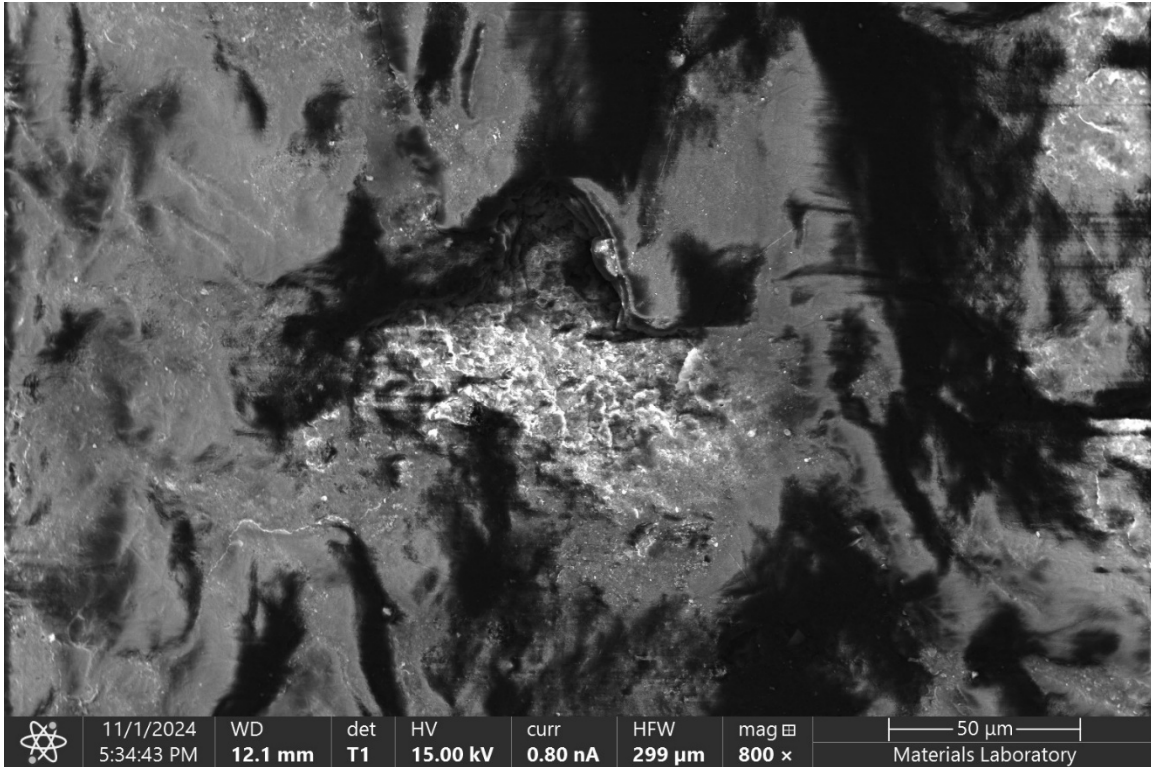
Figure 37. BE micrograph of a closer view of one of the corrosion pits from the surface in Figure 36.
