WPR24LA138

**INVESTIGATION PHOTOGRAPH**

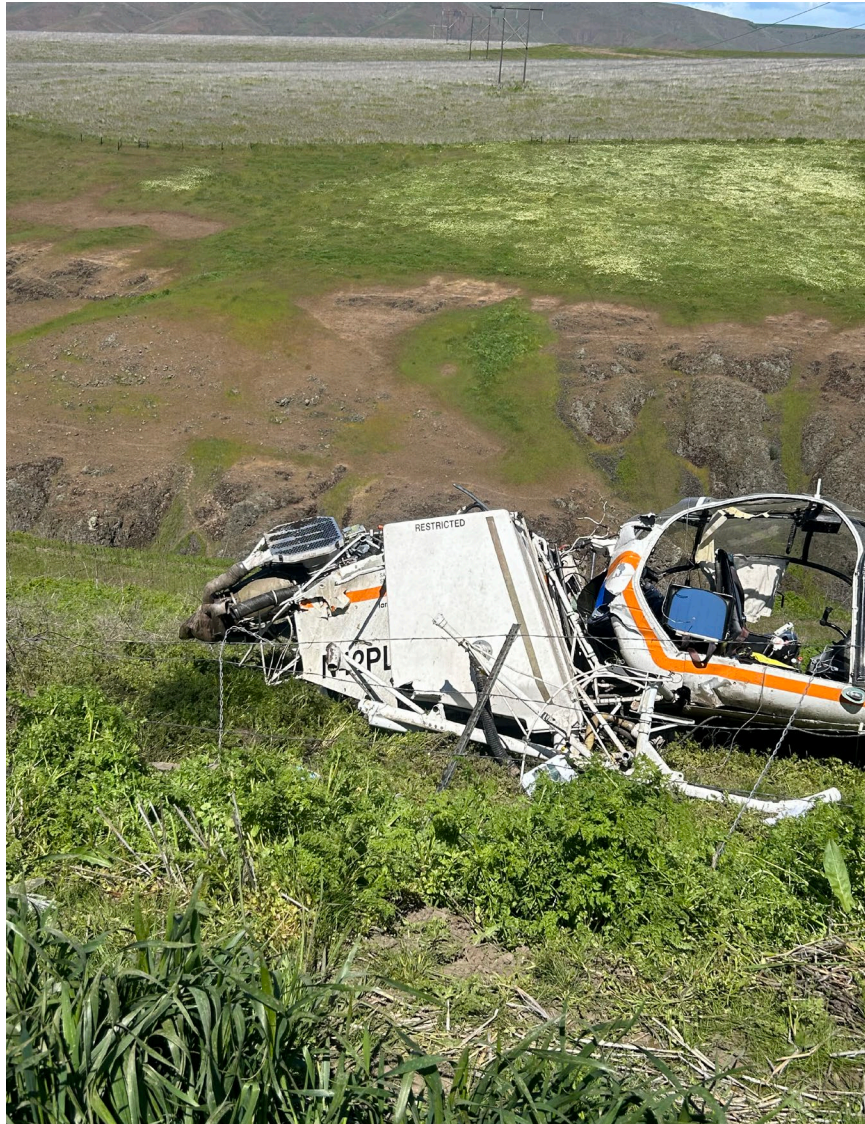
**Photograph 1 - View of substantial damage to main and tail rotor systems (Courtesy of Operator)**
