# National Transportation Safety Board

WPR24LA139

## **AIRFRAME AND ENGINE EXAM SUMMARY REPORT**

Location: Tumwater, Washington  
Date: May 3, 2024  
Time: 16:00 Pacific daylight time  
Aircraft: Robinson R22 BETA, N4082J

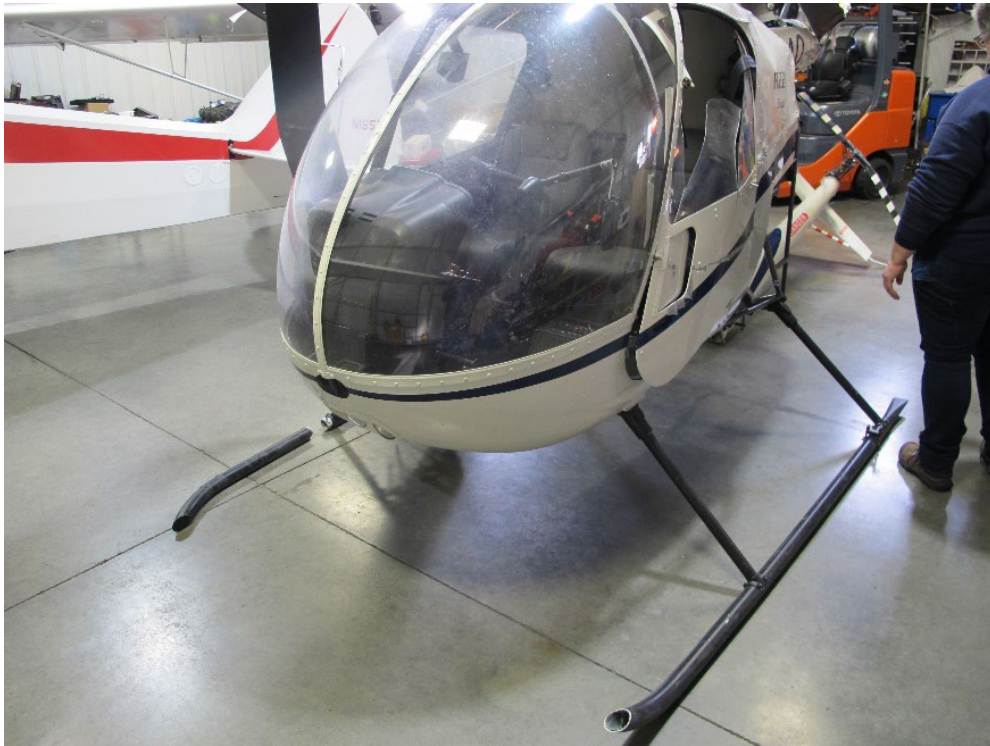
The helicopter was resting upright on its skids. (see figure 1) The toe section of the right skid was separated near the front crossbar, consistent with impact damage.

Figure 1. Front left view (courtesy of Robinson).

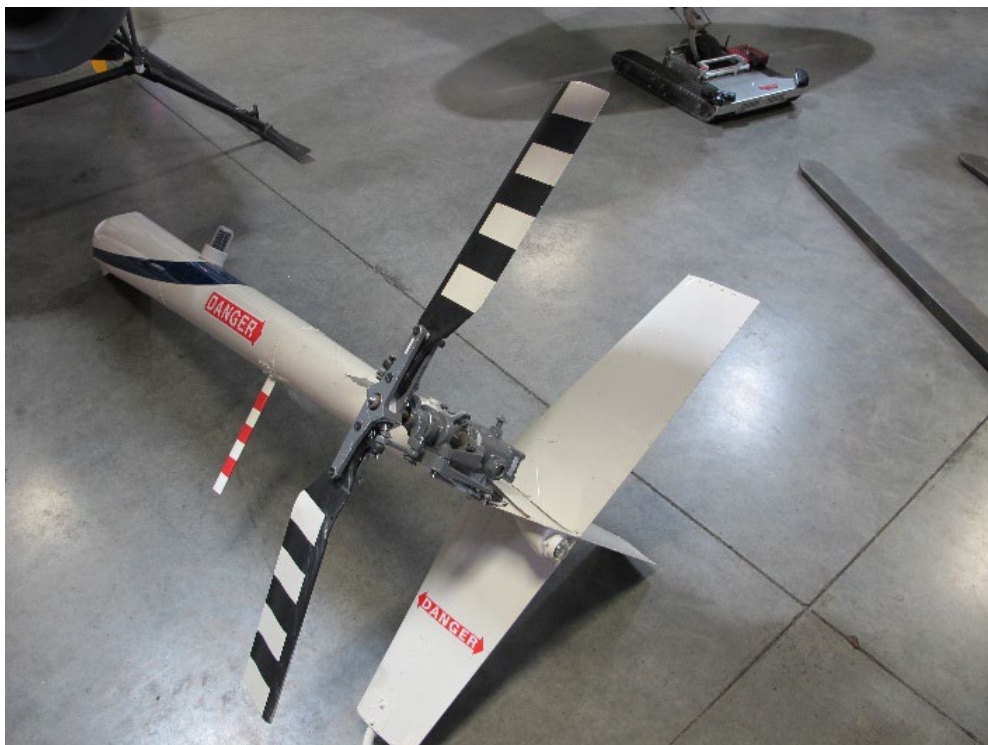
The tail rotor assembly remained attached to the tail rotor gearbox. (see figure 2) Tail rotor driveshaft continuity was established, from the driveshaft fracture separation near tail cone bays 3 and 4, to the tail rotor gear box. The tail rotor gearbox chip detector was removed and found to be clear of ferrous debris. Oil was visible in the oil level sight gauge for the tail rotor gearbox. (see figure 3)

Figure 2. View of tail rotor assembly (courtesy of Robinson).

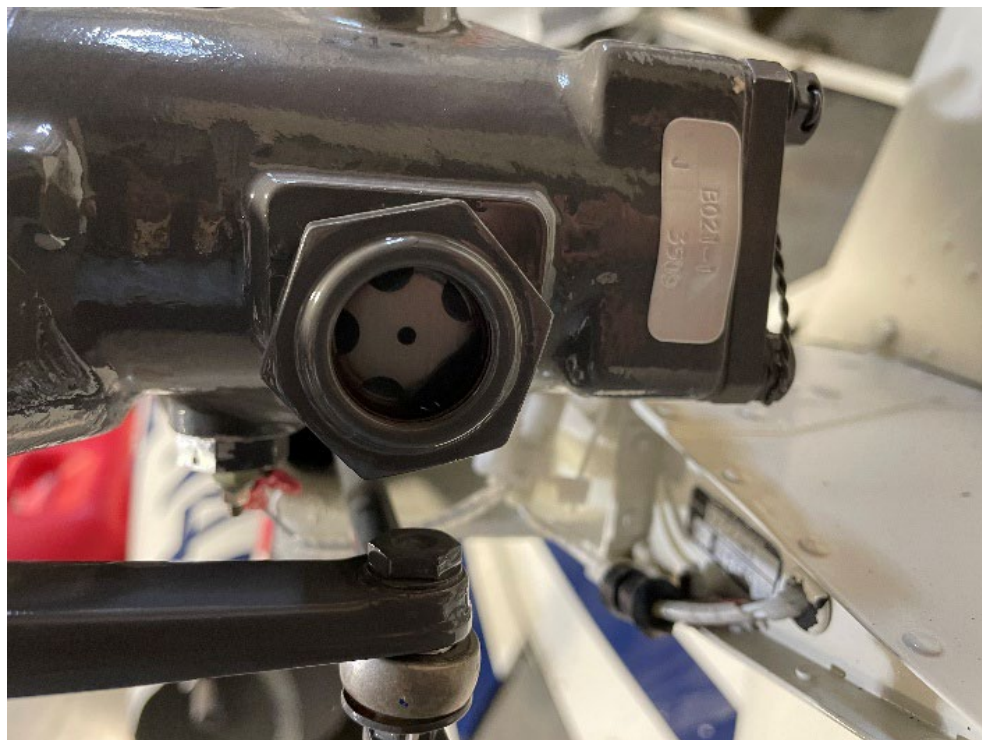
Figure 3. View of tail rotor gearbox oil level sight gage.

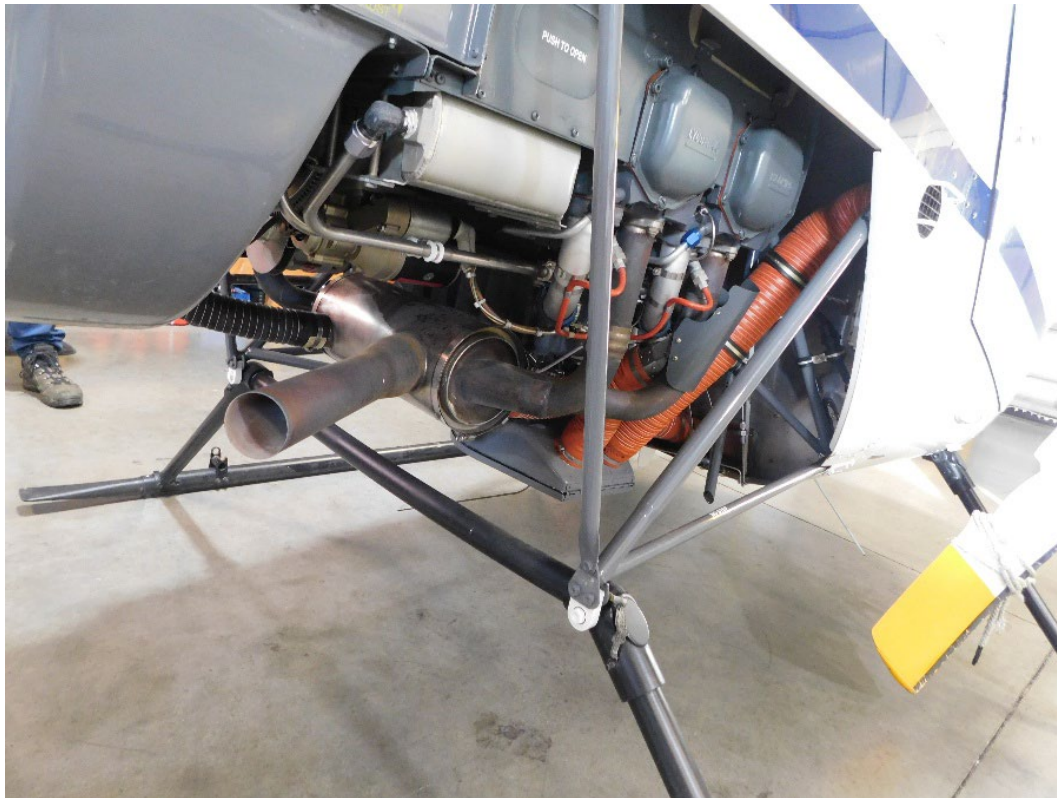
The engine was secure and in place with no damage to the mounts. (see figure 4)

Figure 4. View of right side of engine.

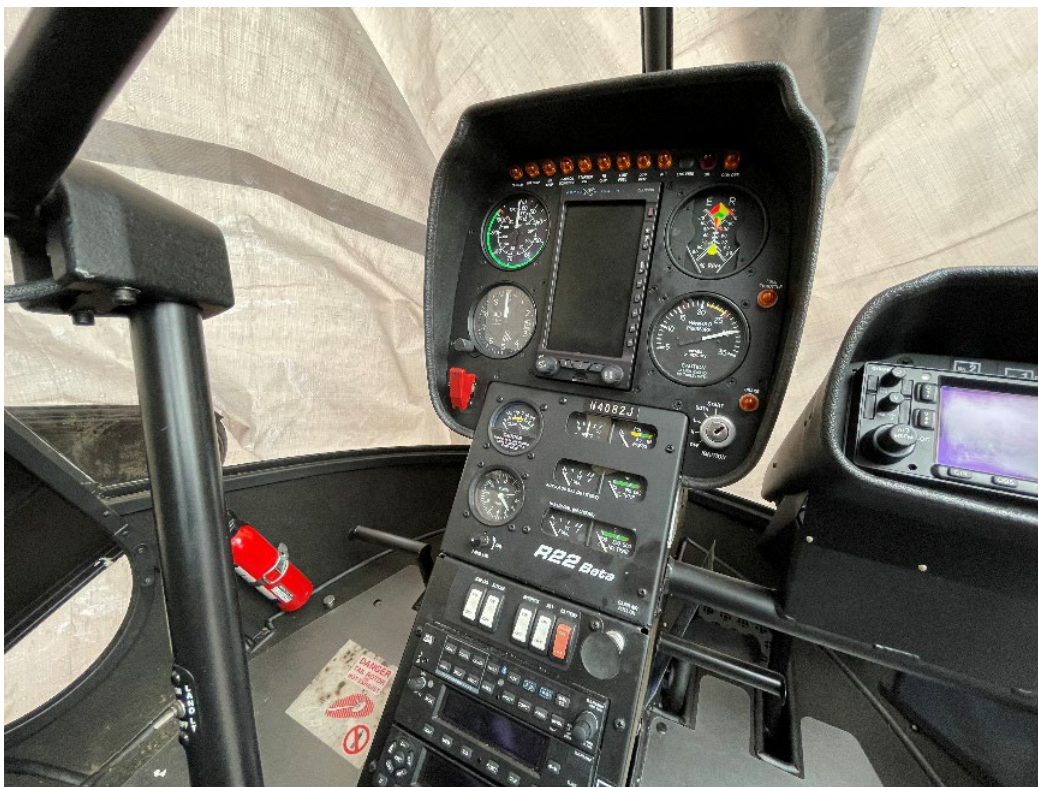
\*\*The instrument panel's upper console was displaced, with loose hinges. Examination inside the upper panel console revealed that multiple wire bundles, including the main electrical harness, the pitot - static lines, and the MAP line were disconnected. Further review of accident aircraft photos taken by NTSB IIC Kristyn Blocher on 5/21/24, and Arnold & Arnold adjuster, Kody Spencer on 5/23/24, revealed that unauthorized alterations had been made, to the instrument panel and other systems, after NTSB instructed the Operator to leave the wreckage unaltered.

\*\*Unauthorized postaccident alterations to the upper instrument console were discovered on November 20, 2024, at the wreckage examination. These alterations resulted in being unable to start the engine using the standard ignition system components, installed in the cabin. The console wire harness and pressure lines (pitot, static, and MAP) were not connected to the main wire harness and pressure lines. Prior to the accident, the main electrical harness in this aircraft had been modified, to accommodate a later version of the upper console (which is what had been installed and in operation at the time of the accident.) At the time of the postaccident examination, the console was found to be the earlier version, which prevented the ability to connect the current (altered postaccident) console harness to the main harness. (see figures 5 and 6)

Figure 5. View of N4082J upper console at OLM prior to wreckage recovery, 5/21/24

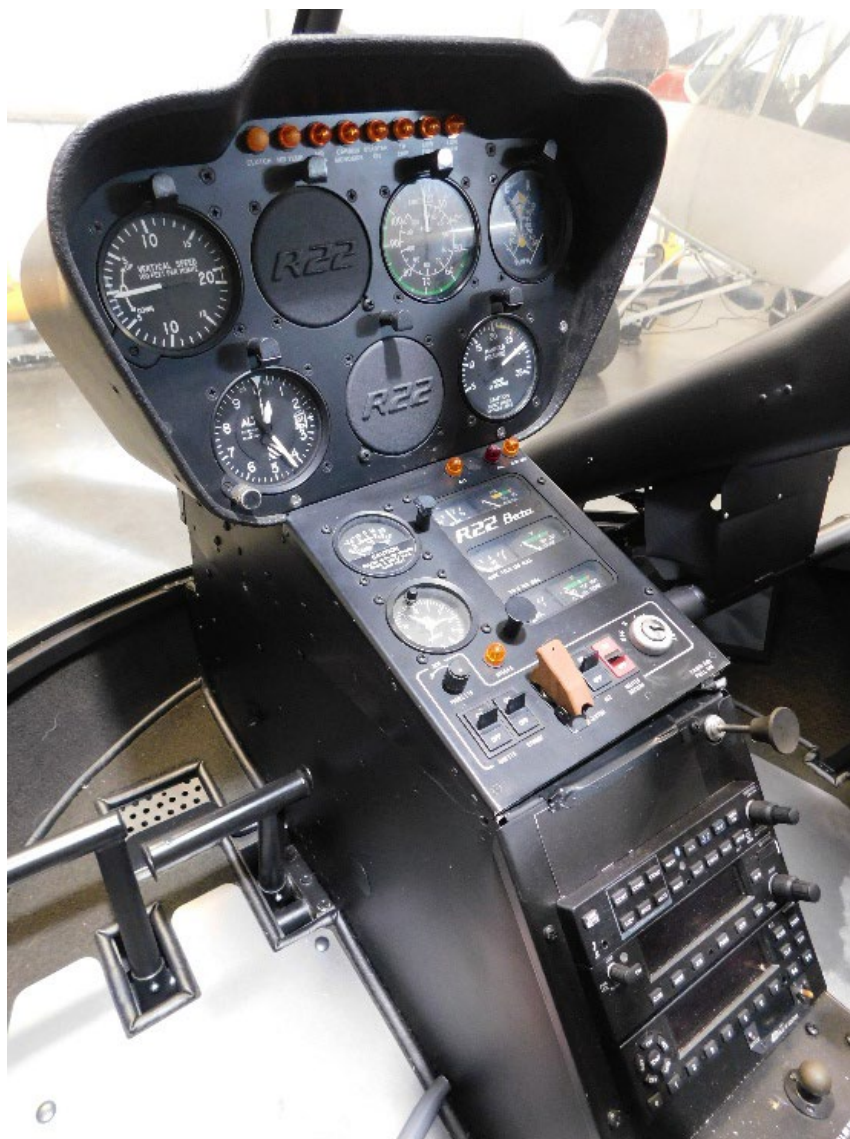
Figure 6. View of N4082J upper console at wreckage exam, 11/20/24

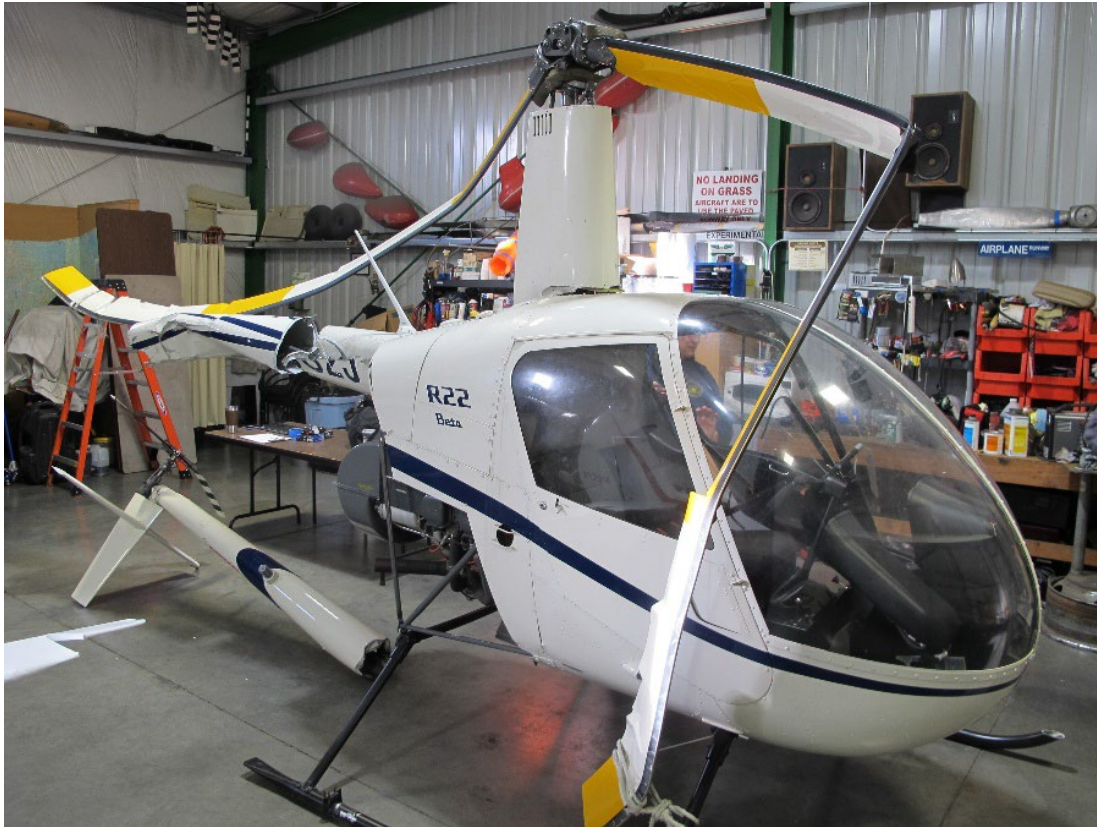
Both main rotor blades exhibited multiple areas of bending, buckling and gouging along the leading edges. One main rotor blade was bowed upward with chordwise creases along the span, and bowed opposite the direction of rotation, near its tip. The other main rotor blade was bent upward 90° and bowed opposite the direction of rotation, near its tip; the droop stop tusk for this blade was fractured, consistent

with impact damage. Both blades displayed scuff marks near their tips, running chordwise. (see figure 7)

Figure 7. View of both main rotor blades.
