WPR24LA141

## INVESTIGATION PHOTOGRAPHS

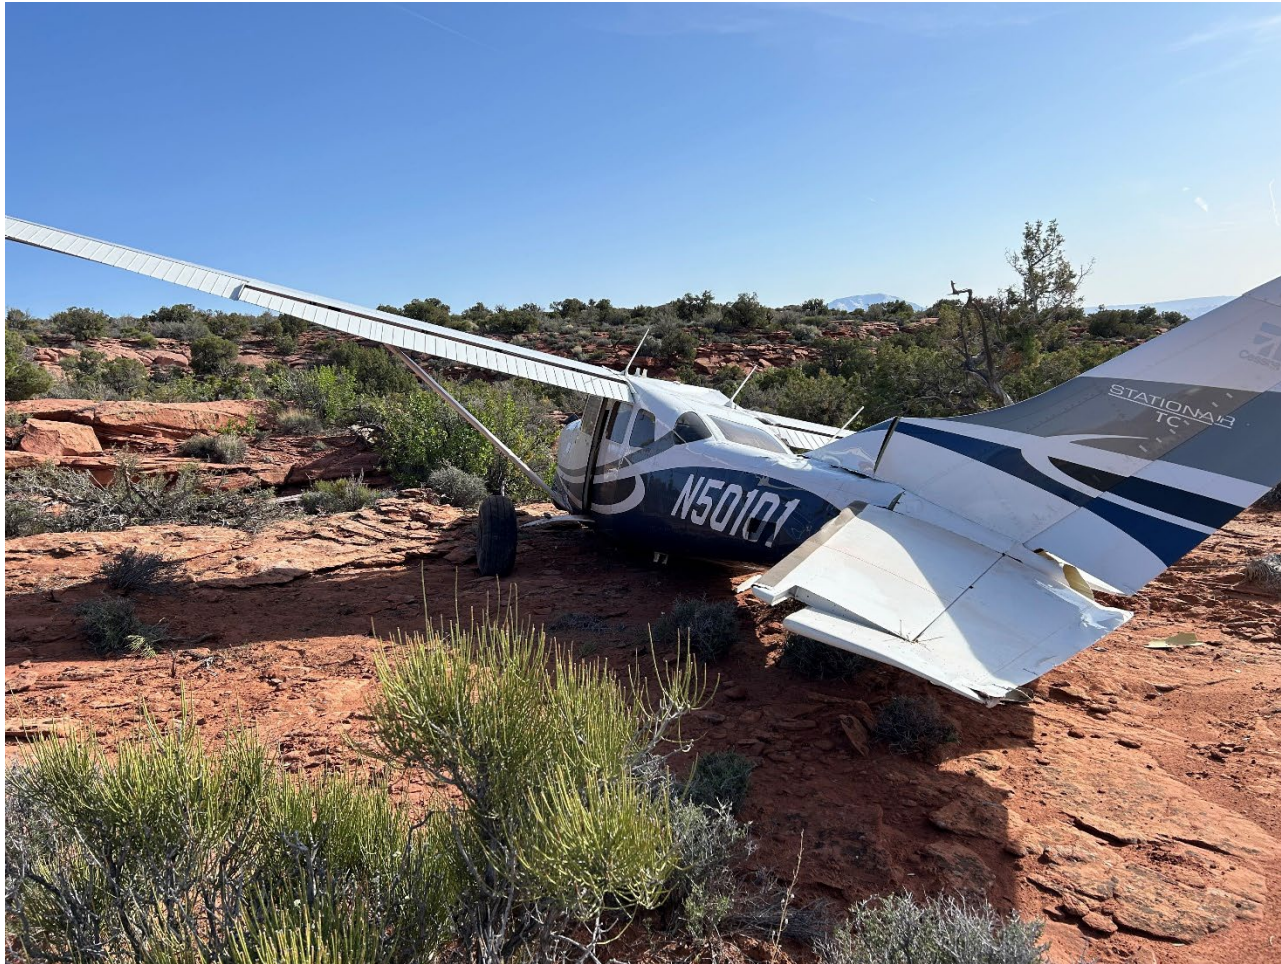
**Photograph 1 - View of substantial damage to the left side empennage (Courtesy of Operator)**

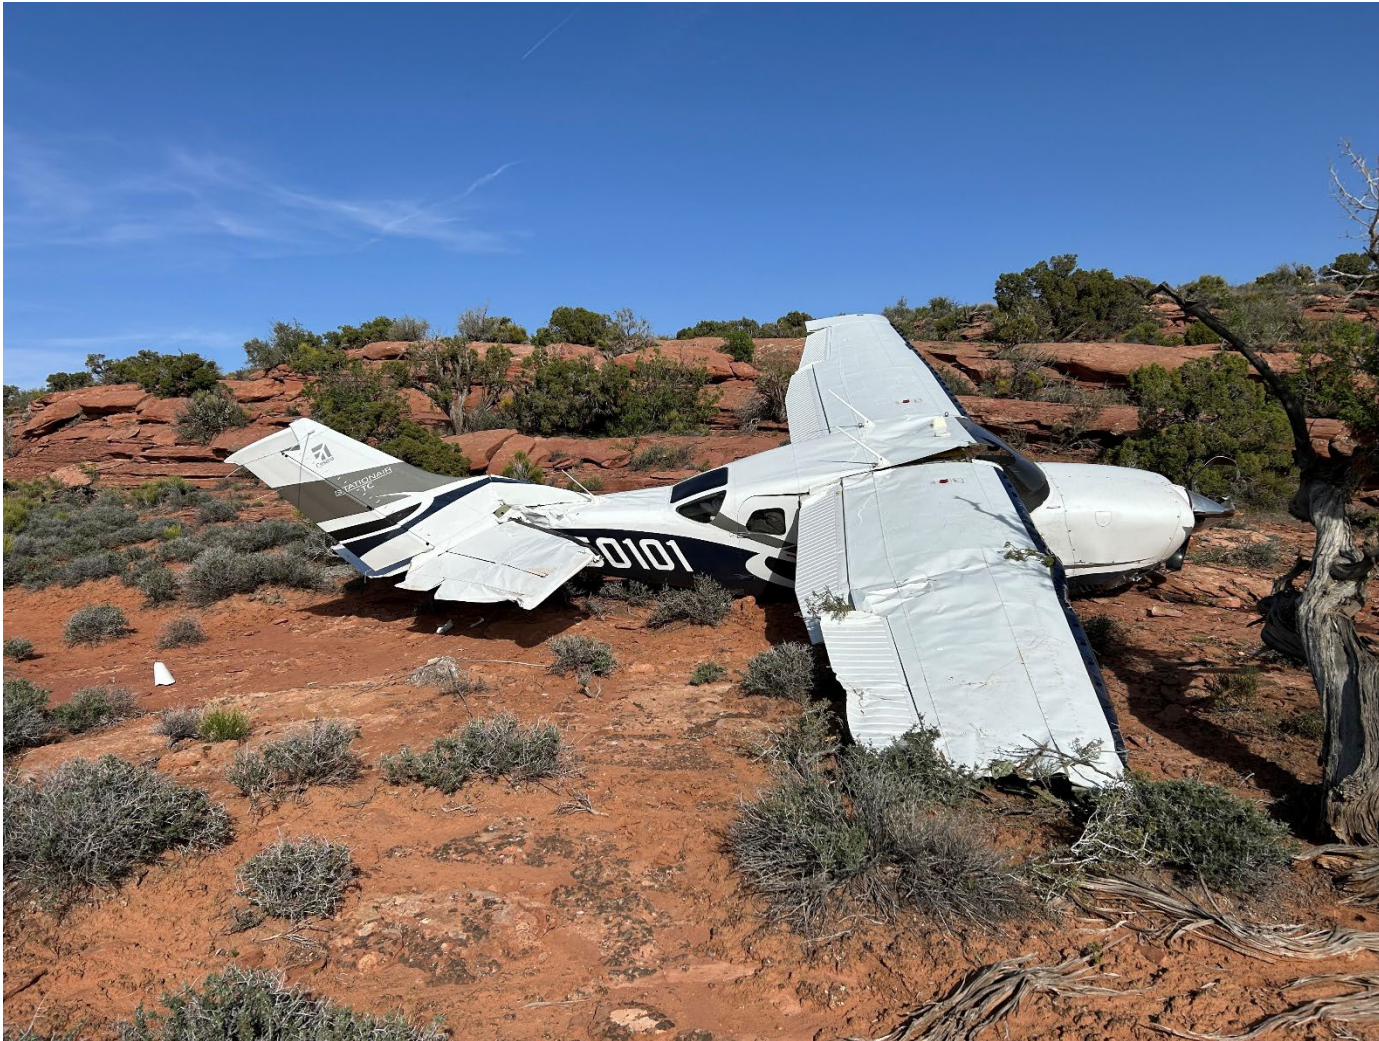
**Photograph 2 - Top view of substantial damage right side empennage and right wing  
(Courtesy of Operator)**
