# National Transportation Safety Board

WPR24LA141

## **BRAKE SYSTEM EXAMINATION**

Location: Nokai Dome, CO  
Date: August 12, 2024  
Time: 0800MST  
1500UTC  
Airplane: N50101  
Manufacturer: Cessna  
Model: T206U

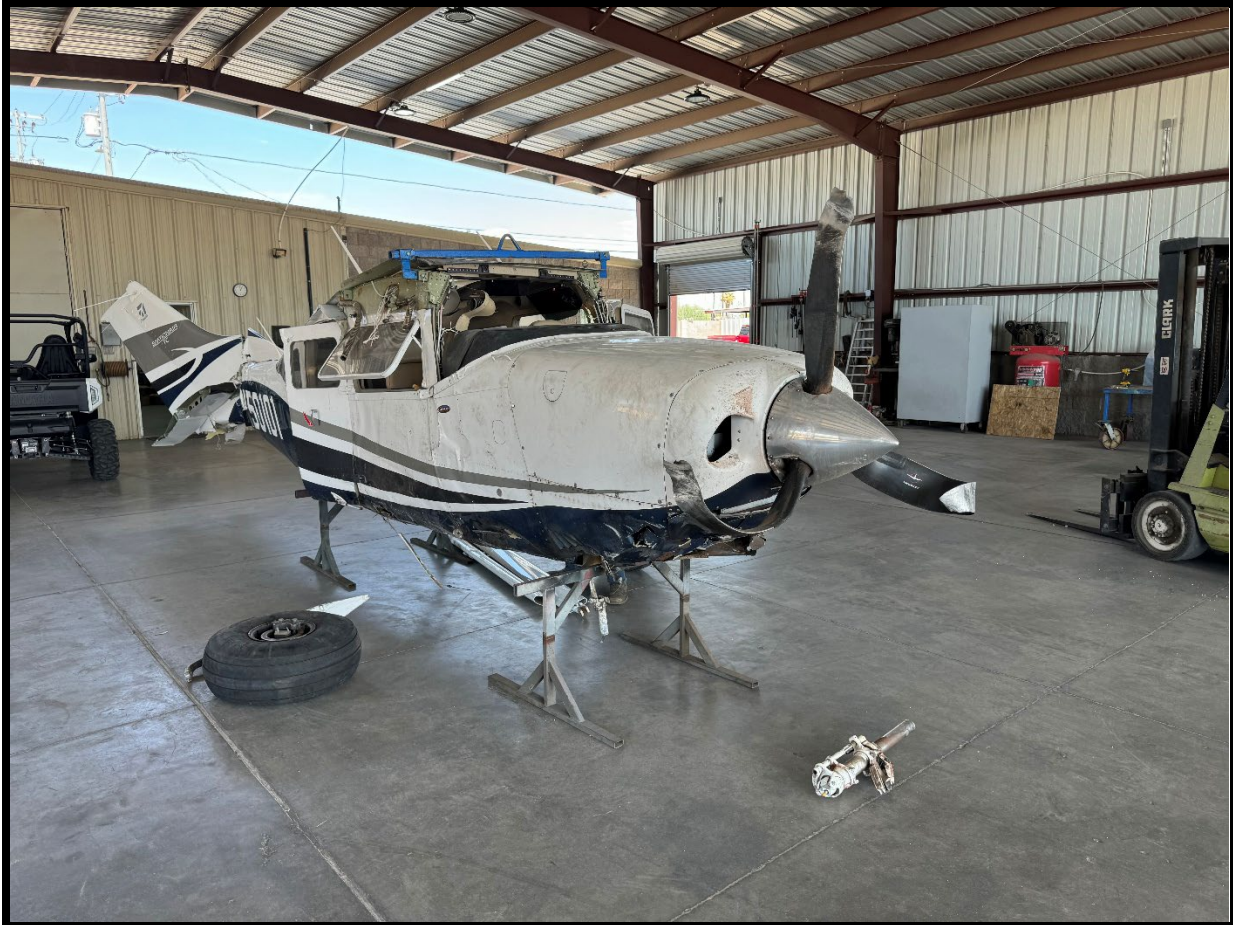
Visual examination of the landing gear revealed that the nose gear strut had completely separated from the lower fuselage (Figure 1). The left main landing gear spring assembly remained attached to the lower fuselage within the channel. The left wheel, inboard and outboard cup bearing seats were fracture separated. The wheel remained attached to the landing gear by the main gear axle. The tire was unremarkable.

**Figure 1:** Forward right side view of the airplane with impact separated nose landing gear and right main landing gear.

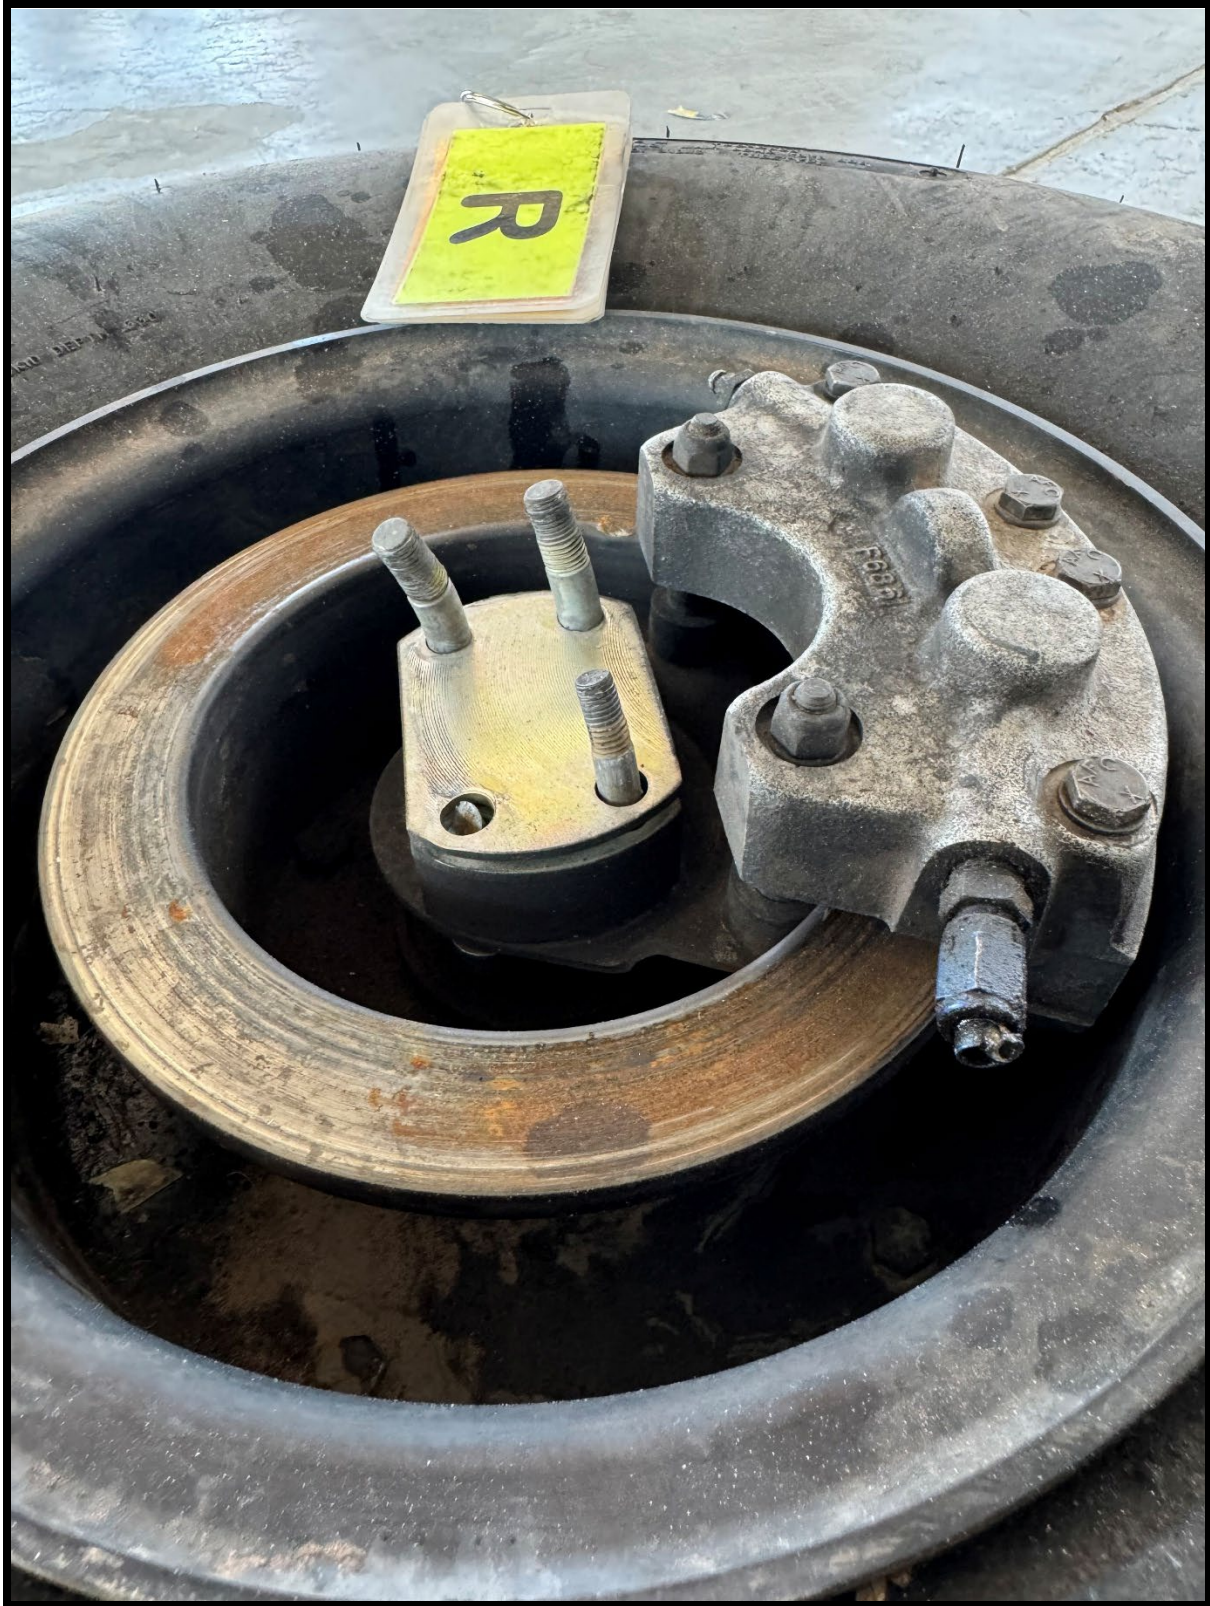
The right main landing gear spring assembly was separated from the channel (Figure 5). The inboard retention bolt sheared, and a portion of the shank remained in the spring assembly bore. The forward (Figure 7) and aft channel retention bolt and nut remained in the channel, with deformation identified on the aft upper channel surface (Figure 6). The landing gear spring was separated from the hydraulic brake line (Figure 1), and the wheel was separated from the spring (Figure 2). The main gear axle was separated from the landing gear spring.

**Figure 2:** Close up view of the separated right main landing gear wheel and caliper with impact damage to hydraulic line AN fitting, and deformation to axle attachment bolts.

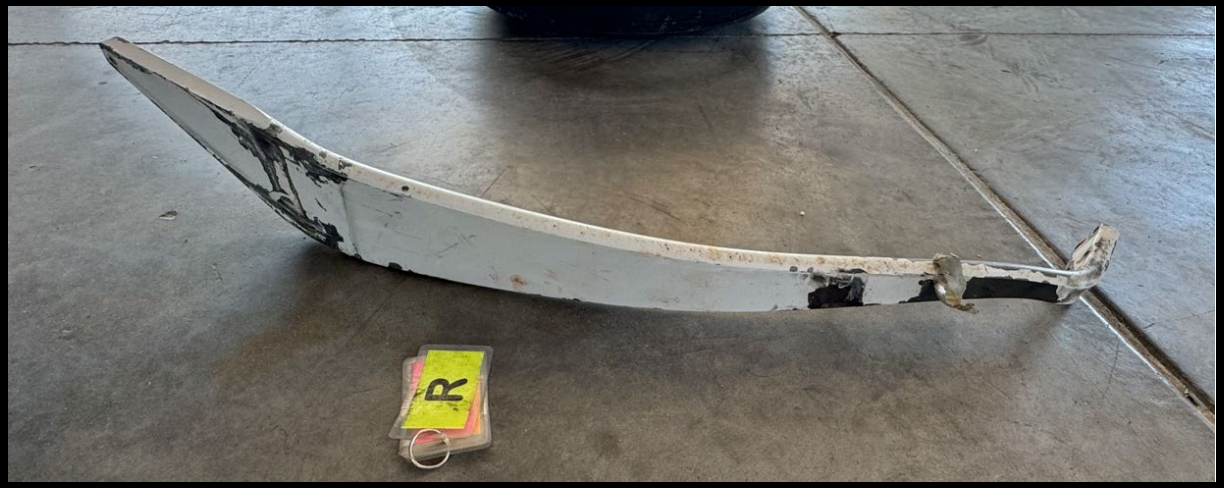
**Figure 3:** Top to bottom view of impact separated right main landing gear spring

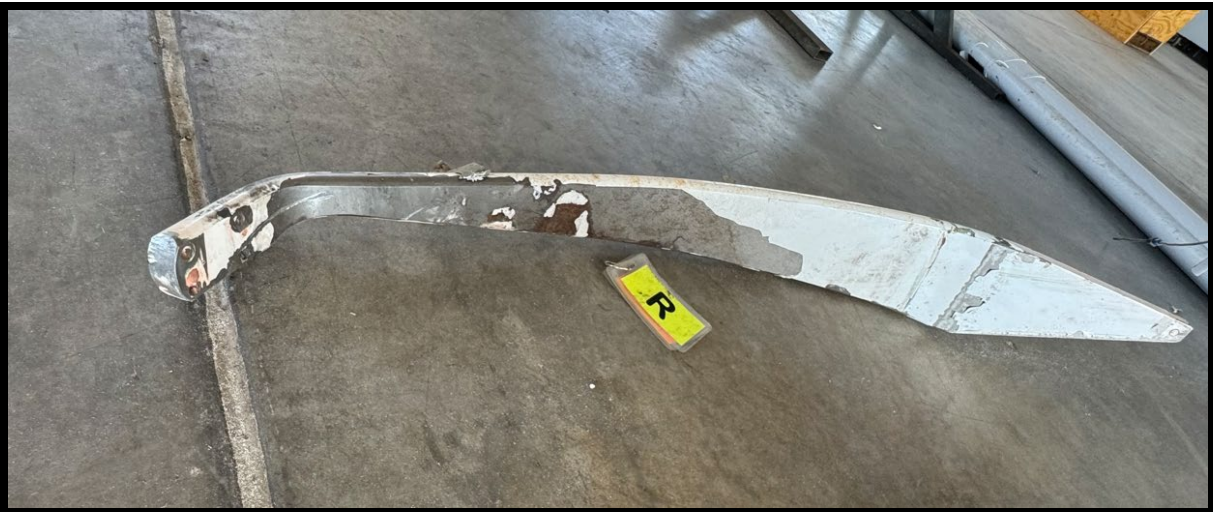
**Figure 4:** Bottom to top view of impact separated right main landing gear spring

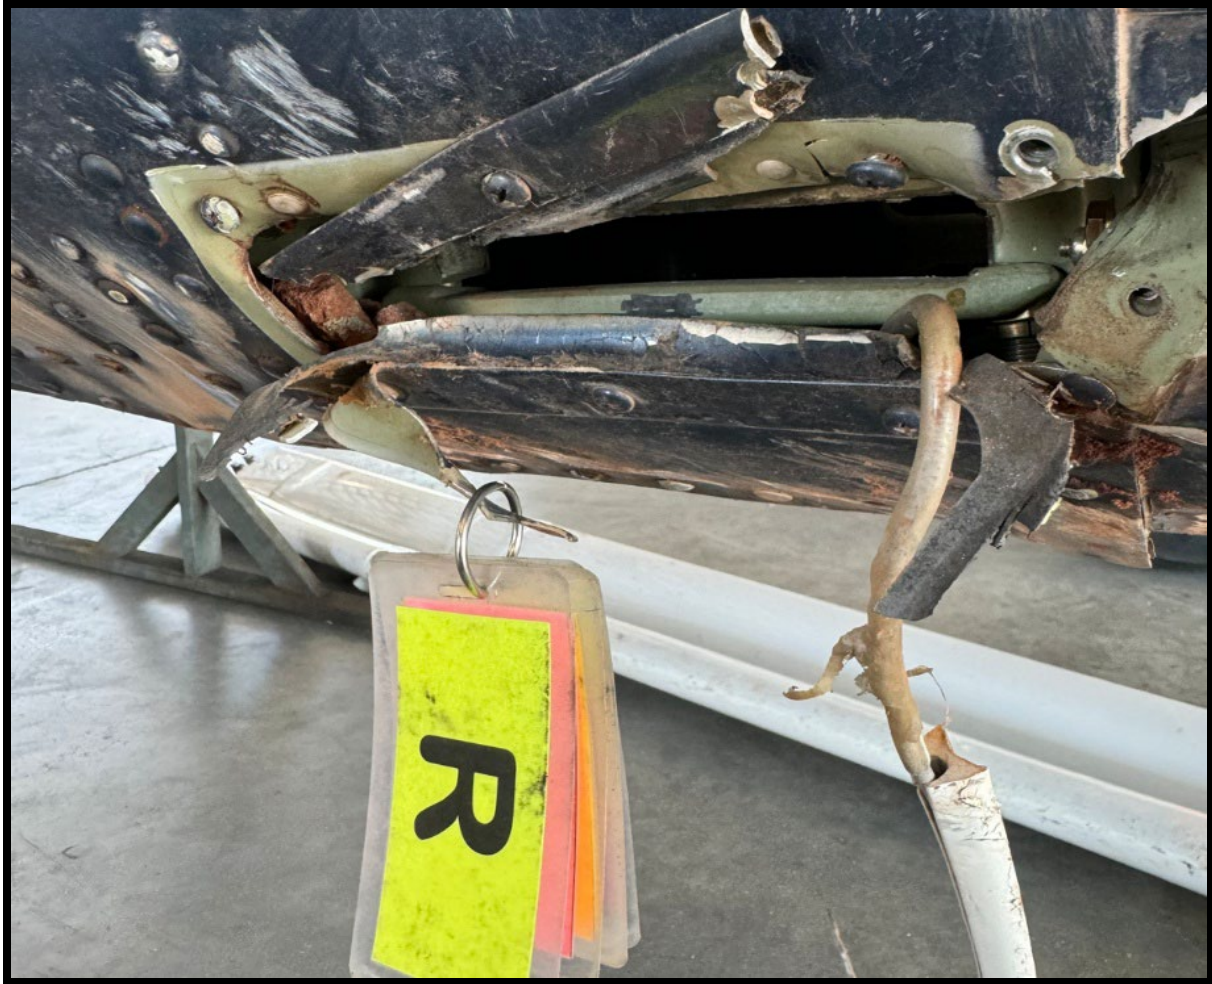
**Figure 5:** Initial view of right main landing gear spring lower fuselage separation.

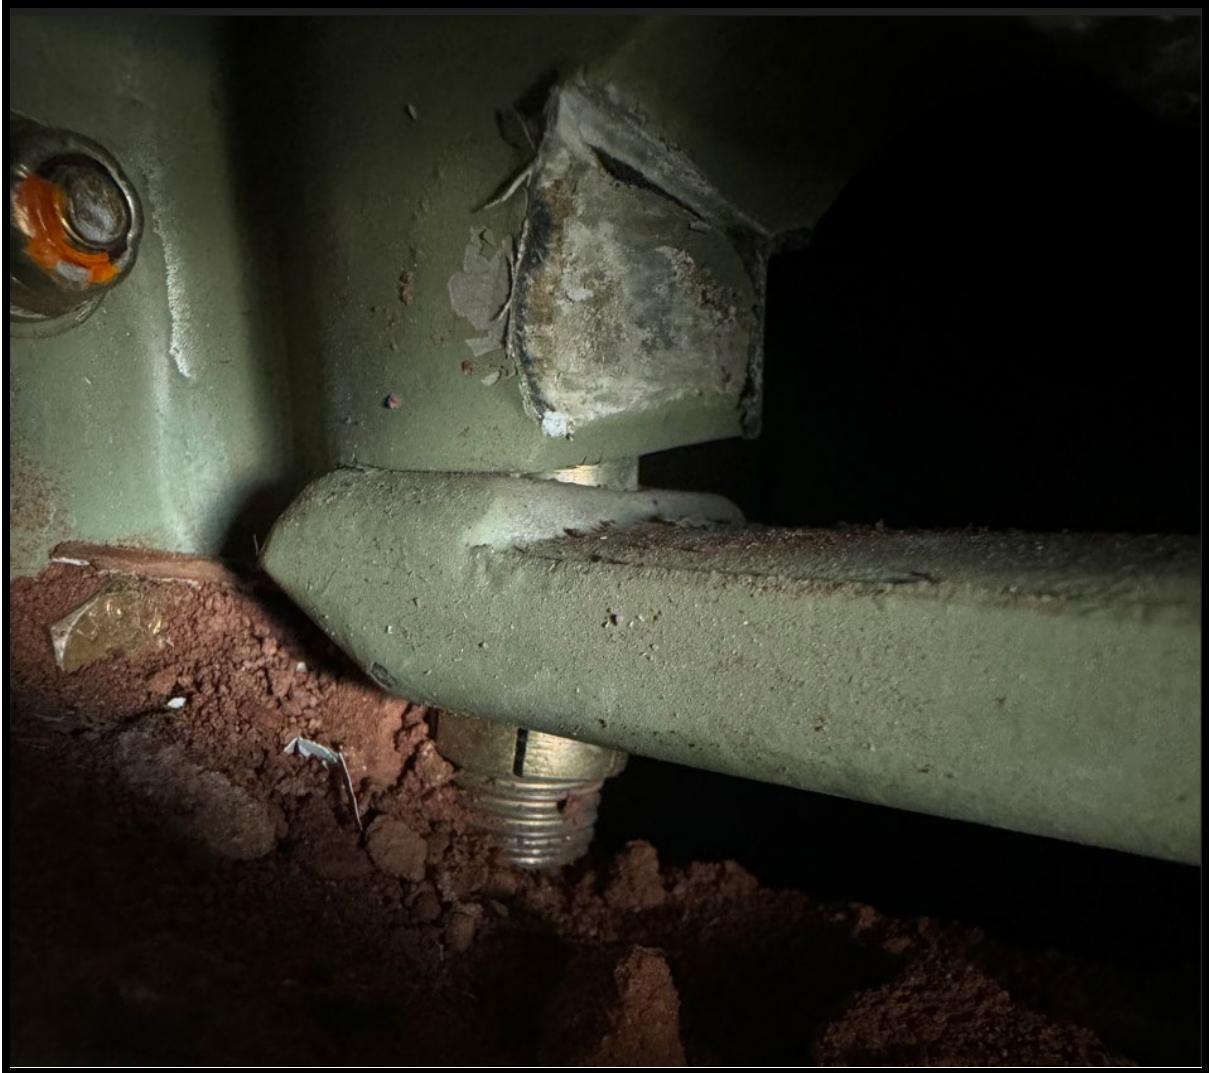
**Figure 6:** Close up view of left main landing gear spring aft channel separation.

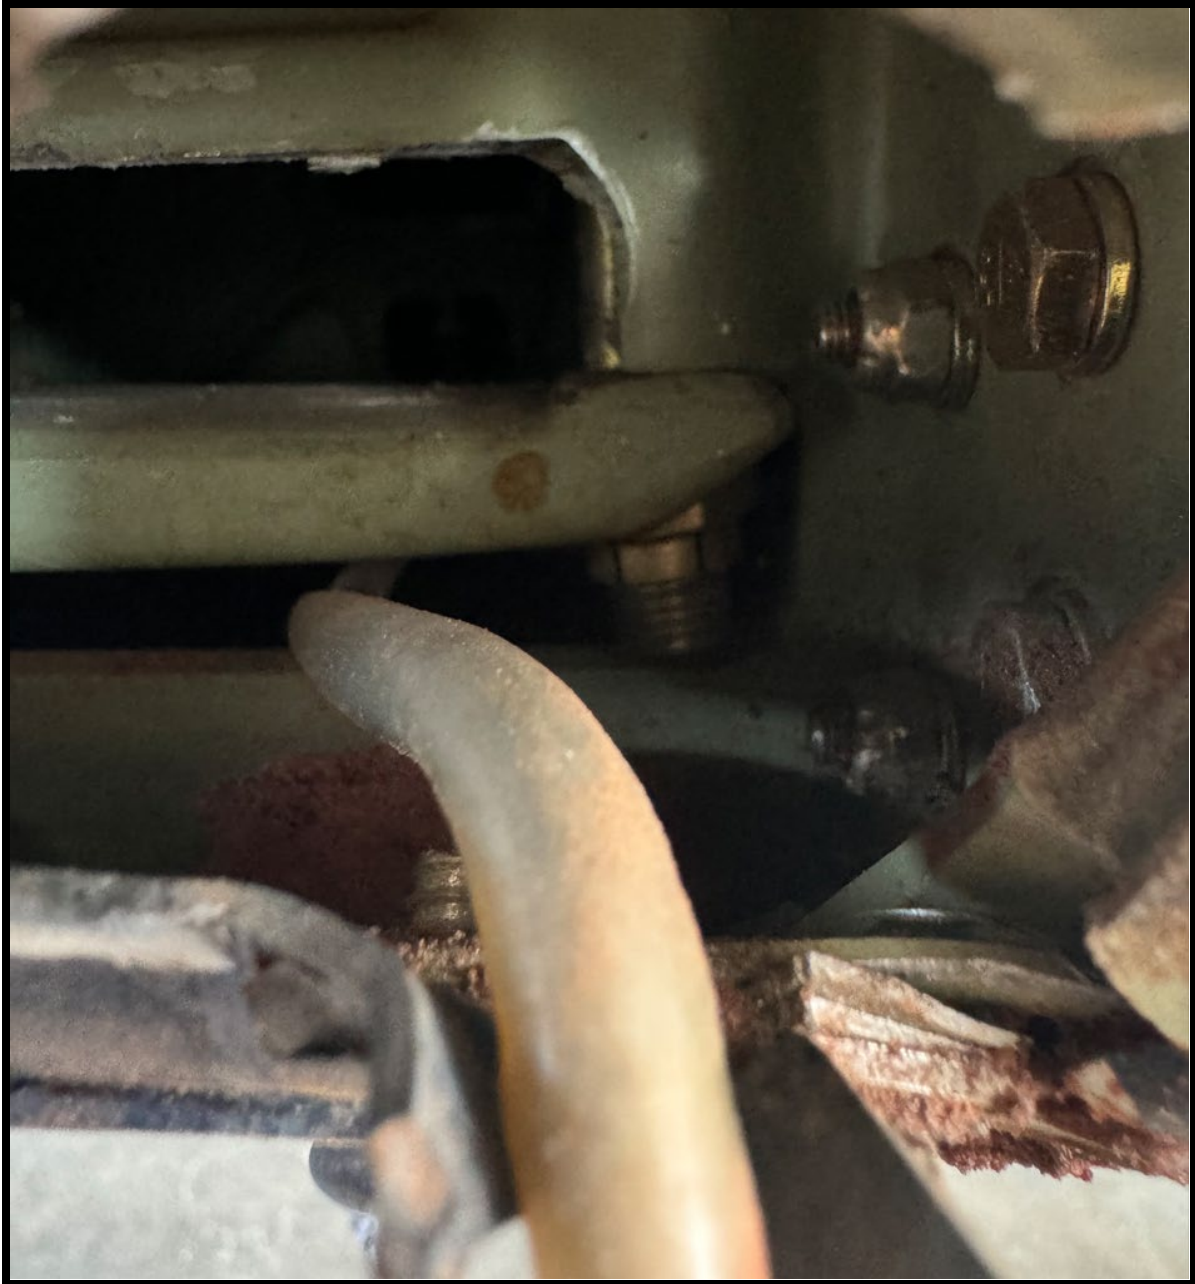
**Figure 7:** Close up view of left main landing gear spring forward channel separation.

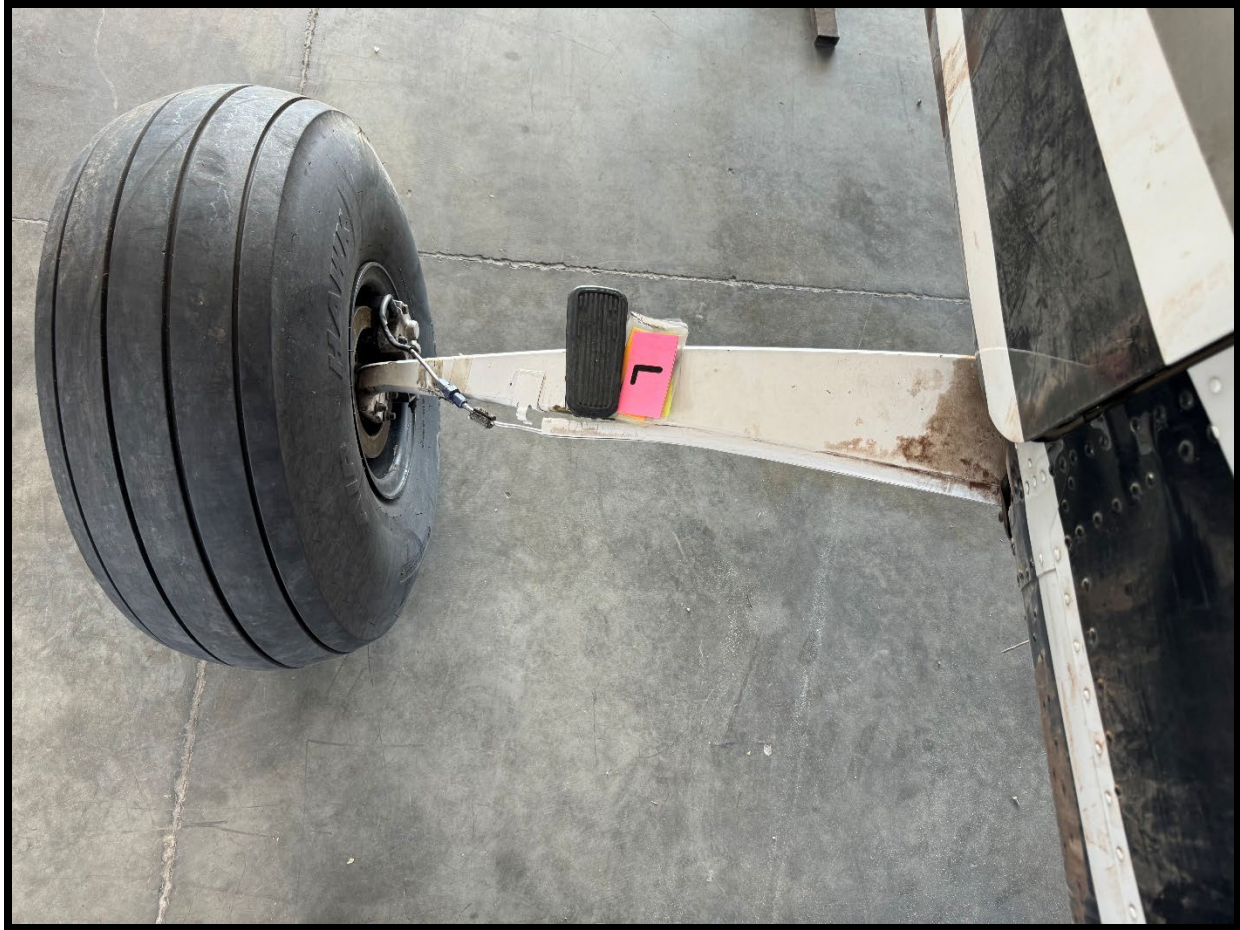
**Figure 8:** Initial view of the left main landing gear, connected hydraulic fluid line and caliper.

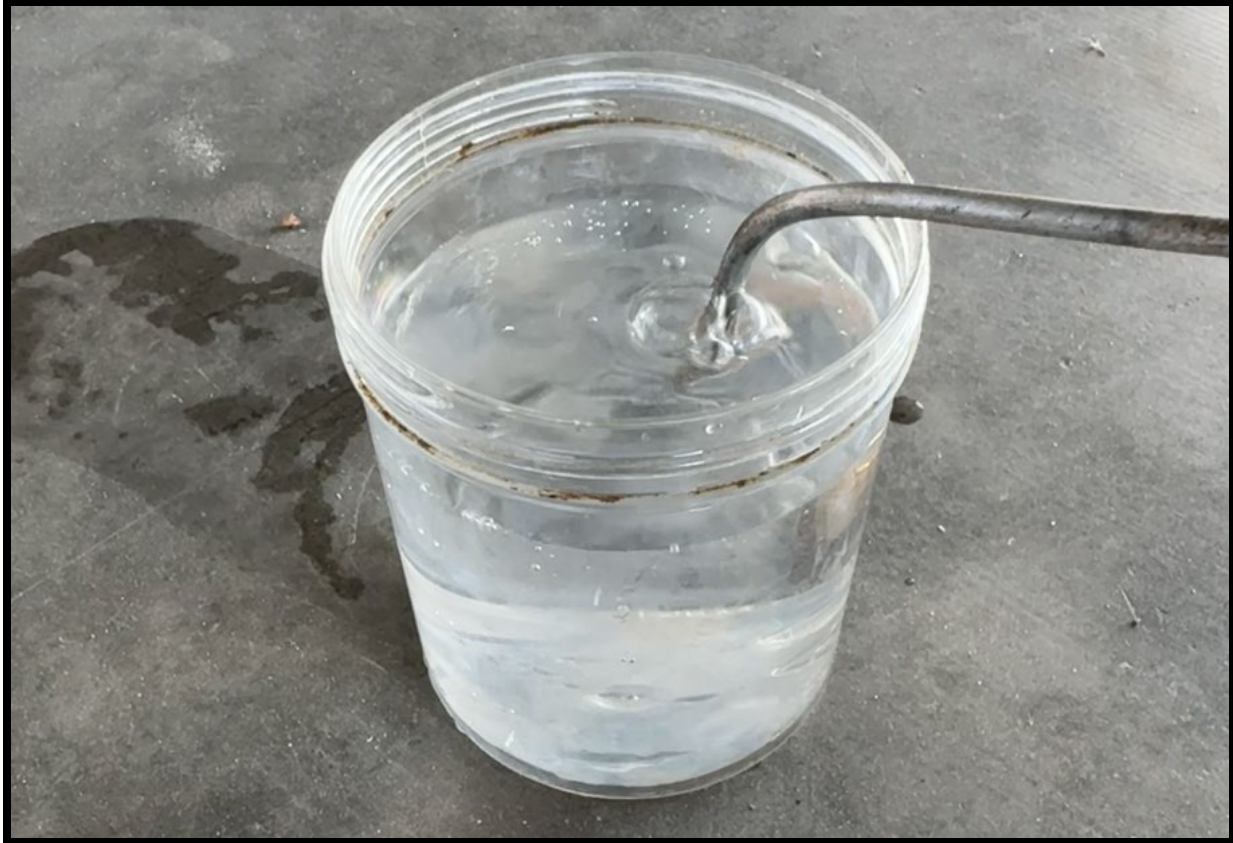
The right main landing gear hydraulic brake line was separated and extended about 2 ft from the lower fuselage. The separated end of the hydraulic brake line was placed in mason jar filled with water (Figure 9). Manual application of the left seat, right brake pedal with the master cylinder attached revealed a corresponding pressure throughout the brake line, observed by the outflow pressure indicated by bubble formation in the water of the mason jar.

**Figure 9:** Right hydraulic brake line function test showing mason jar and bubble production, pressure indication.

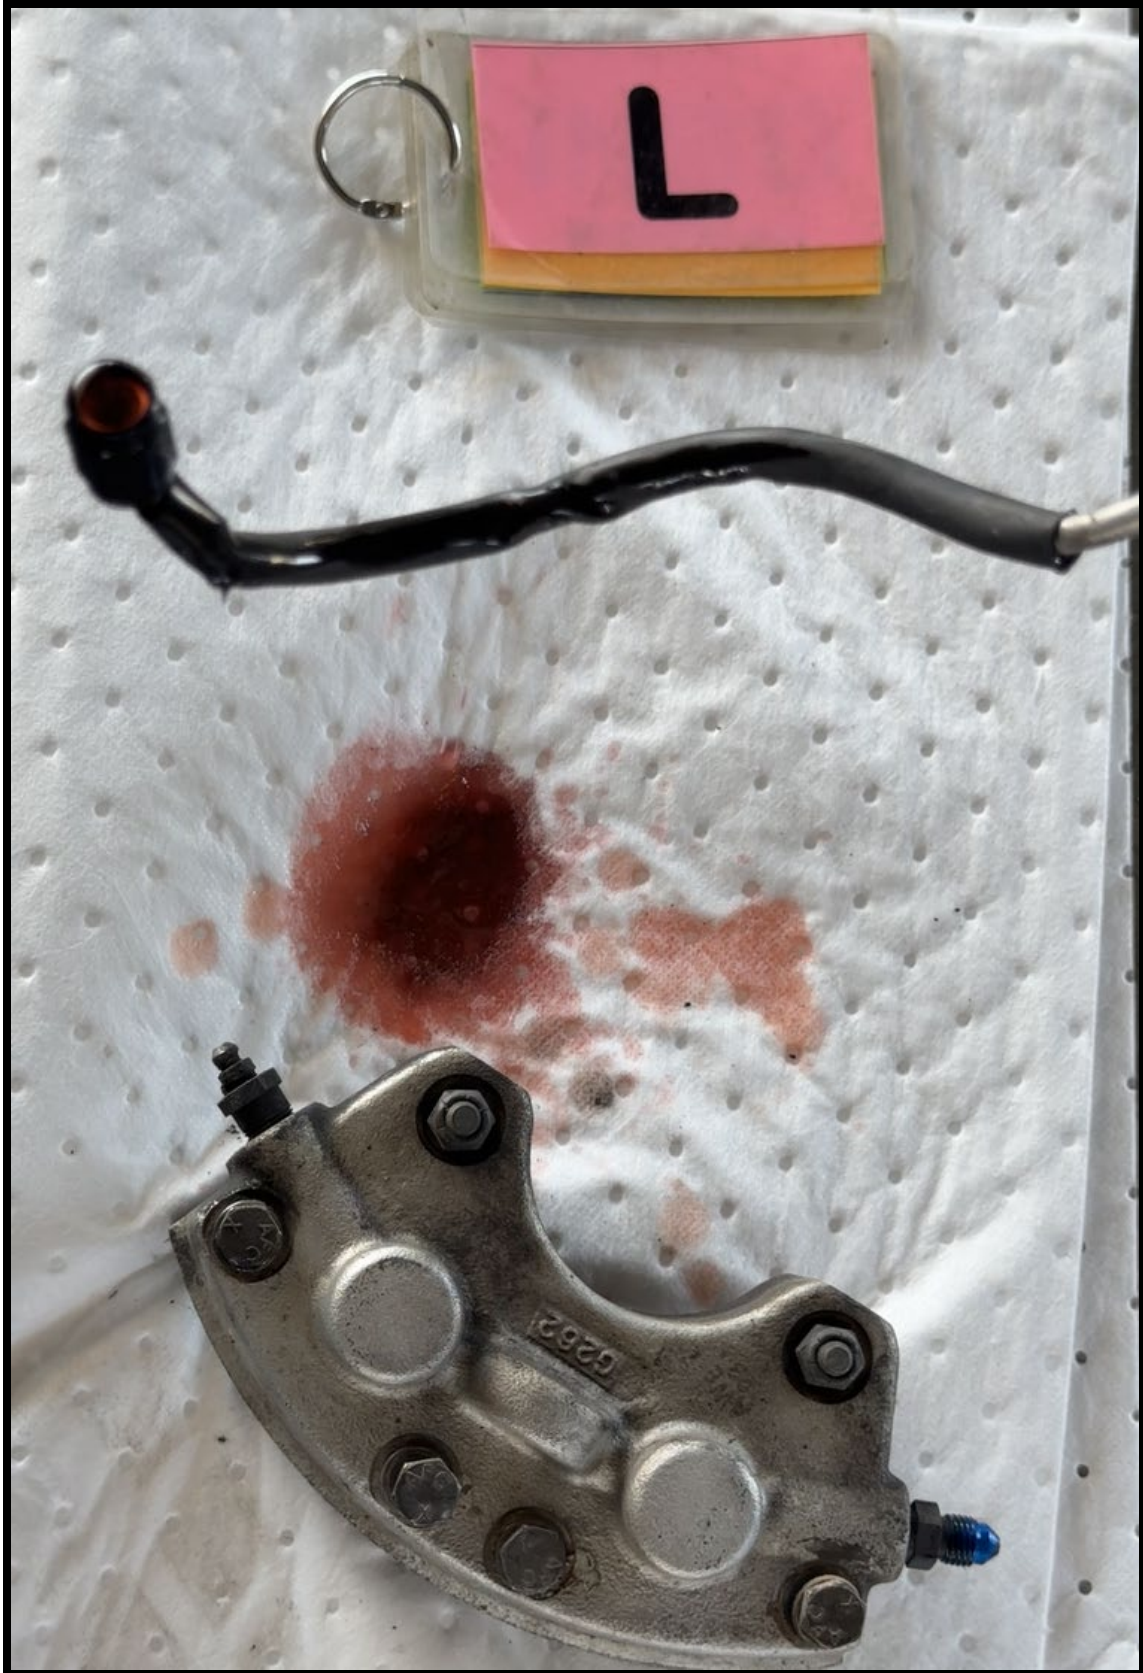
The left main landing gear hydraulic line was unremarkable and remained attached to the left main gear axle and caliper. Pressure was applied to the pilot seat, left brake pedal with the master cylinder attached. Manual application of the left brake pedal revealed that the left brake caliper pistons functioned normally, applying pressure to the torque plate lining and the back plate lining. A subsequent release of the brake pedal application revealed a corresponding retraction of the pistons, torque plate lining, and back plate lining. The hydraulic brake line was removed at the AN fitting, the manual application of brake pedal pressure was applied and hydraulic fluid was observed emanating with force (Figure 10).

**Figure 10:** Left main gear hydraulic brake line function test showing fluid pressure at AN fitting body.

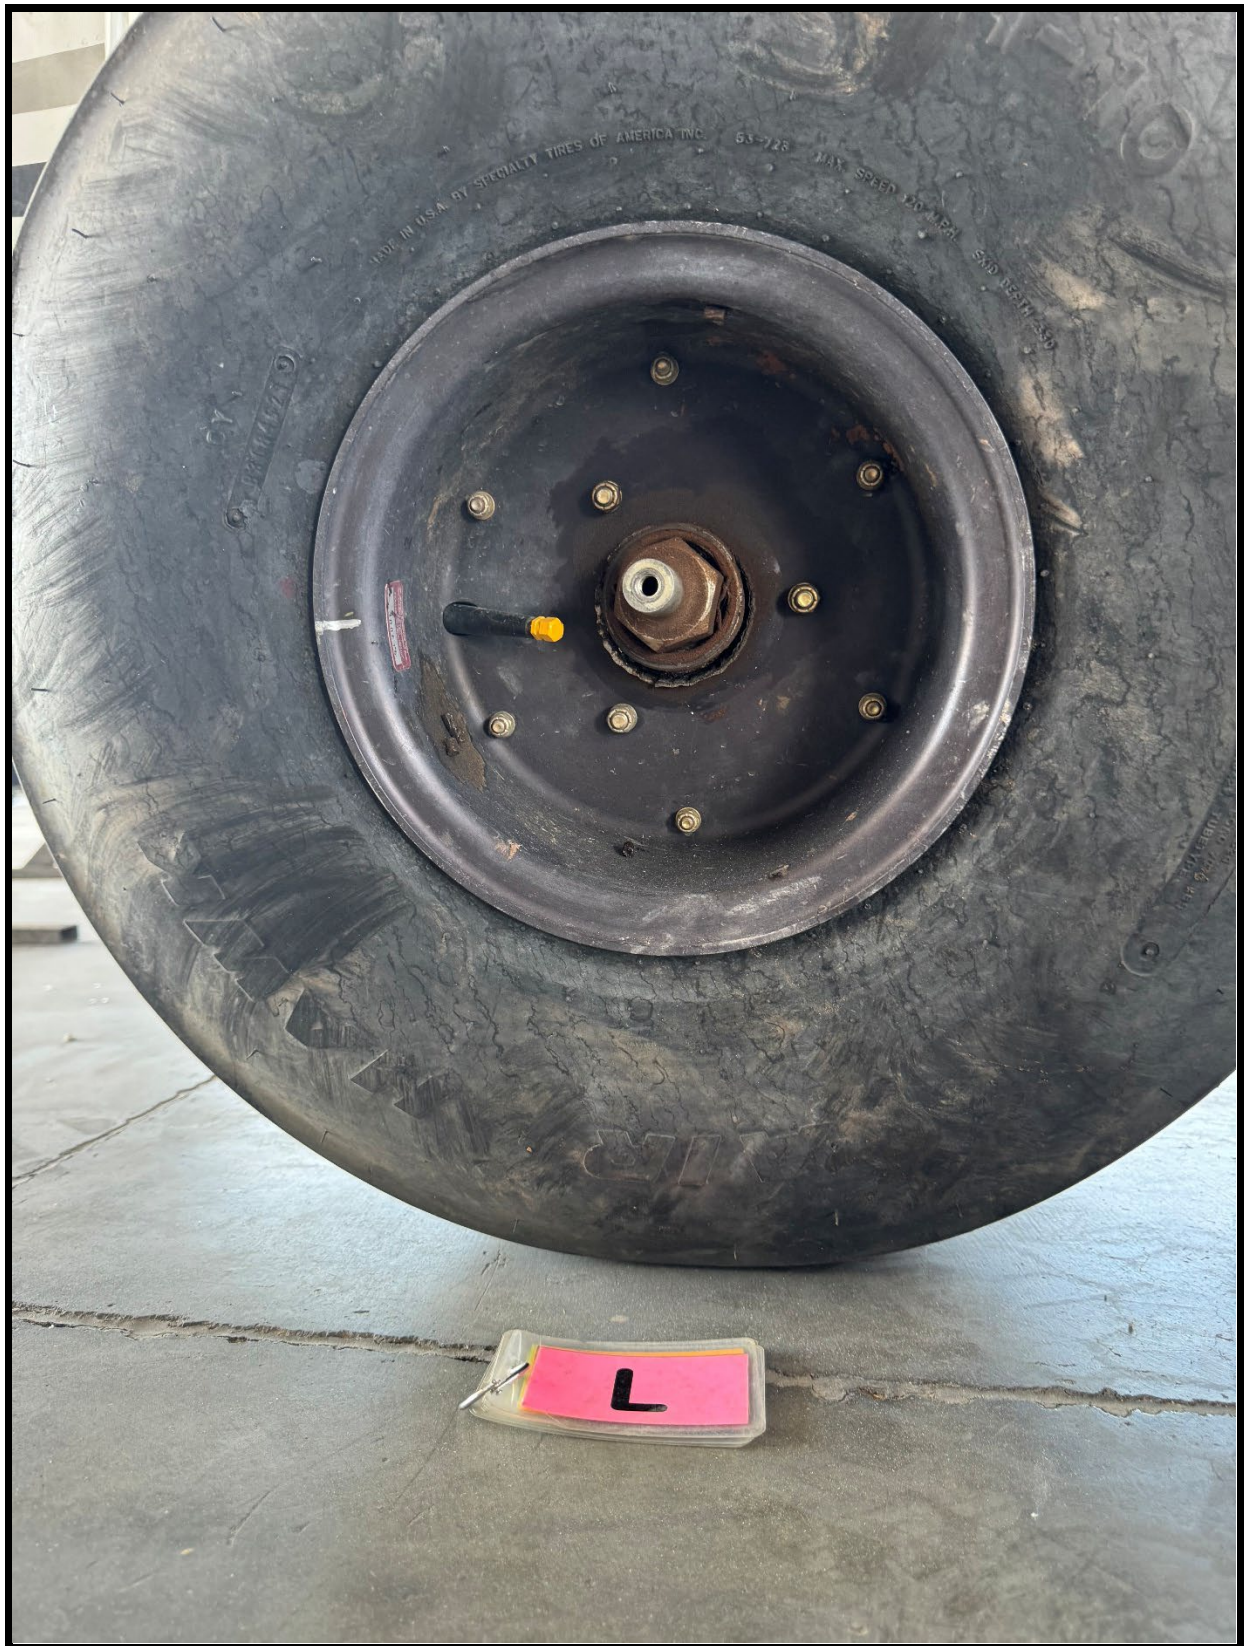
The left and right main landing gear wheels were equipped with aftermarket 29 x11-10 Air Hawk tires, and the main gear brake assemblies were manufactured by Cleveland Wheel and Brake Systems. The left wheel sustained impact damage to the inboard and outboard wheel half assembly cup bearings (Figure 11) (Figure 12). The inboard and outboard wheel half cup bearing lips were fracture separated. The left wheel was removed from the main gear axle by removing the cotter pin and retaining nut. The inboard assembly revealed impact damage to the cup bearing lip, retainer ring, felt grease retainer seal, felt grease seal, retainer and cone bearing. The left outboard wheel assembly revealed impact damage to the cup bearing lip, retainer ring, felt grease retainer seal, felt grease seal, retainer and the cone bearing was missing most of its roller bearings. Once disassembled, neither the inboard or outboard cup bearing lip was found between the wheel halves, and about 33 percent of its diameter surface was not present.

**Figure 11:** View of damage to the left wheel outer half.

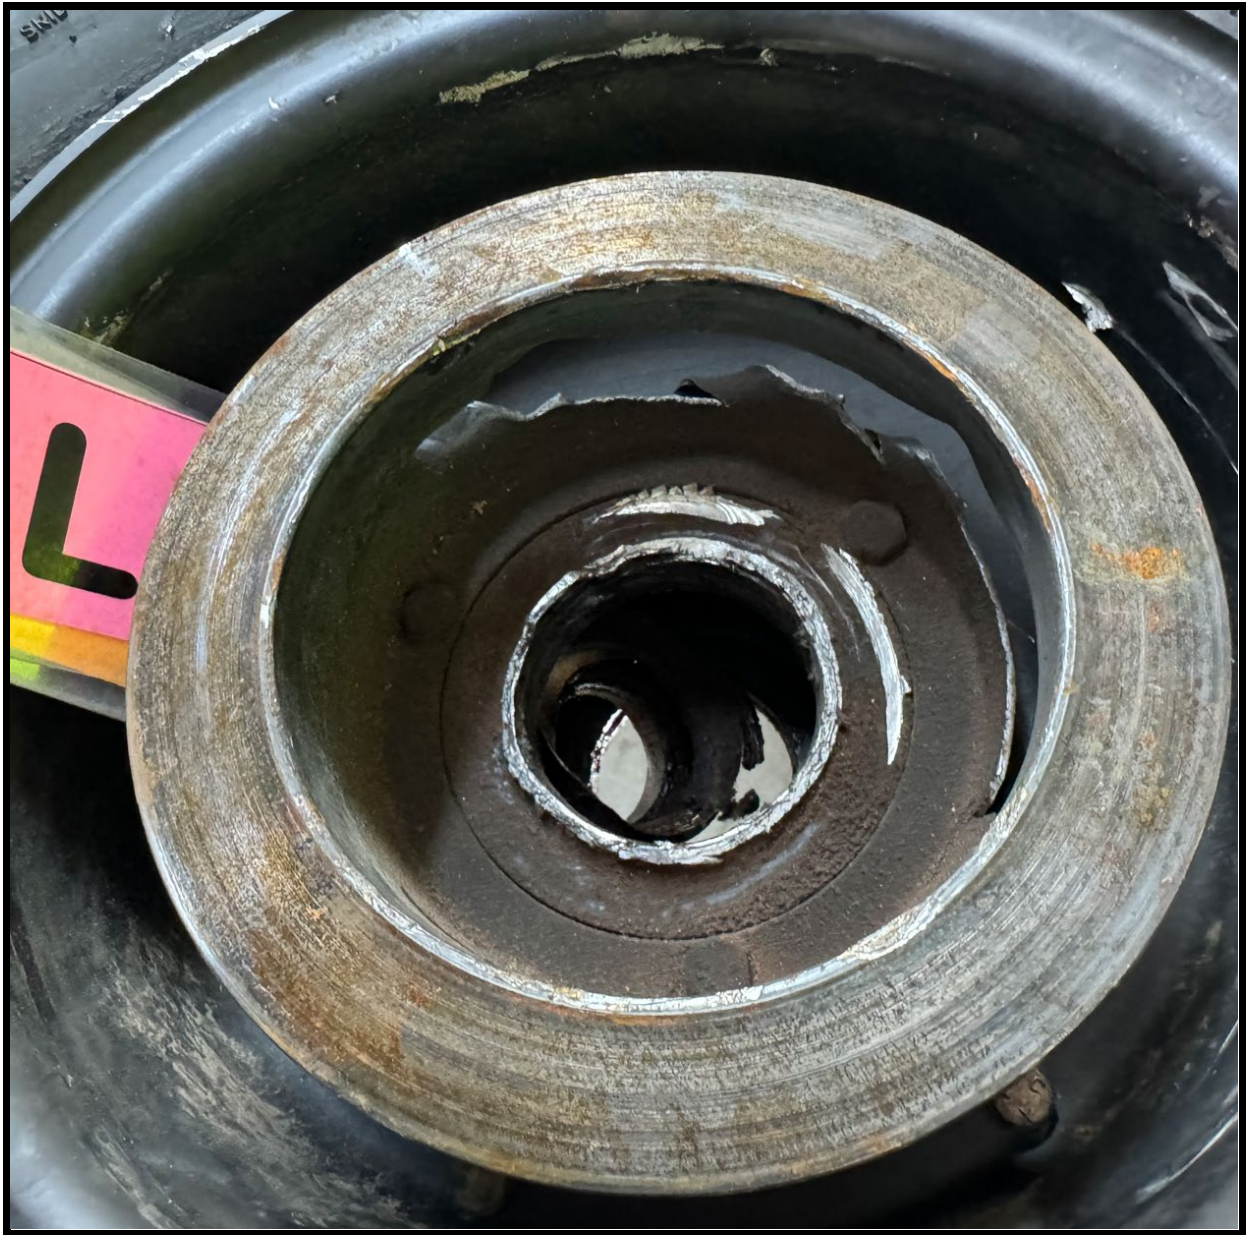
**Figure 12:** View damage to the left wheel inner half and bearing assembly.

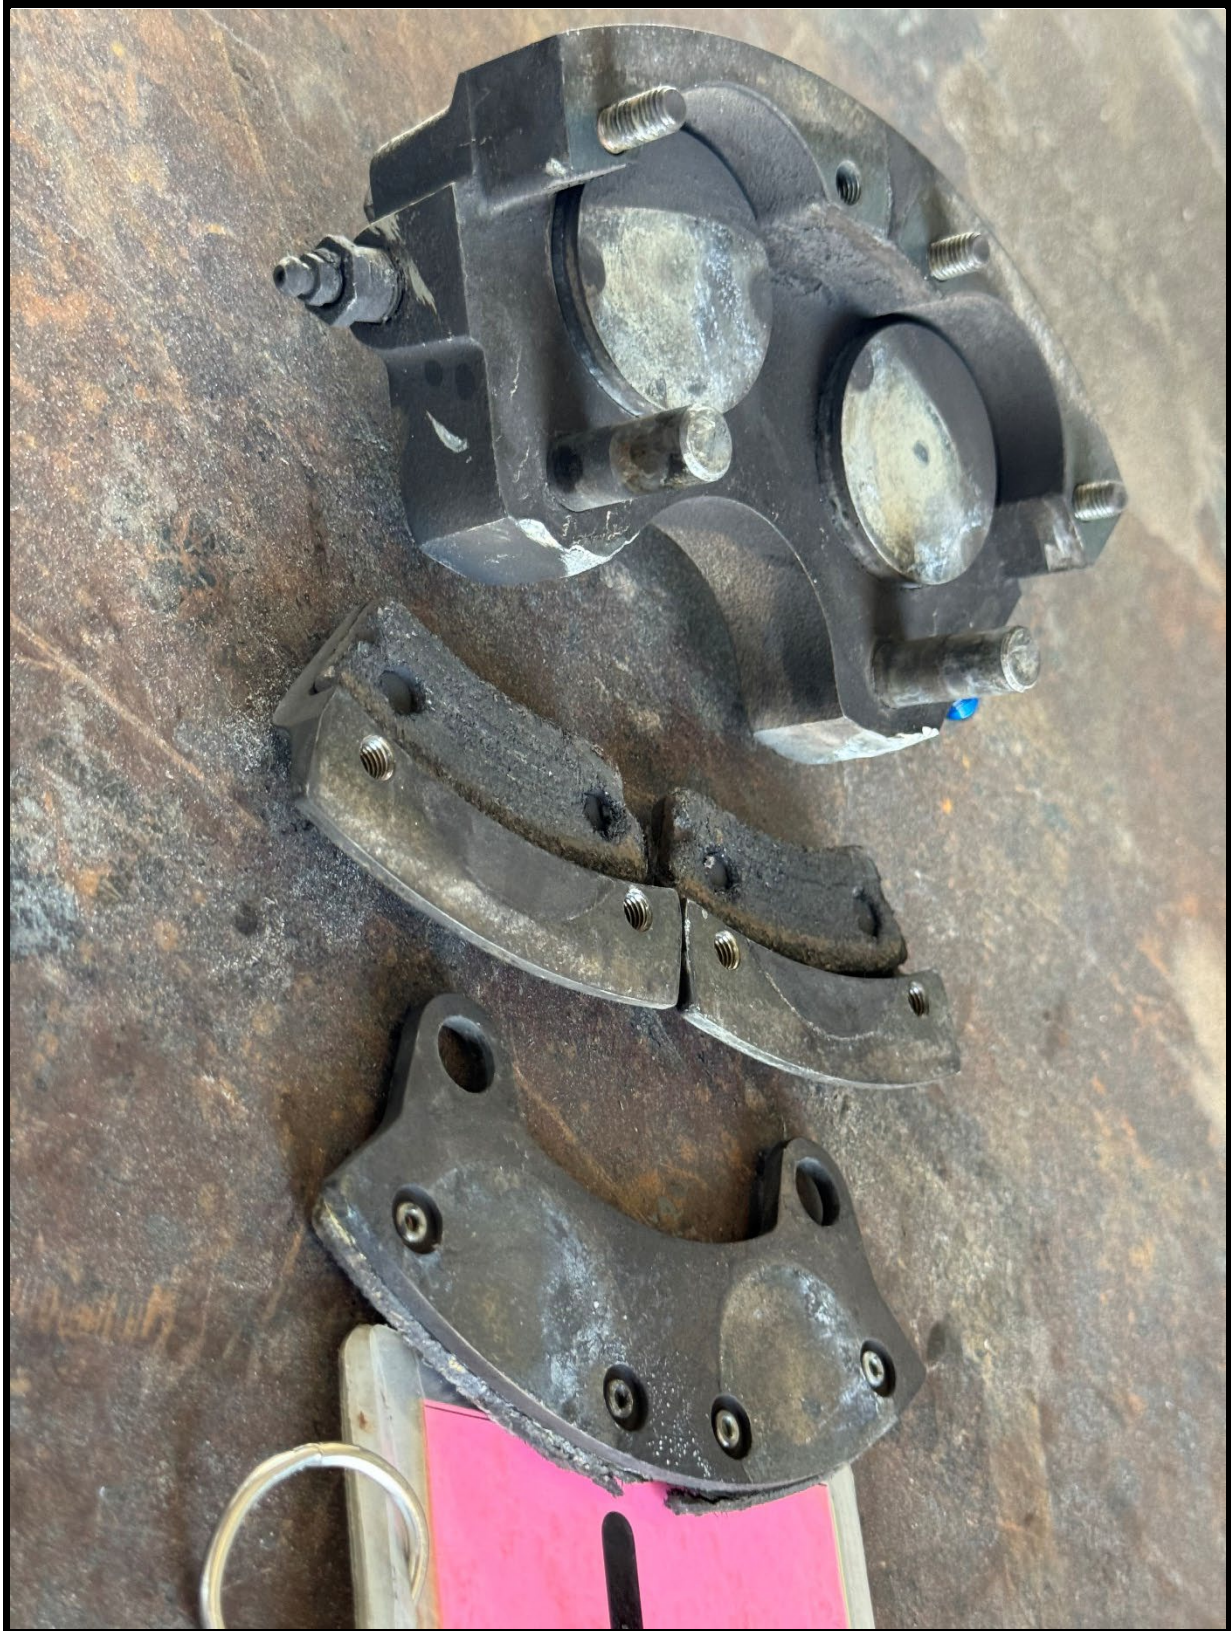
The left main landing gear inboard shims remained unremarkable and wedged between the main gear axle and landing gear spring. The caliper remained attached to the disc assembly but separated from the torque plate. The caliper was removed from the disc and revealed that the pressure plate assembly, the torque plate and back plate assemblies were intact. The pressure plate and back plate linings were present and unremarkable (Figure 14).

**Figure 13:** Left main gear cylinder, pressure plate and back plate.

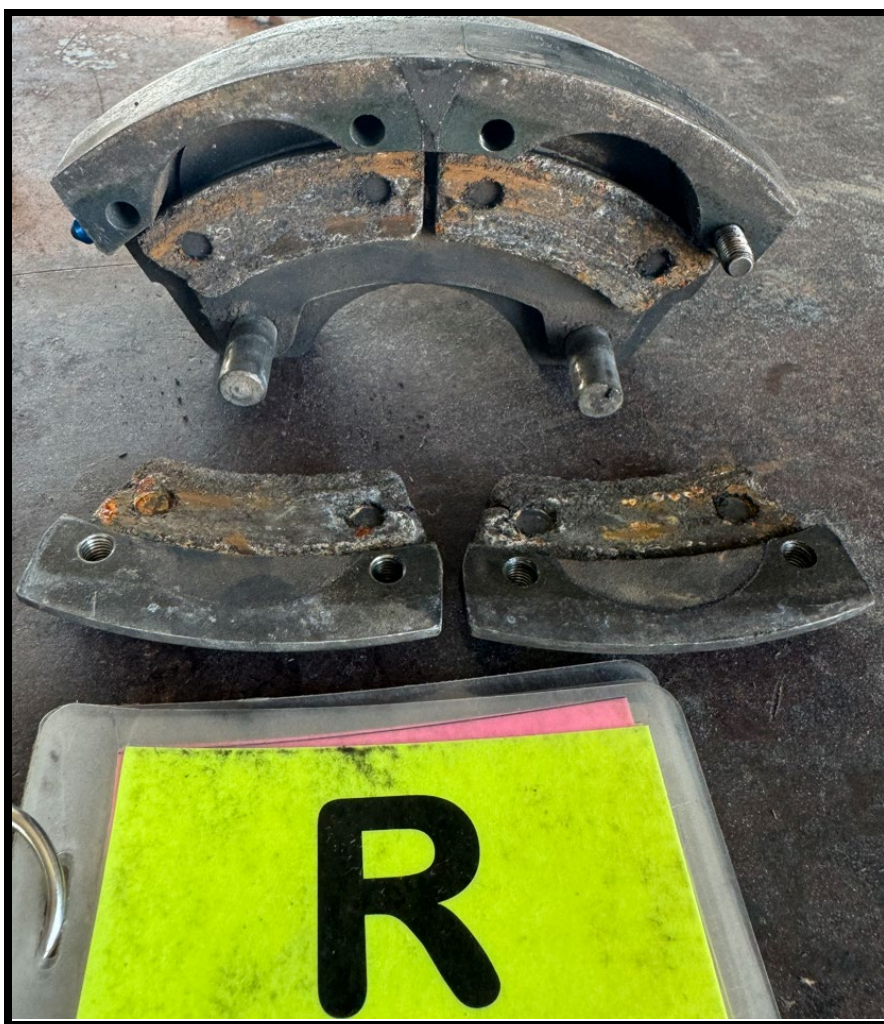
The right wheel separated from the right main gear spring. The separation point was located at the upper and lower main gear axle bolts which were stripped at their respective threads and bent. One of the shims remained attached to the main gear axle, while one shim was not present during the examination. The inboard and outboard wheel half assembly cup bearings were unremarkable. The right wheel was removed from the main gear axle by removing the cotter pin and retaining nut. The inboard wheel assembly revealed an unremarkable cup bearing lip, retainer ring, felt grease retainer seal, felt grease seal, retainer and cone bearing. The outboard wheel assembly revealed an unremarkable cup bearing lip, retainer ring, felt grease retainer seal, felt grease seal, retainer and cone bearing.

**Figure 14:** View of the right main landing gear break assembly.

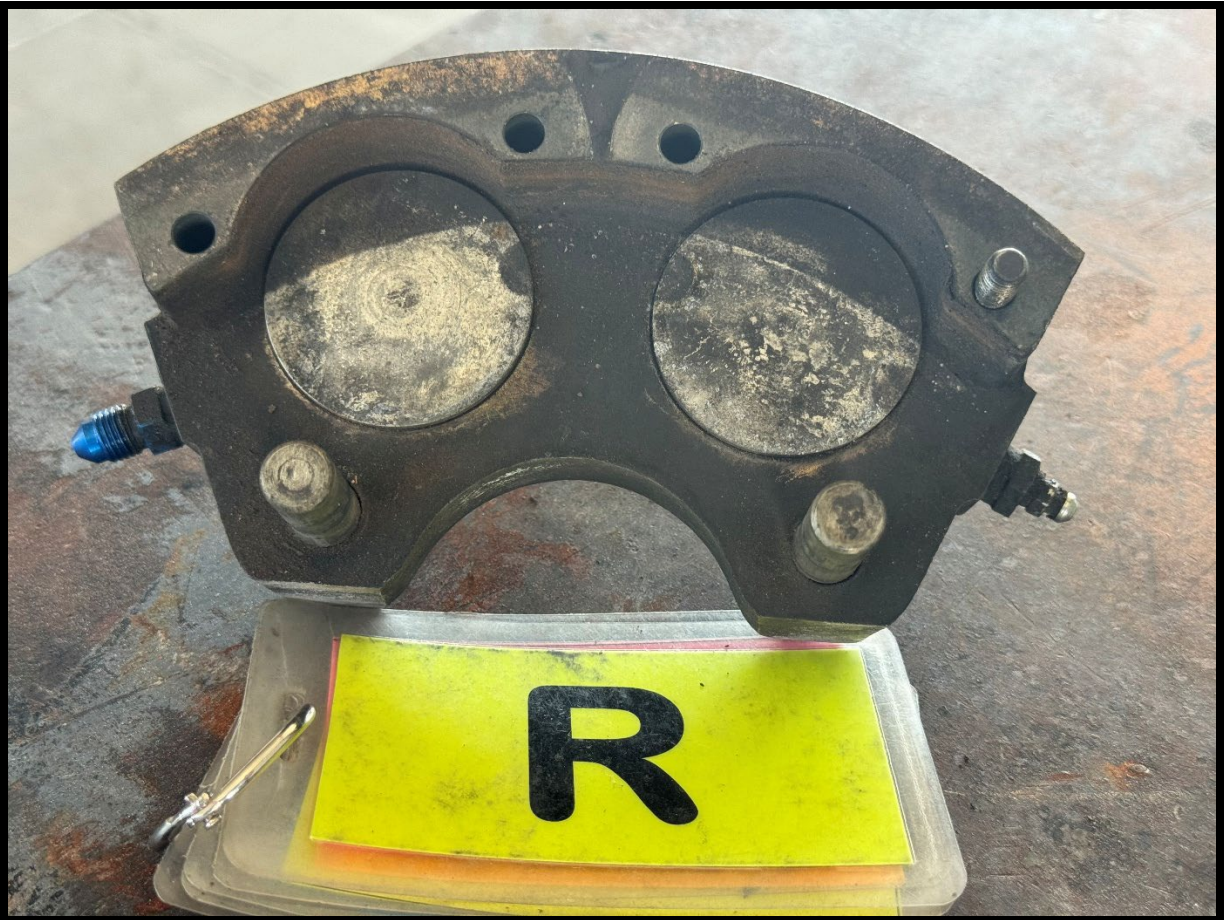
The right main landing gear brake caliper remained attached to the disc assembly and torque plate. The caliper was removed from the disc and revealed that the pressure plate assembly, the torque plate and back plate assemblies were intact

(Figure 15). The pressure plate and back plate linings were present and unremarkable. The right brake caliper pistons were unremarkable (Figure 16).

**Figure 15:** Close up view of right main landing gear brake caliper pistons with pressure plate removed.
