# National Transportation Safety Board

WPR24LA146

## **FUEL SERVO SYSTEM EXAMINATION**

Location: Lake Havasu City, Arizona  
Date: May 9, 2024  
Airplane: Sterling Robert 4P, N78GP

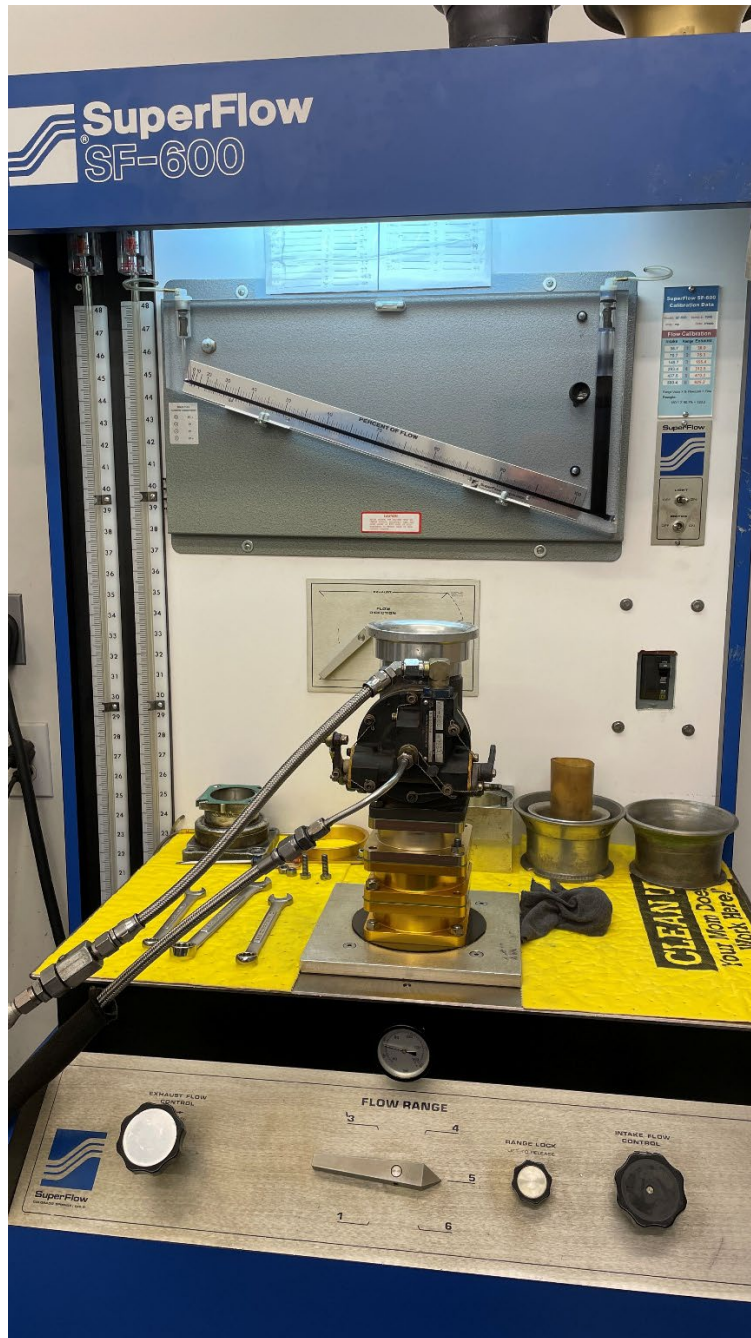
The unit was fitted to the AP flow bench, and fuel pressure applied (see figure 1). Drips of fuel were initially observed to leak from the fuel mixture and idle cutoff plates but stopped after fuel was flowed through the system. The group determined that the initial leaks were likely a function of the O-rings being deformed due to exceedance of their service life.

Figure 1 - Servo in flow bench

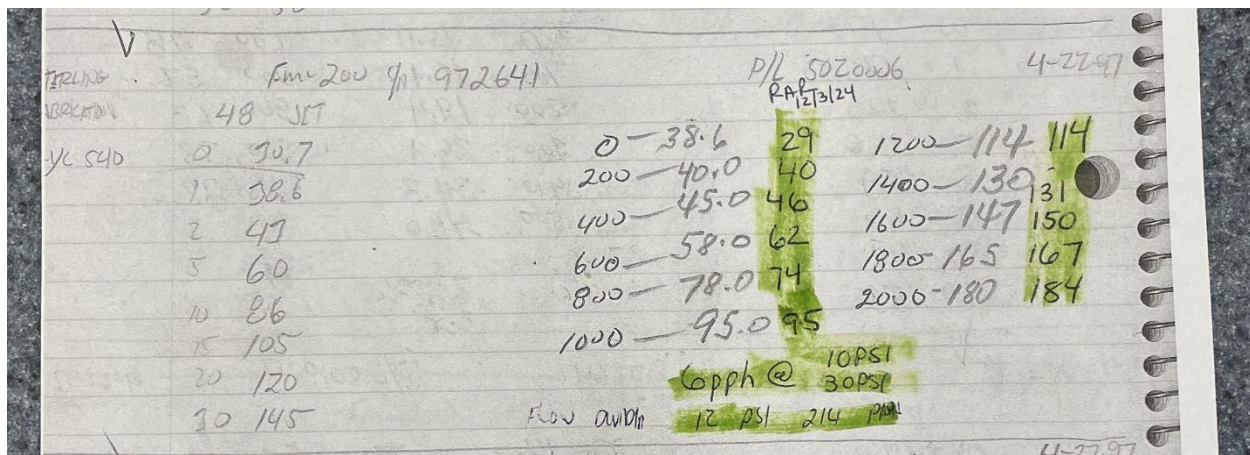
The unit was tested in accordance with the original test procedure performed in 1997. It met, within acceptable tolerances, all those test parameters (see figure 2).

**Figure 2 - Original and current (highlighted) test results**

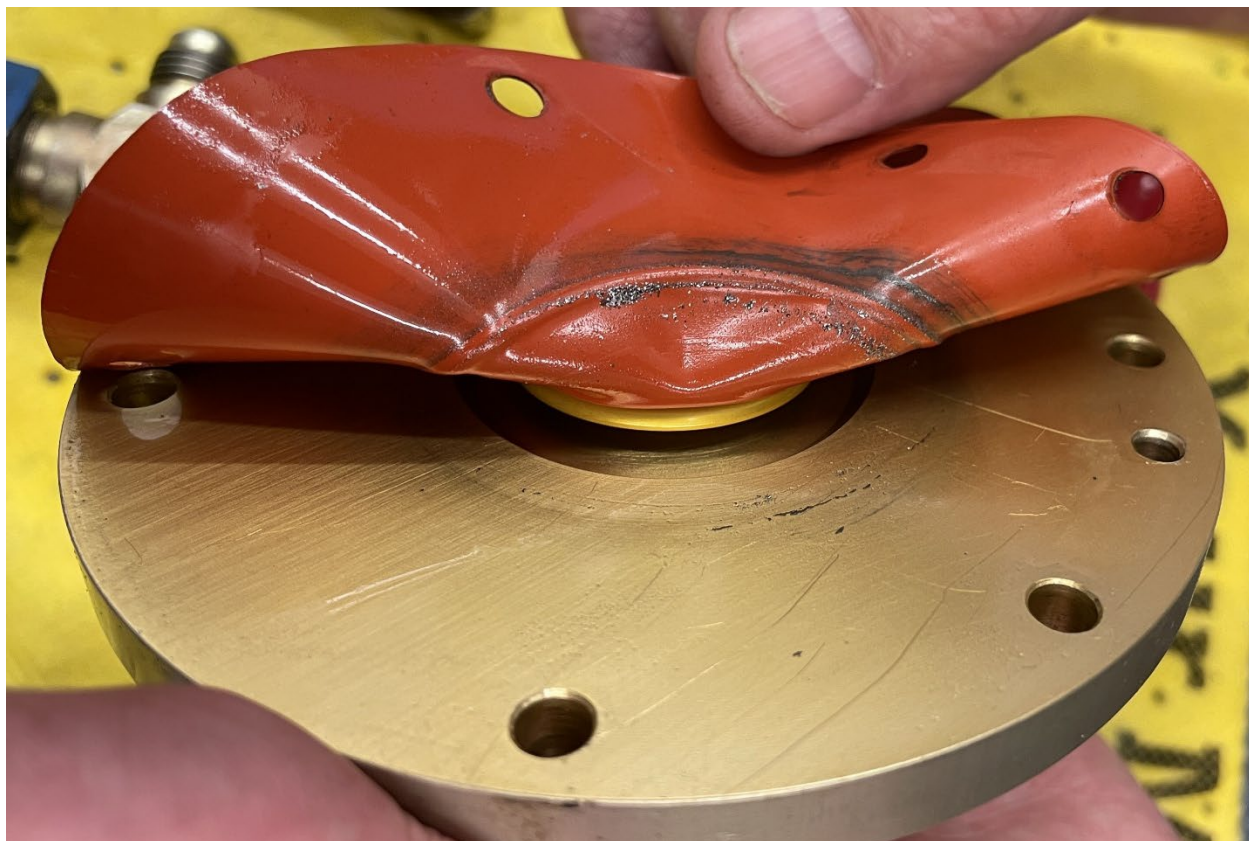
The unit was then disassembled. No internal anomalies were noted beyond deformity of all O-rings consistent with operation beyond their service life. All diaphragms were intact and pliable, the shutoff and mixture control valves were free of grooves or excessive wear. Fine non-ferrous particles were present on the fuel side diaphragm surfaces and the corresponding servo body (figure 3, 4). The particles appeared to be finer than the inlet screen<sup>1</sup>. According to representatives from AP, it is not uncommon to see debris in this location when units are returned for overall. None of the particles appeared to be large enough to obscure any downflow orifice or line.

<sup>1</sup> It is possible that the material was aluminum particles abraded from fuel filler nozzles against the fuel tank filler neck.

**Figure 3 - Non-ferrous particles on the fuel-side diaphragm surface**

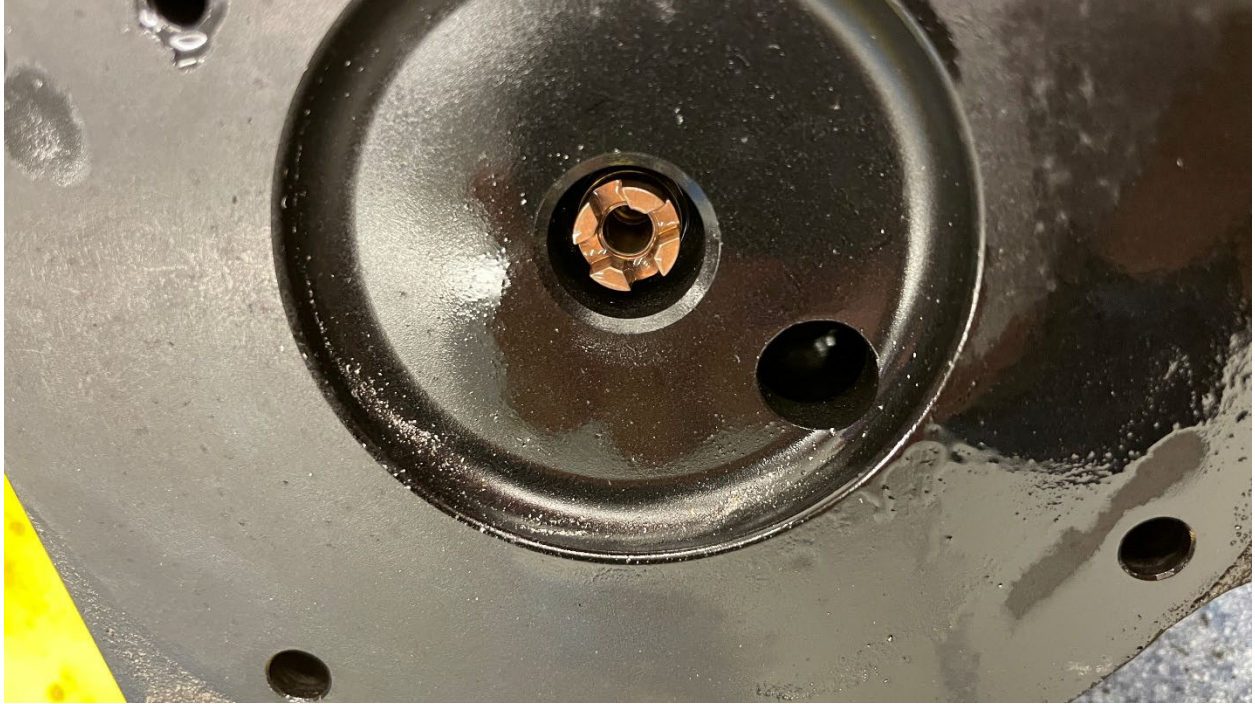
**Figure 4 - Non-ferrous particles on the fuel-side plate**

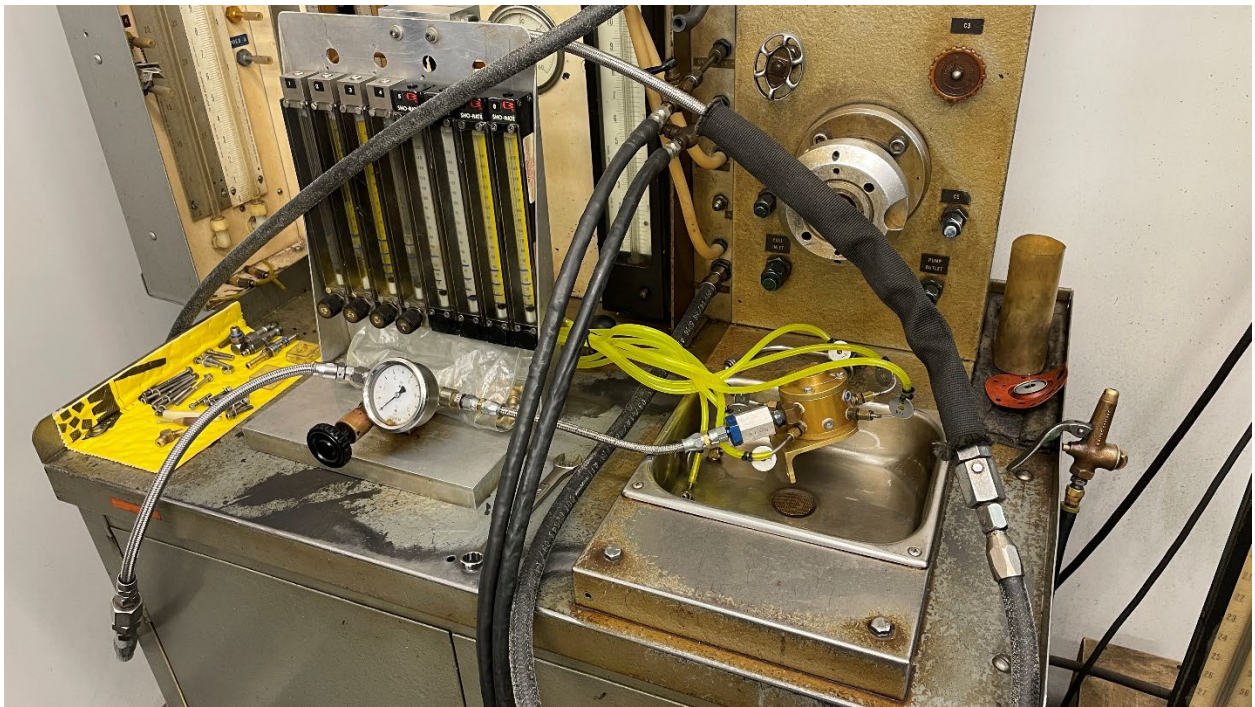
The unit was tested on the AP flow divider work bench and performed within specifications (see figure 5). Flow division at idle flow and opening leakage was within new parts limits. At the highest inlet pressure of 12 psi, the unit flowed 214

lbs/hr. of fuel equivalent to about 36 gph. The fuel output at all nozzles was equal throughout the tests.

**Figure 5 - Flow divider fitted to test bench**

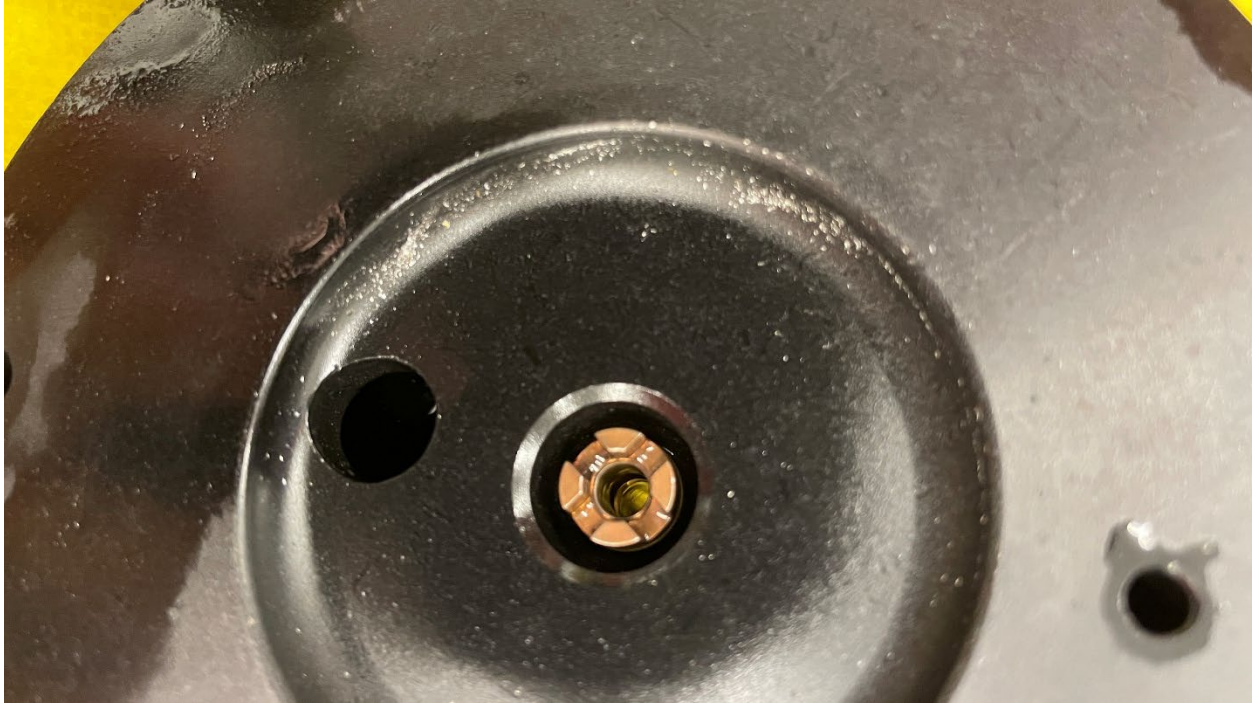
The unit was disassembled. The diaphragm was pliable and free of leaks, and similar fine debris was noted within the body (see figure 6). There were no anomalies that would have precluded normal operation.

**Figure 6 - Non-ferrous particles on the body inner surface**
