# National Transportation Safety Board

WPR24LA146

## ENGINE EXAMINATION

Location: Lake Havasu City, Arizona  
Date: May 9, 2024  
Airplane: Sterling Robert 4P, N78GP

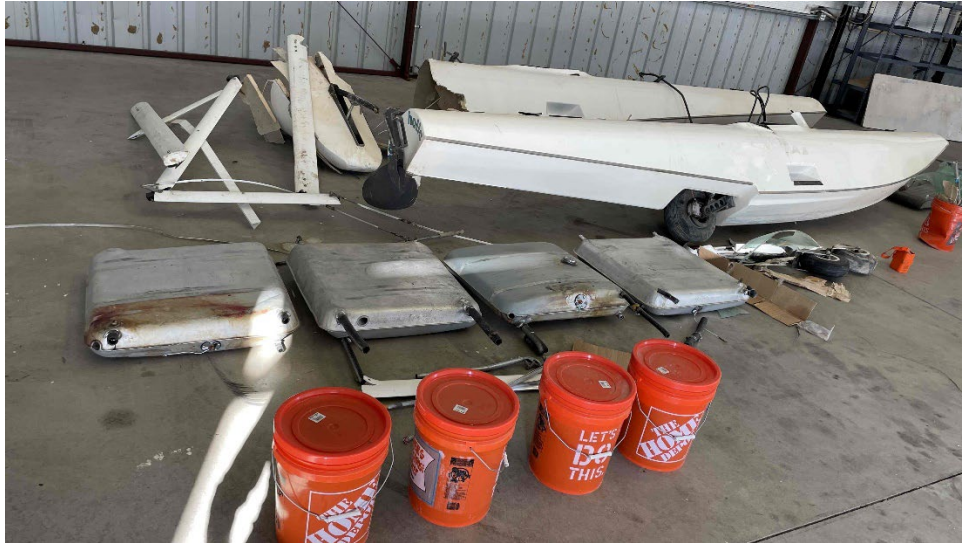
**Figure 1 - Fuel tanks.**

All four of the airplanes fuel tanks had already been removed prior to the examination (figure 1). According to the owner, about 20 gallons of fuel were removed during recovery, and this fuel was observed with the wreckage in four 5 gallon buckets (figure 1). The fuel had the color and odor of 100 low-lead aviation gasoline.

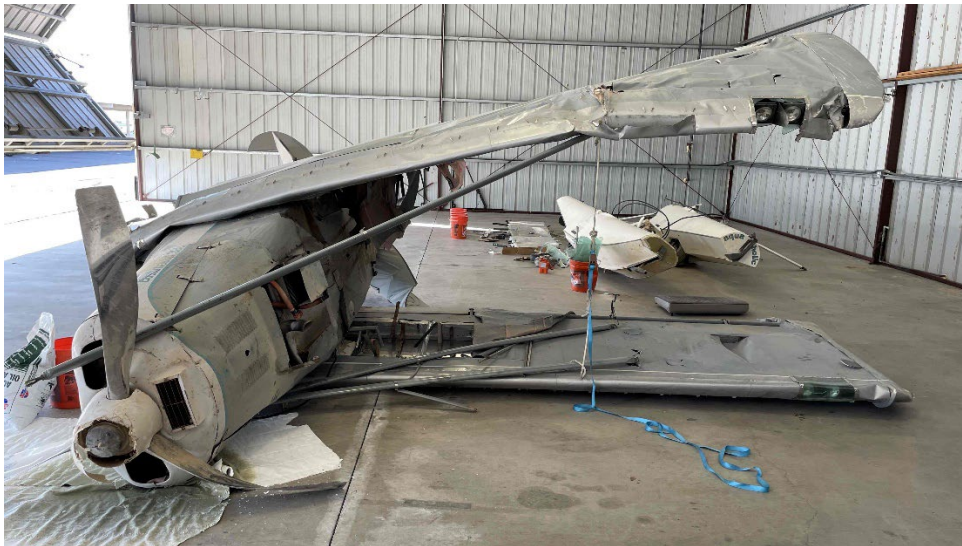
**Figure 2 - Airplane as examined.**

The airplane had been laid on its right side, with both wings folded downwards (figure 2) such that the cabin could not be accessed through the doors, therefore access was accomplished through the windscreen.

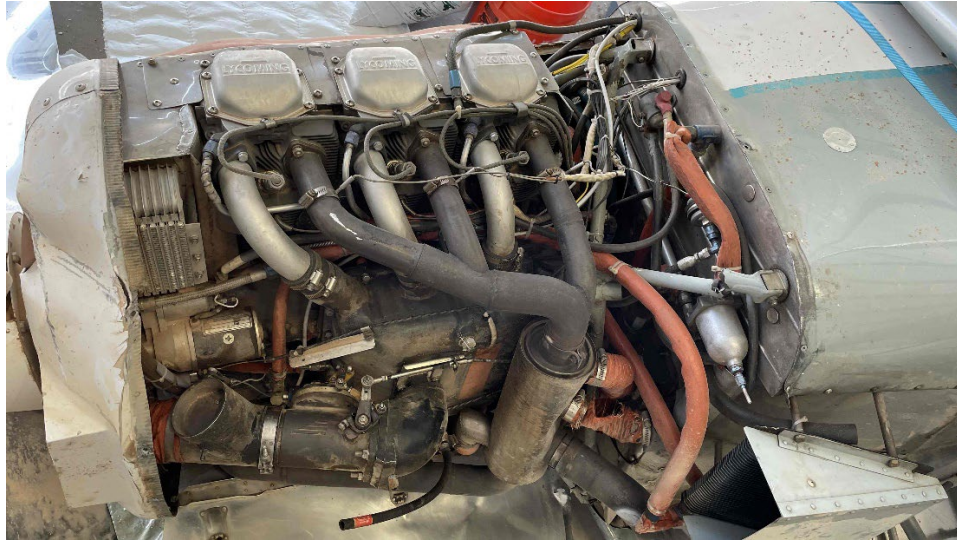
**Figure 3 - Engine.**

The engine appeared essentially undamaged, with no evidence of catastrophic internal failure (figure 3). The engine exhaust pipes exhibited light cream deposits and no evidence of oil residue (figure 4).

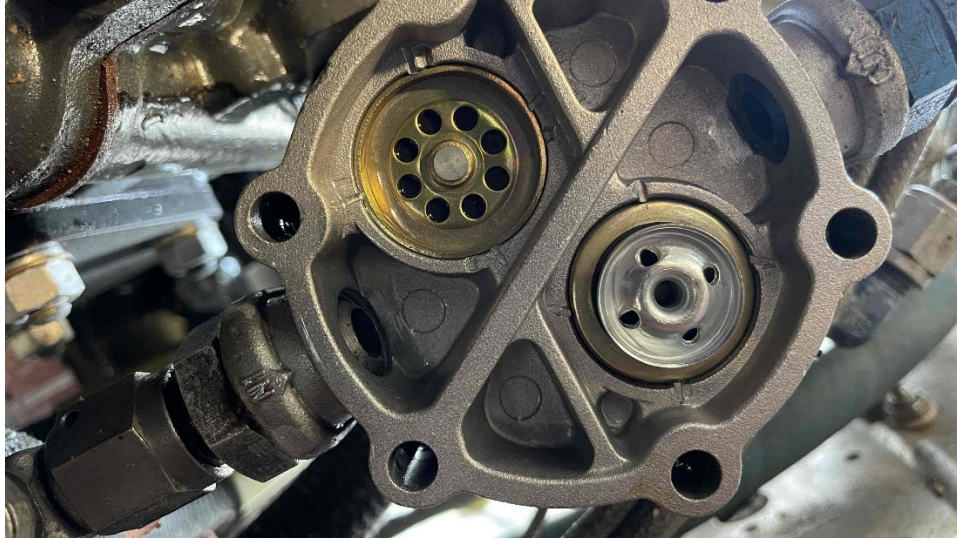
**Figure 5 - Engine-driven fuel pump valves.**

The engine-driven fuel pump was disassembled in place, and fuel was observed within its cavity. The outer diaphragm was intact and pliable, and the valves appeared intact. The pump appeared relatively new (figures 5,6).

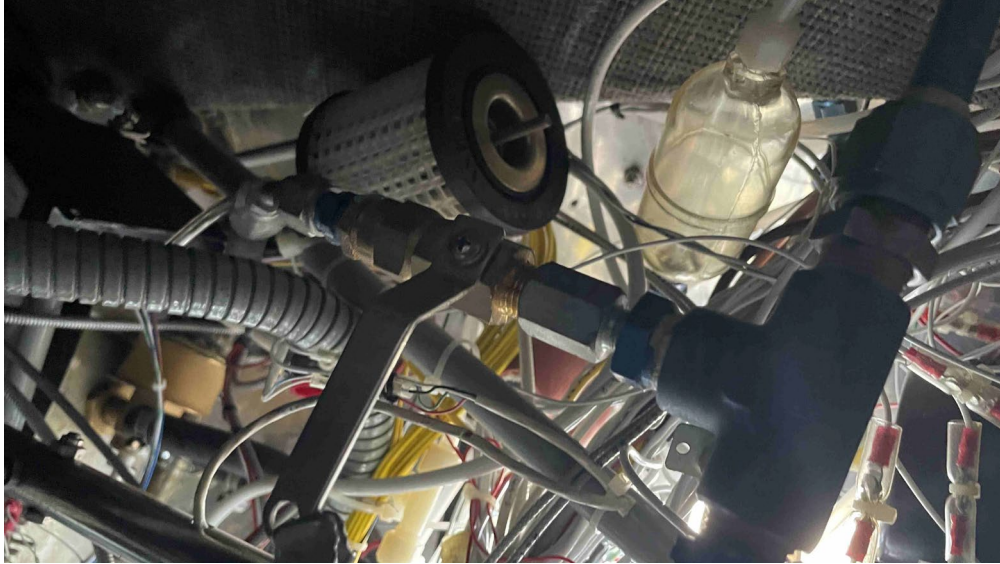
**Figure 7 - Bypass valve**

The fuel selector valve was in the OFF position, and the fuel "bypass" valve, located underneath the instrument panel was in the OFF position (figure 7).
