# National Transportation Safety Board

WPR24LA148

## ENGINE EXAMINATION SUMMARY

Location: Powell, WY  
Date: 5/10/2024  
Time: 1030 MST  
1730 UTC  
Airplane: N605GK, experimental amateur-built Kitfox airplane

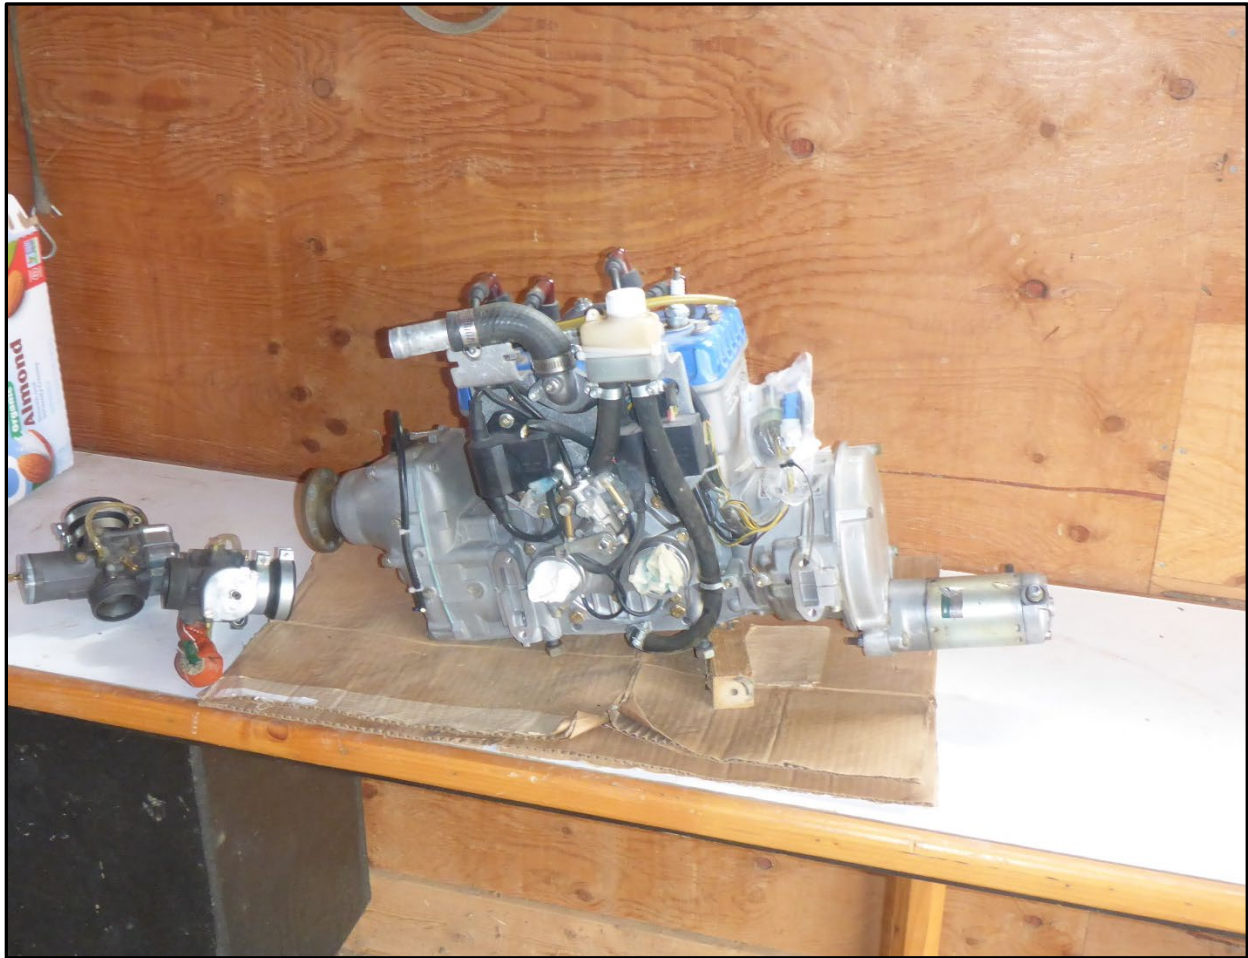
**Photograph 1: Engine as received for the examination.**

The Rotax 582 Mod 99 engine was previously removed from the fuselage by the airplane owner and positioned on a table. Both carburetors had been removed. Hence, the airplane's exhaust, fuel pump, fuel system, coolant system, oil system, and engine control continuity was unable to be examined. The propeller was not attached to the propeller flange and was not available to examine.

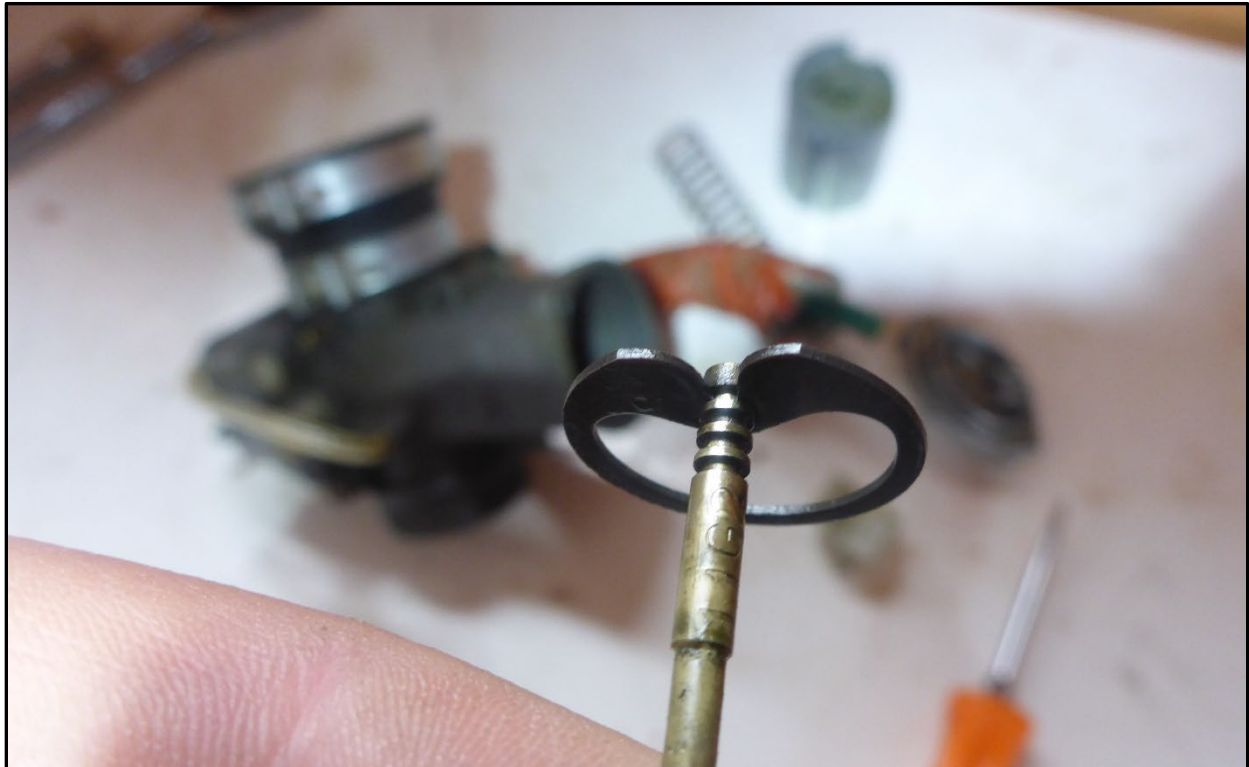
Examination of the engine revealed that the MAG carburetor's needle clip was not in the proper position. No additional evidence of preimpact mechanical failures or malfunctions that would have precluded normal operation were noted during the examination of the airplane wreckage

**Photograph 2: The MAG carburetor needle clip in the number 1 (most lean position).**

The rear (MAG) carburetor was examined. The carburetor bowl was clear of contaminants and the floats intact. The needle clip was observed set in the number 1 position (most lean) and the O-ring was missing. The carburetor's piston slide was observed to have slight scoring.
