WPR24LA153

## INVESTIGATION PHOTOGRAPHS

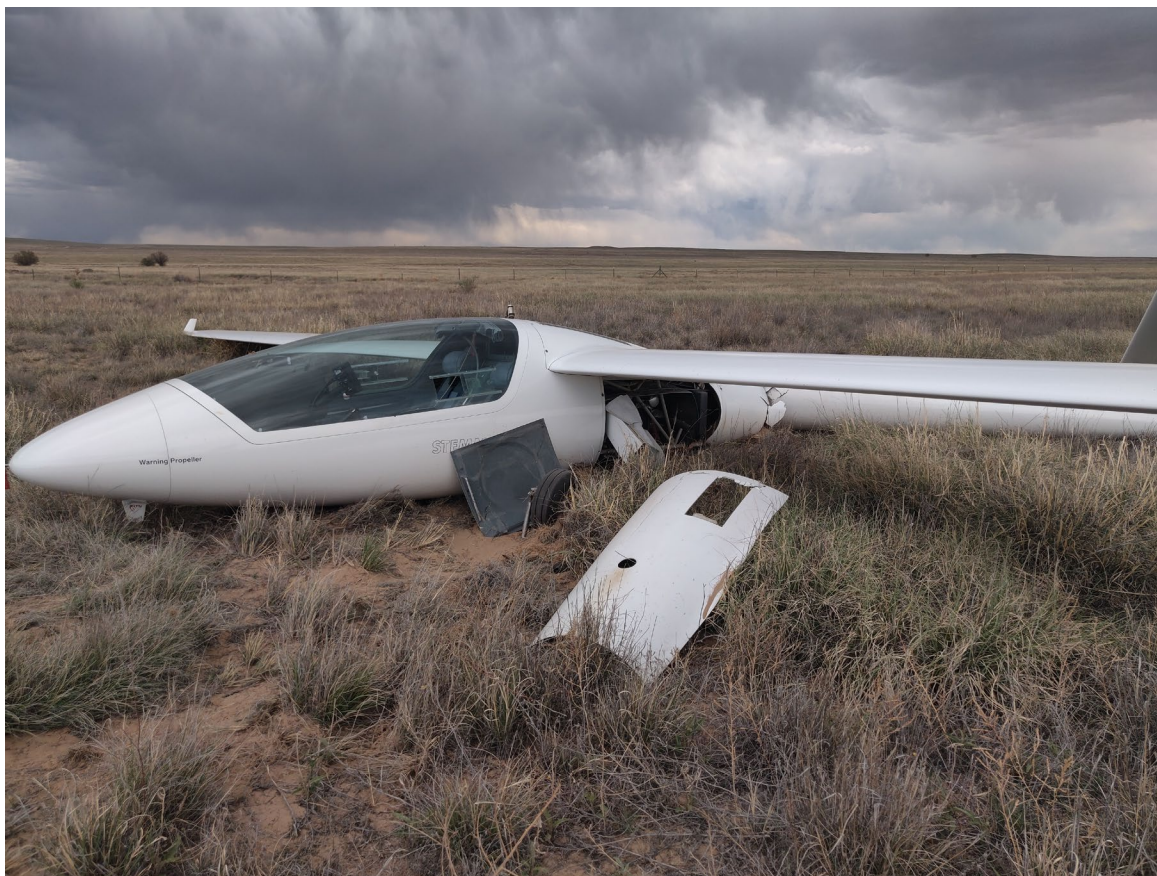
**Photograph 1 - View of left side of motorglider. (Courtesy of airport manager)**

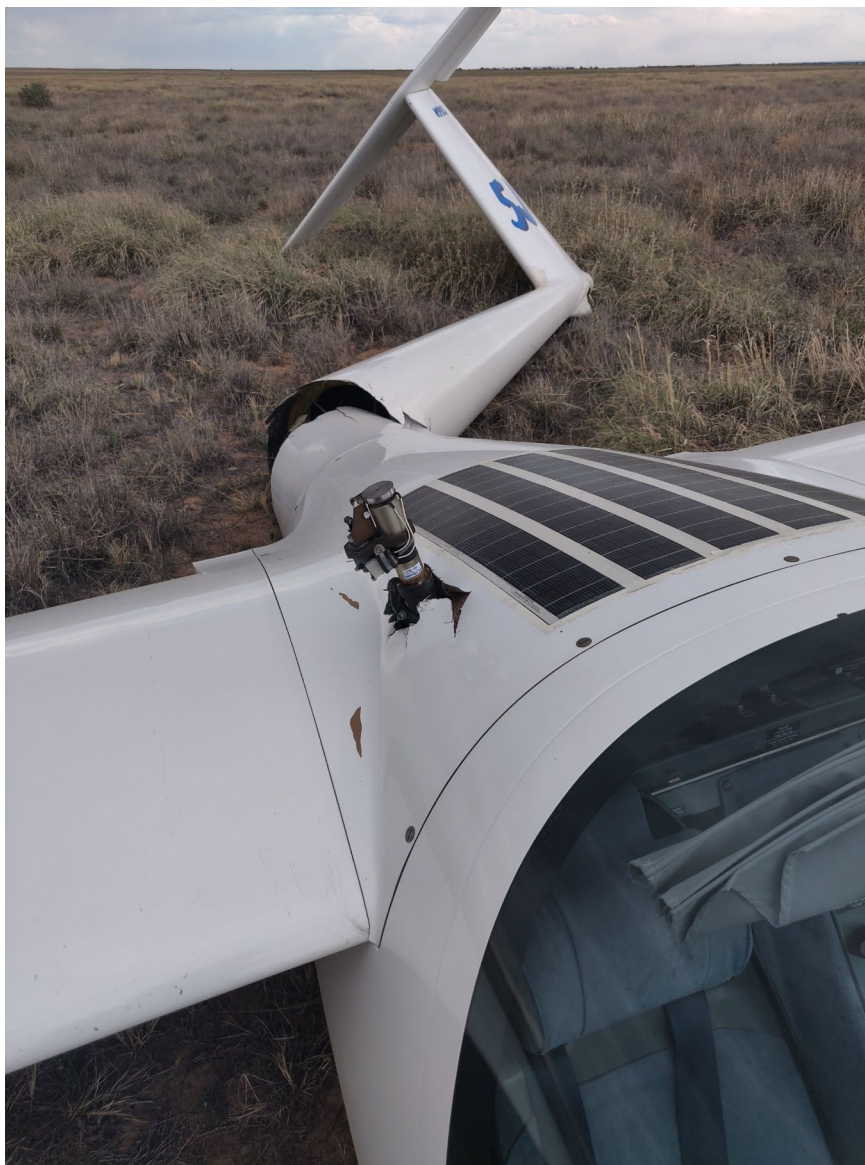
**Photograph 2 - View of aft fuselage damage. (Courtesy of airport manager.)**

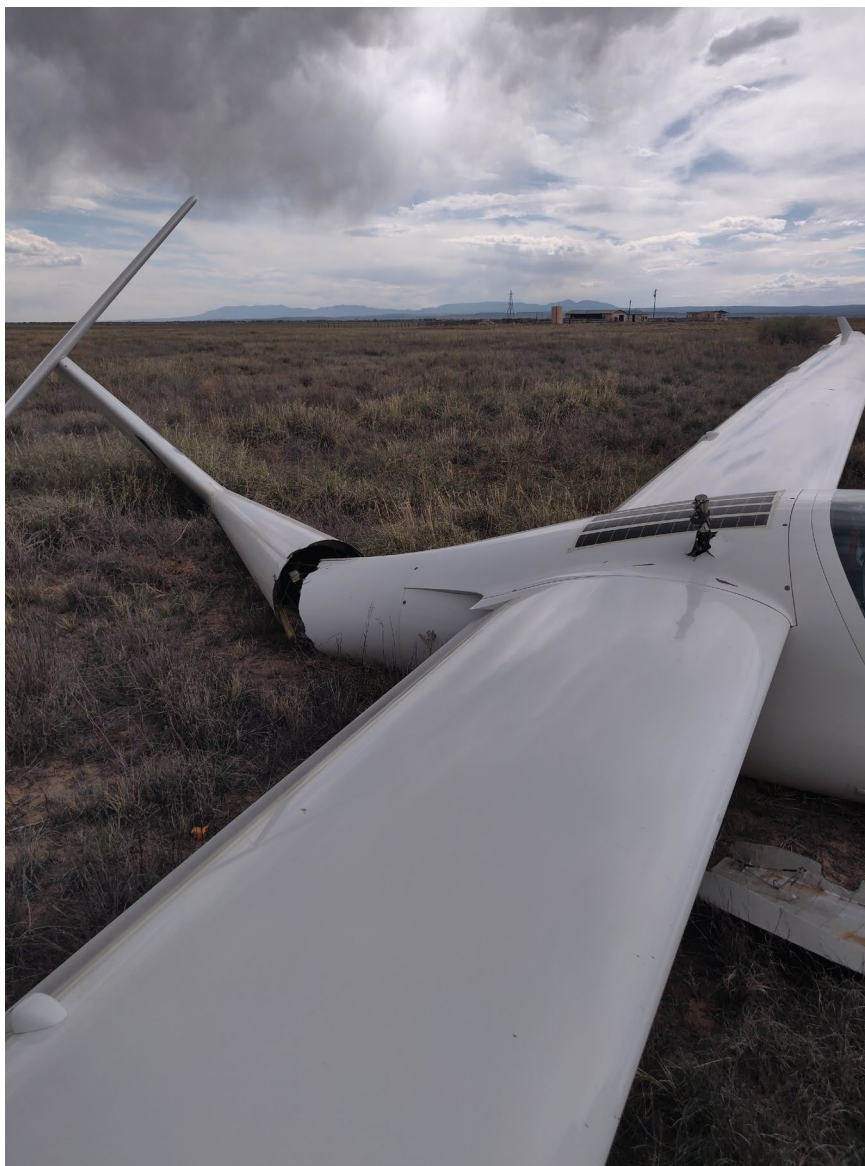
**Photograph 3 - View of empennage damage. (Courtesy of airport manager)**
