# National Transportation Safety Board

WPR24LA154

## **WRECKAGE EXAMINATION REPORT**

Location: Lakeport, California  
Date: May 16, 2024  
Time: 0900 Pacific daylight time  
Airplane: Cessna 172G, N4448L

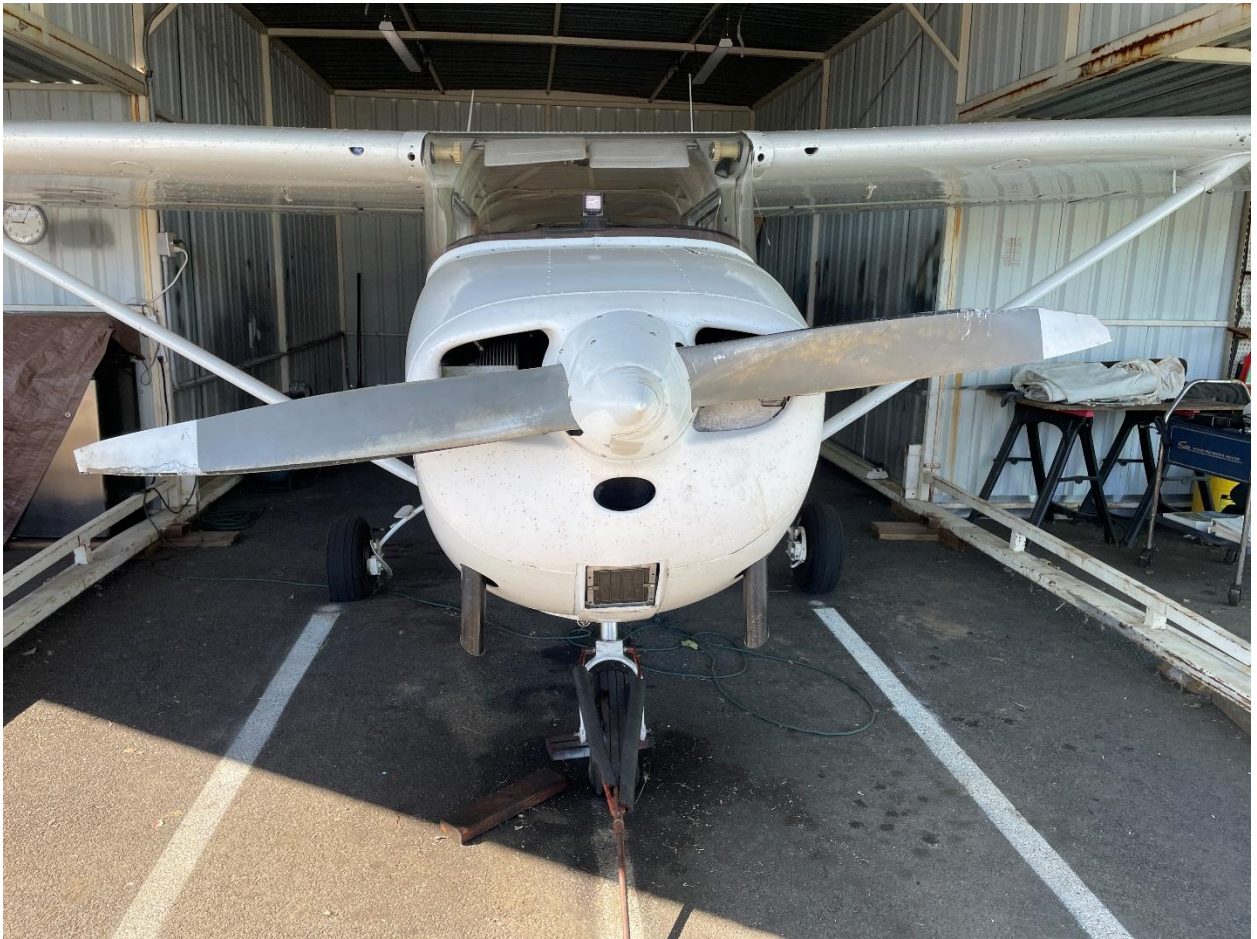
Figure 1: Front View of Airplane

The airplane remained intact with no damage to the wings. The tail section partially separated at the empennage.

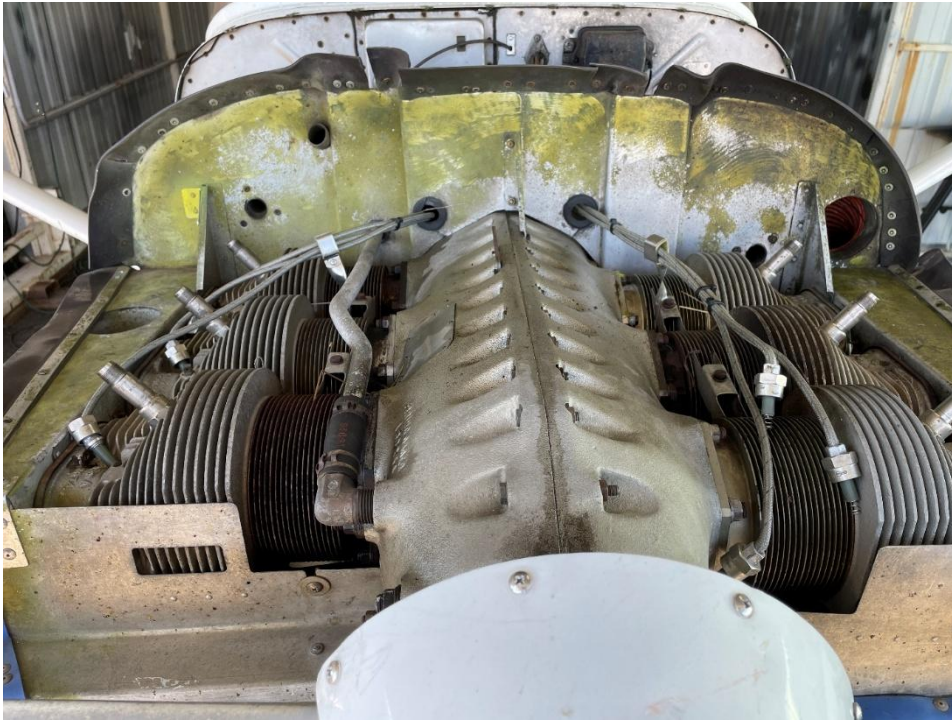
Figure 2: Top View of Engine

Visual examination of the engine revealed no obvious holes in the engine cowlings or the engine case, and the fuel system was not breached. Fuel system continuity was established from both wings to the carburetor. Continuity of the throttle and mixture control cables were established from the cockpit controls to the carburetor and all levers moved freely from stop to stop when actuated by hand.

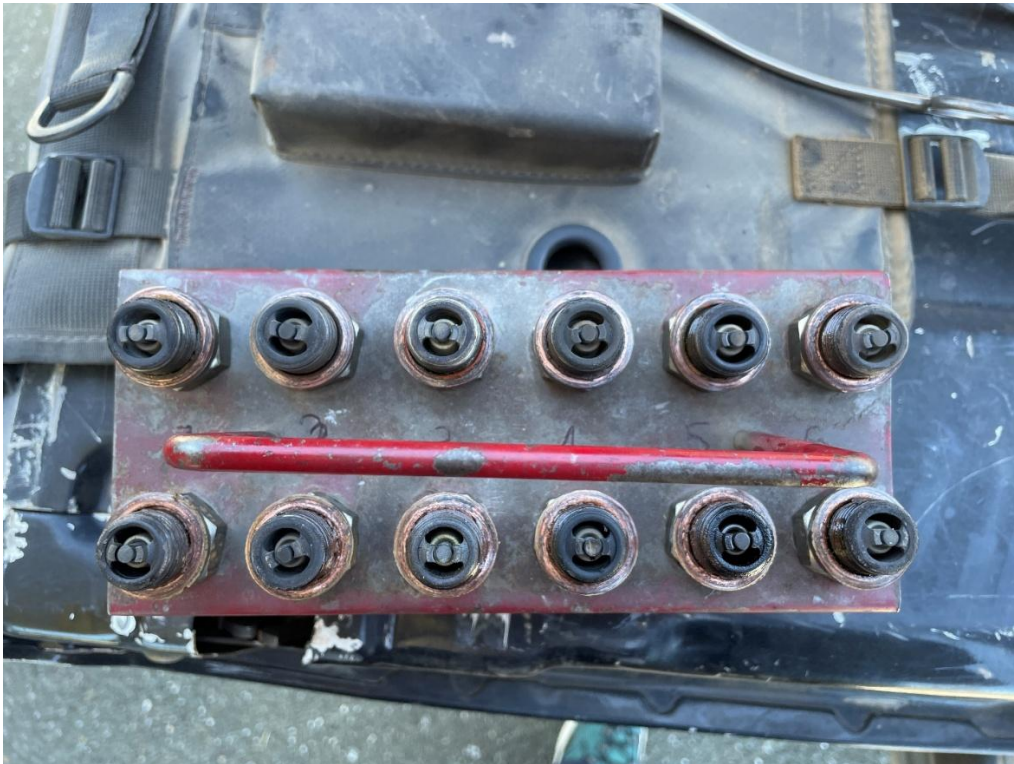
Figure 3: View of Spark Plugs

The top and bottom spark plugs were removed and showed normal wear according to the Champion Aviation Check-A-Plug Chart AV-27. The Nos 2, 3, 5, 6 electrodes were rounder in shape than the Nos 1, 4. The No 5 bottom spark plug was carbon/oil fouled.

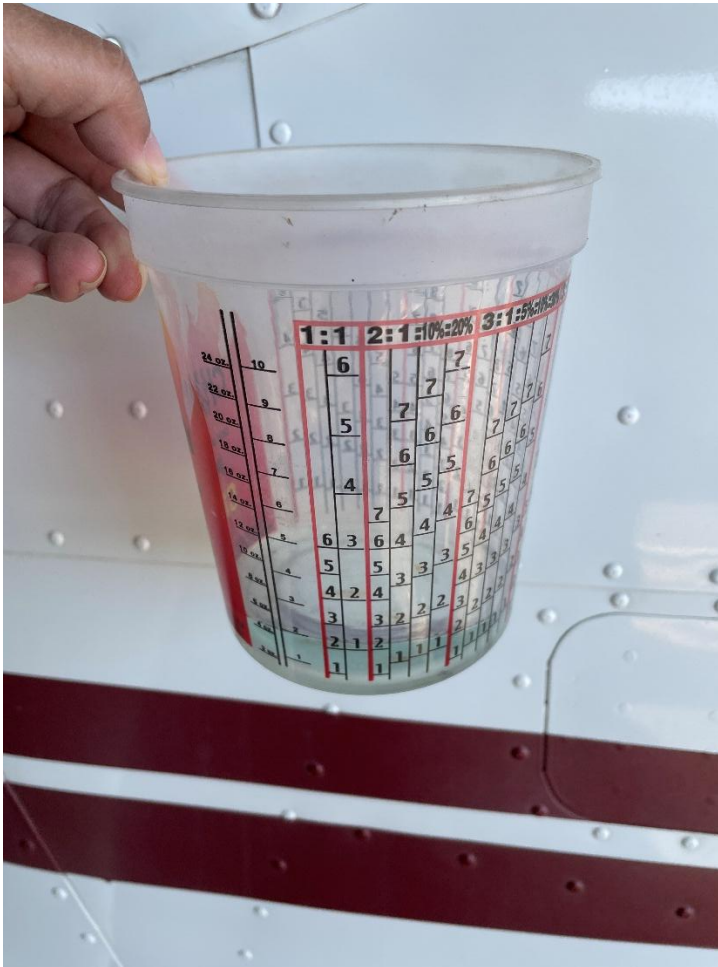
Figure 4: Fuel Sample

Fuel sample was taken from lower sump and was blue in color and had the smell of aviation fuel.

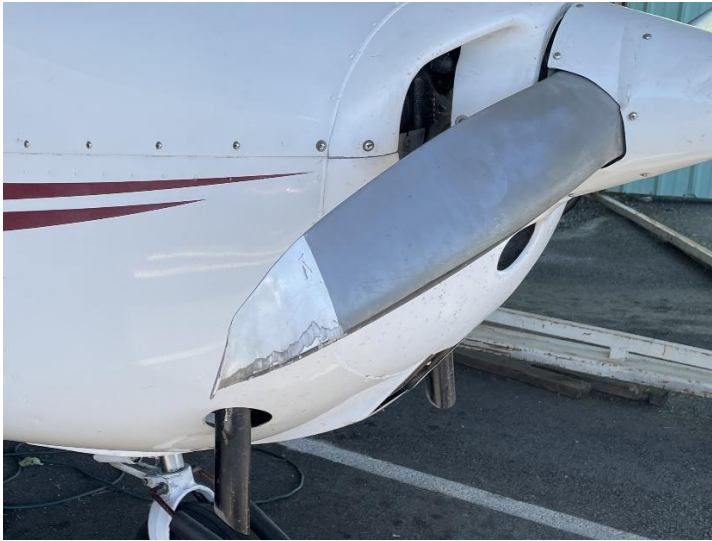
Propeller assembly remained attached to the engine. Both blades had torsional S-bending. One blade had some tip damage with gouges. The other blade had leading edge gouges and nicks with some damage to the tip.

Figure 5: View of Propeller Blade Note Tip Damage

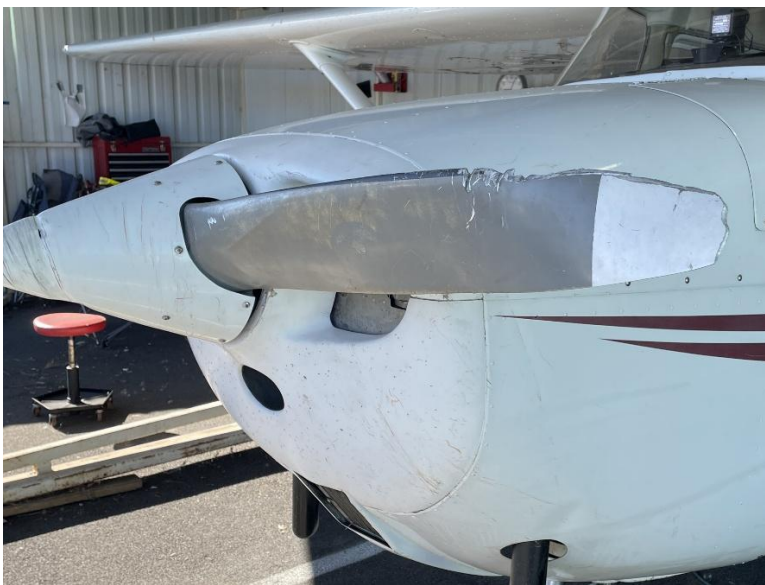
Figure 6: View of Propeller Blade Note Damage
