**From:** [REDACTED]  
**To:** [REDACTED]  
**Subject:** N4769K  
**Date:** Thursday, June 6, 2024 5:03:33 PM

## N4769K

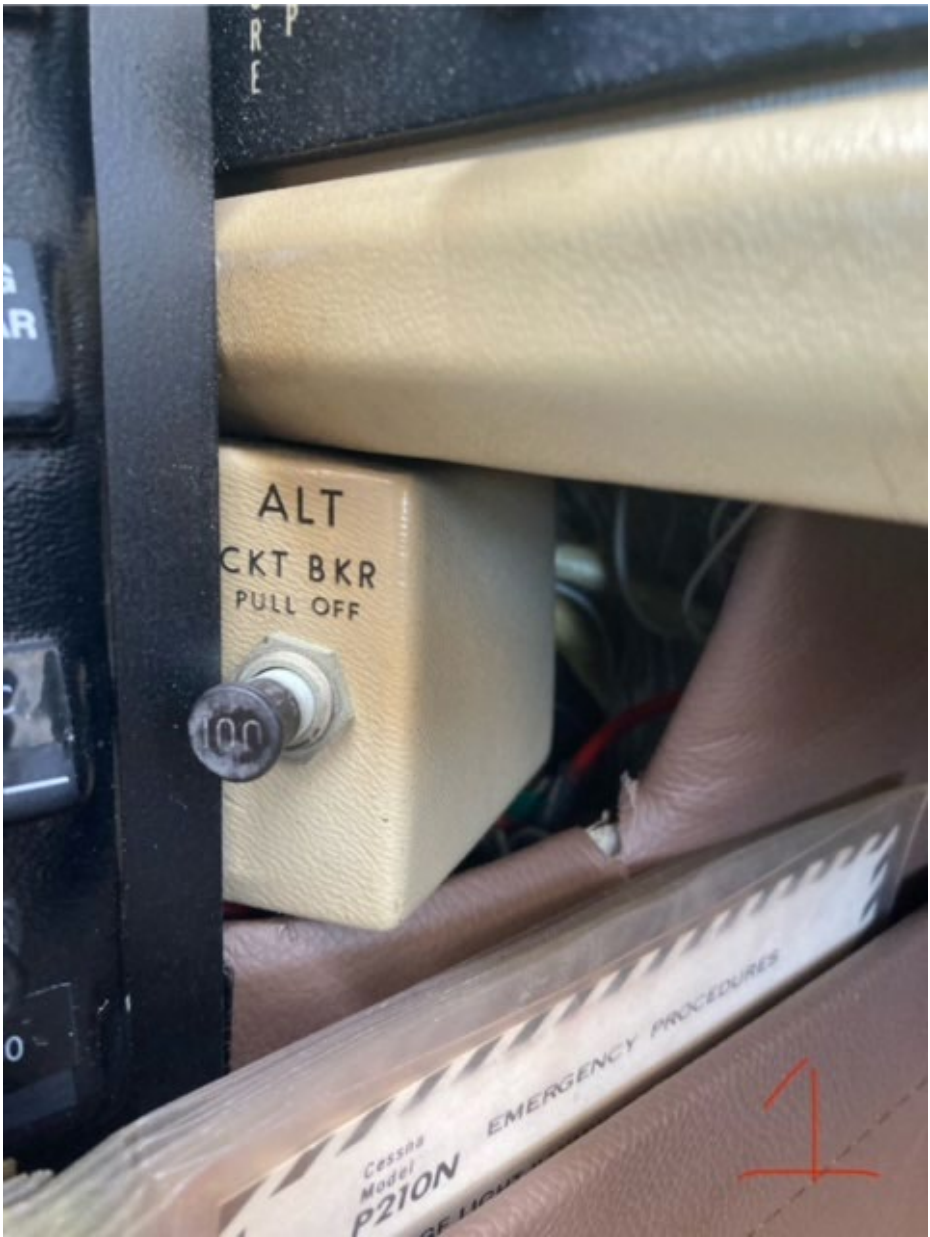
Upon initial inspection the alternator main circuit breaker had been tripped (fig 1) (100ampere). After re-setting breaker voltage was observed at the field terminal of the alternator with master on and field switch on.

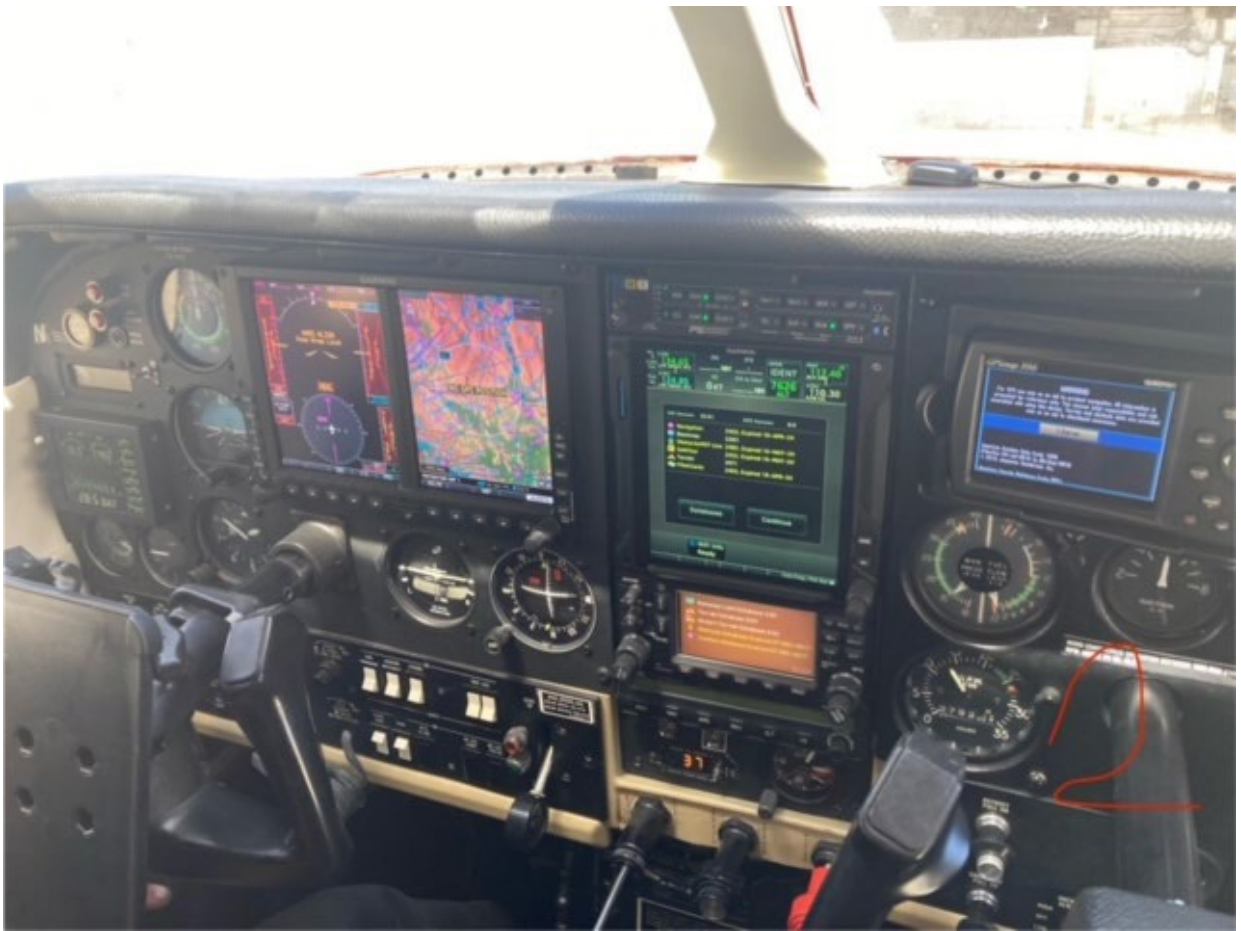
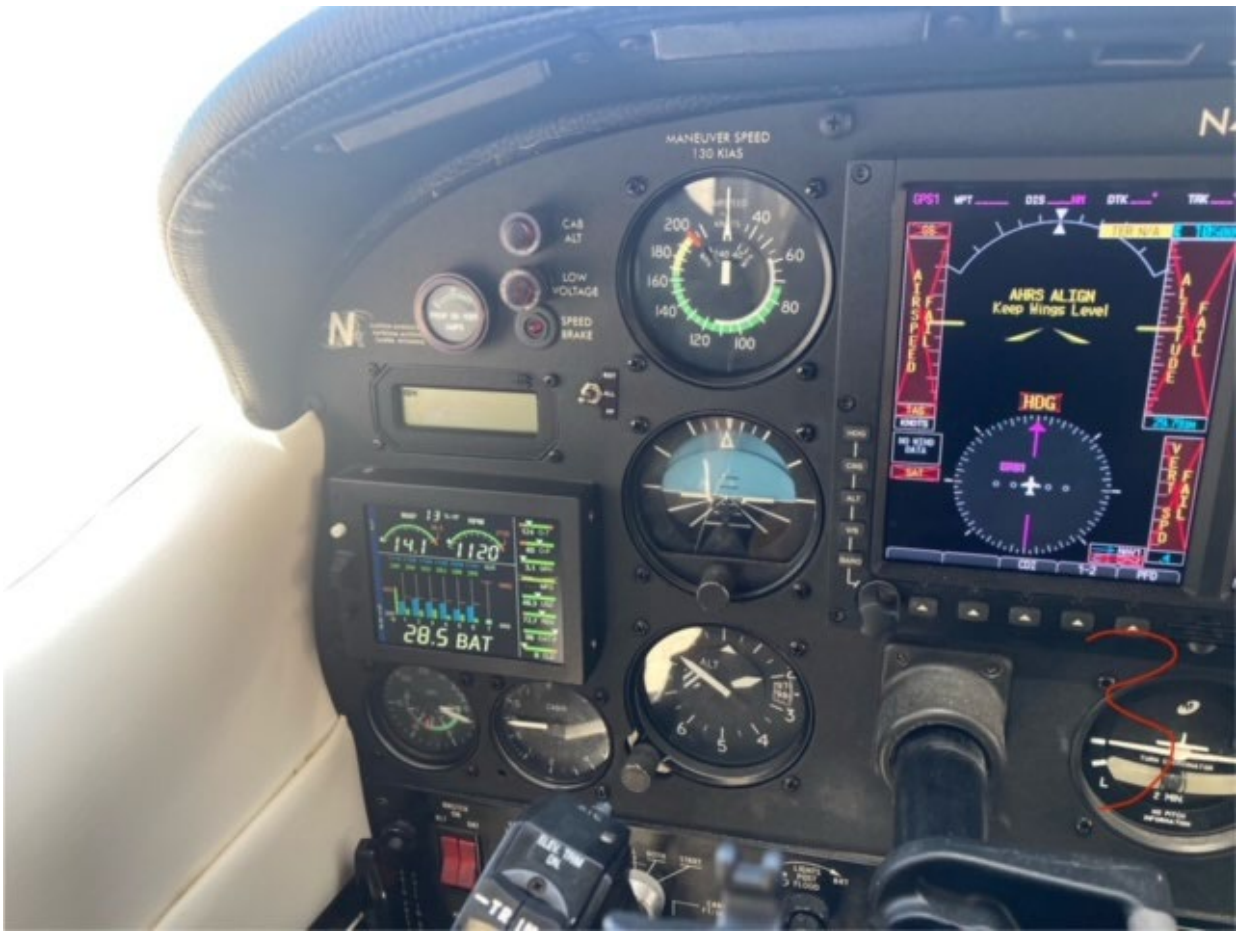
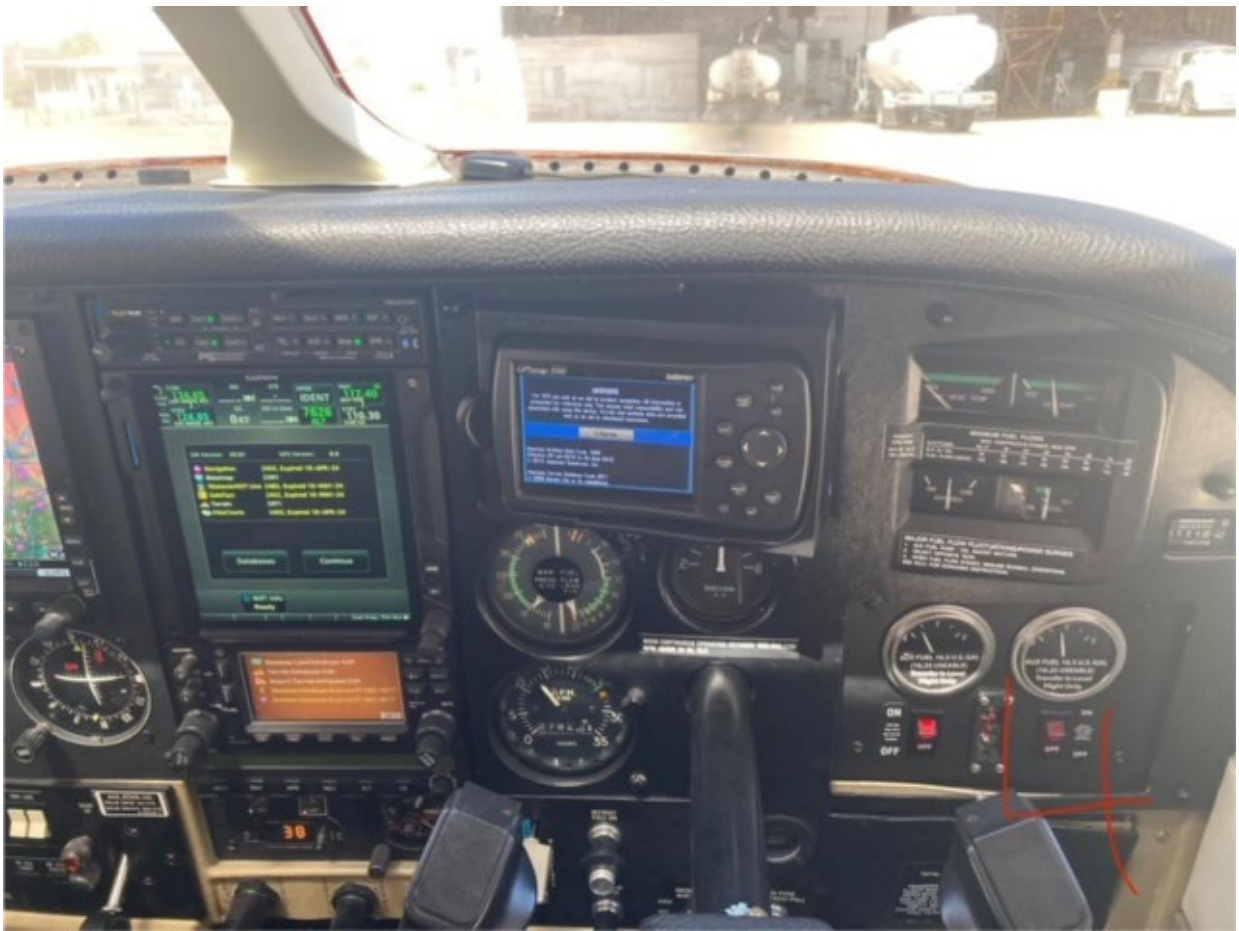
Engine was run and normal rate of charge was observed on ammeter. In aircraft voltmeter read 28.5 to 28.8 VDC with all lights and avionics on at 1,400 rpm.(fig 2-4)

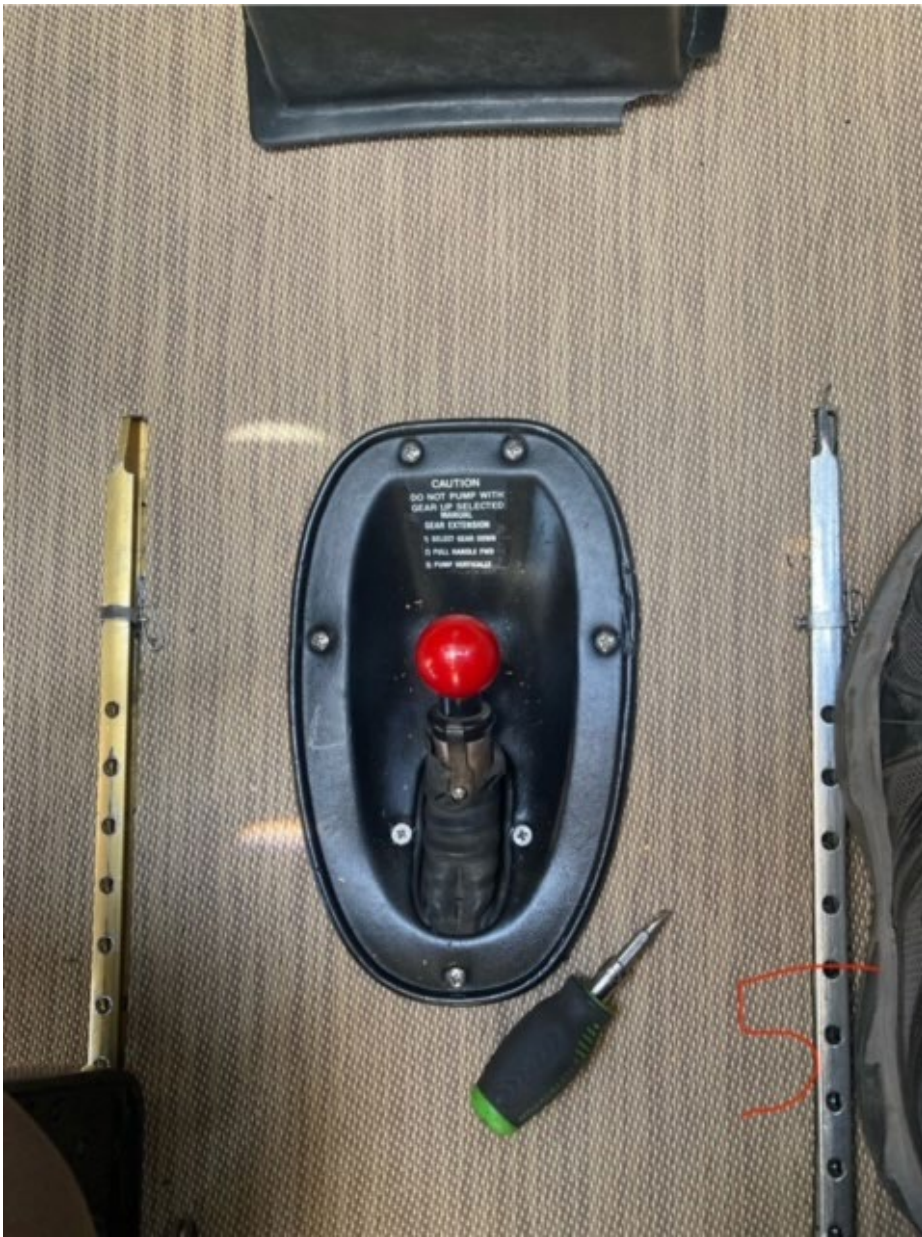
The emergency gear extension pump handle (fig 5) would not extend due to a screw that attaches the retaining clip (fig 6) for the inner handle.

The screw being too long penetrates the outer handle and presses against the inner handle much like a set screw preventing its extension and preventing the use of the emergency gear extension pump.

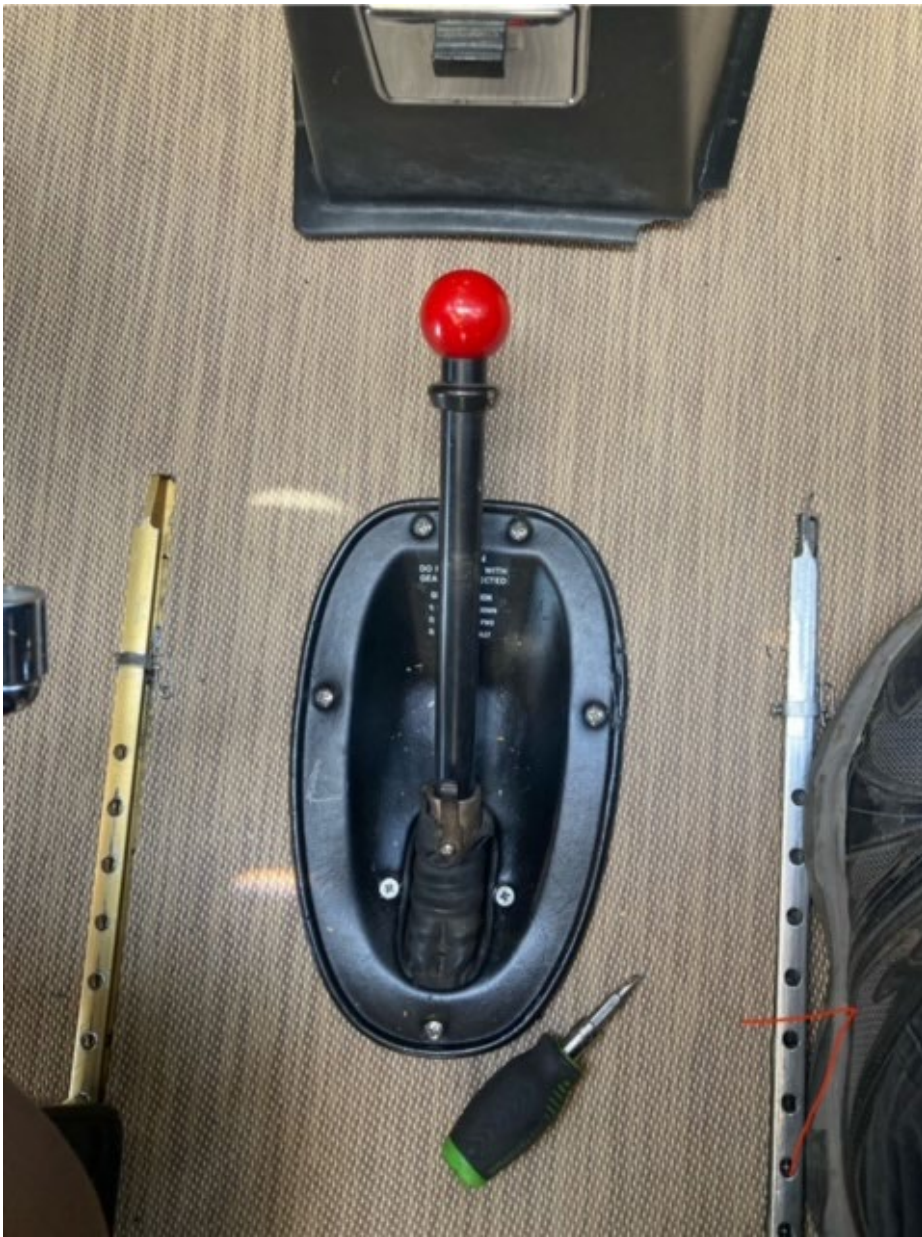
Loosening the screw allowed extension of the handle. (Fig 7)
