WPR24LA157

## **INVESTIGATION PHOTOGRAPHS-POSTACCIDENT EXAMINATION**

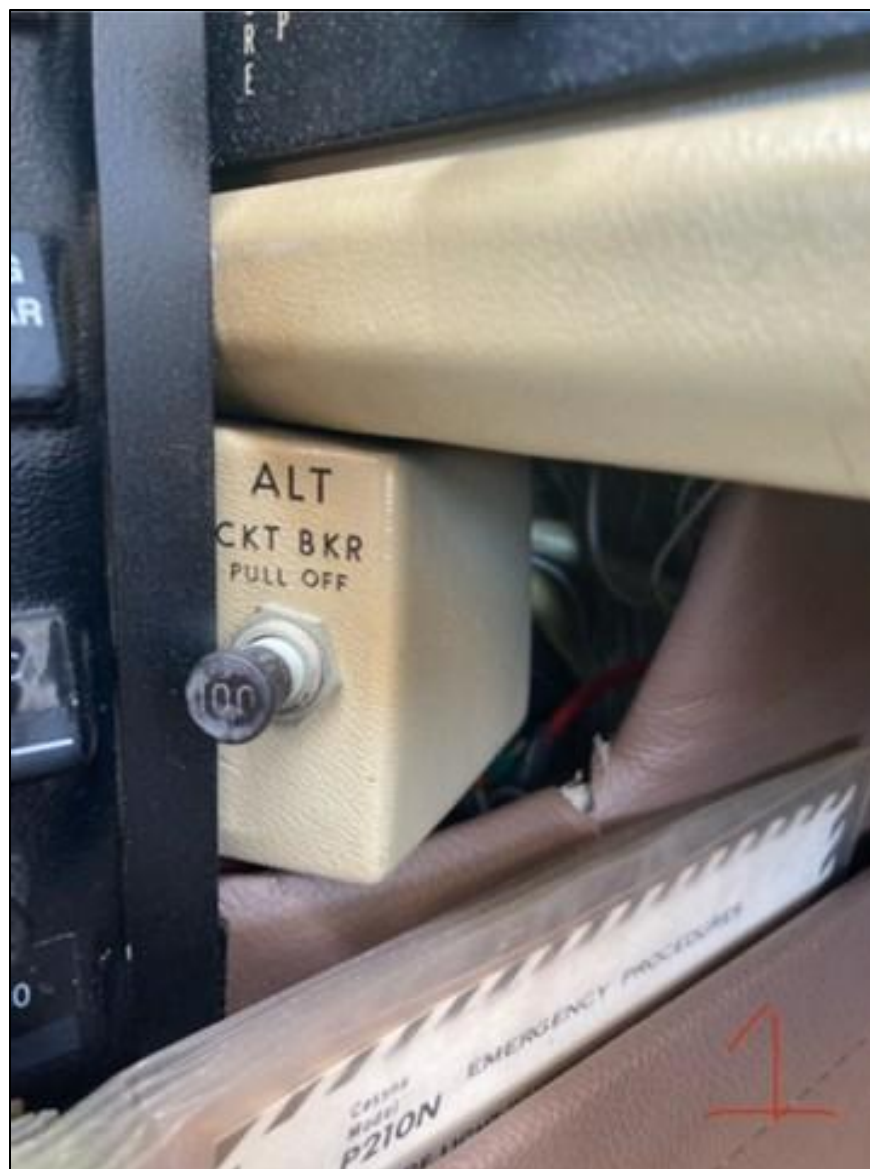
**Photograph 1 - Accident airplane, alternator circuit breaker. (Courtesy of the Mechanic)**

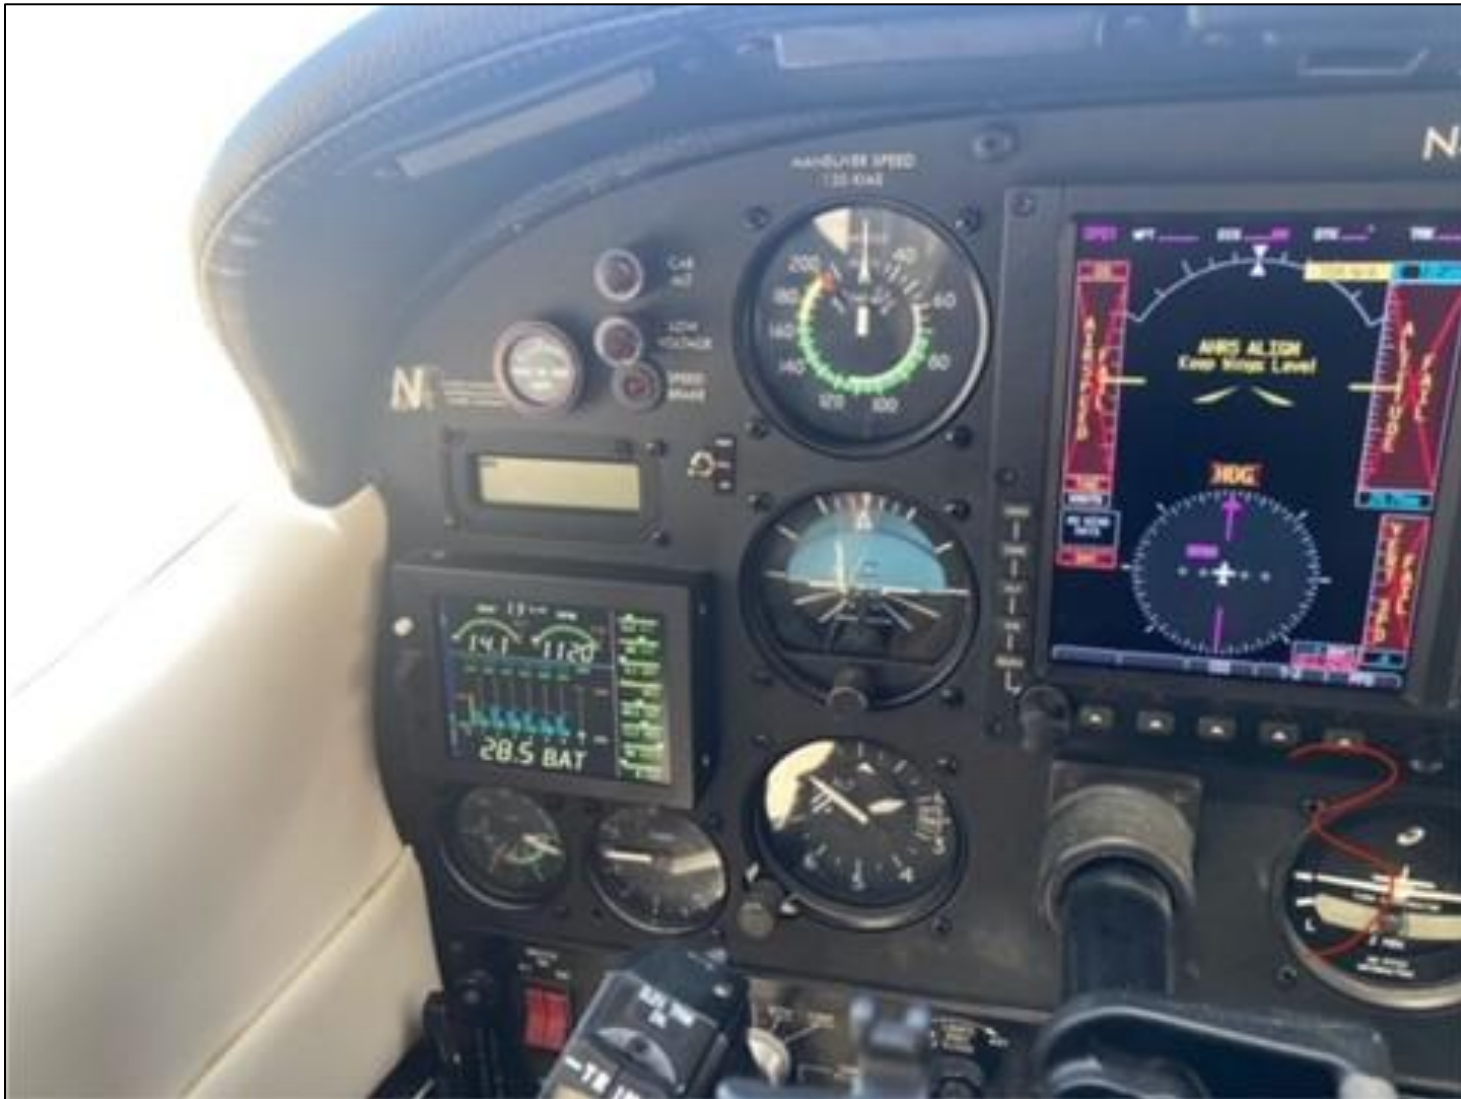
**Photograph 2 - Engine test run, left side instrument panel. (Courtesy of the Mechanic)**

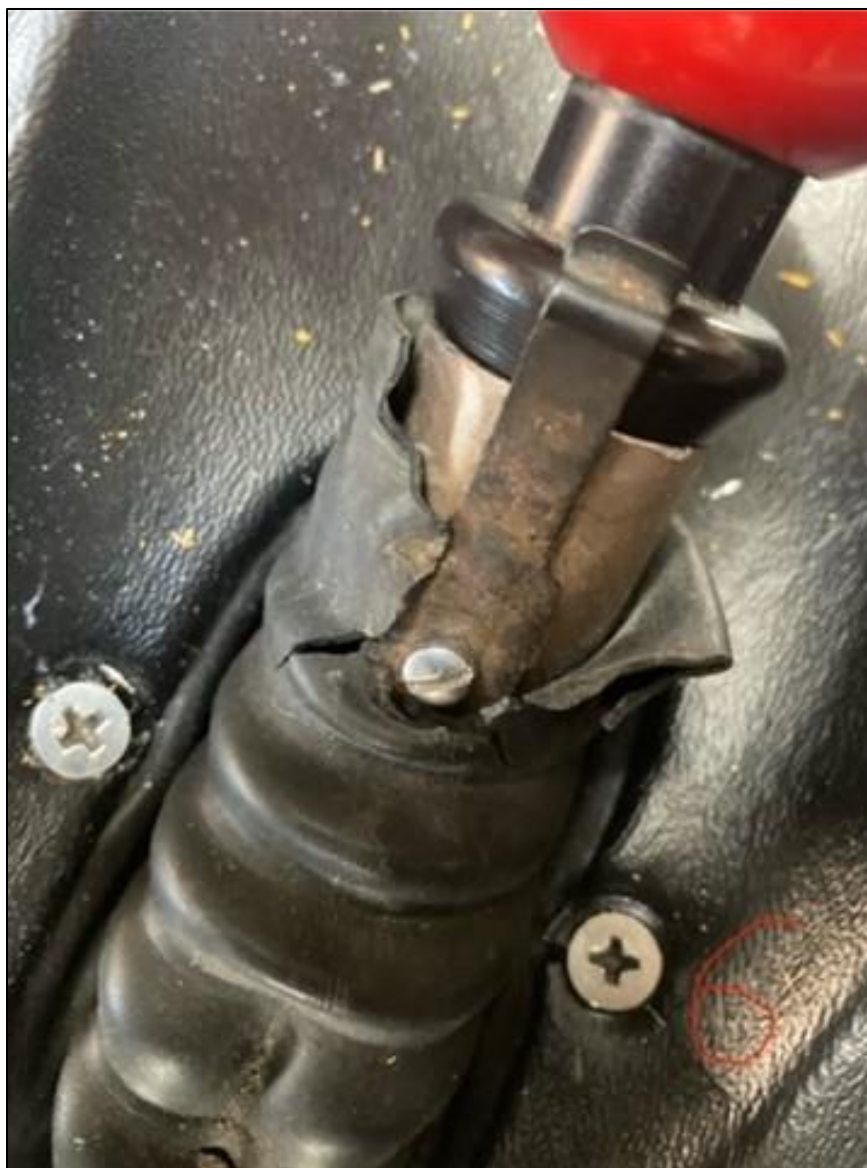
**Photograph 3 - Landing gear emergency extension handle. (Courtesy of the Mechanic)**

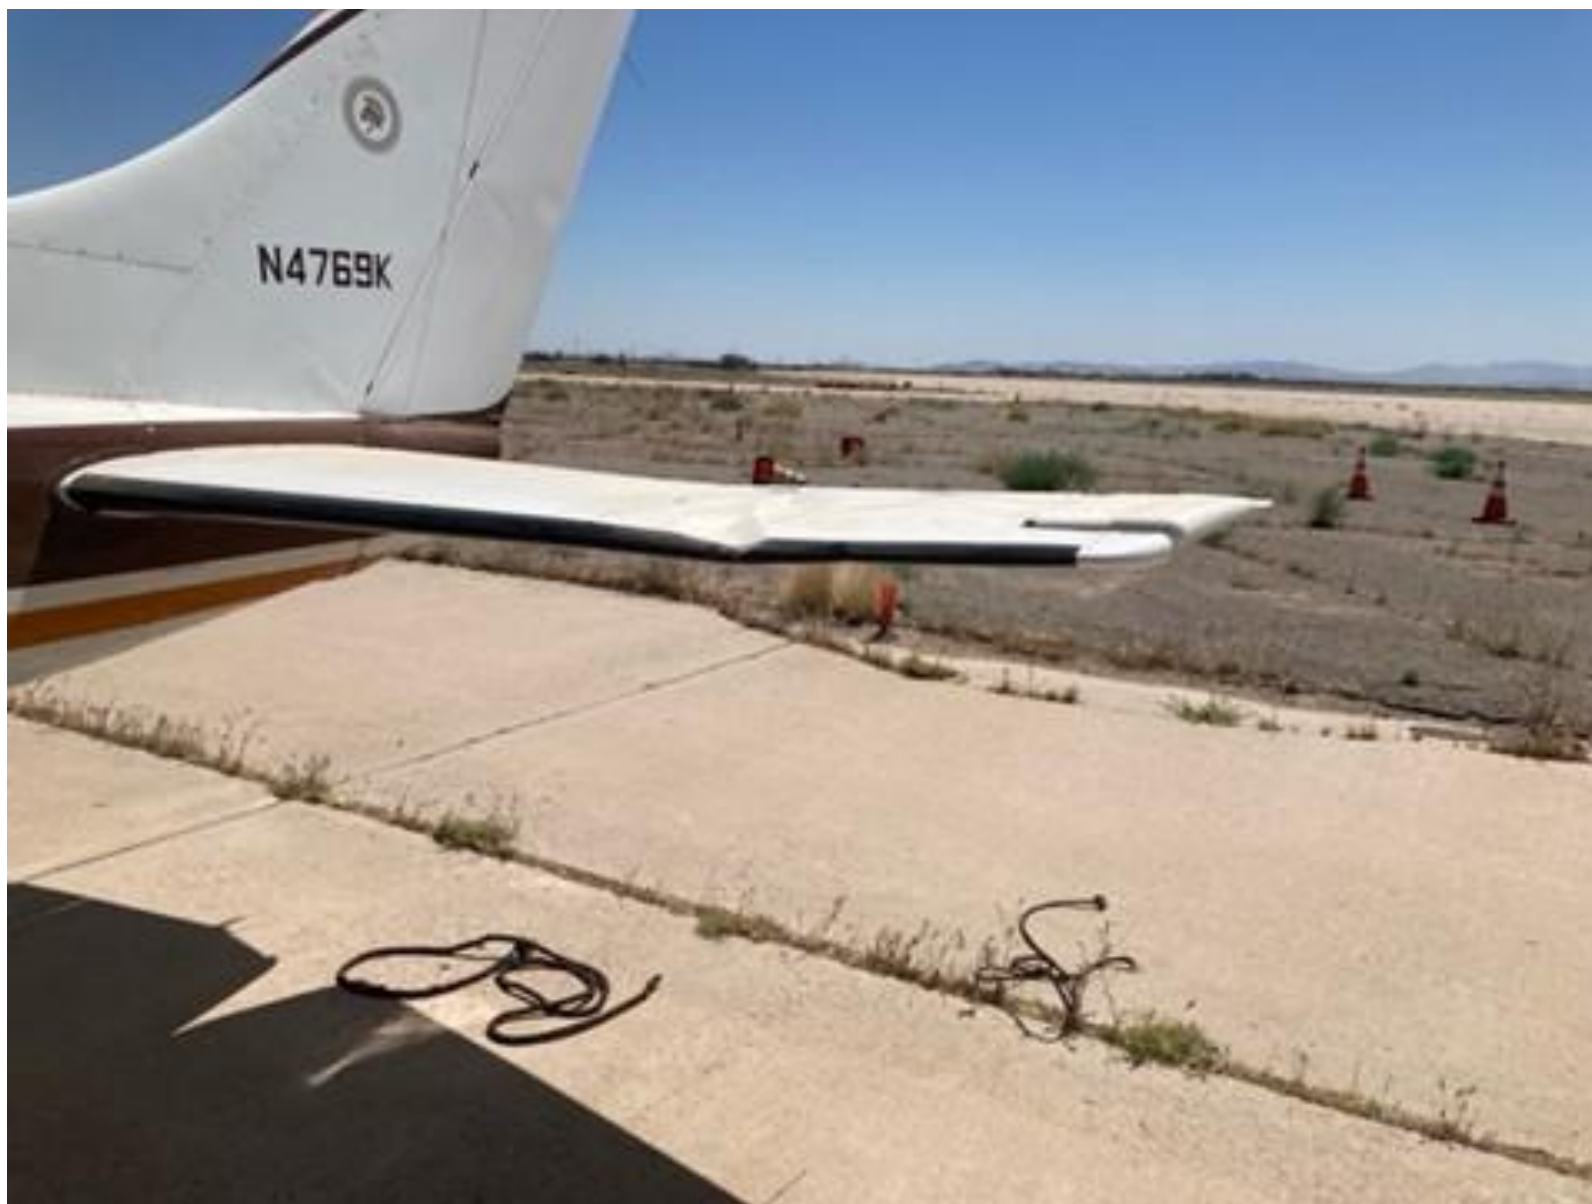
**Photograph 4 - Left horizontal stabilizer and elevator damage. (Courtesy of the Mechanic)**

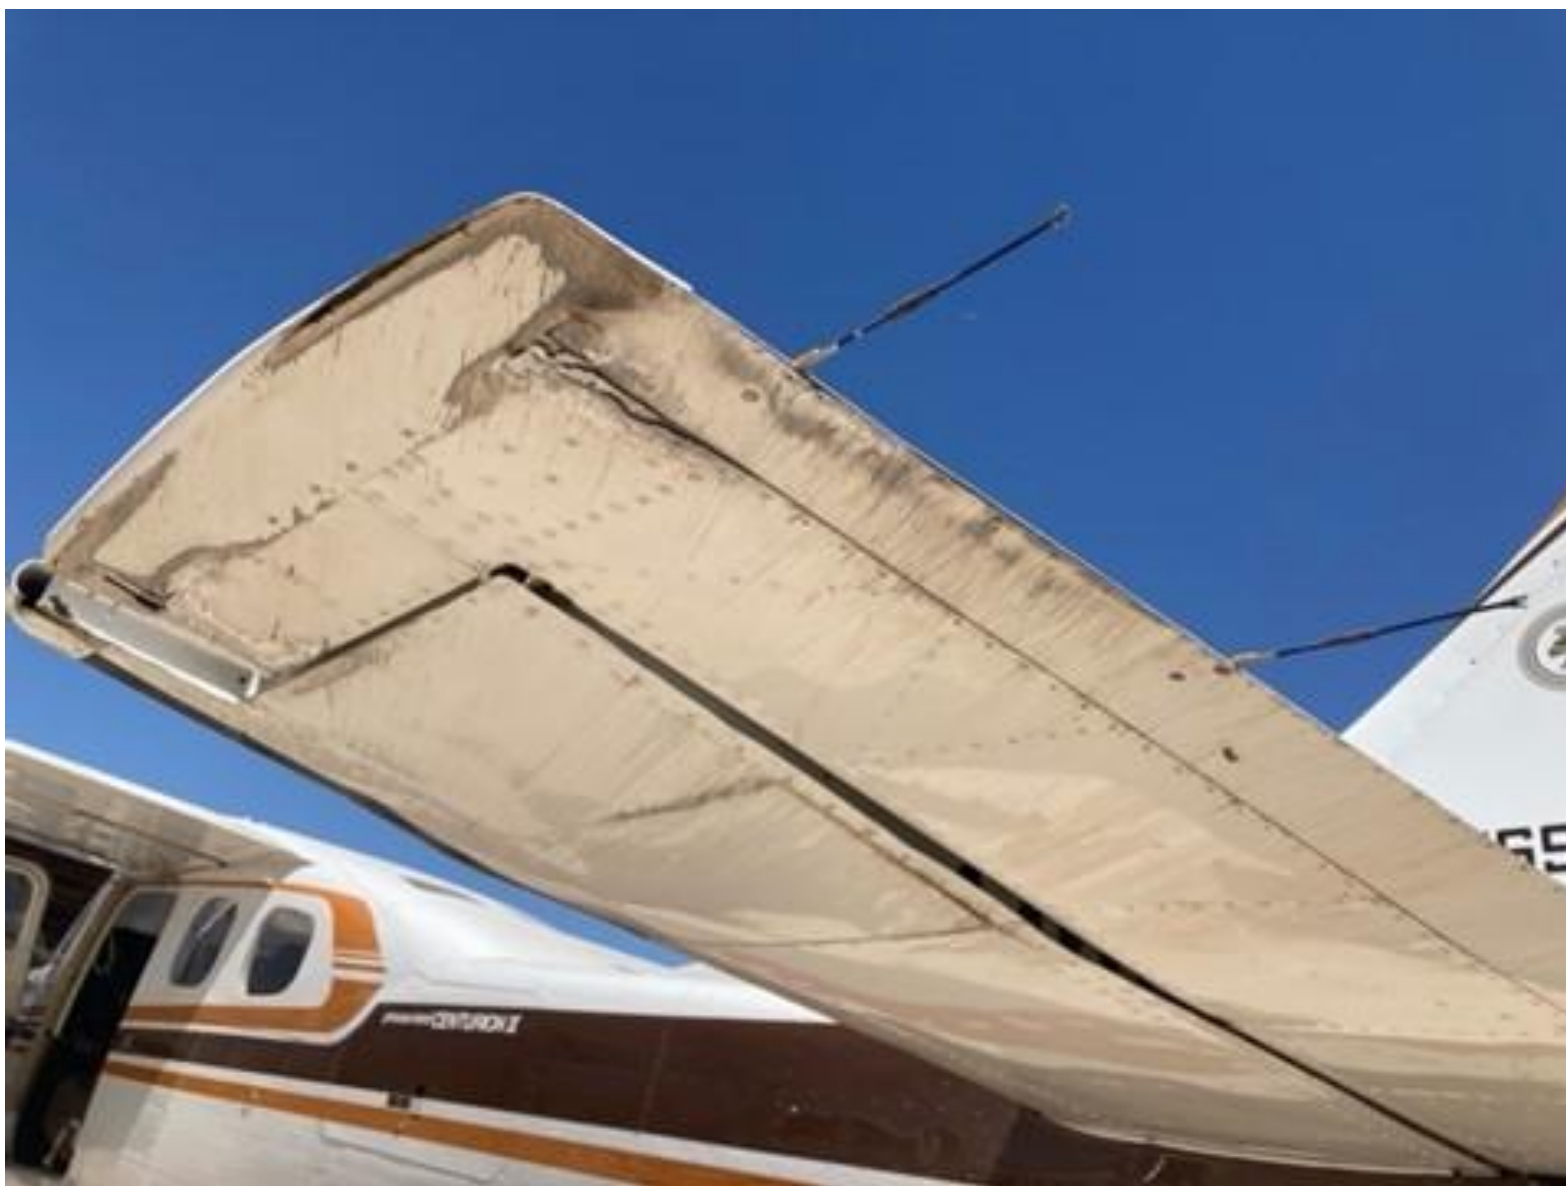
**Photograph 5 - Left horizontal stabilizer and elevator damage. (Courtesy of the Mechanic)**
