# National Transportation Safety Board

WPR24LA159

## **WRECKAGE EXAMINATION**

Factual Report

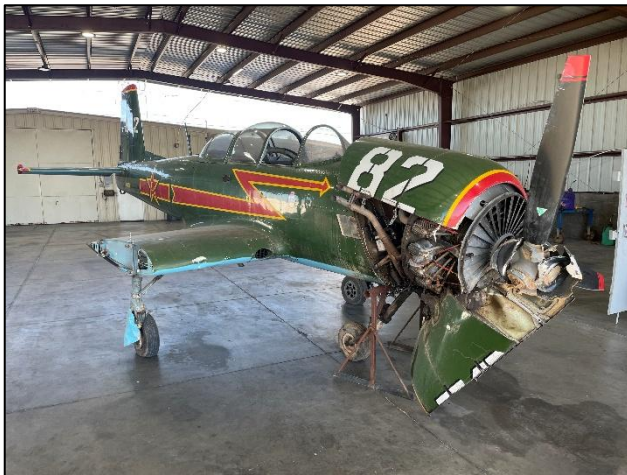
The airplane wreckage was relocated to Air Transport in Phoenix, Arizona, for further examination. The wings were removed and only the fuselage and engine were examined.

Figure 1-Main wreckage and engine.

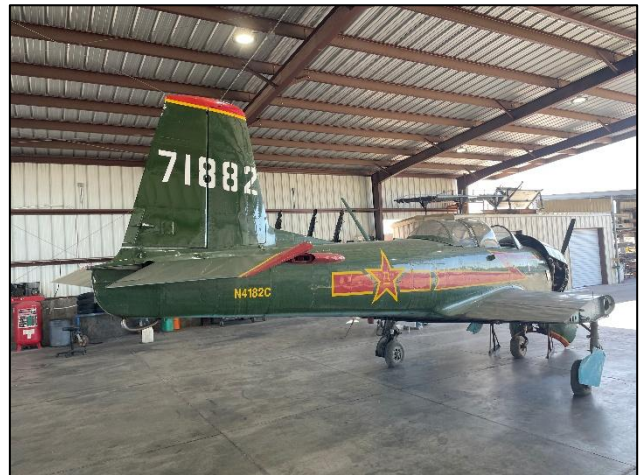
Figure 2-Main wreckage.

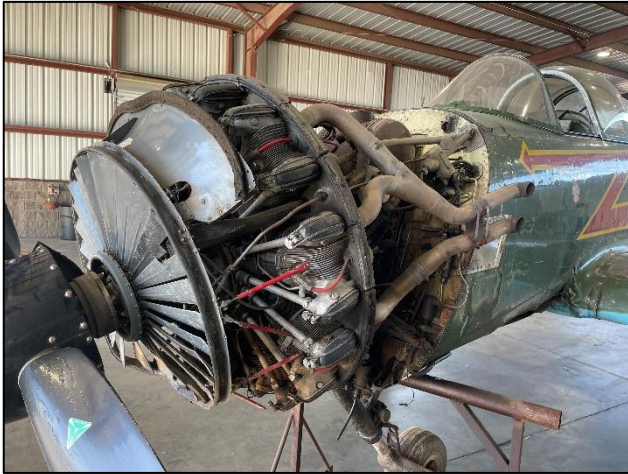
The engine remained partially attached to the impact damaged engine mounting carriage. The propeller assembly remained attached to the crankshaft propeller

flange and had impact damage to the spinner. One blade separated from the hub and was not found during the recovery efforts. The engine was tilted downward and had impact damage to the air induction box and the lowest cylinder rocker valve area. Thick black colored oil continued to drip during the examination from the rocker valve area. The oil reservoir tank was empty of oil.

**Figure 3-Left view of the engine.**

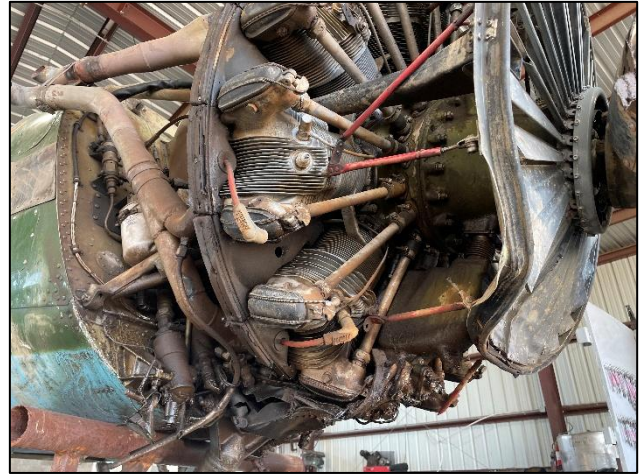
**Figure 4-Right lower view of the engine.**

The right magneto separated from the engine case and had damage to its outboard mounting flange. An upper engine mount tube was damaged and positioned near the magneto.

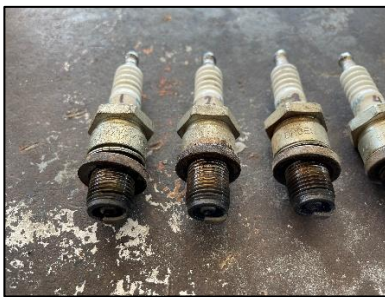
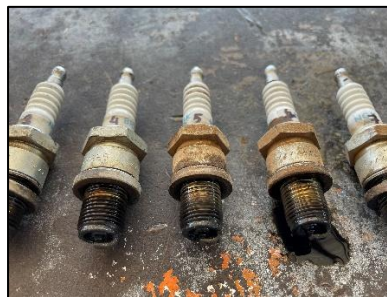
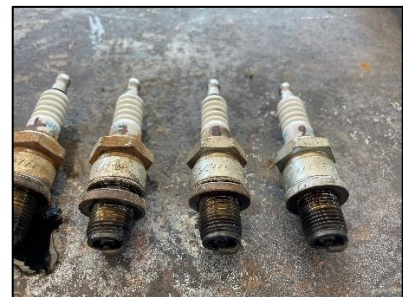
The forward spark plugs were removed from the cylinders. The electrode areas were undamaged and showed normal operational wear. The No. 6 forward spark plug was oil soaked.

**Figure 5-Fwd spark plugs.**

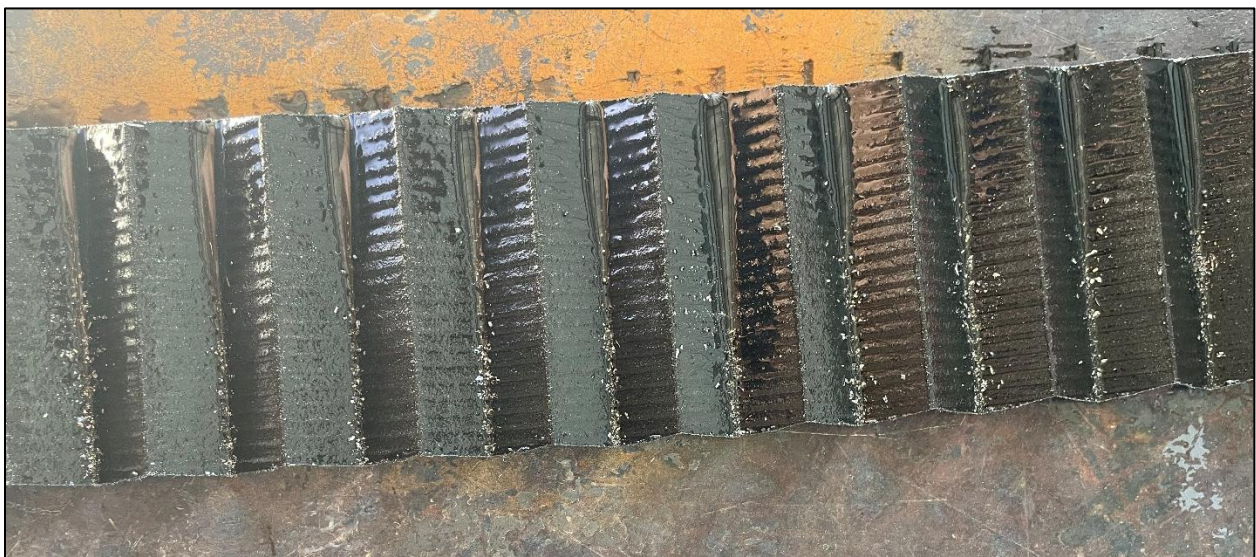
The oil filter was removed and disassembled. The filter was full of black thick oil that contained metallic contaminates. Metallic fragments were identified in the folds of the filter element. The filter element material was stiff and brittle.

**Figure 6-Oil filter disassembled.**

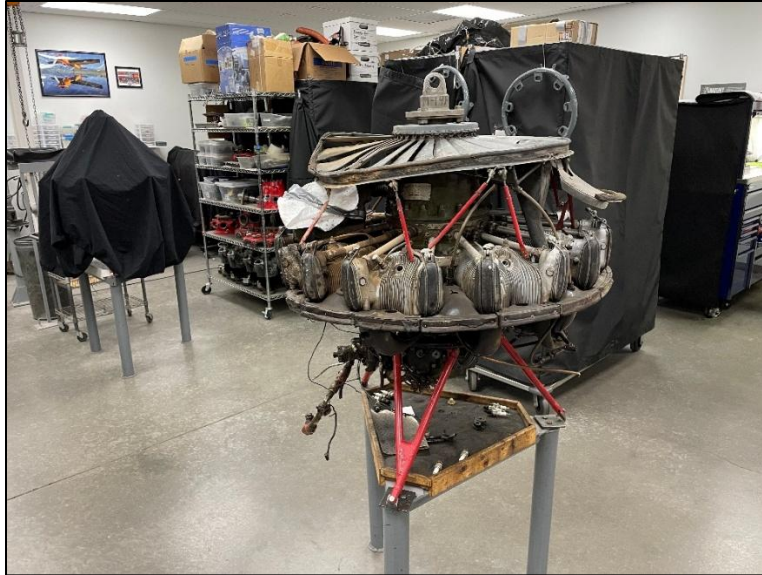
The engine was shipped to a facility for further examination. The engine was setup on an engine stand and the induction and exhaust assemblies were removed. The crankshaft rotated freely, and gear continuity was established to the accessory section.

**Figure 7-Engine examination.**

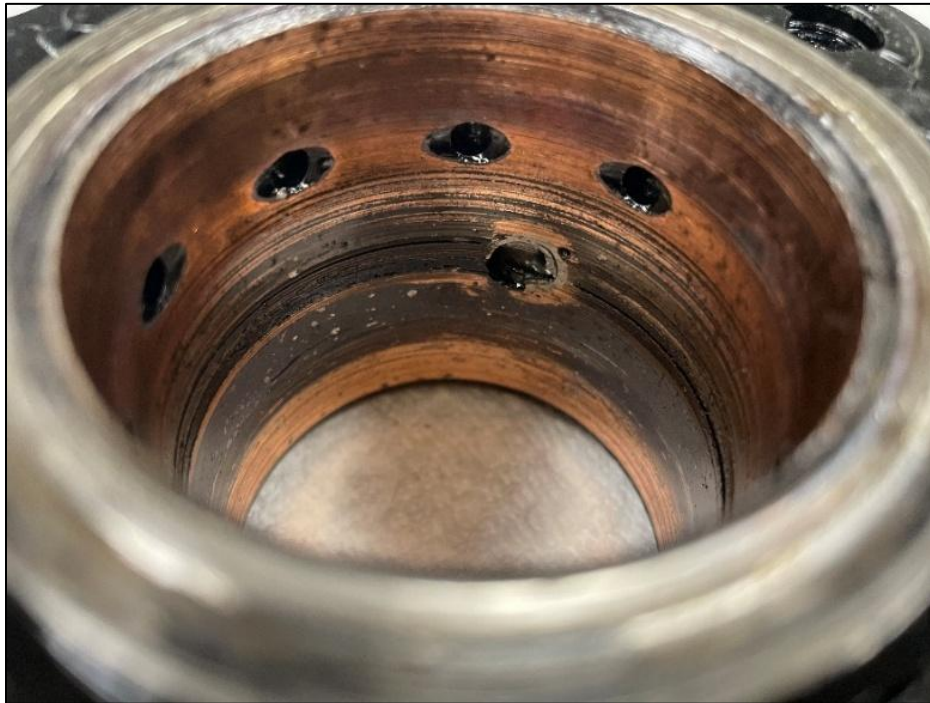
The master-rod main bearing (bushing) showed signatures of wear and scoring on its interior surface. (See figure 8) Both bushing set screws (checking pins) separated and were not found during the examination. The bushing was rotated about 90° from its original position. The forward side of the bushing edge (positioned nearest to the journal radius) had mechanical damage. The connecting rods remained attached to the main-connecting rod and had damage to the sides of the I-beam, consistent with impacting the sides of the cylinder skirts.

**Figure 8-Master rod main bearing and set screw hole.**

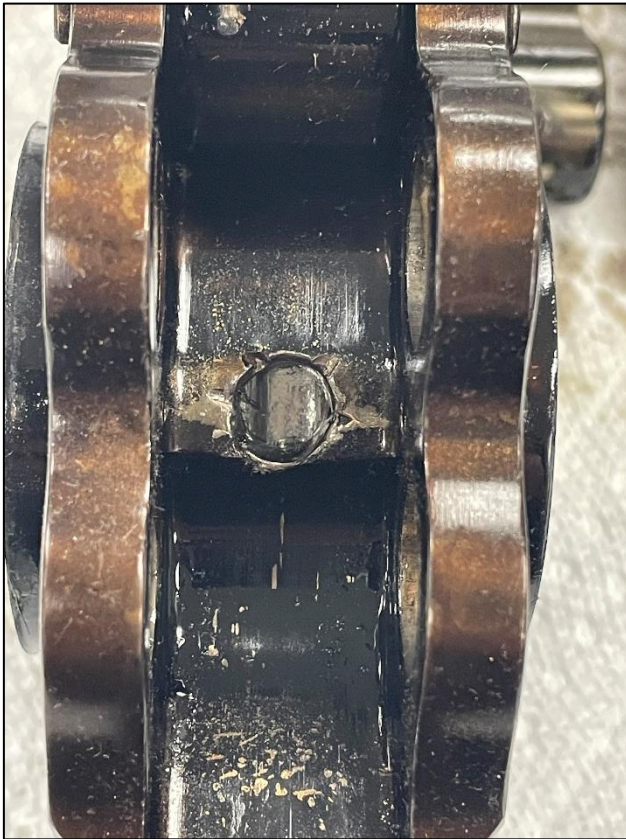
Four connecting rods were removed from the main-connecting rod to gain access to the main bearing set screw areas. The connecting rod ends near the set screw areas had mechanical damage and deformation. The set screw holes were mechanically damaged and deformed and showed 3 installation chiseled strike marks. (See figures 9 and 10)

**Figure 10-Master rod main bearing set screw hole and installation strike marks.**

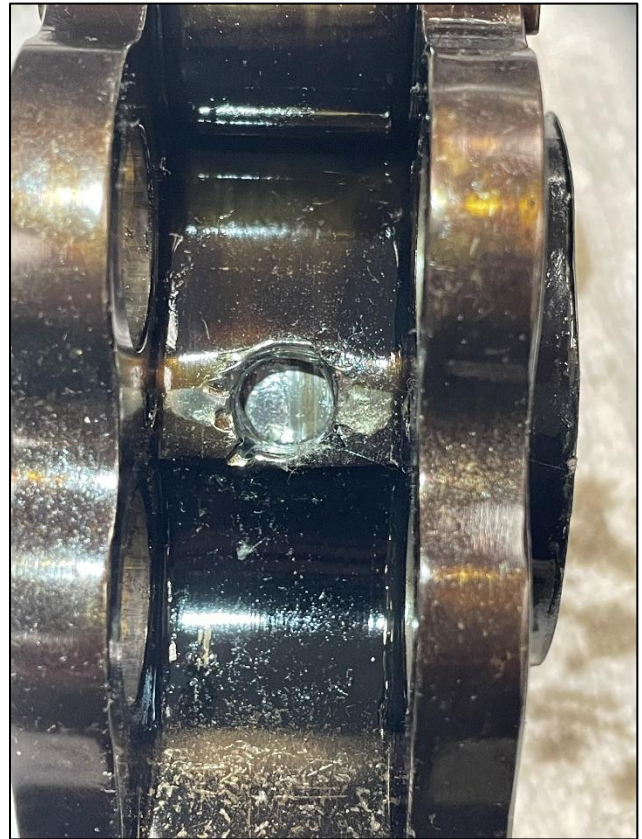
**Figure 11-Master rod main bearing set screw hole and installation strike marks.**

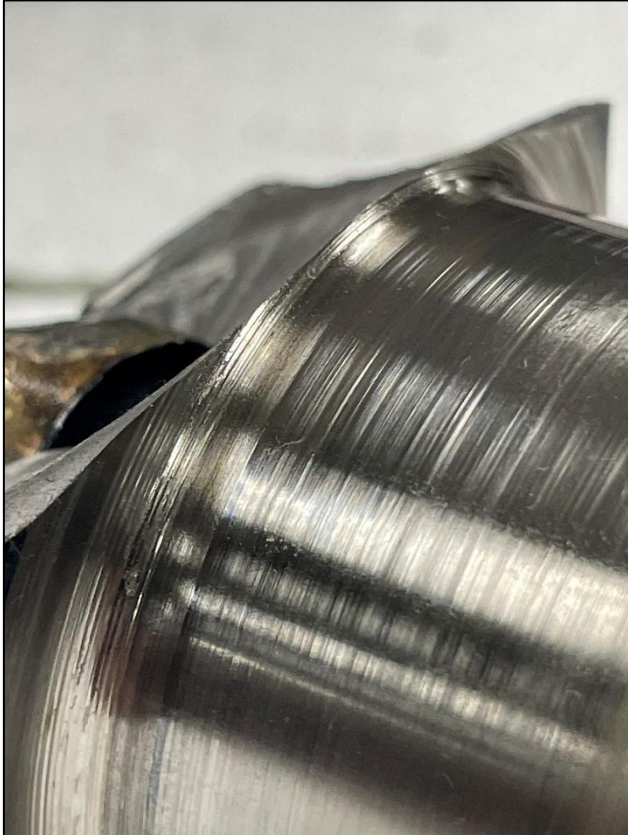
The separated journal section remained attached to the crankshaft rear section. The coupling bolt was removed, and the journal section was separated from the crankshaft rear section. The crankshaft forward section separated surfaces had a small amount of mechanical deformation and the majority of the surface area showed ratcheting and beach marks consistent with a fatigue stress fracture. The origin of the beach marks was located at the journal radius.

**Figure 92-Separated journal section.**

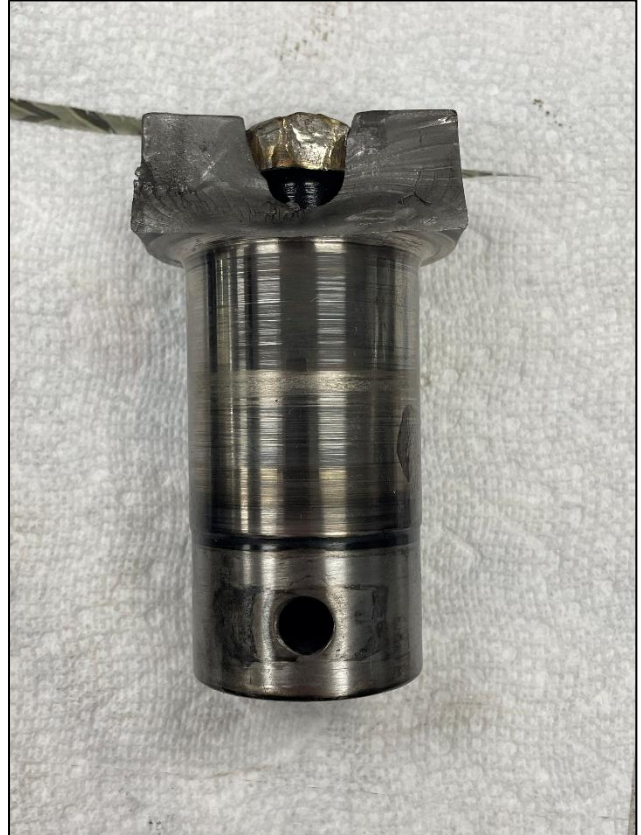
**Figure 13-Separated journal section.**

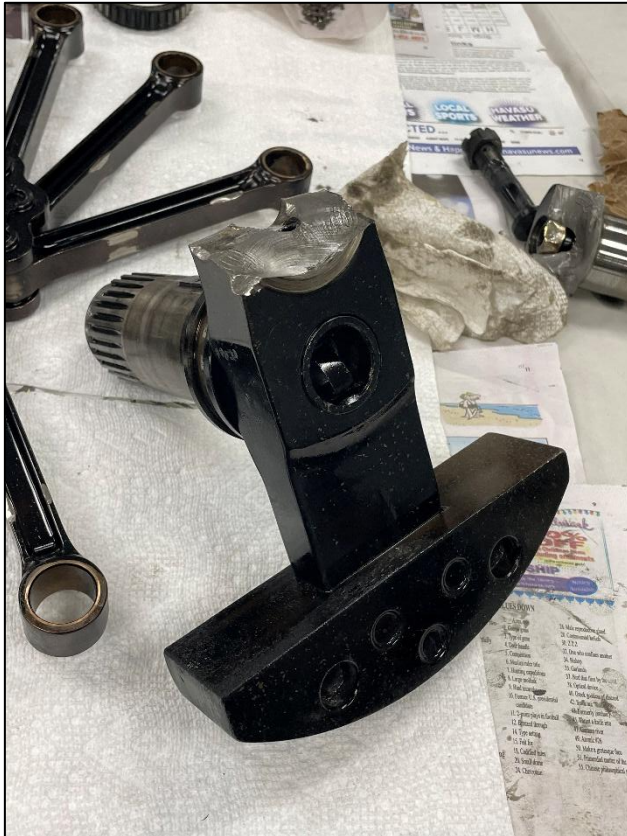
The crankshaft forward section separation surface had a small amount of mechanical deformation and the majority of the surface area showed ratcheting and beach marks consistent with a fatigue stress fracture. The origin of the beach marks are at the journal radius area.

**Figure 13-Crankshaft forward section.**

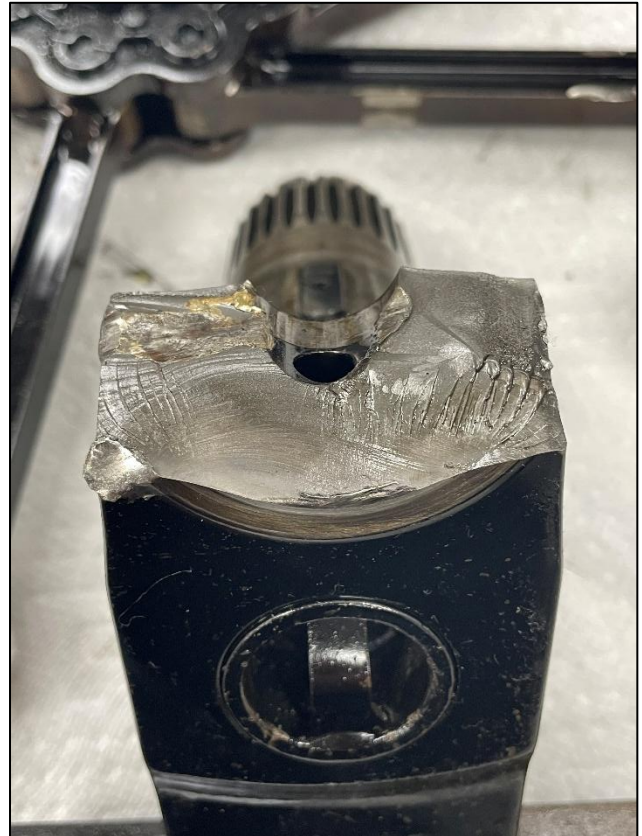
**Figure 14-Crankshaft forward section separation surface.**
