# National Transportation Safety Board

WPR24LA160

## **ENGINE AND FUEL SYSTEM EXAM**

Location: Santa Maria, California  
Date: May 25, 2024  
Time: 1715 Pacific daylight time  
0015 UTC  
Airplane: FREEMAN STEEN SKYBOLT, N873X

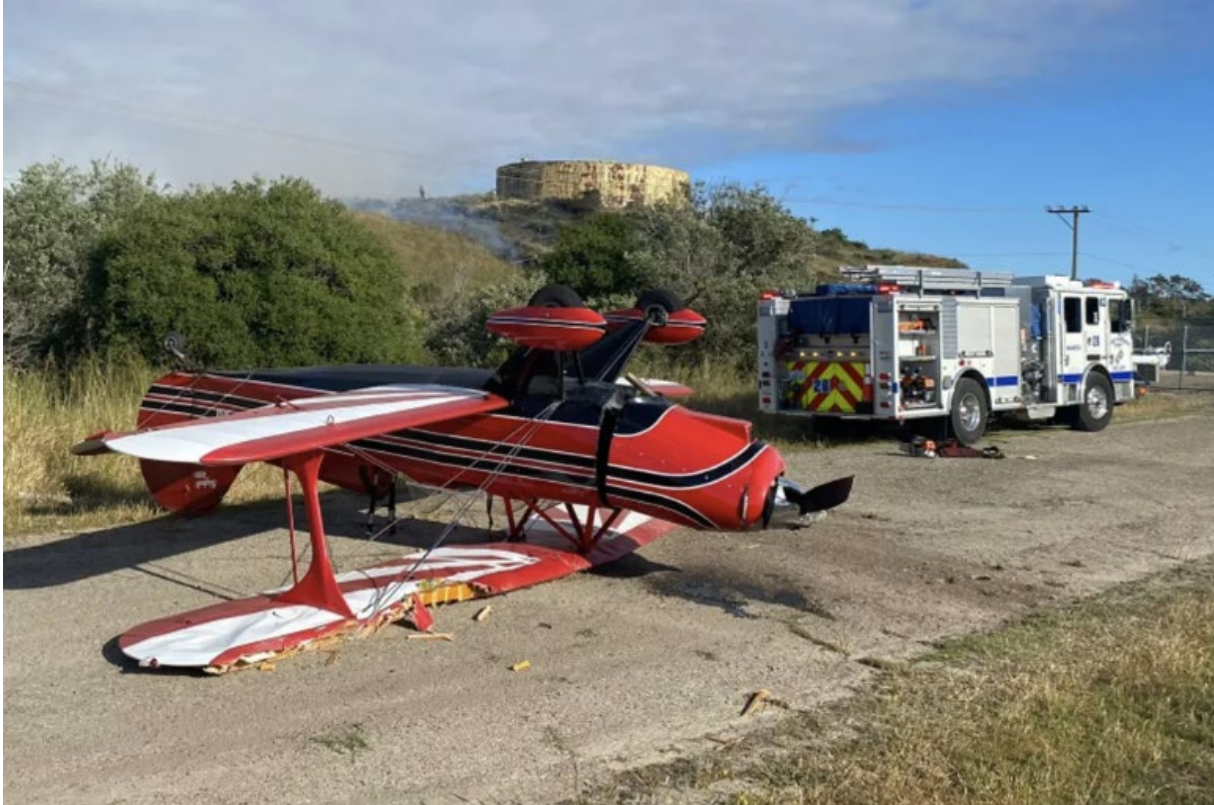
Postaccident examination of the airplane revealed that the upper wing was substantially damaged. The airplane was recovered to the pilot's hanger for further examination.

**Figure 1 View of airplane at accident scene (Courtesy of first responders)**

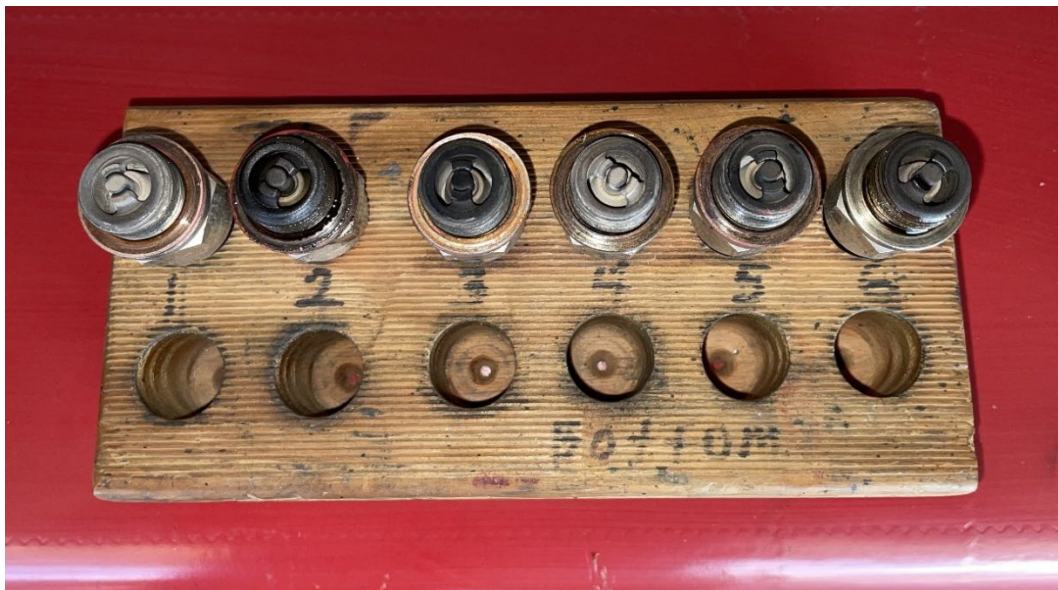
The upper spark plugs were removed from the engine, and they were the massive electrode type. The sparkplugs indicated normal and worn out normal with some black deposits within the electrode area when compared to the Champion Check-A-Plug comparison chart.

**Figure 2: Top spark plugs removed.**
