Eric M. Gutierrez  
Air Safety Investigator  
Western Pacific Region

**Date:** June 5, 2024

**Subject:** WPR24LA167, Memorandum for Record

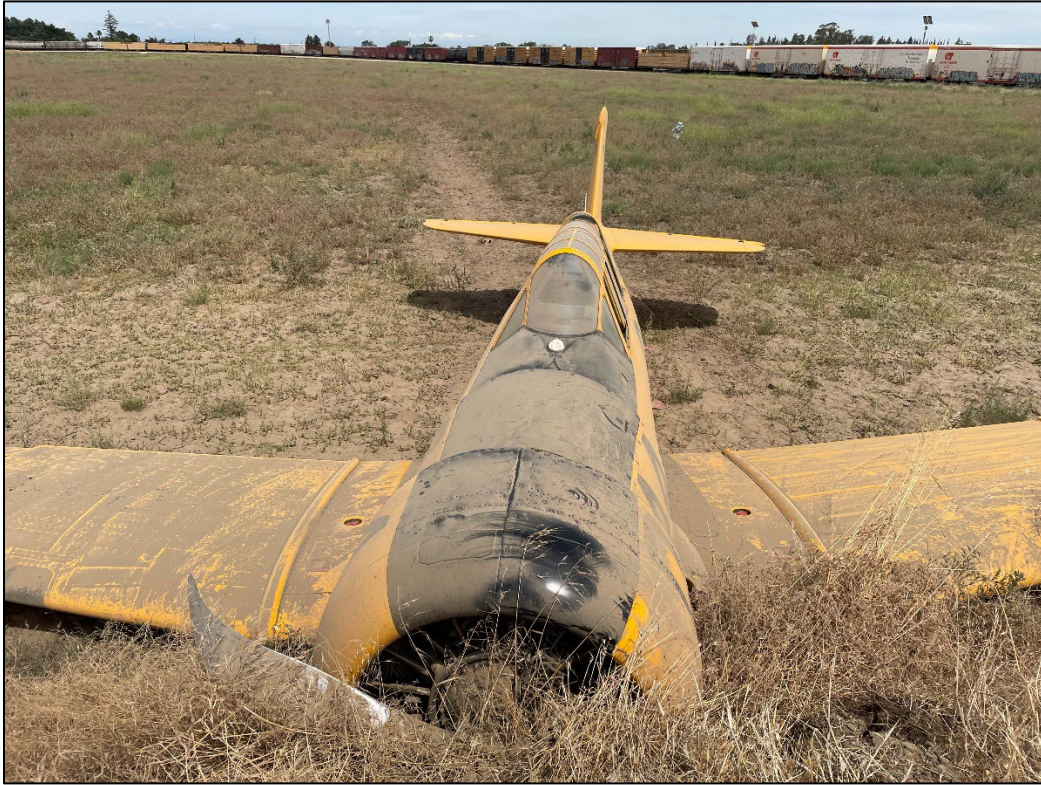
*Figure 1: Front view of accident airplane (Courtesy of the FAA)*

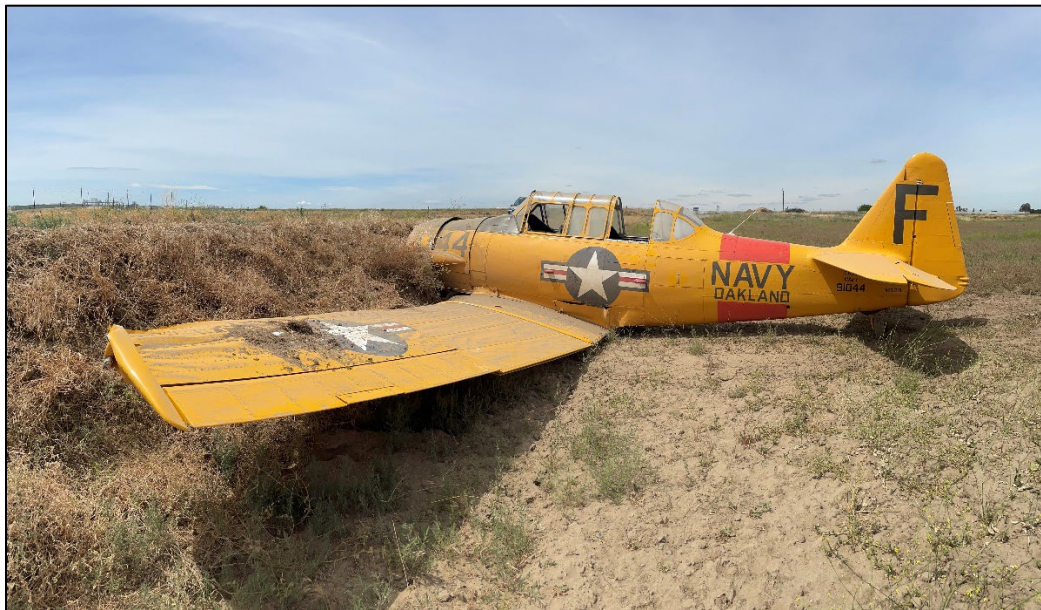
The left wing remained attached to the fuselage. The left flap and aileron remained attached via their mounts. The flap was observed fully retracted. The main fuel tank fuel cap was observed in place and secure. No liquid was observed in the fuel tank. Damage to the leading edge, from the wing tip to about mid span, consistent with impact damage was observed.

*Figure 2: Left side view of accident airplane (Courtesy of the FAA)*

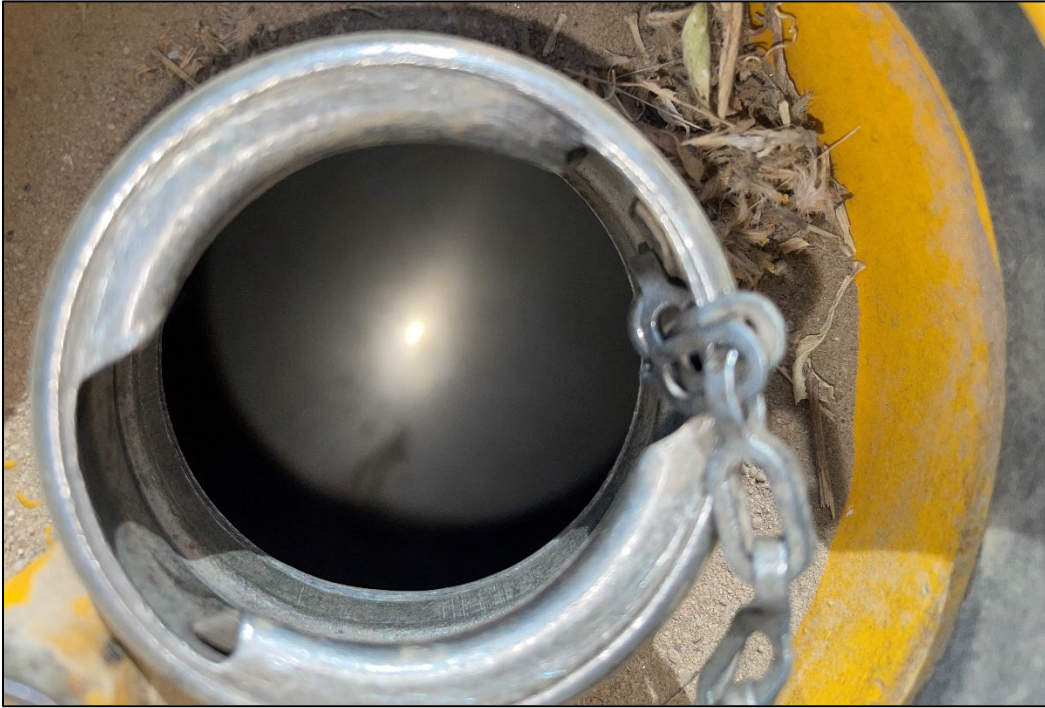
*Figure 3: View of left wing fuel tank. (Courtesy of the FAA)*

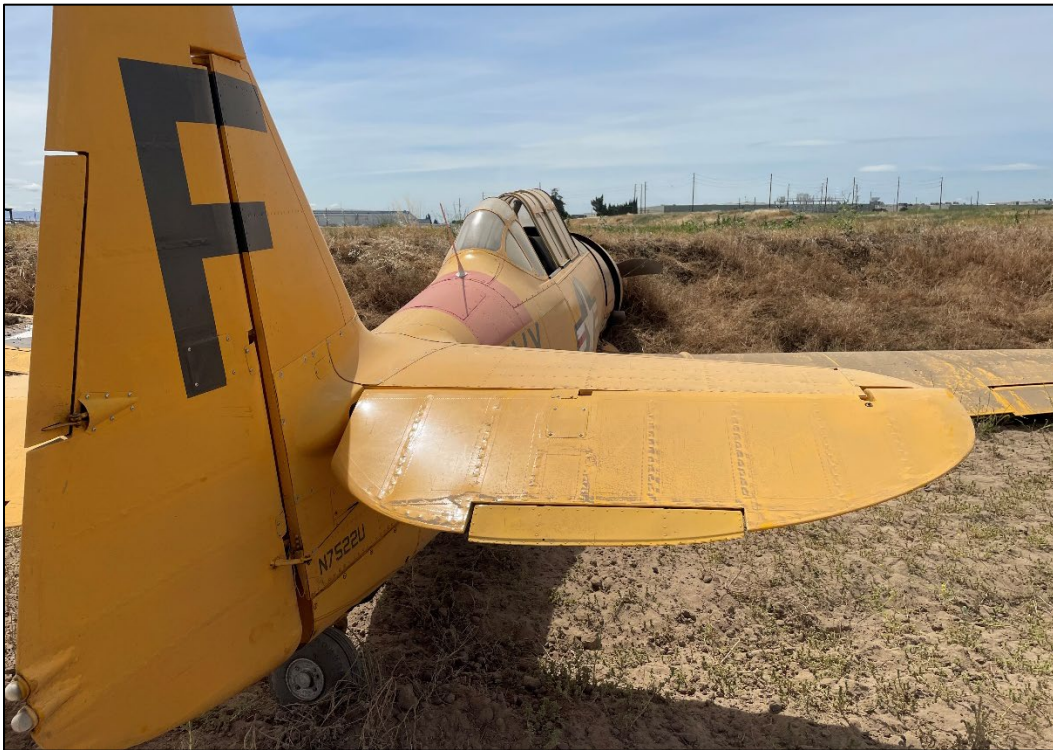
*Figure 4: Rear view of accident airplane (Courtesy of the FAA)*

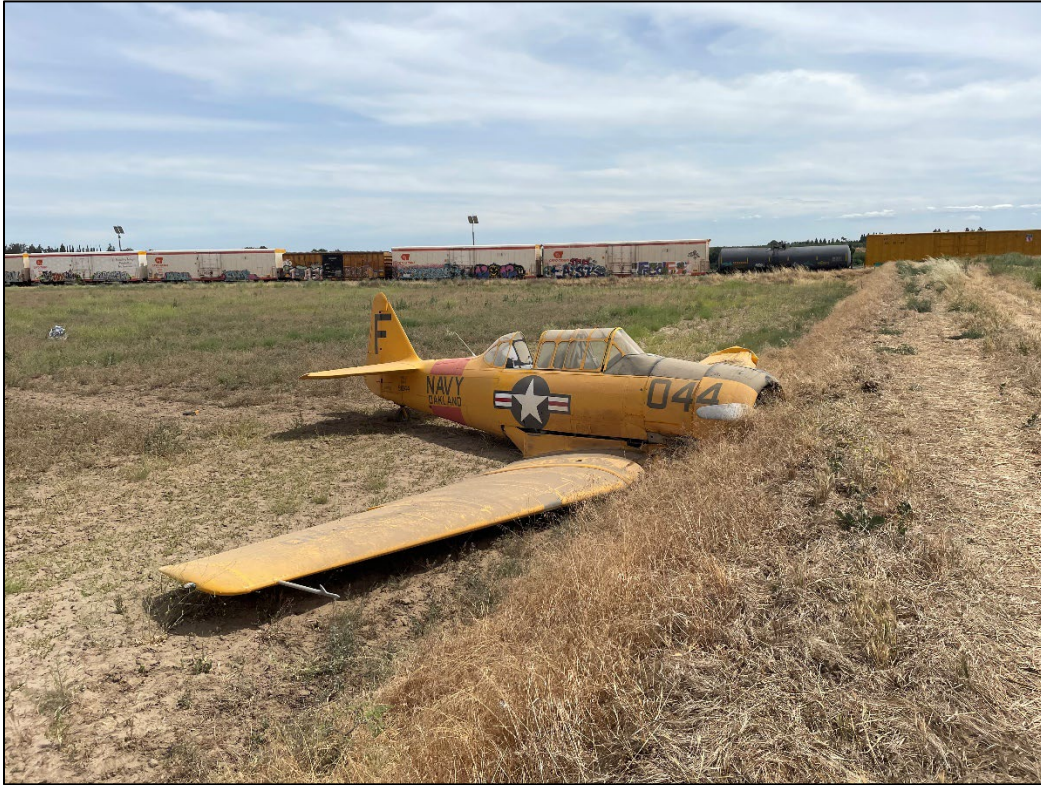
The right wing remained attached to the fuselage. The right flap and aileron remained attached via their mounts. The flap was observed fully retracted. The main fuel tank fuel cap was observed in place and secure. A minor amount of blue in color liquid, consistent with 100 LL was observed in the fuel tank. Damage to the wing tip, consistent with impact damage was observed.

*Figure 5: Right side view of accident airplane (Courtesy of the FAA)*

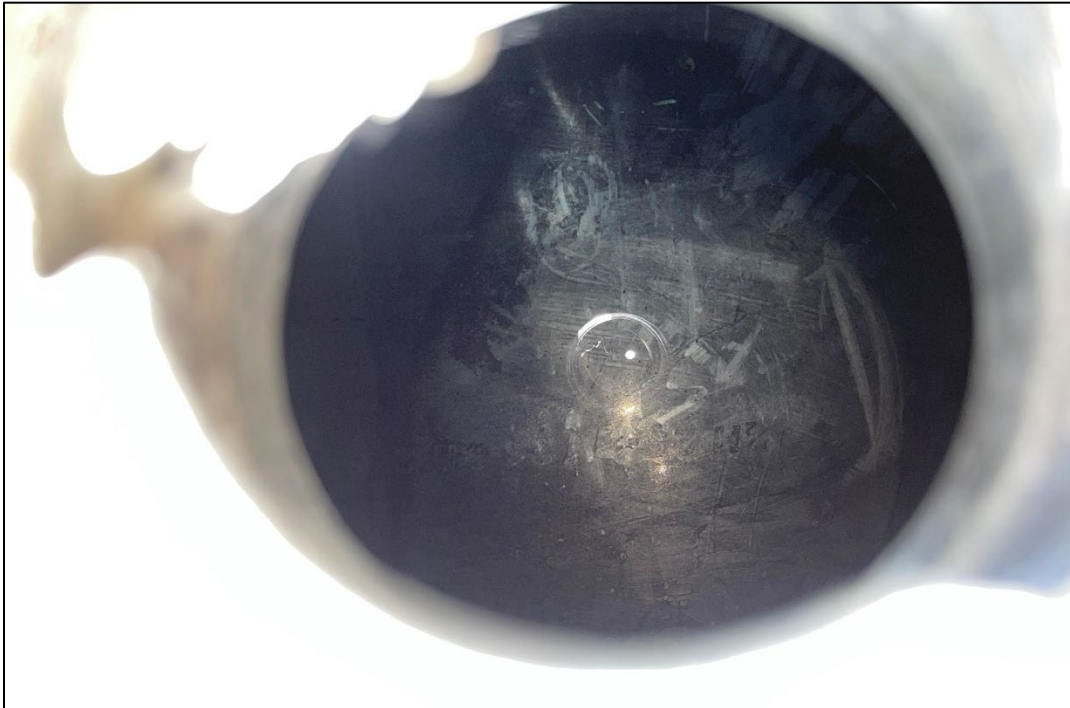
*Figure 6: View of right wing fuel tank. (Courtesy of the FAA)*

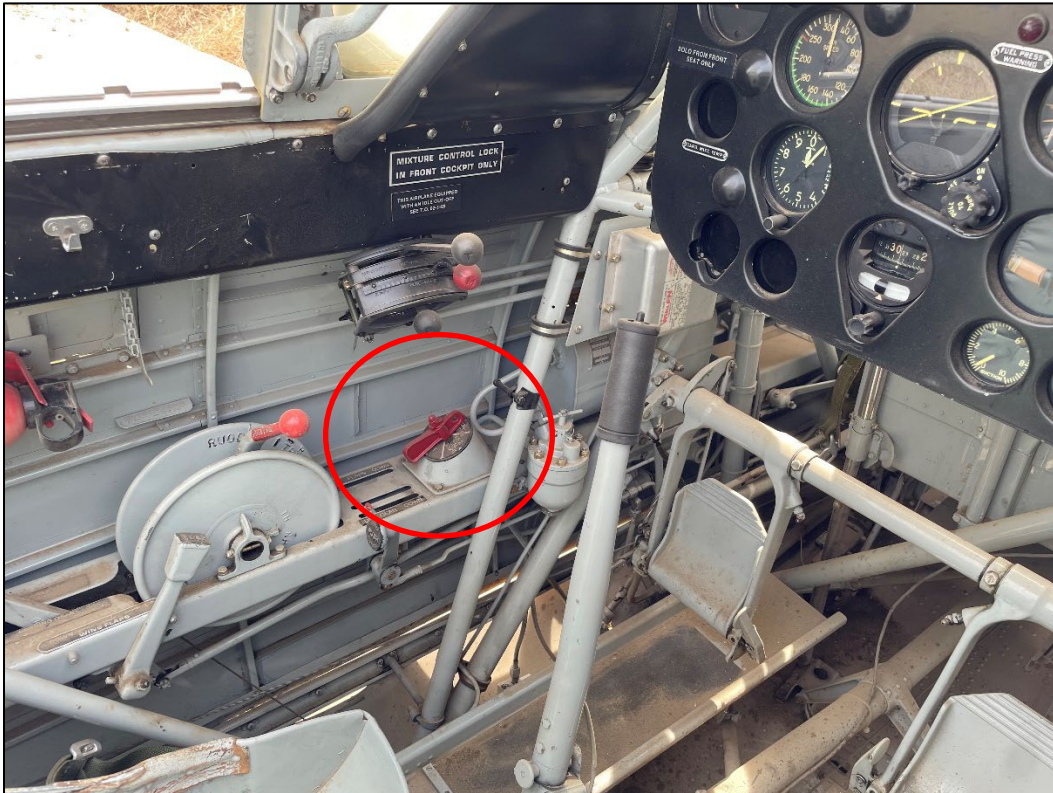
The fuselage mostly intact, crushing and bending to the fuselage undercarriage, consistent with impact damage was observed. The fuel selector lever was observed in the left tank position. The accident site was void of fuel indications.

Figure 7: View of fuel selector lever. (Courtesy of the FAA)
