National Transportation Safety Board

WPR24LA174

**INVESTIGATIVE SUPPLEMENTAL MATERIAL**

Location: San Diego, California  
Date: June 01, 2024  
Time: 1355 Pacific daylight time  
Airplane: Beechcraft

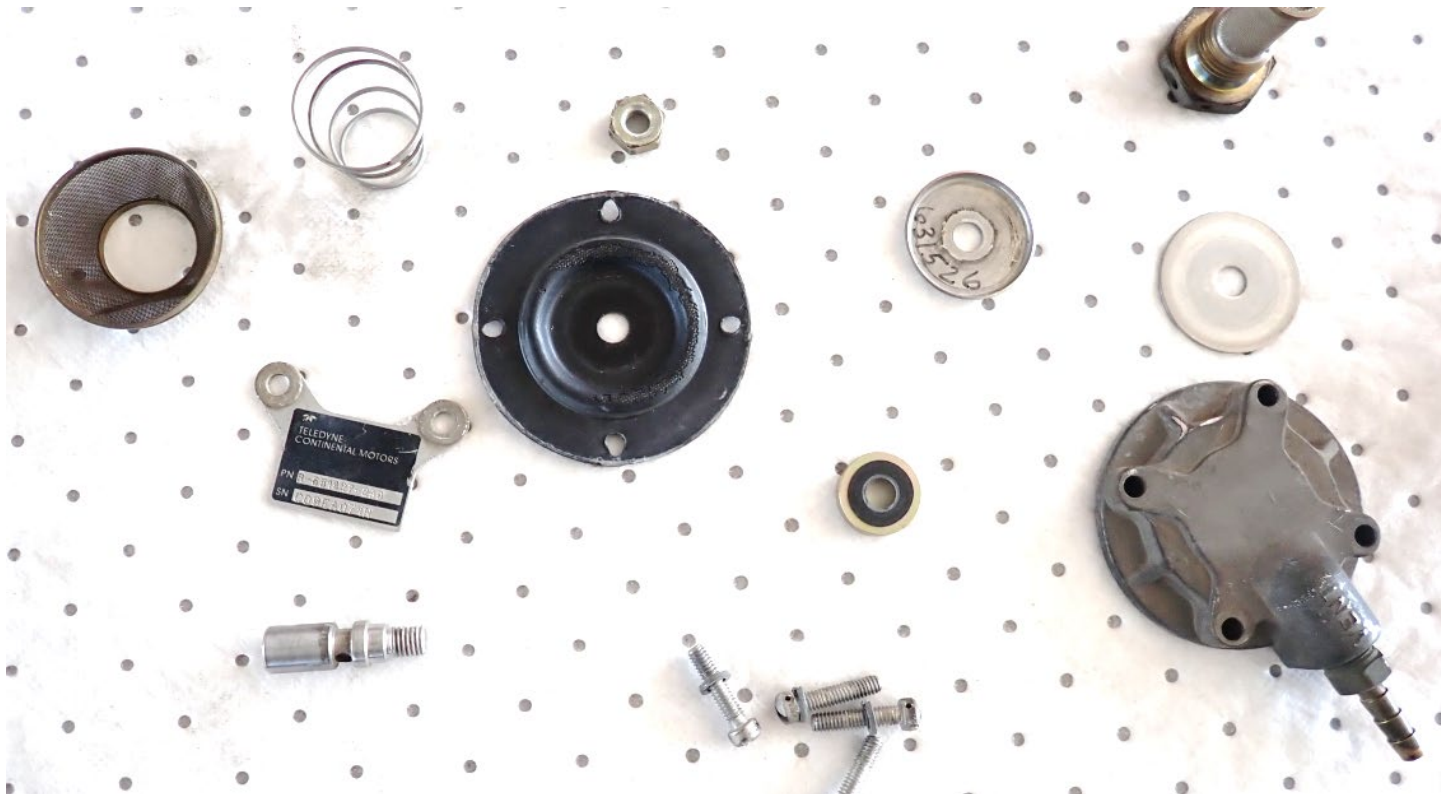
Figure 2: Fuel manifold disassembled

The fuel manifold part number R631427-2A9 (serial number C09EA071B) was disassembled. The diaphragm inside the fuel manifold, part number 631526, was found to be brittle, not pliable, and exhibited peeling on its upper surface. There were numerous flakes from the rubber found during the removal, but it could not be determined if the contaminants would have prohibited the venting of the unit. The vent hole was free of debris and no blue staining was noted at the end of the

vent line and surrounding fuselage skin. It is unknown if the wear and condition of the diaphragm resulted in the manifold malfunctioning, but the lack of fuel staining is consistent with a normally operating manifold..

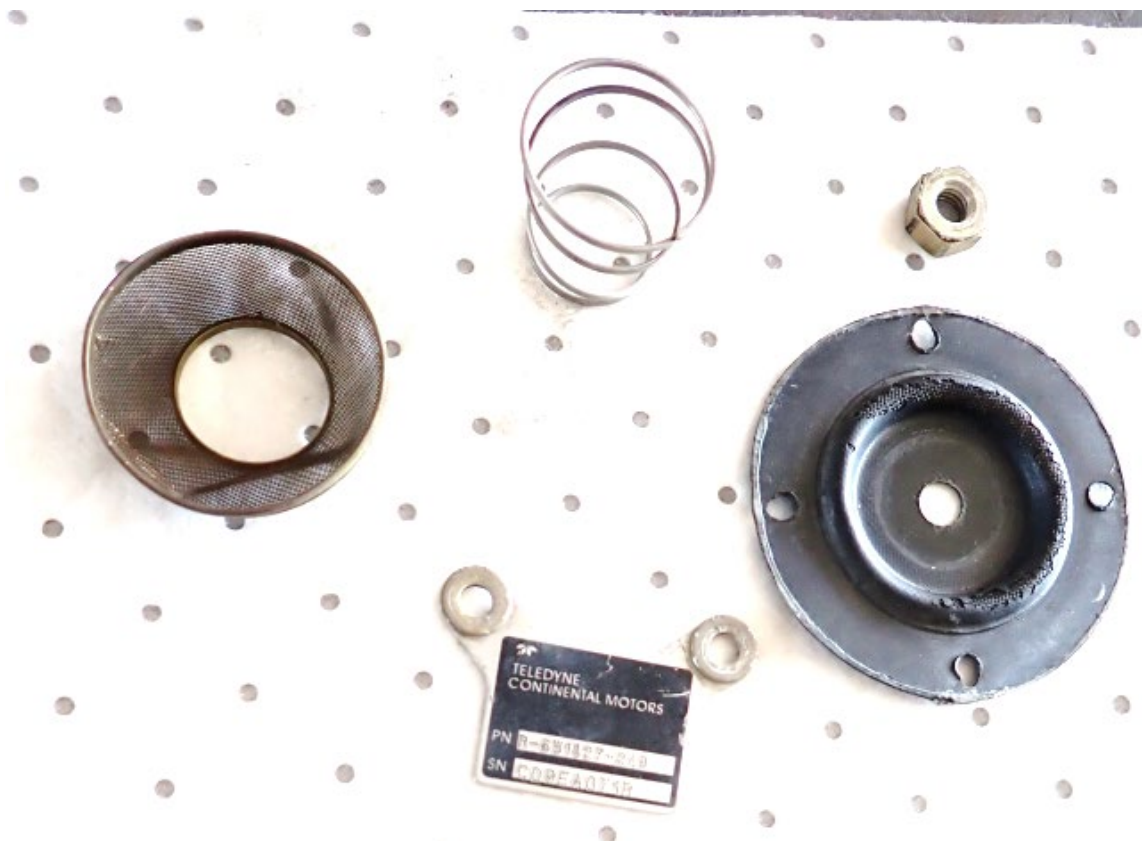
Figure 3: Manifold screen and diaphragm

The fuel manifold screen was clean of debris but rust colored. The manifold body contained trace amounts of rust, consistent with water being in the fuel.

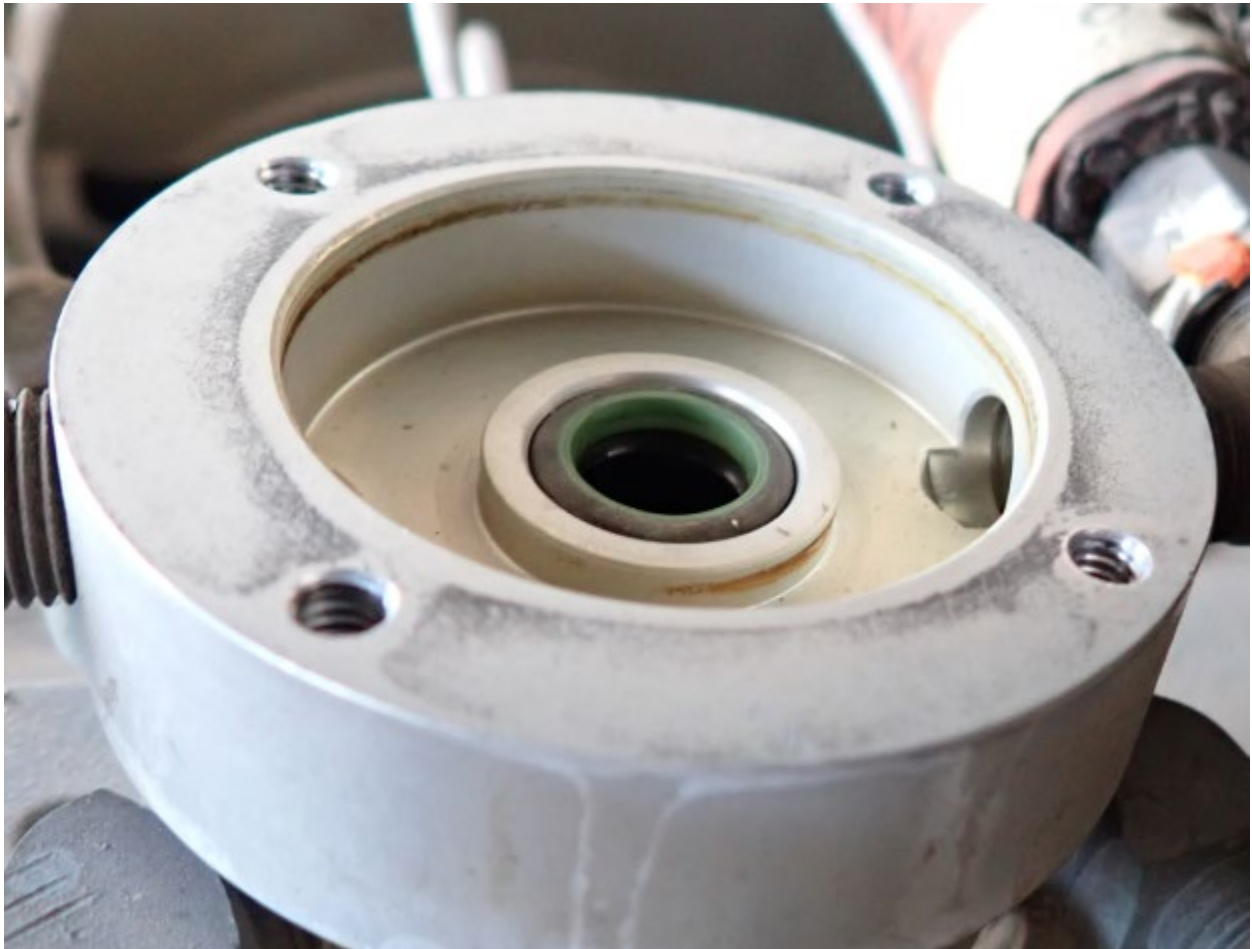
*Figure 5: Manifold body (showing corrosion)*

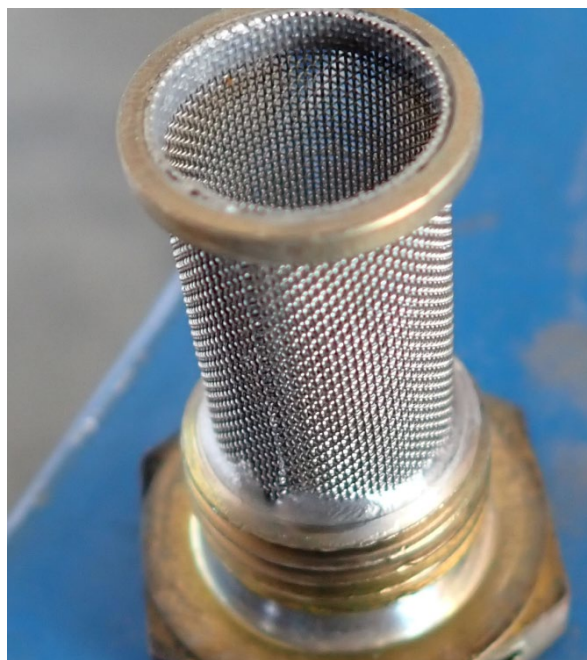
The throttle and mixture manifold screen was also examined and found clean. The fuel strainer screen was removed and exhibited areas of corrosion.

*Figure 6: Fuel screen (showing corrosion)*

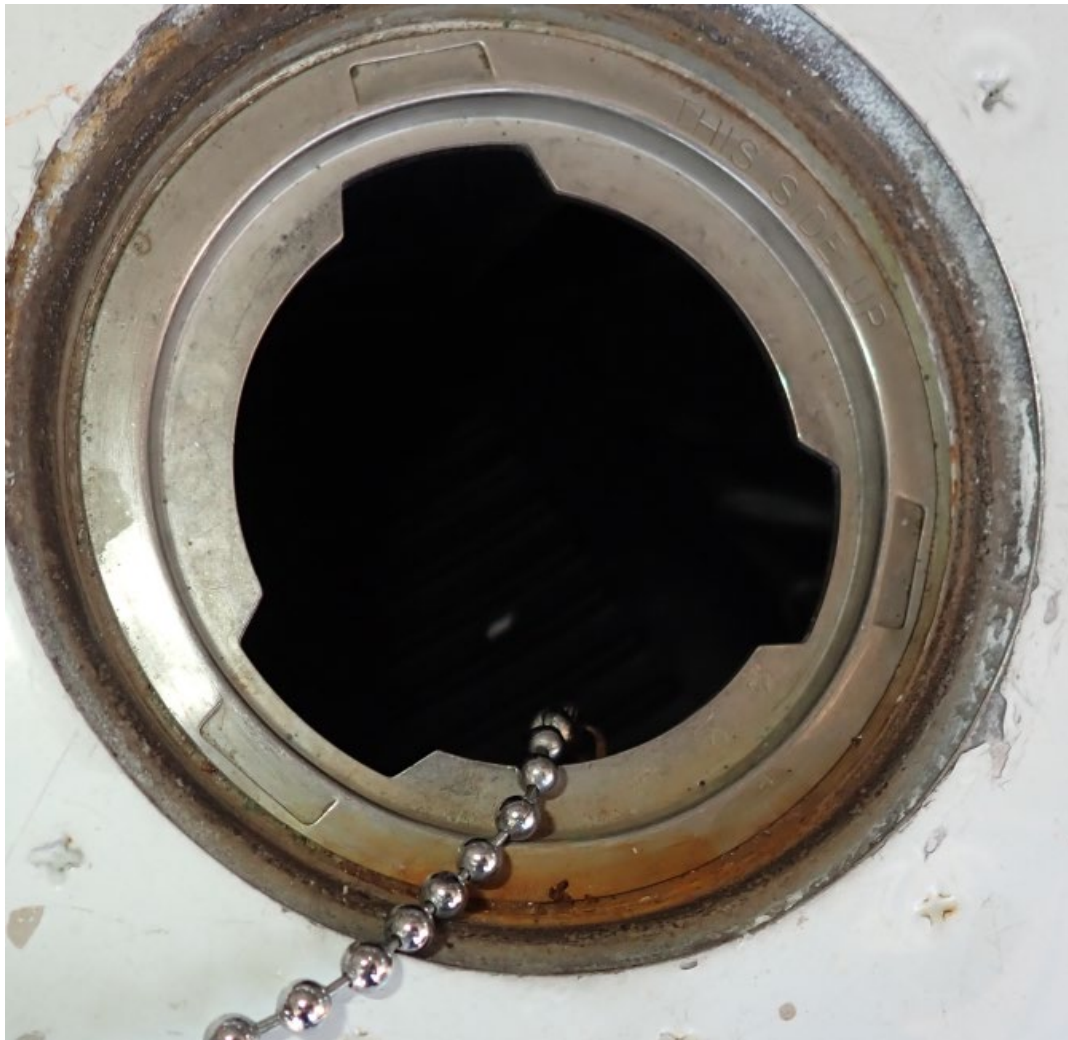
Continuity of the vent system was verified by blowing air pressure through the system. The vent line at the outboard section of the left wing was removed and air was introduced, resulting in fluid discharge consistent with water. The right wing vent system was similarly tested; pressurized air introduced at the inlet resulted in airflow out of the vent system and trace amounts of fluid exiting the lines. A water-detecting paste turned deep magenta when exposed to liquid recovered from the system, consistent with the presence of water. There was visible corrosion on the bottom of the fuel cap and receptacle screens. Fuel cap seals were pliable, the mating surfaces contained corrosion.

*Figure 7: Fuel cap receptacle (showing corrosion)*
