**Photo 1 –N7838W engine area. Photo NTSB.**

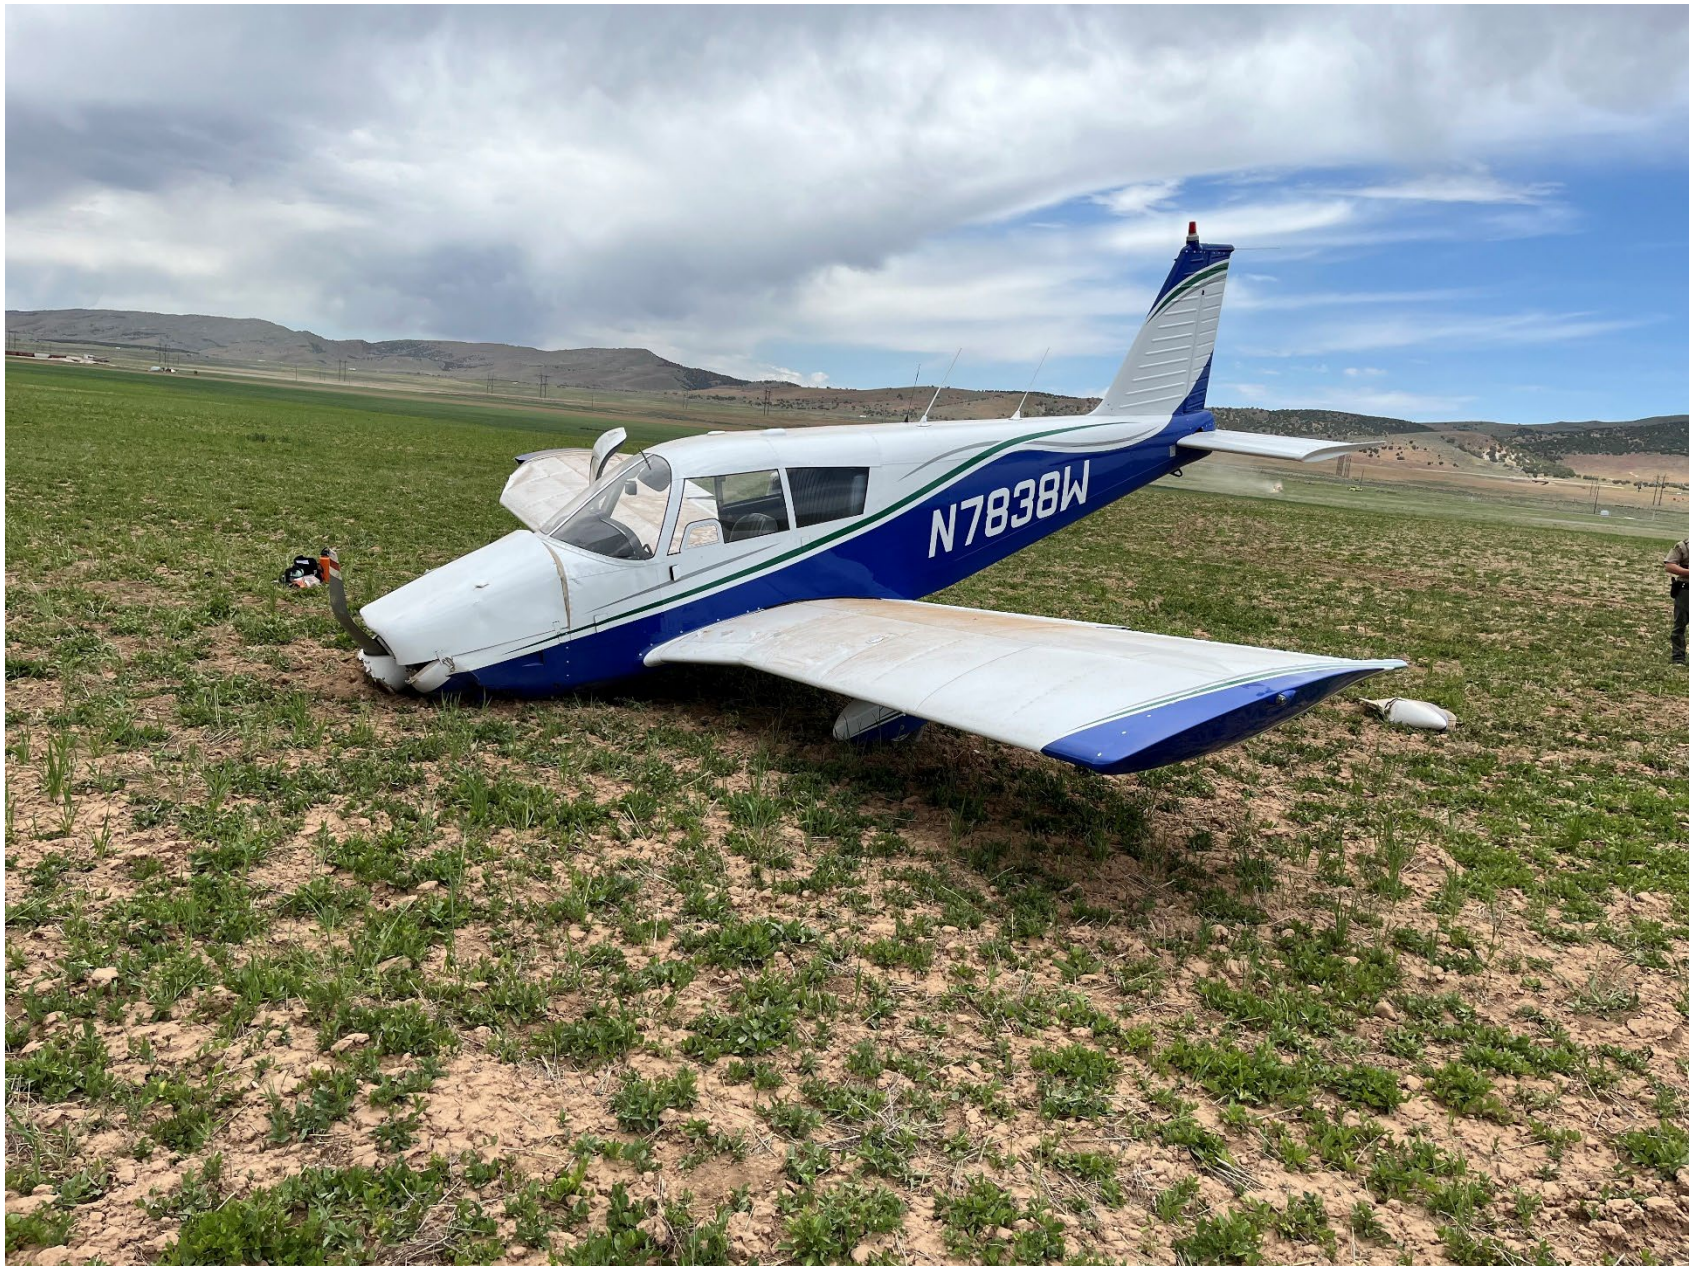
**Photo 2 -N7838W Left-side view. Photo insurance provider.**

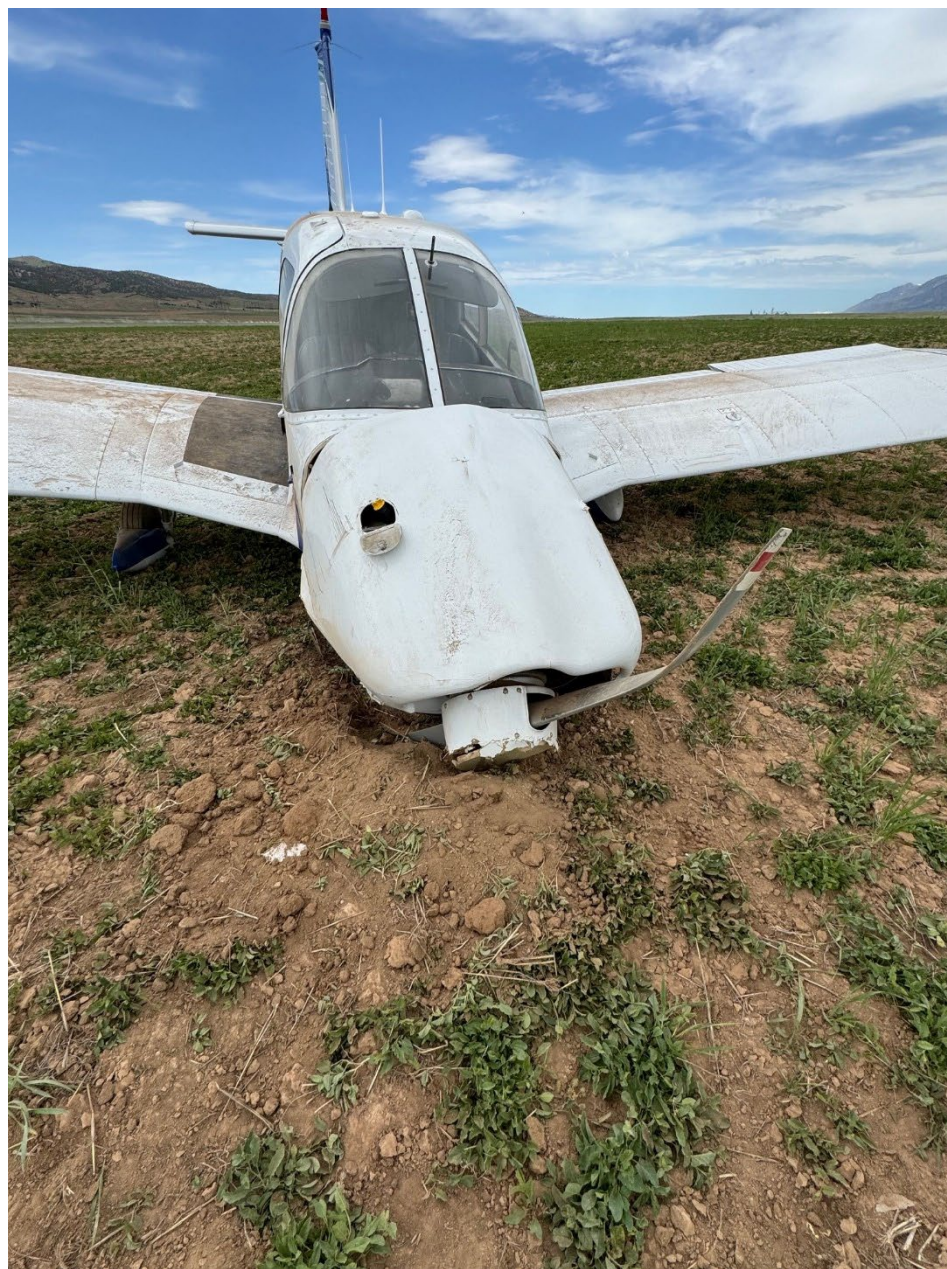
**Photo 3 -N7838W at the accident site, front view. Photo insurance provider.**
