WPR24LA183

## INVESTIGATION PHOTOGRAPHS

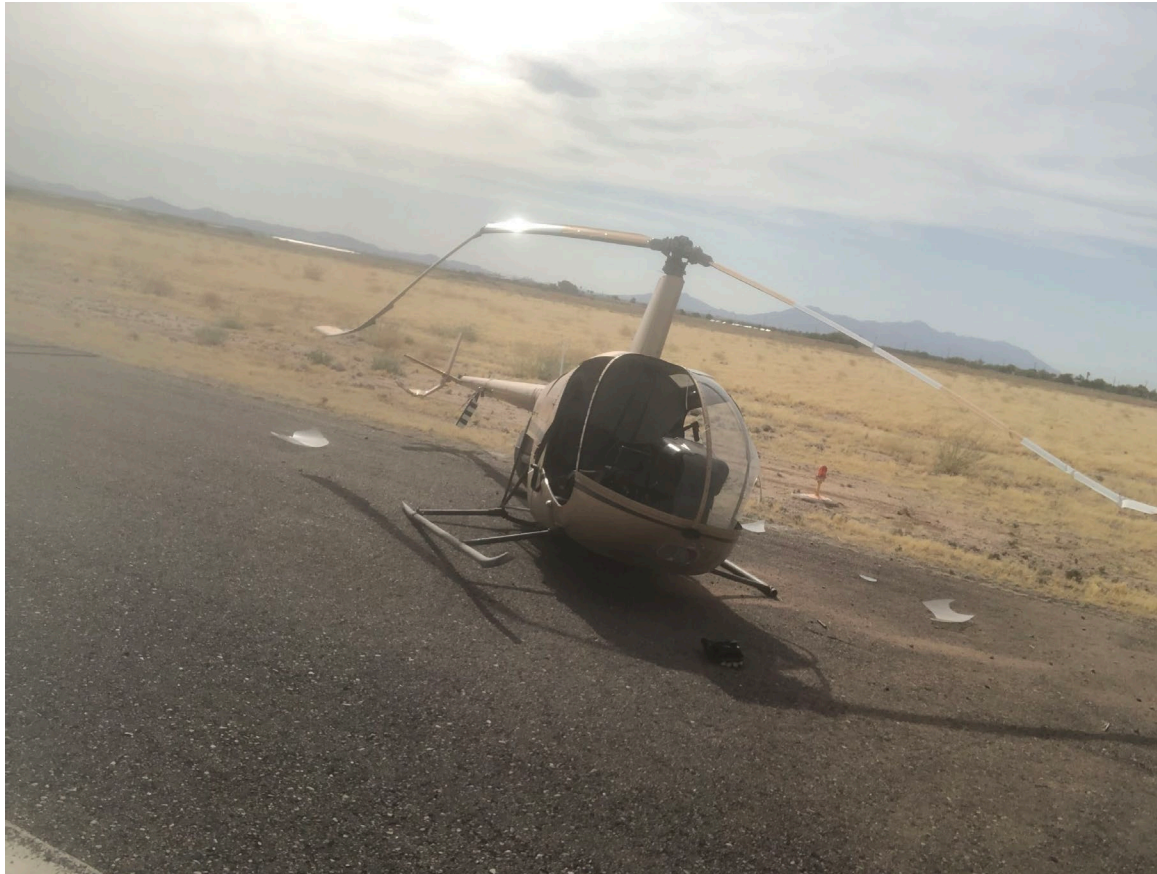
**Photograph 1 - View of damage to main rotor blades (Courtesy of Flight Instructor)**

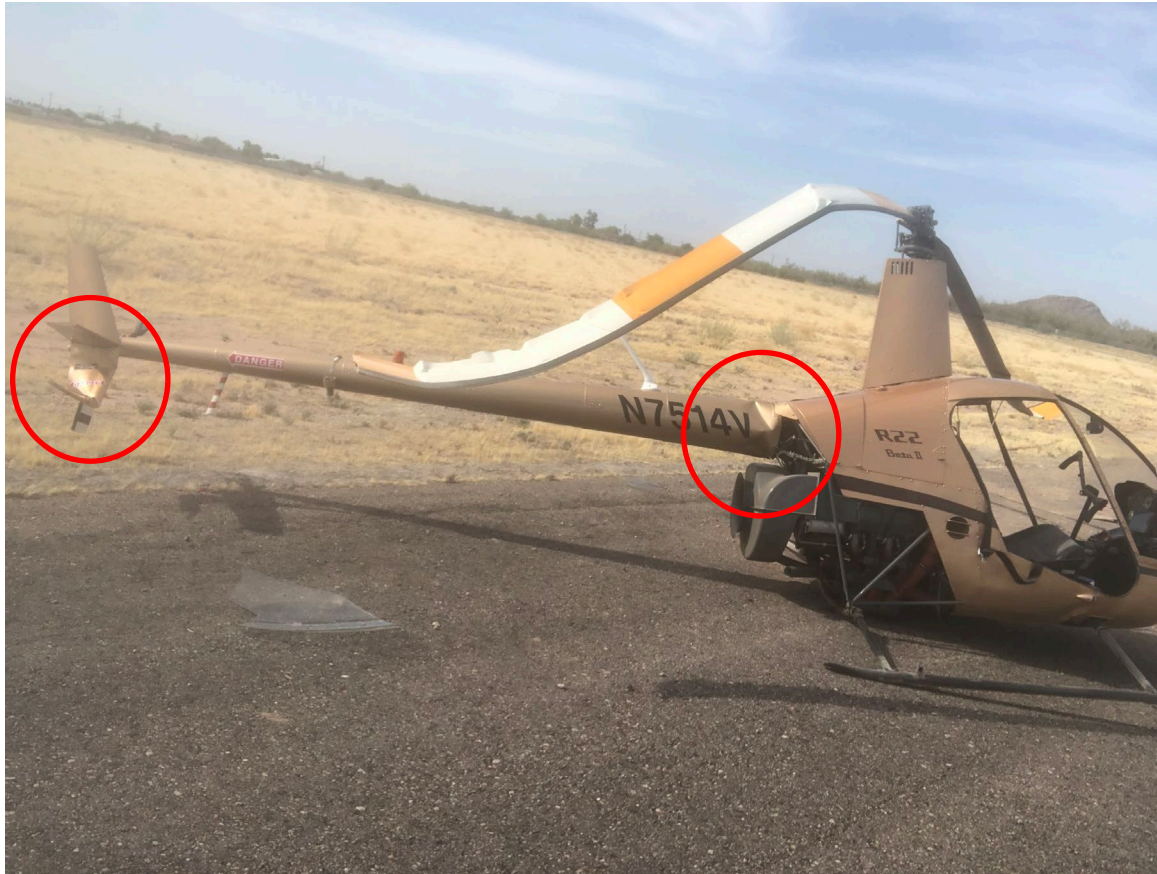
**Photograph 2 - View of damage to tail boom and vertical stabilizer (Courtesy of Flight Instructor)**
