WPR24LA186

## INVESTIGATION PHOTOGRAPHS

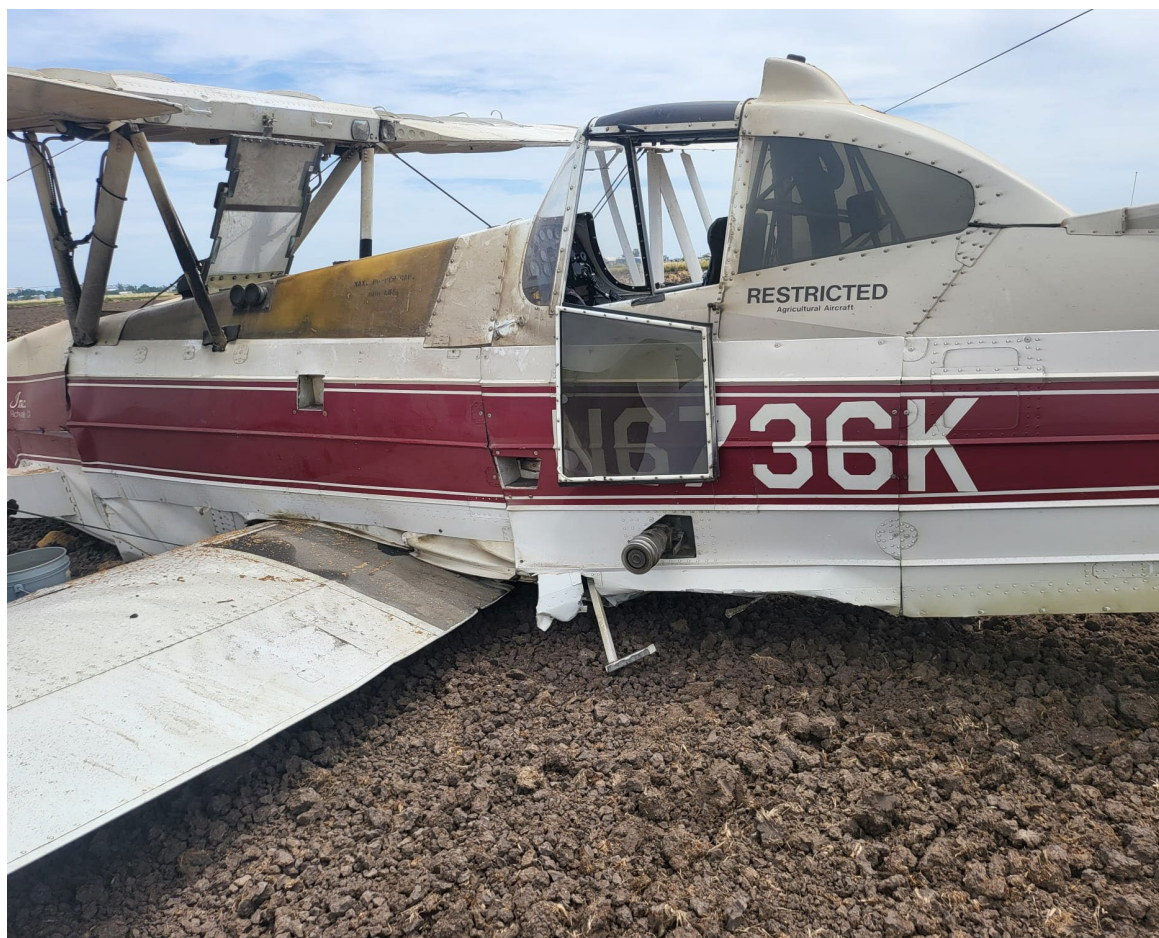
**Photograph 1 - Left-side view at accident site (Courtesy of the owner)**

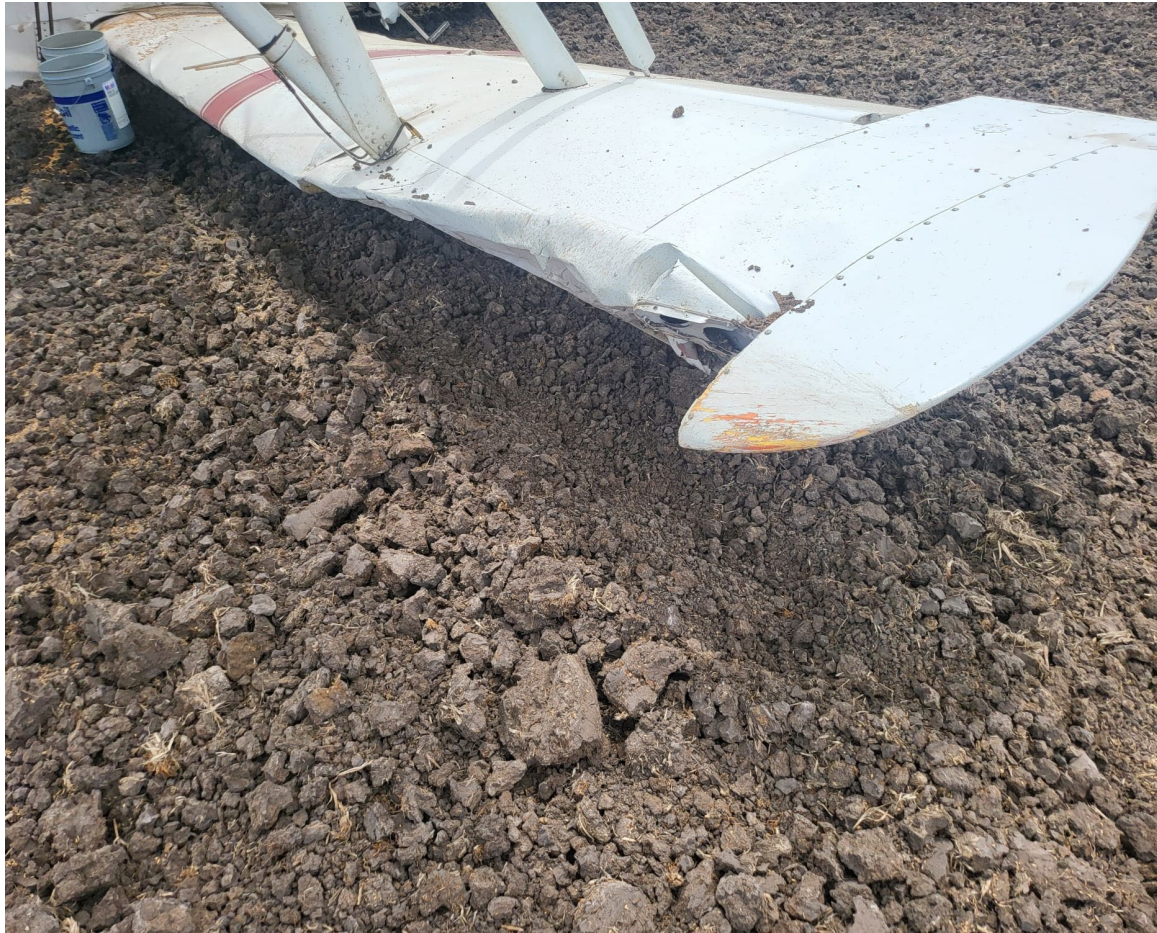
**Photograph 2 - Left side view of wing at accident site (Courtesy of the owner)**

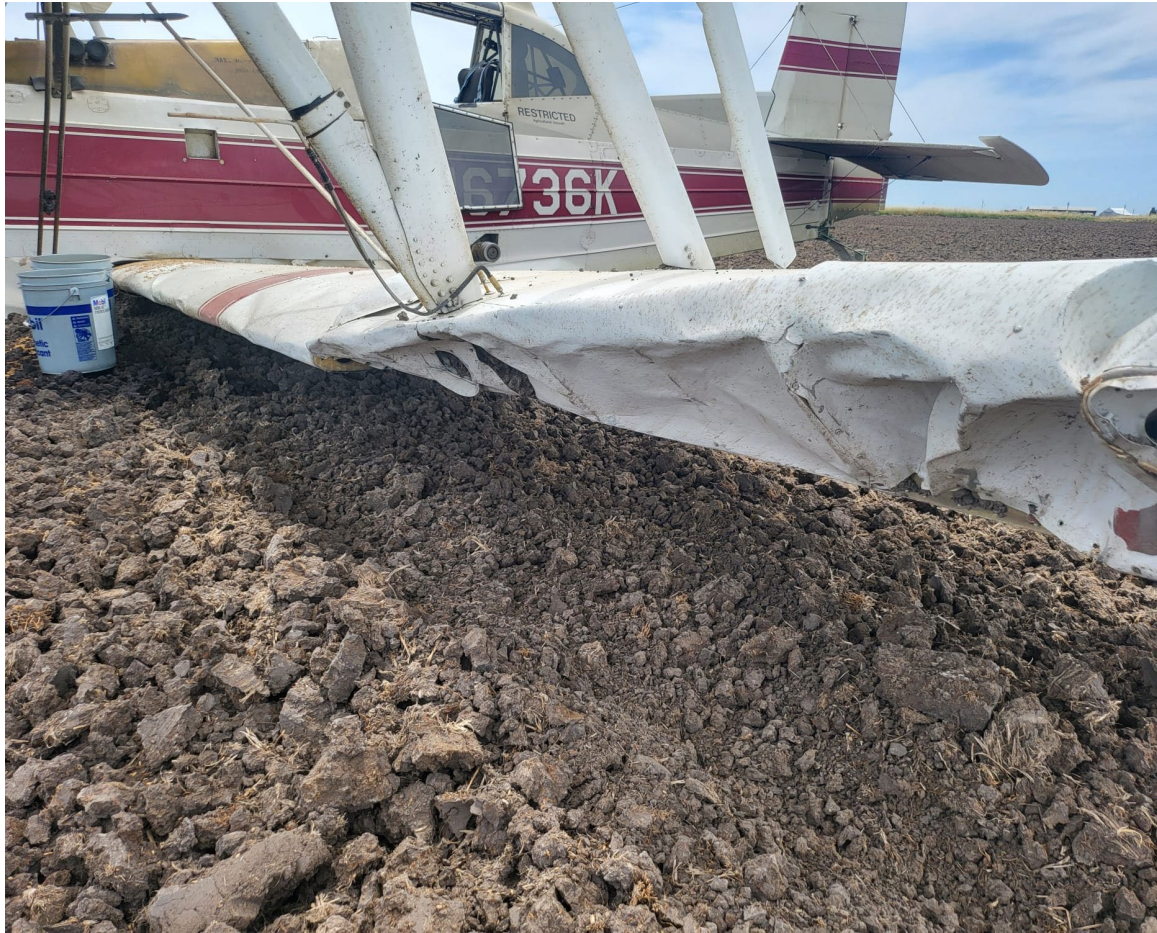
**Photograph 3 - Left wing leading edge at accident site (Courtesy of the owner)**
