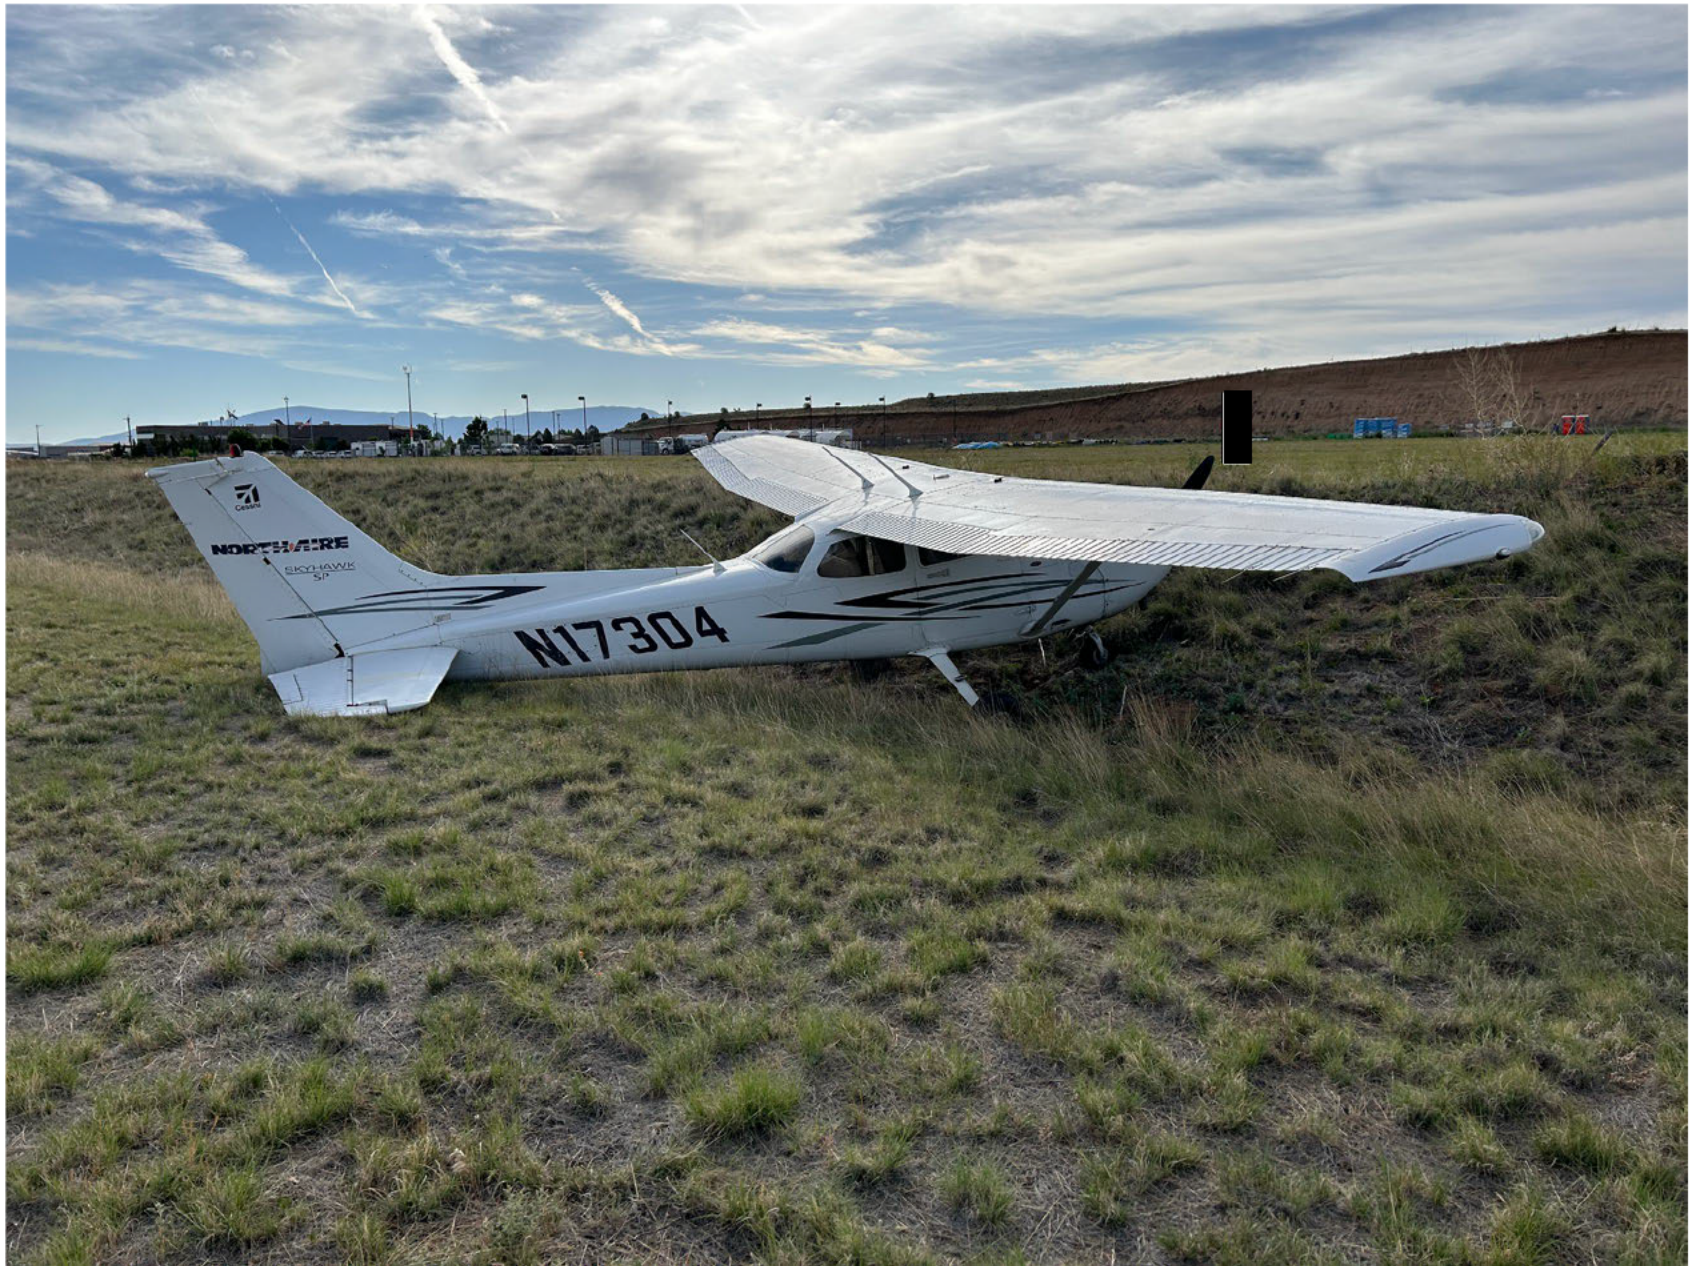
**Photo 1 – N17304 at the accident site. Photo courtesy of Airport Operations**

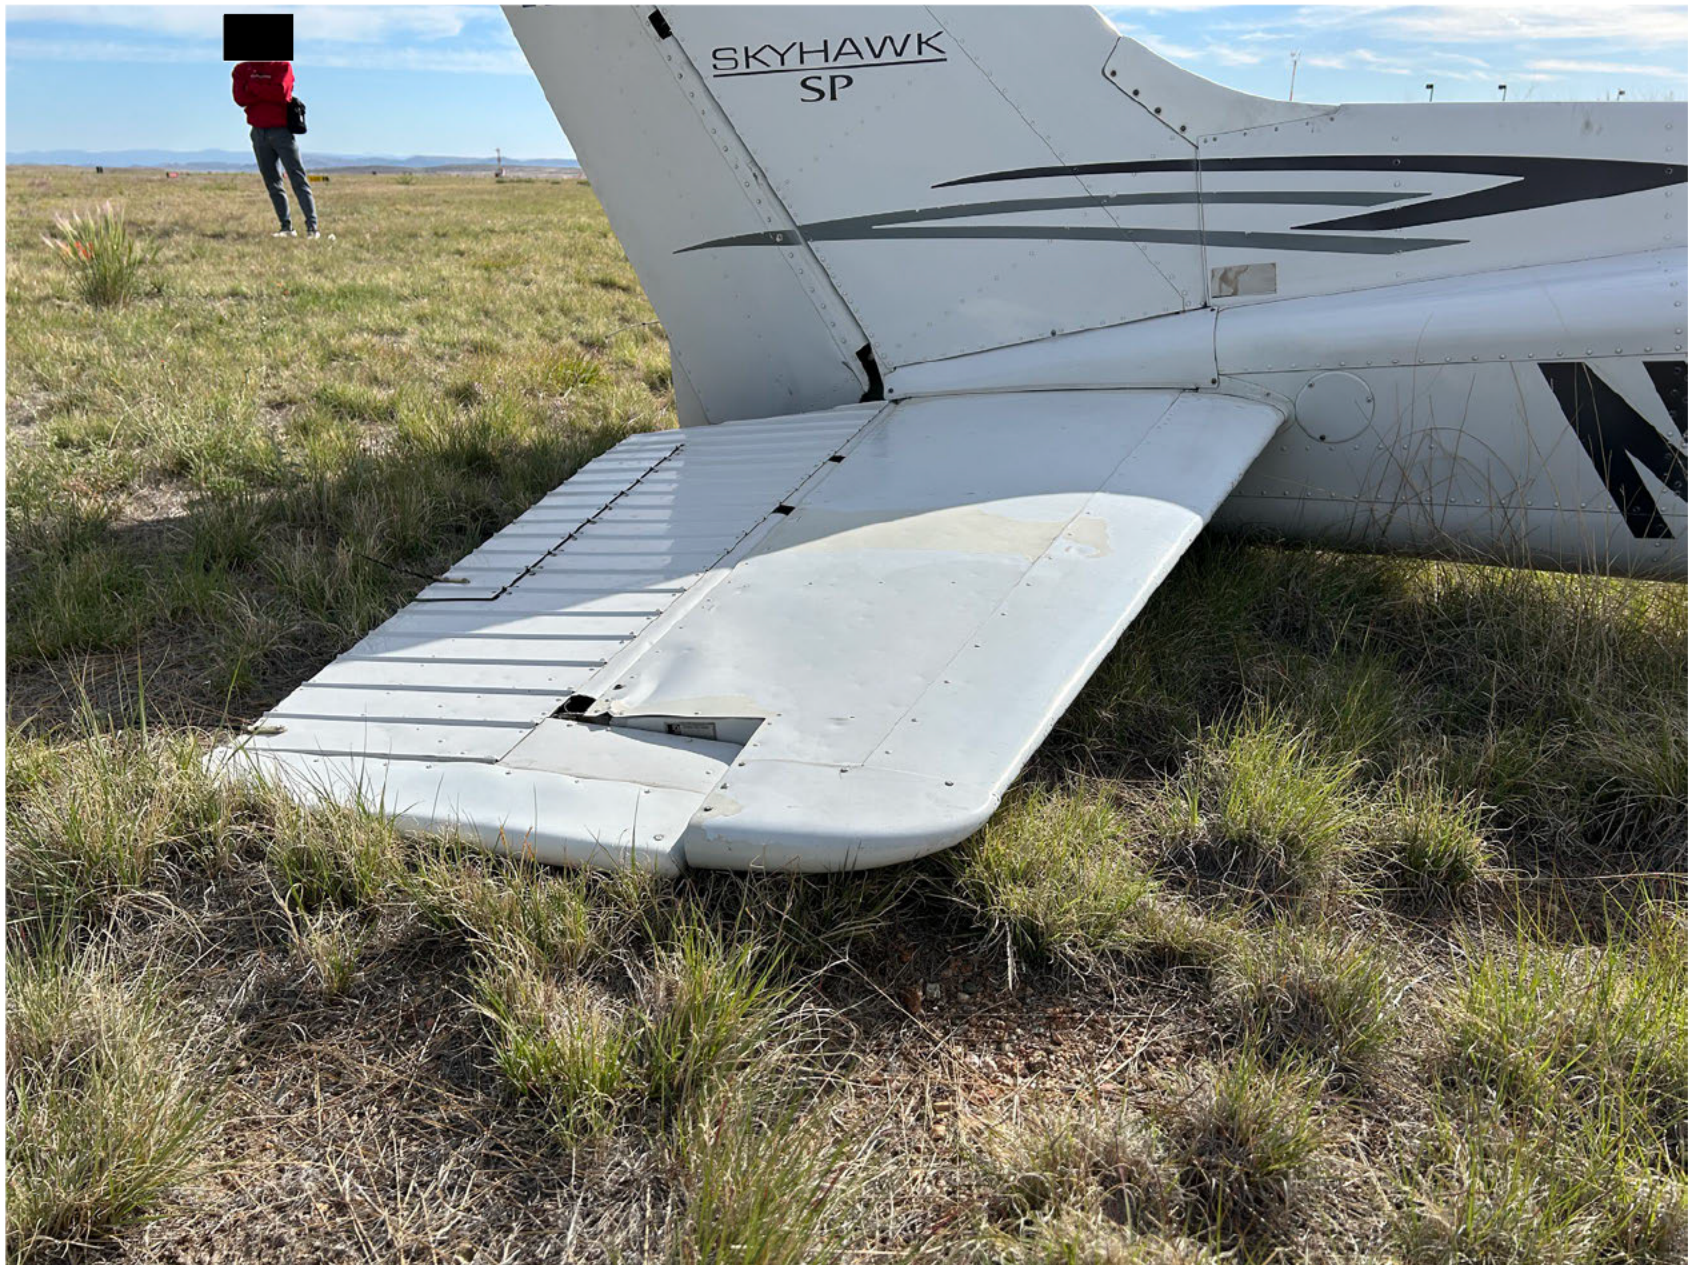
**Photo 2 – Substantially damaged horizontal stabilizer. Photo courtesy of Airport Operations**
