WPR24LA192

## INVESTIGATION PHOTOGRAPHS

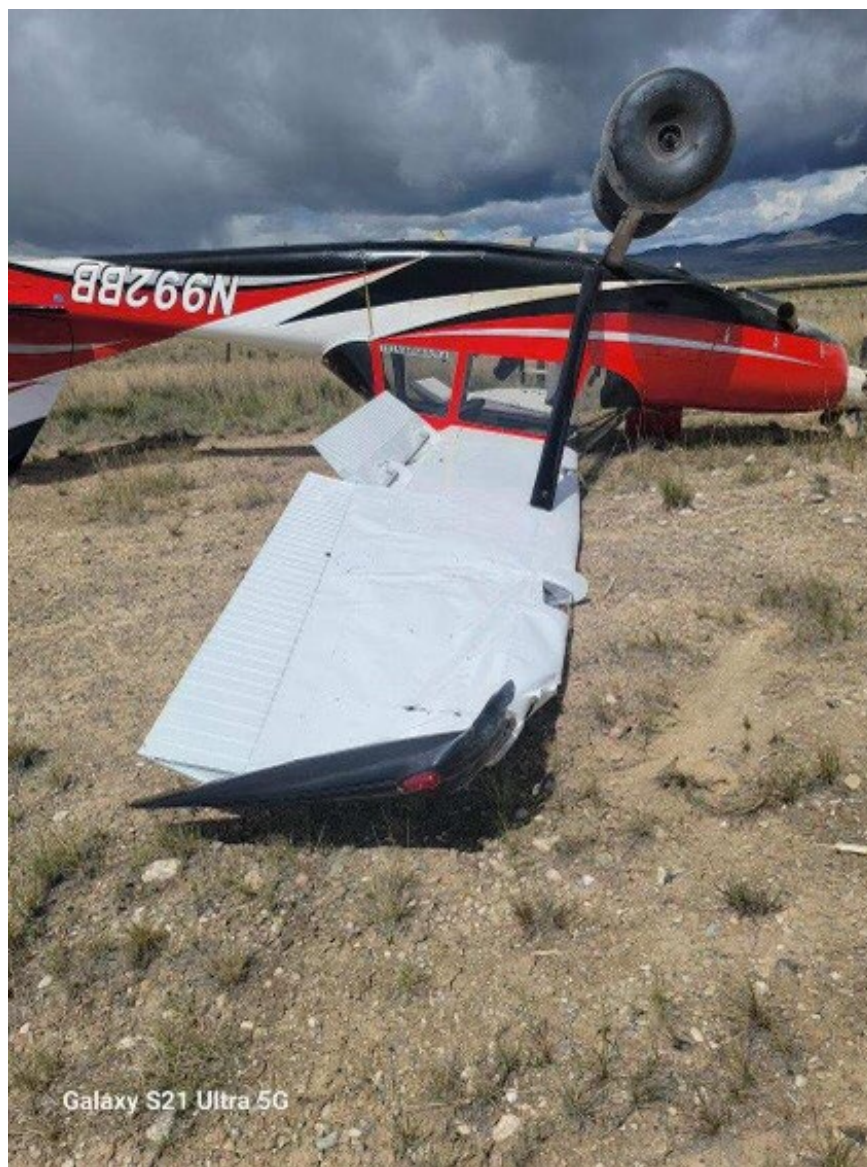
**Photograph 1 - Aircraft inverted with left wing damage (Courtesy of the owner)**

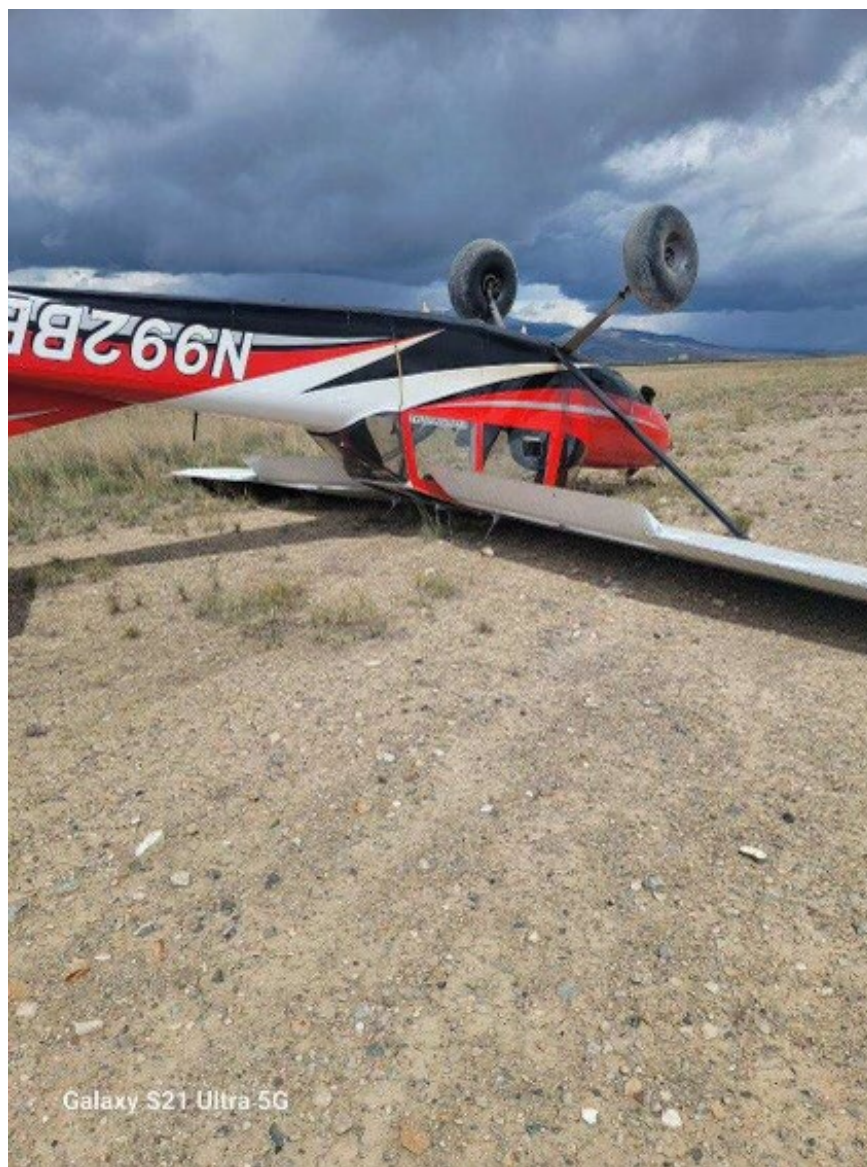
**Photograph 2 - Aircraft inverted at accident site (Courtesy of the owner)**

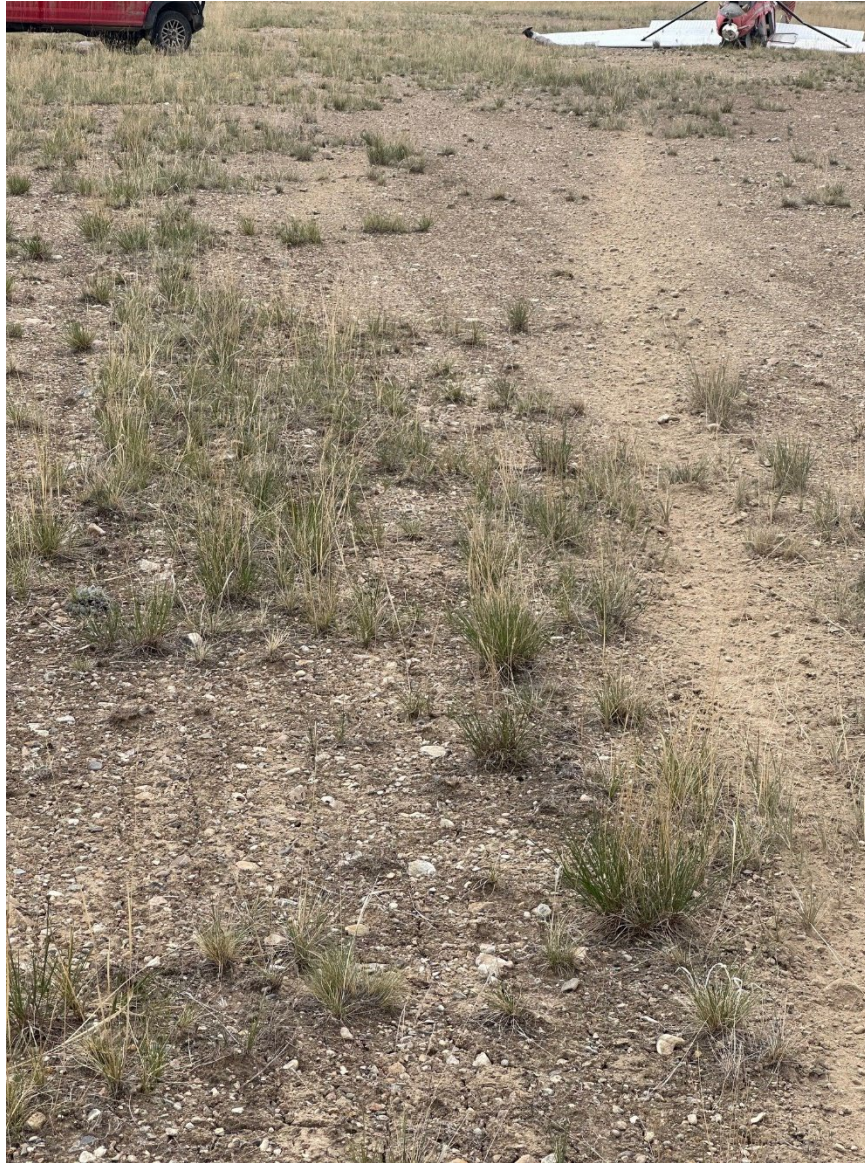
**Photograph 3 - View of skid marks leading to inverted aircraft (Courtesy of owner)**
