# National Transportation Safety Board

WPR24LA194

## **MATERIALS LABORATORY**

Factual Report 25-032

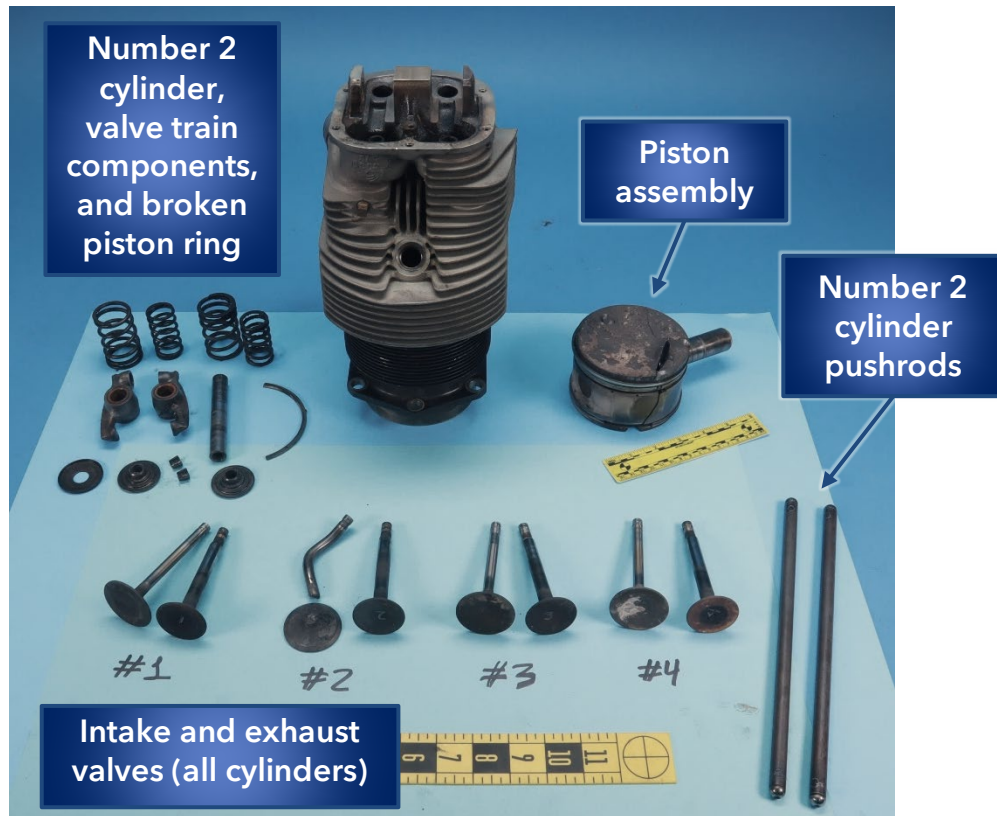
An overall view of the submitted components as received is shown in figure 1. The components included the number 2 cylinder assembly with pushrods, rocker arms, rocker shaft, valve springs and seats, valve spring seat locks (keepers), and valves disassembled from the cylinder as shown in figure 1. The number 2 piston assembly with partially removed piston pin was also received as shown in figure 1. Intake and exhaust valves from the numbers 1, 3, and 4 cylinders were also received, and all the valves are shown labeled with their respective cylinder number in figure 1.

**Figure 1.** Overall view of the number 2 cylinder assembly including disassembled components from the valve train, number 2 piston assembly, and intake and exhaust valves for the remaining cylinders as received.

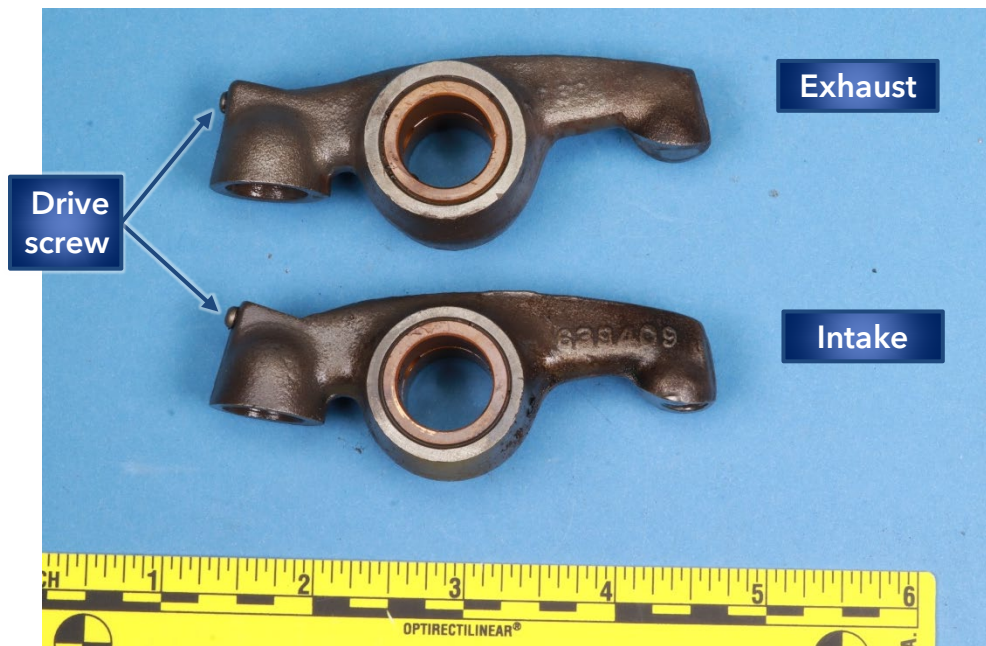
The intake and exhaust rocker arms for the number 2 cylinder are shown in figure 2 after oily deposits were wiped from the surfaces. Both rocker arms had a drive screw at the pushrod end of the rocker arm consistent with an oil channel between the pushrod and the rocker bushing. However, neither of the rocker arms had a drive screw or an oil orifice for valve stem lubrication at the rocker pad end.

The Continental Aerospace Technologies Standard Practice Maintenance Manual (SPMM) includes a section titled "Rocker Arm Identification" that shows differences between the intake and exhaust rocker arm part numbers 639614 and 639615, respectively, that are installed on Continental O-200-series engines.<sup>1</sup> Both rocker arms have oil channels with drive screws at the pushrod end, but the part number 639615 exhaust rocker arm also has an oil channel with a drive screw and orifice at the rocker pad end. According to the SPMM, the distinction is important. "Installing rocker arms in the incorrect position may cause oil starvation to the valve train and/or shorten cylinder life."

**Figure 2.** Side view of the intake and exhaust rocker arms from the number 2 cylinder.

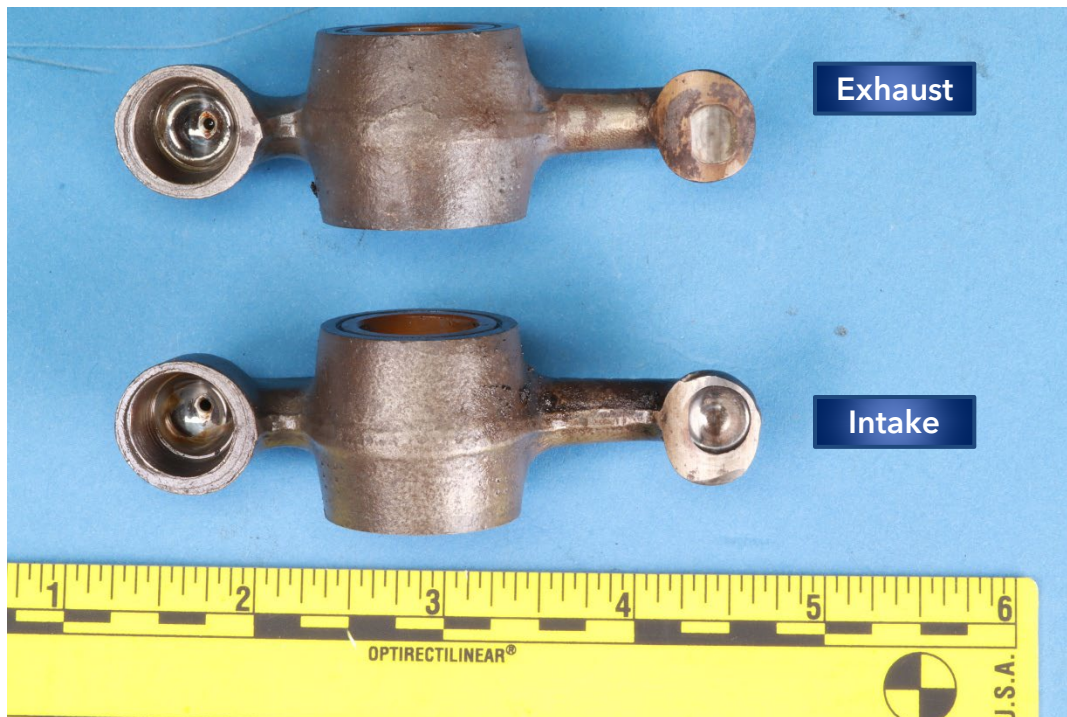
The rocker pads for both rocker arms are shown in figure 3. Both rocker pads were worn from contact with the valve tips, and the wear patterns corresponded to mating wear patterns observed on the respective valve tips. The pad for the rocker arm installed in the exhaust position was tinted dark around the worn area, and coked oil adhered to portions of the pad surfaces around the worn area. The wear on the intake rocker arm was deeper than the wear observed on the exhaust rocker pad. Within the worn area on the intake rocker pad, the wear was deeper around the edges than at the center, forming a convex shape to the wear pattern. The edges of the intake rocker pad were also worn from contact with the inside diameter of the intake valve seat.

**Figure 3.** View of the rocker pads on the intake and exhaust rocker arms for the number 2 cylinder.

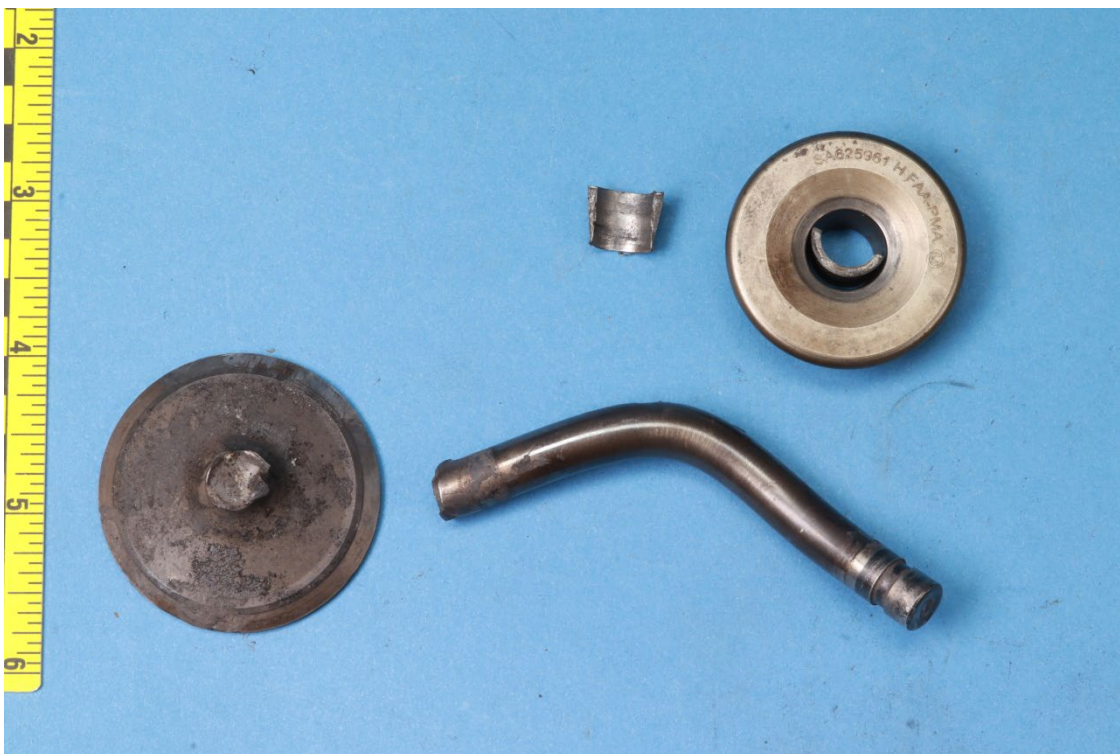
A closer view of the number 2 intake valve, valve seat, and keeper halves is shown in figure 4. One of the keeper halves was loosely held within the valve spring seat and could not be separated from the seat when manipulated by hand. The inside diameters of both intake keeper halves were severely worn, and the locking tab for keeping the intake valve in place was missing on both halves. The outside

diameter surfaces were also worn, and corresponding wear was observed on the inside diameter of the valve spring seat. The inboard edges of the intake keeper halves were deformed outboard, deformation that contributed to trapping one of the keeper halves within the valve spring seat.

**Figure 4.** Number 2 intake valve, keepers, and spring seat.

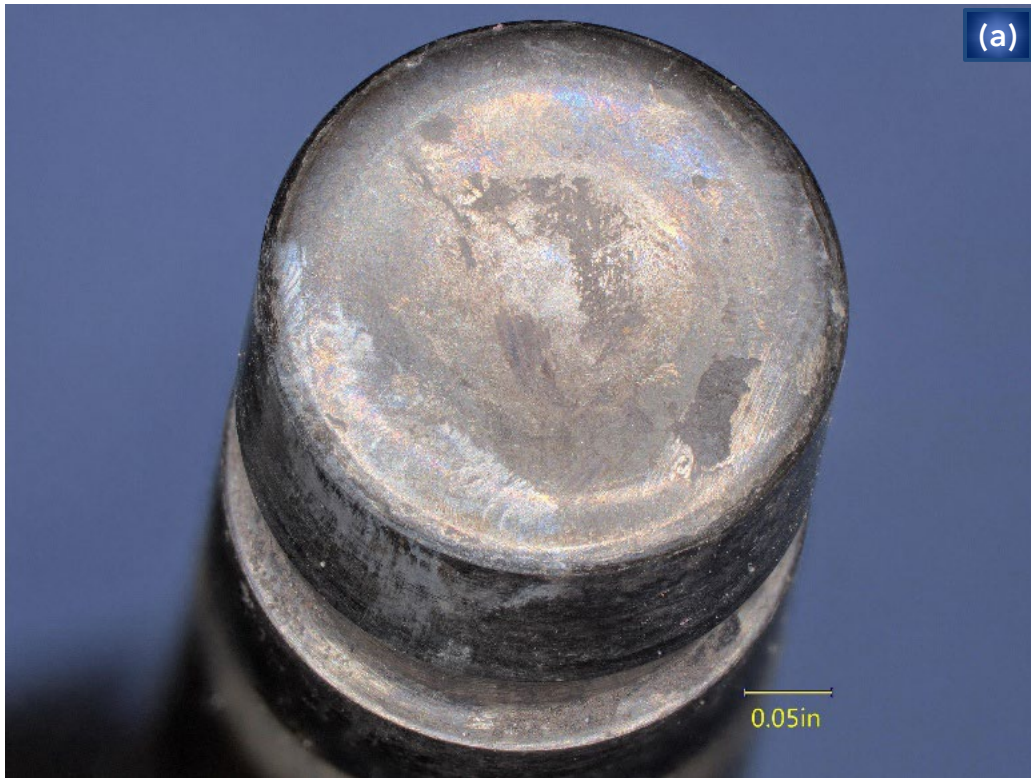
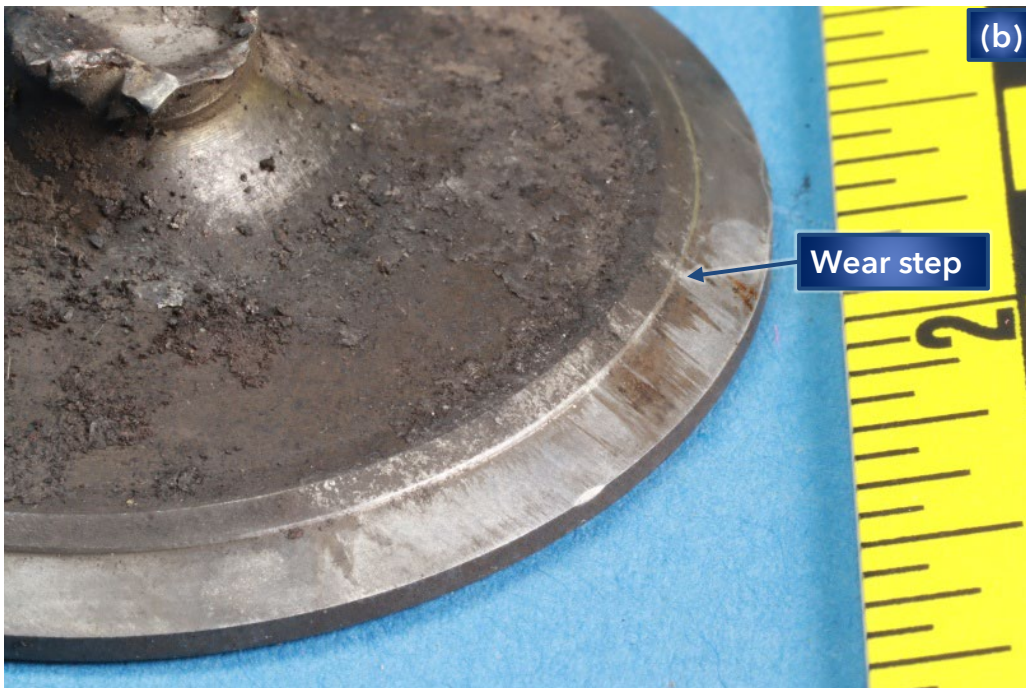
The tip end face of the number 2 intake valve was smooth as shown in figure 5(a). The middle portion was worn more extensively than the surrounding area, forming a concave surface profile across the central portion of the surface. The outer edges around the circumference of the tip face were rounded from wear. In the keeper contact area near the tip of the stem, the surfaces were tinted black. The fracture through the stem adjacent to the head was irregular and on slant planes, features consistent with overstress fracture. A close view of the valve seat contact face is shown in figure 5(b). The contact face was worn, leaving a step on the contact face as indicated in figure 5(b).

**Figure 5.** (a) Number 2 intake valve tip end face and (b) valve seat contact face.

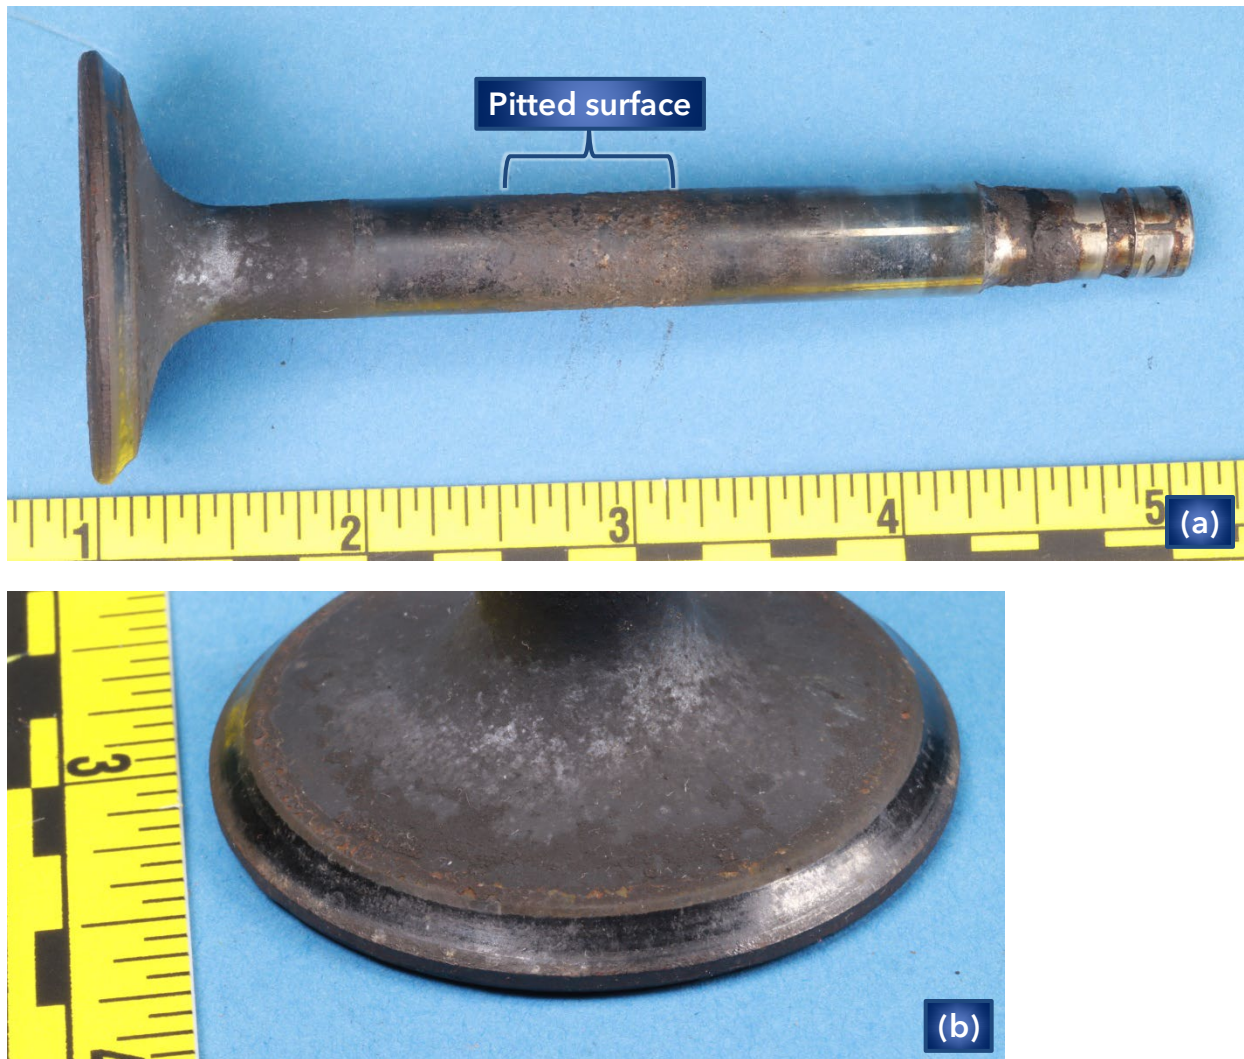
Views of the number 2 exhaust valve are shown in figure 6. The tip end face had a circular contact pattern that was smooth from wear, and the edges at the outer circumference were rounded. Isolated pits with rounded edges were also observed on the tip end face. Thick coked oil deposits were observed at the tip end of the valve stem between the stem's shoulder and the tip end face. Keeper contact faces showed pitting and wear consistent with fretting damage. Corresponding wear was observed on the exhaust keeper halves including worn contact surfaces on the outboard sides of the locking tabs mostly near the longitudinal edges (split faces) of the keeper halves.

The valve stem had a dark tint extending up to 2.5 inches from the head end face. Substantial pitting damage was observed on the stem between 1.5 inches and 2.2 inches from the head end face as indicated in figure 6(a). The valve seat contact area mostly had a black, glazed appearance as shown in figure 6(b). The contact area for the valve seat appeared uneven around the circumference. Isolated areas of dark gray deposits and radially-oriented streaks were also observed on the valve seat contact area around the circumference.

**Figure 6.** (a) Number 2 exhaust valve with (b) a close of the valve seat contact face.

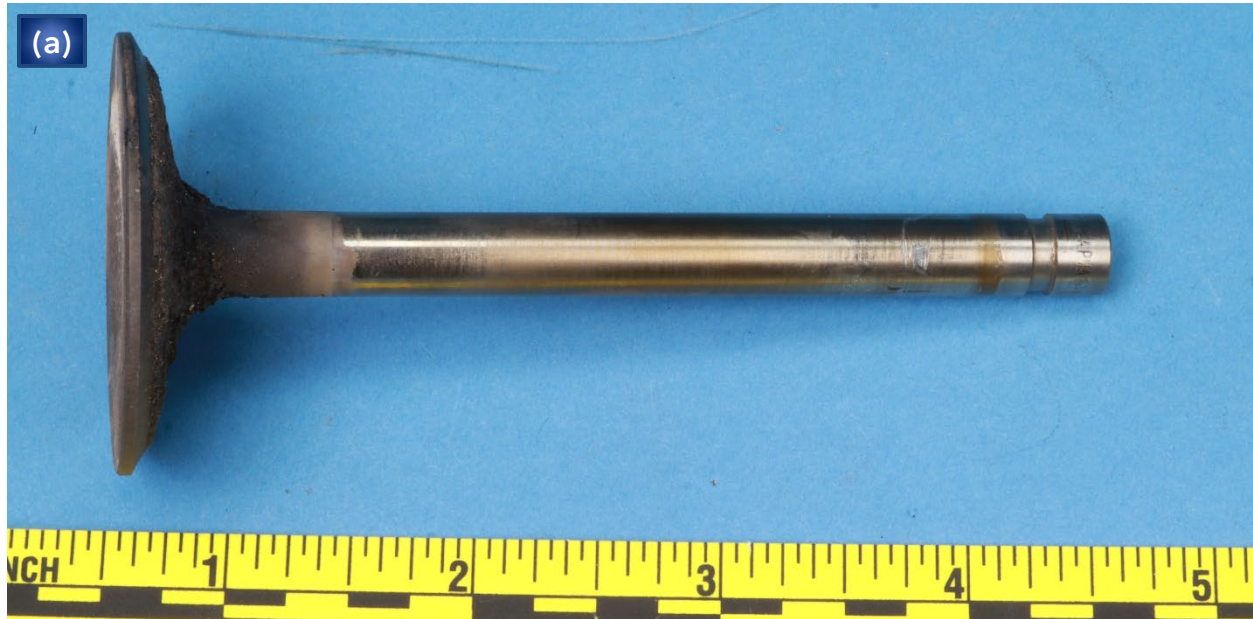
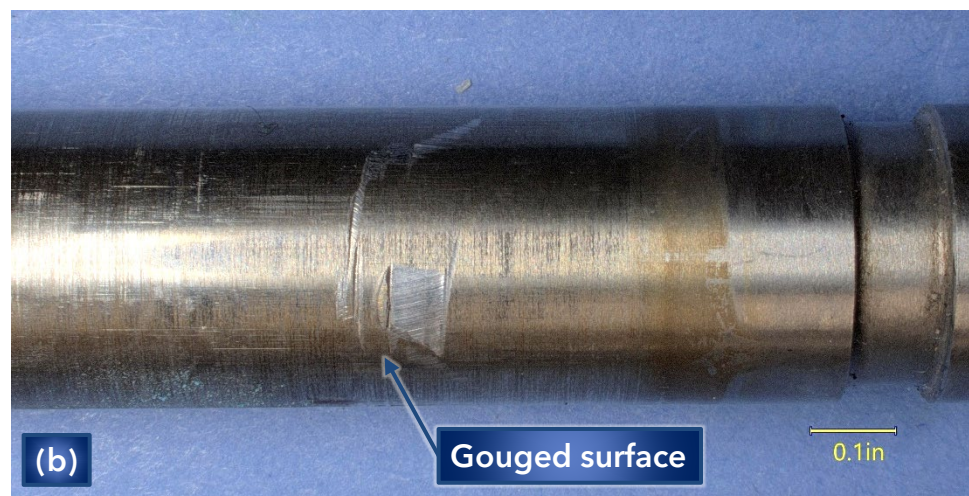
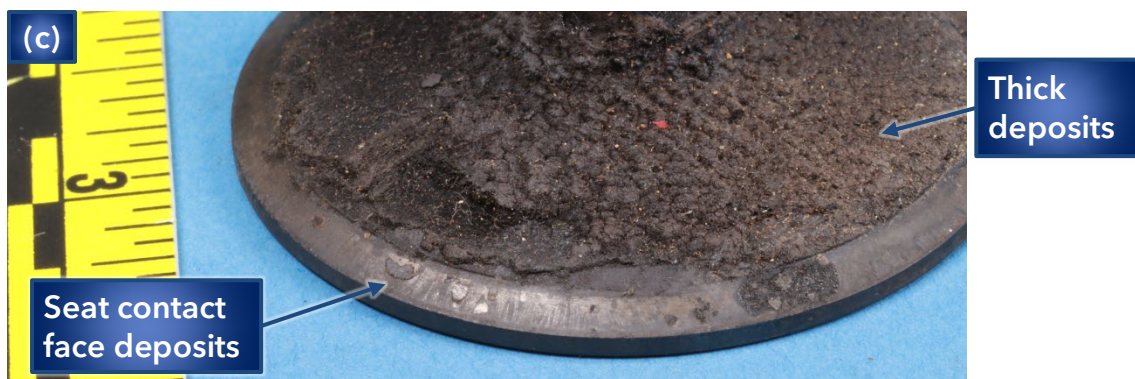
Each of the intake valves from cylinders 1, 3, and 4 had circumferential gouges and adjacent linear scrape marks near the tip end of the valve stem. Gouged and scraped areas on the number 4 intake valve stem are shown in figure 7(a and b).

Thick black deposits were observed on the stem side of the head on each of the intake valves from cylinders 1, 3, and 4. A view of typical deposits on the number 4 intake valve are shown in figure 7(c). Flattened deposits were also observed on the valve seat contact surfaces on each valve, including the number 4 valve seat contact face shown in figure 7(c). On the number 4 intake valve, the deposits on the valve seat contact face were also associated with radial flow lines. Tan deposits were observed on portions of the head end face of the number 4 intake valve that were not observed on other intake valve heads.

**Figure 7.** Number 4 intake valve (upper image) with closer views of a damaged area on the valve stem (middle image) and deposits on the stem side of the valve head including on the valve seat contact face (lower image).
