# National Transportation Safety Board

WPR24LA194

## **WRECKAGE EXAMINATION SUMMARY REPORT**

Location: Roll, Arizona  
Date: June 11, 2024  
Time: 1250 local  
Airplane: Cessna 150M

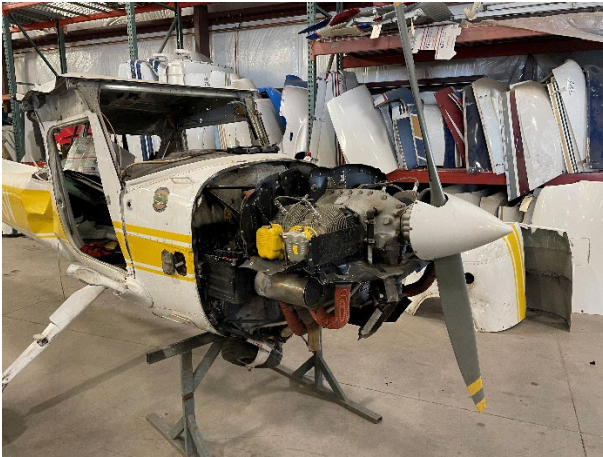
Figure 1-Follow-up examination, main wreckage.

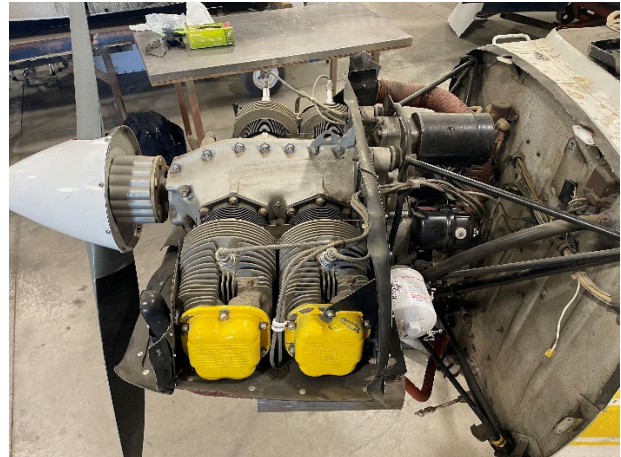
Figure 2-Engine de-cowled.

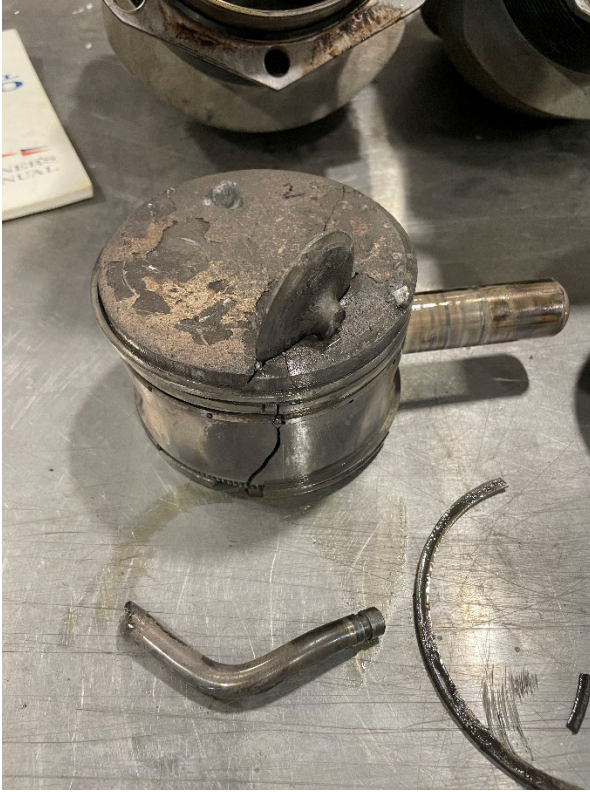
Figure 3- Intake valve head embedded in No. 2 piston head.

The No. 2 induction valve head was found imbedded into the No. 2 piston head. The valve head separated from its stem near the radius at the head. The stem was found in the carburetor throat when the carburetor was removed during the examination. The separation surfaces on the valve head and stem were jagged in appearance. The No. 2 piston was cracked in half, and the rings kept the cylinder from separating. The No. 2 exhaust valve was removed from the cylinder and the valve stem revealed pitting corrosion about 1 inch from the head. All the valves were removed from the cylinders.

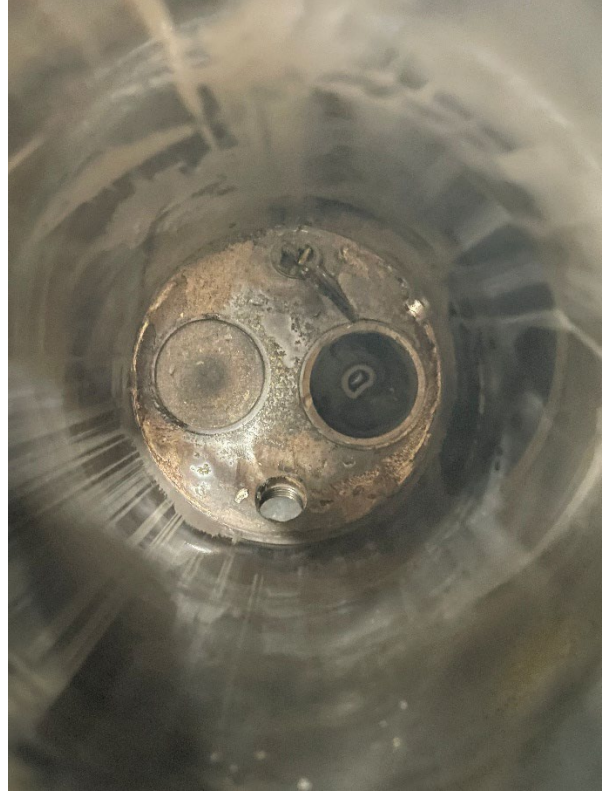
Figure 4- Interior view of No. 2 cylinder.

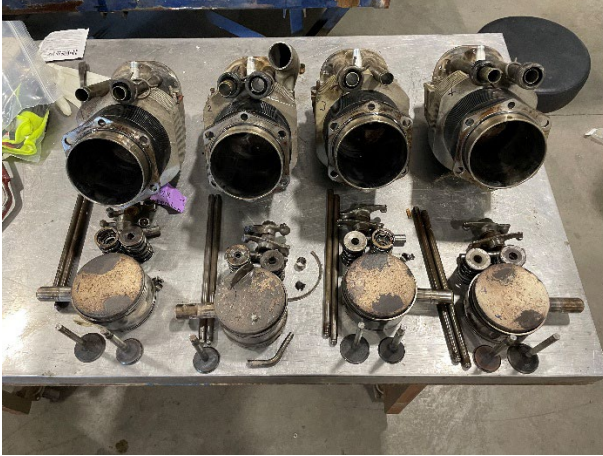
The No. 2 cylinder, piston, and all eight valves were shipped to the NTSB Materials Laboratory for further examination.

Figure 3- All cylinders, pistons, and valves laid out on table.

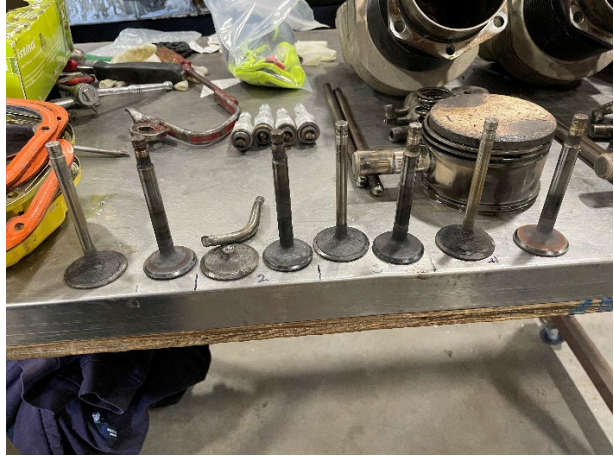
Figure 4- Intake and exhaust valves.
