WPR24LA197

## INVESTIGATION PHOTOGRAPHS

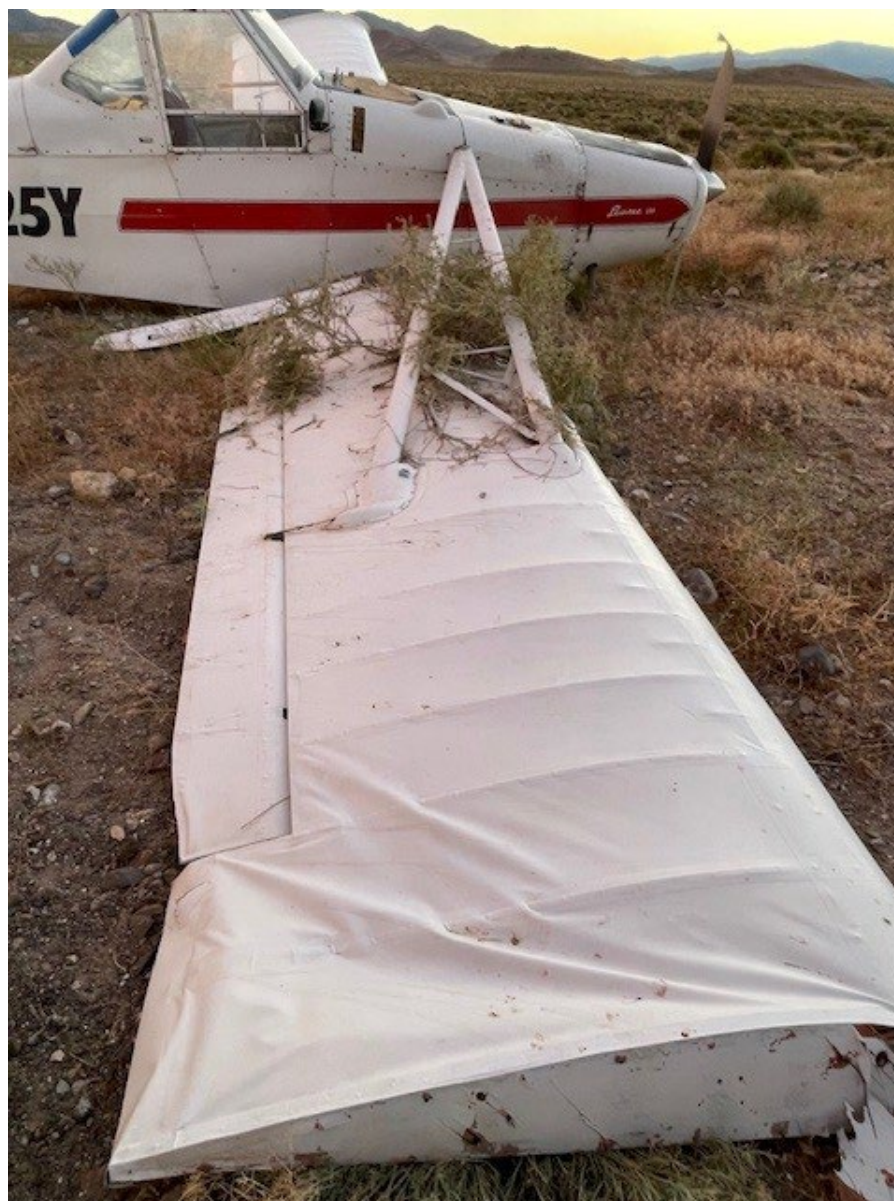
**Photograph 1 - View of damage to right wing. (Courtesy of owner)**

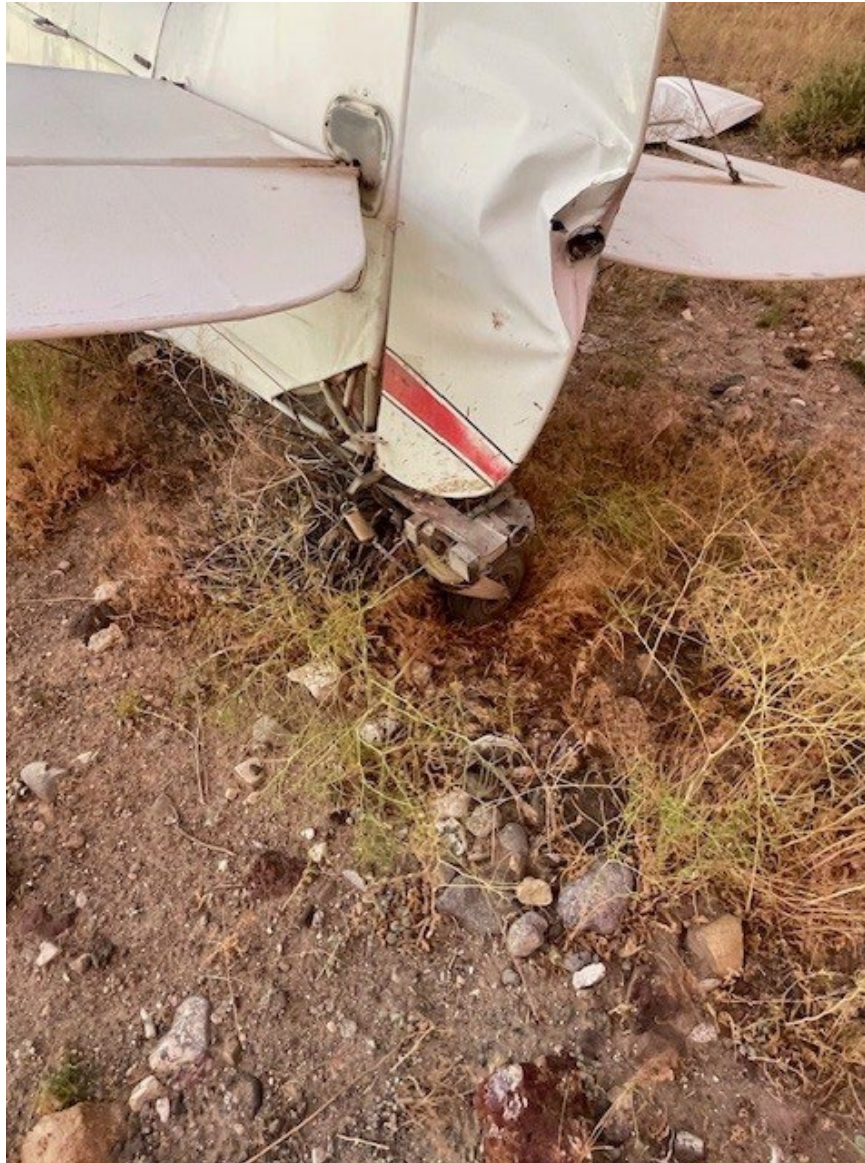
**Photograph 2 - View of damage to rudder. (Courtesy of pilot)**
