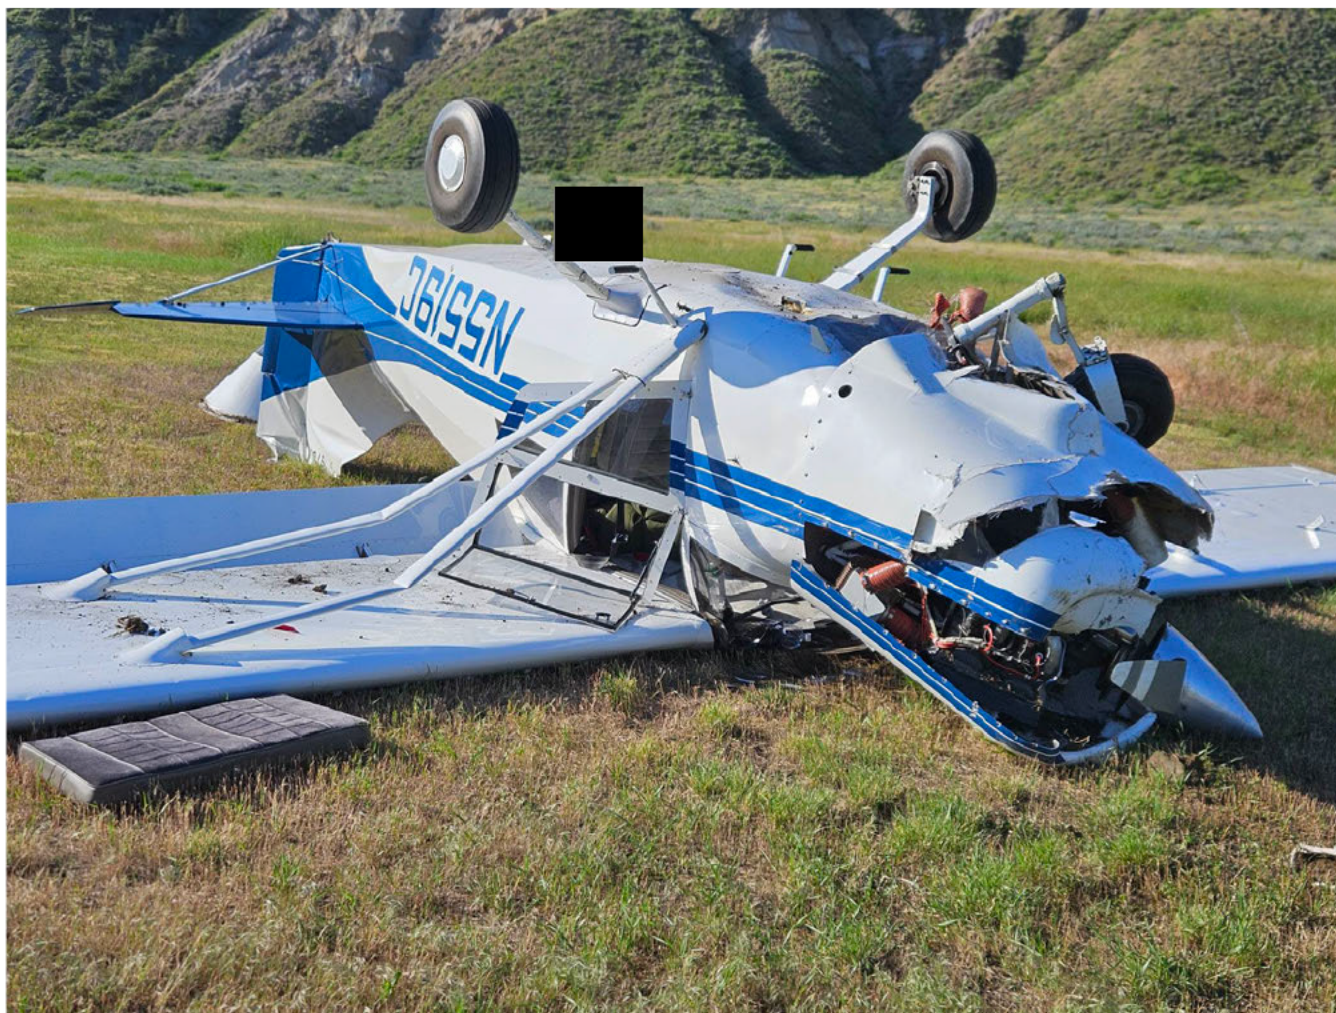
**Photo 1 – N5519C at accident site (courtesy of accident pilot)**
