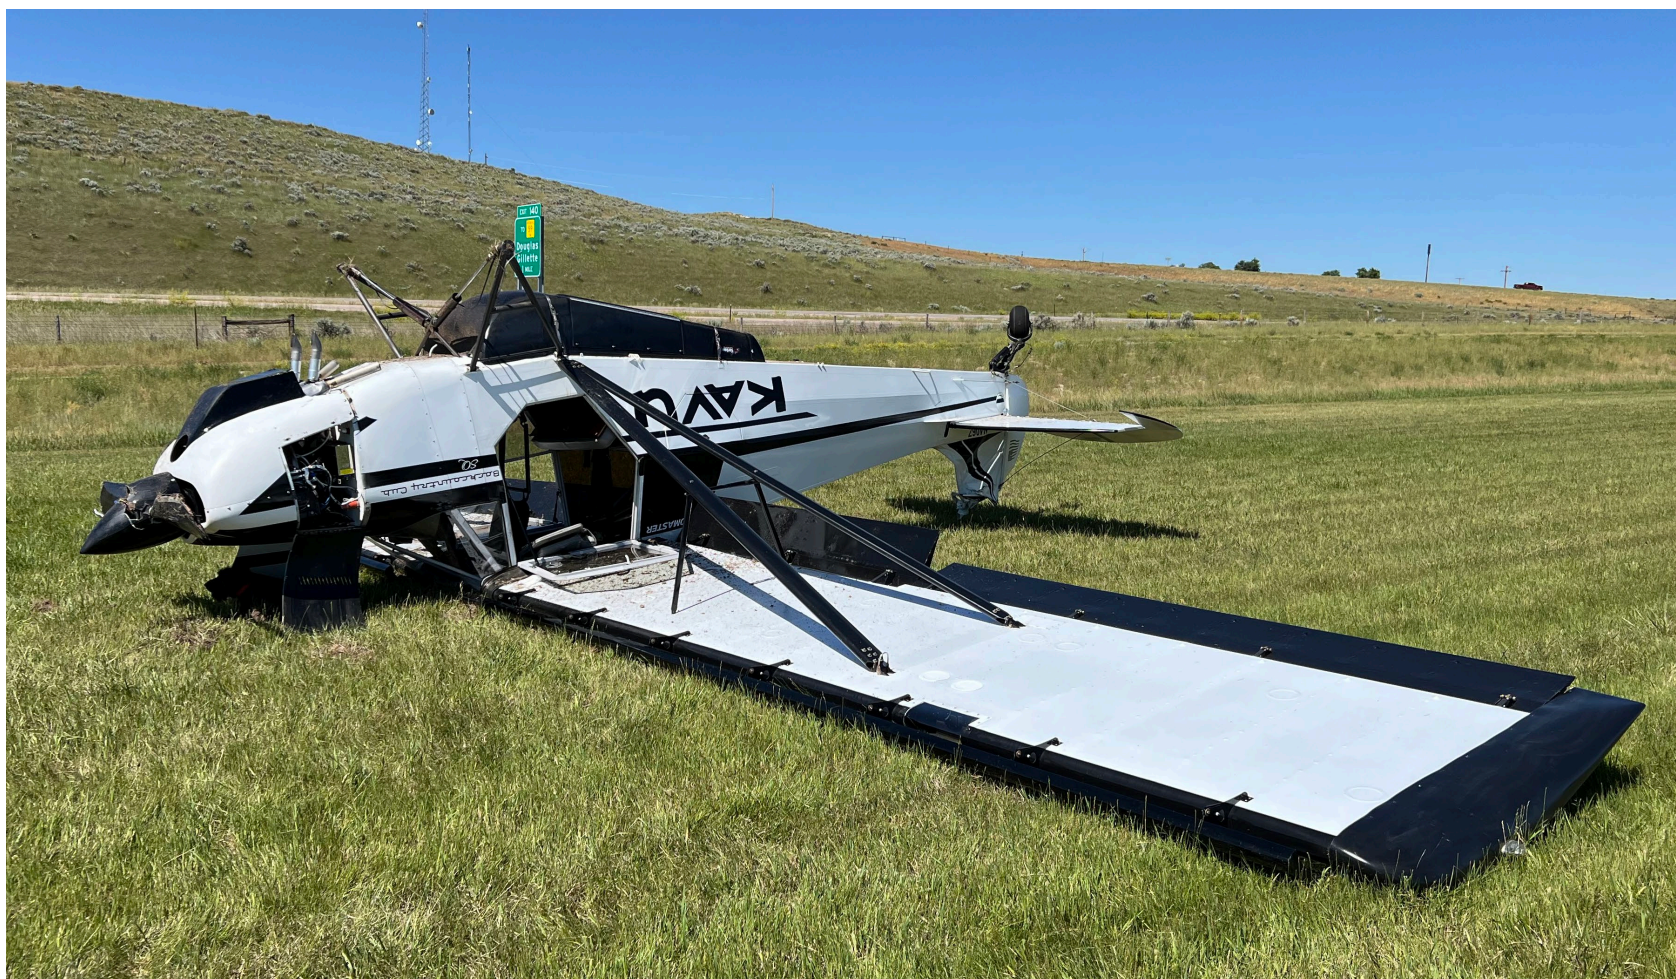
**Photo 1 – Accident airplane inverted at accident site (courtesy of Federal Aviation Administration)**

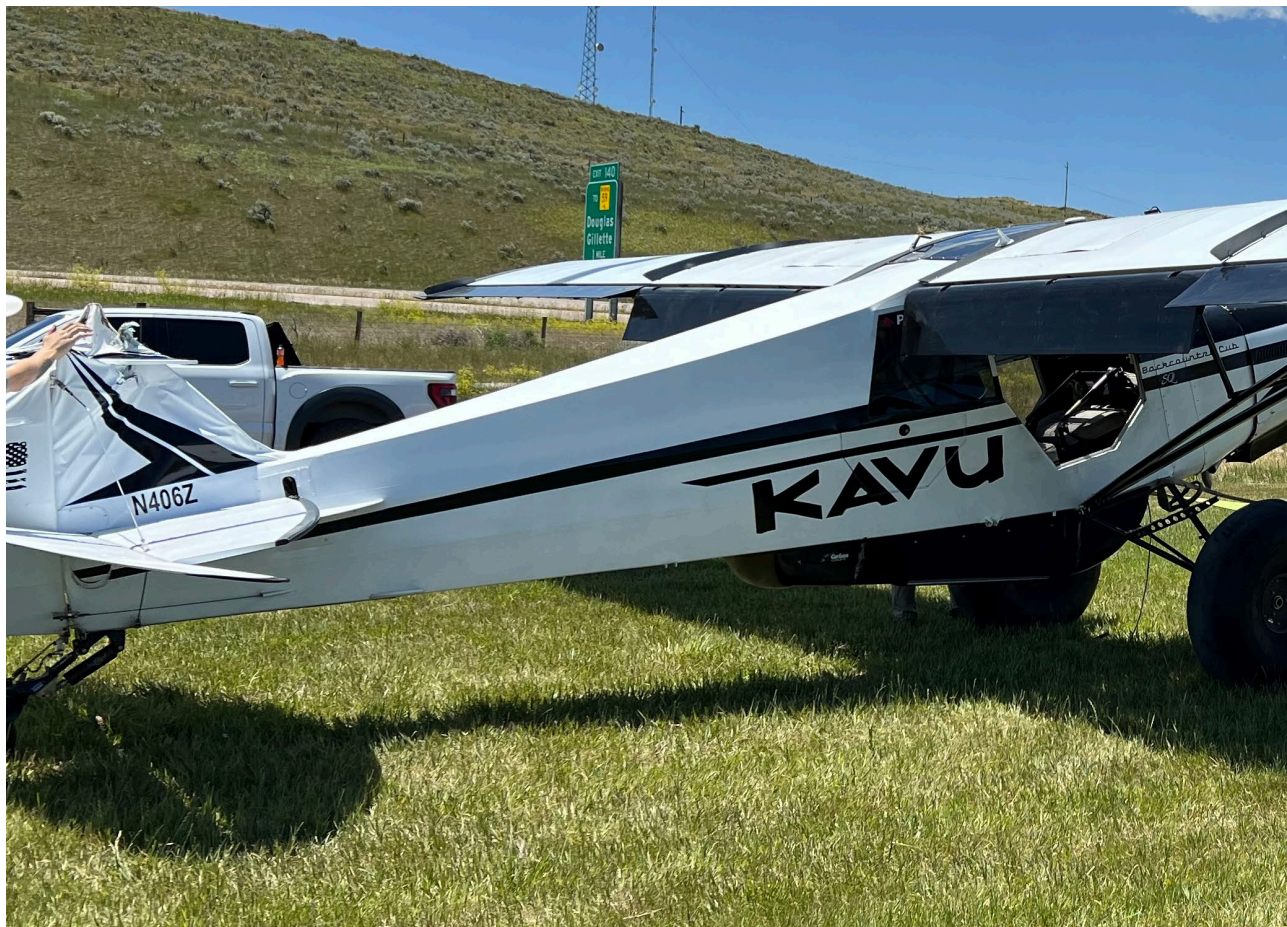
**Photo 2 – Accident airplane after recovery; note damage to vertical stabilizer and rudder (courtesy of Federal Aviation Administration)**

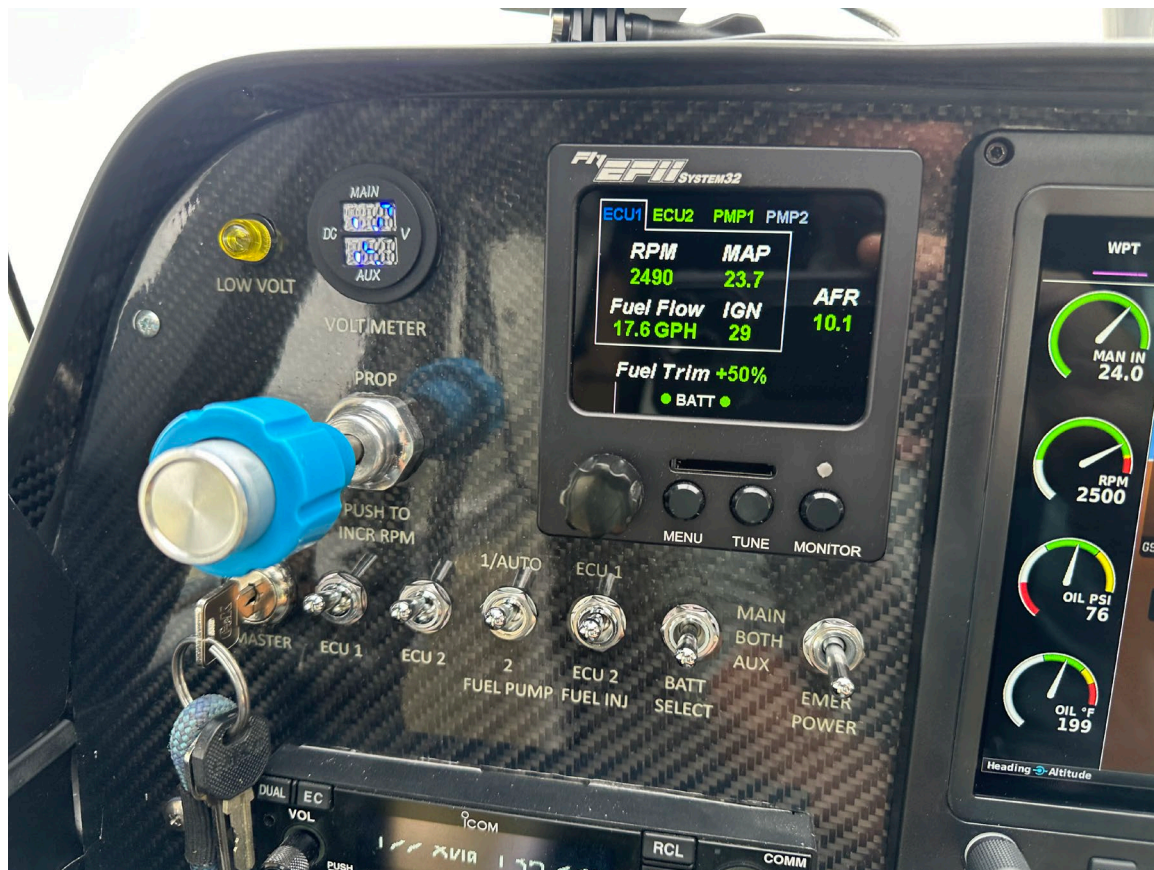
Photo 3 – EFII monitor during flight on June 21, 2024 (10:41am lcl) (courtesy of accident pilot)

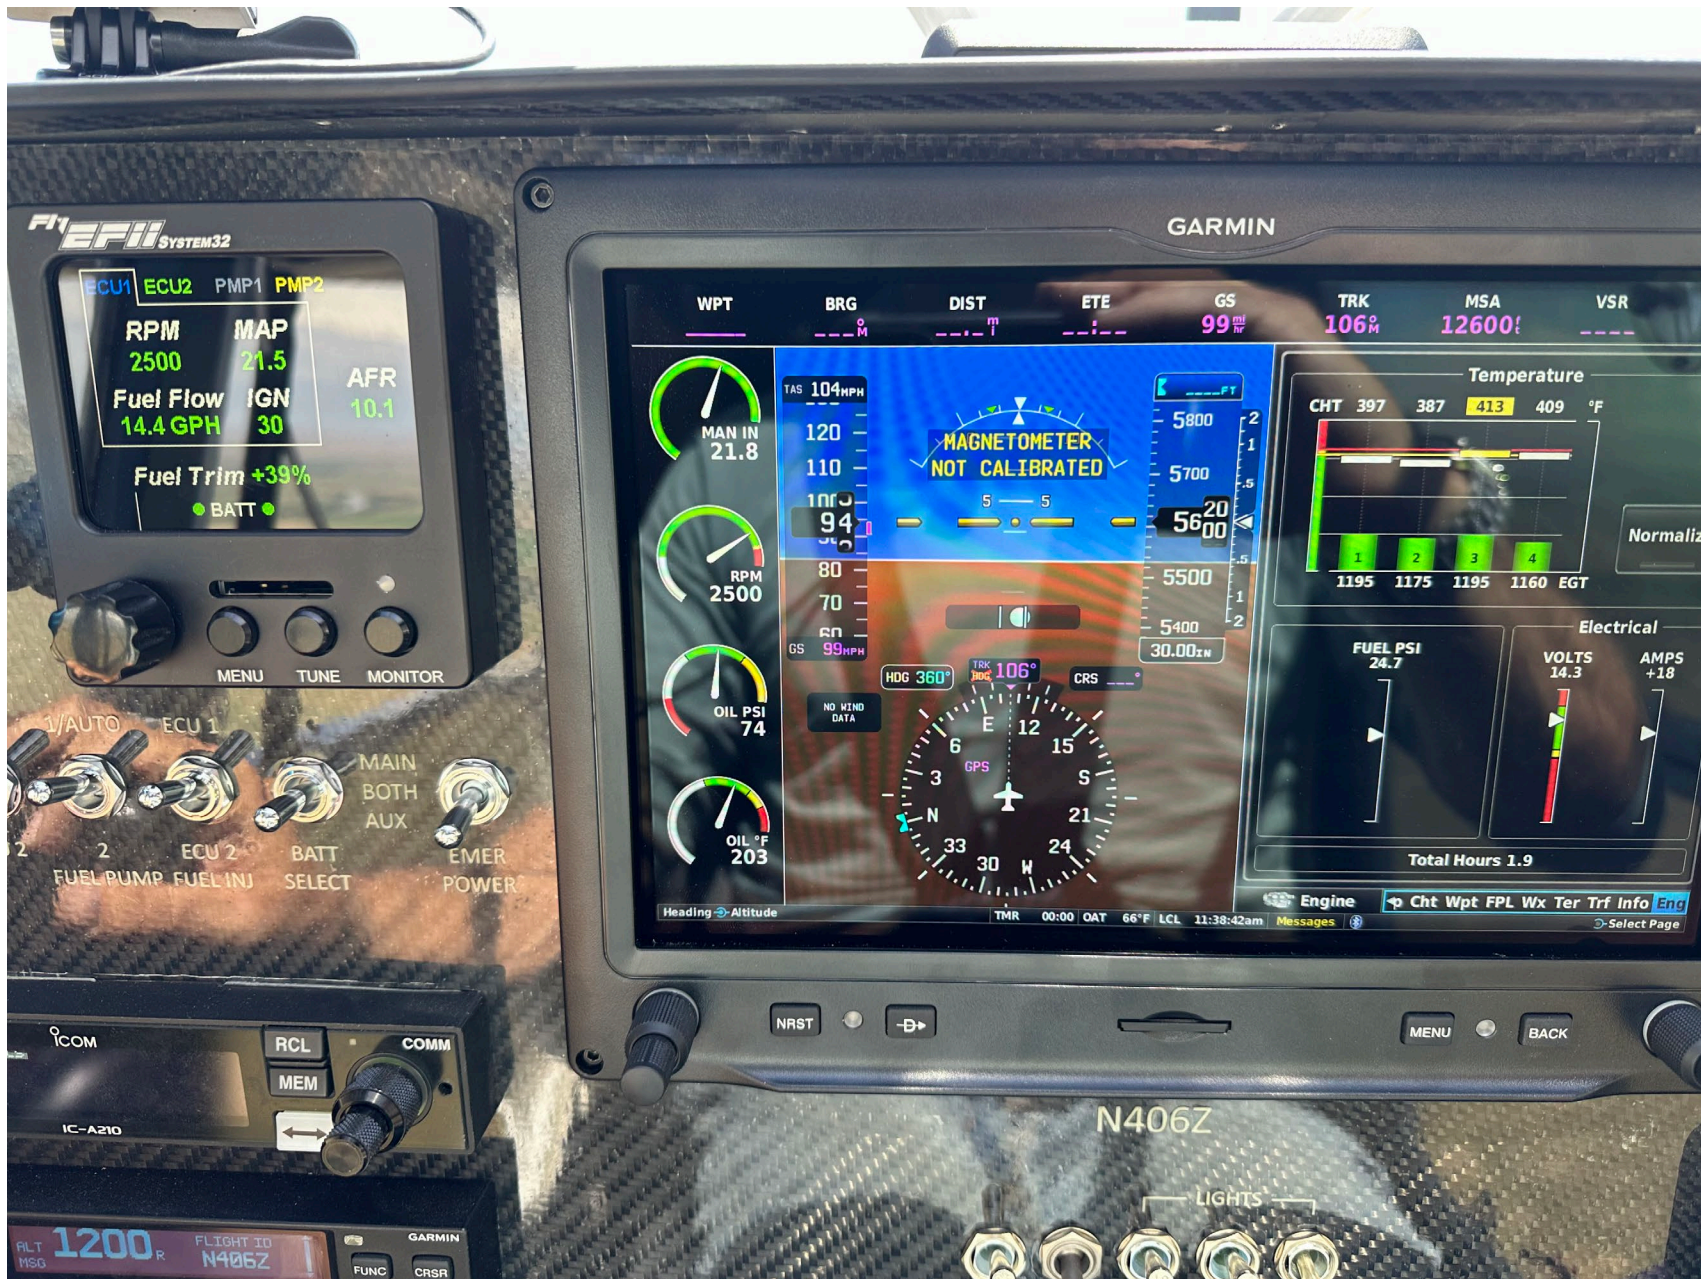
Photo 6 – EFII monitor and multi-function display during flight on June 21, 2024 (1138 lcl) (courtesy of accident pilot)

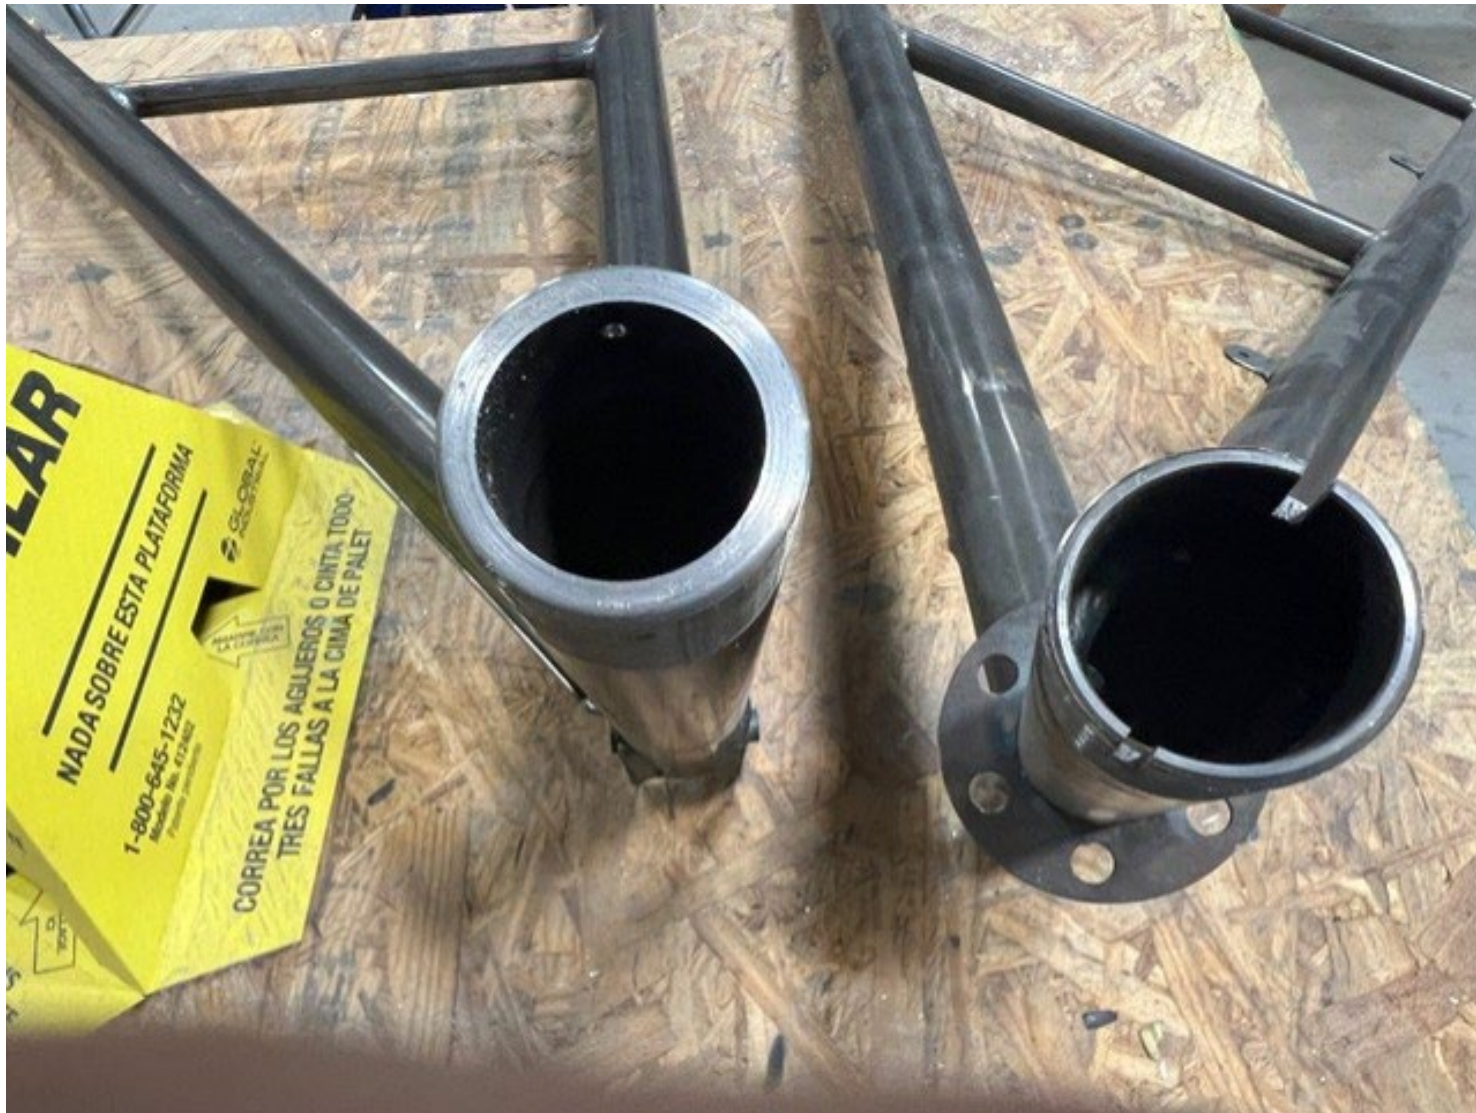
**Photo 7 – Exemplar axles normally installed in Super Cubs (by Backcountry Super Cubs) (Courtesy of Backcountry Super Cubs)**

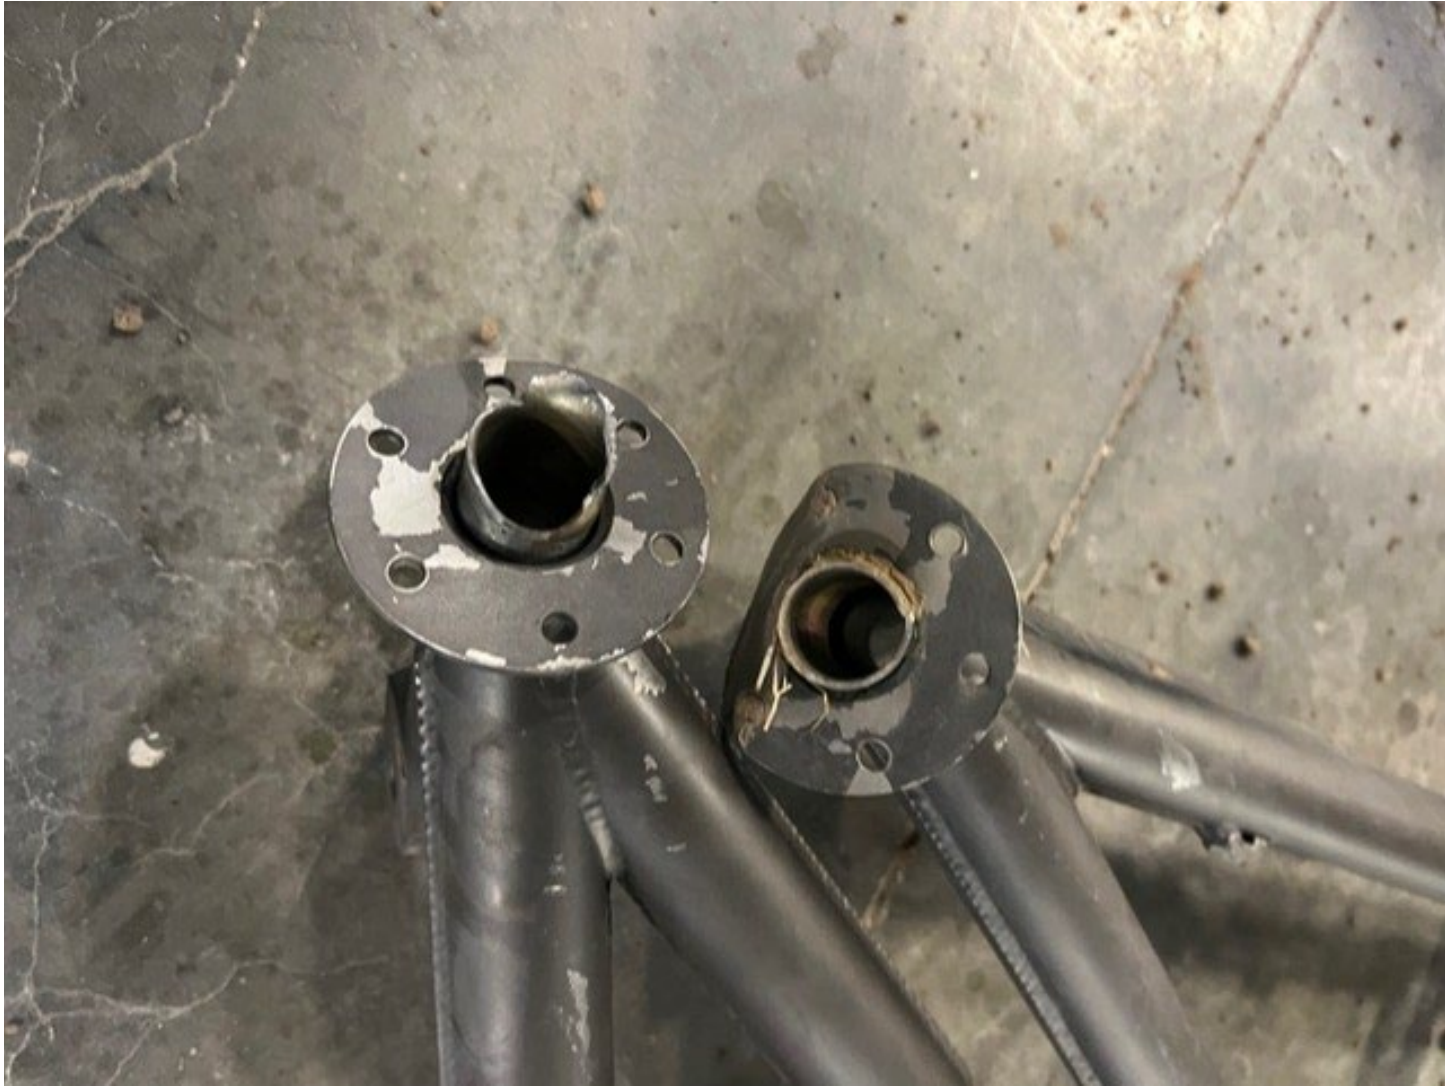
**Photo 8 – Main landing gear axles from accident airplane with fractures (Courtesy of Backcountry Supercubs)**
