Kathryn Whitaker  
Aviation Accident Investigator  
Office of Aviation Safety- Western Pacific Region

**Date:** August 21, 2024

**Subject:** WPR24LA209

**Contact:** Flo Ghighina, Airport Inspector/Obstructions Evaluator, Idaho  
Transportation Department/Division of Aeronautics

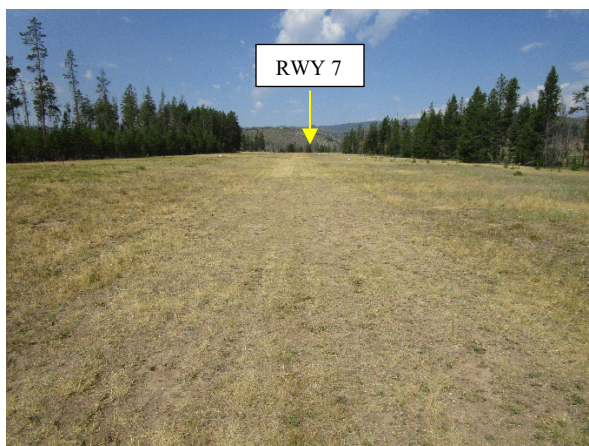
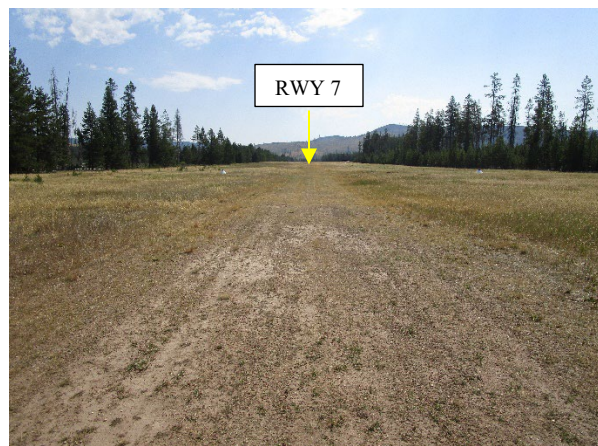
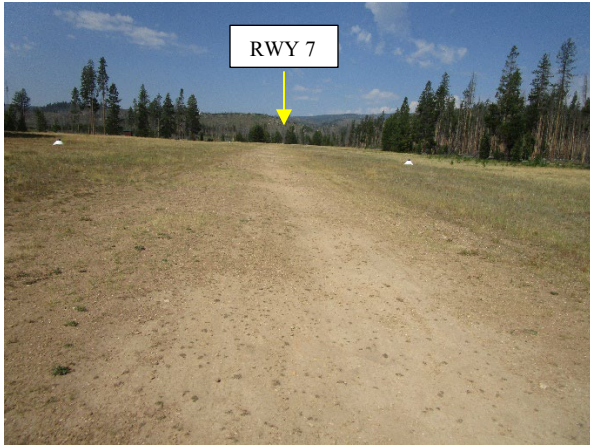
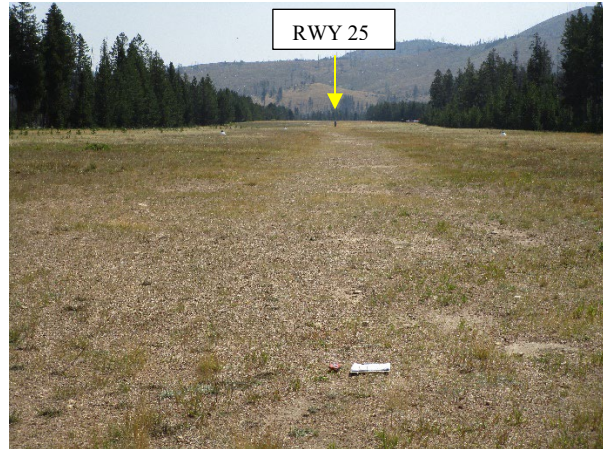
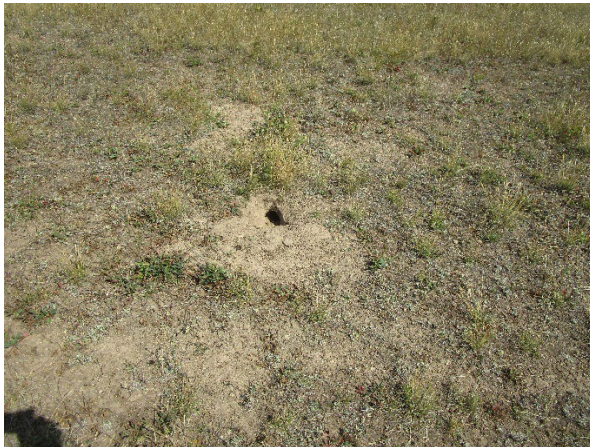
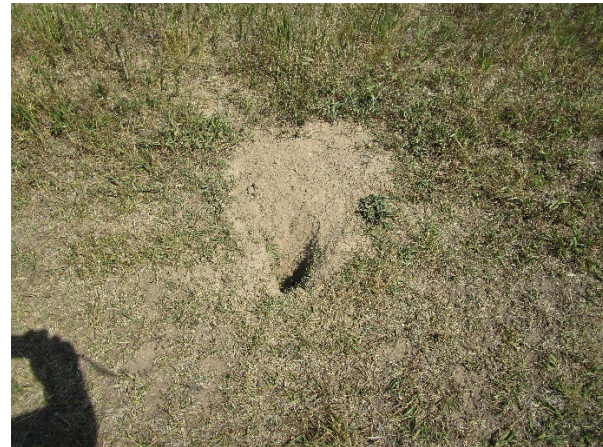
Mr. Ghighina indicated that he visited Chamberlain Guard Station (U79) on August 5, 2024. Mr. Ghighina indicated that the main runway surface area was outlined/bordered by 3 ft tall white cones, and that the center 20-25ft portion of Runway 7-25 was in overall good repair. Outside of the center and most used portion of the main landing area, he characterized the area to have "abundant grass growth" and some larger rodent holes, which he estimated to be 6 to 8 inches in size.
