# National Transportation Safety Board

WPR24LA210

## **ENGINE EXAMINATION**

Location: Fortuna, California  
Date: June 20, 2024  
Airplane: Lancair LC42-550FG, N141PB

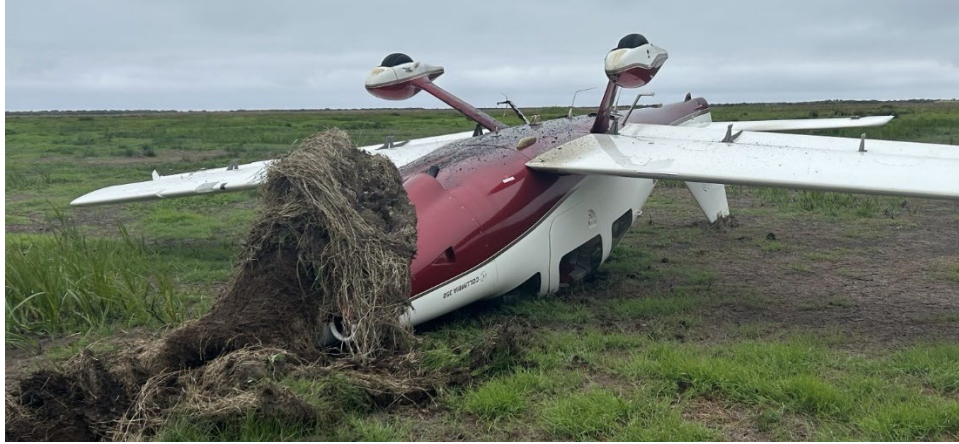
The airplane came to rest inverted following the accident. At that time, the entire belly was coated in oil through to the tail (figure 1, 2).

**Figure 1 - Oil on belly of airplane (photo courtesy of the pilot)**

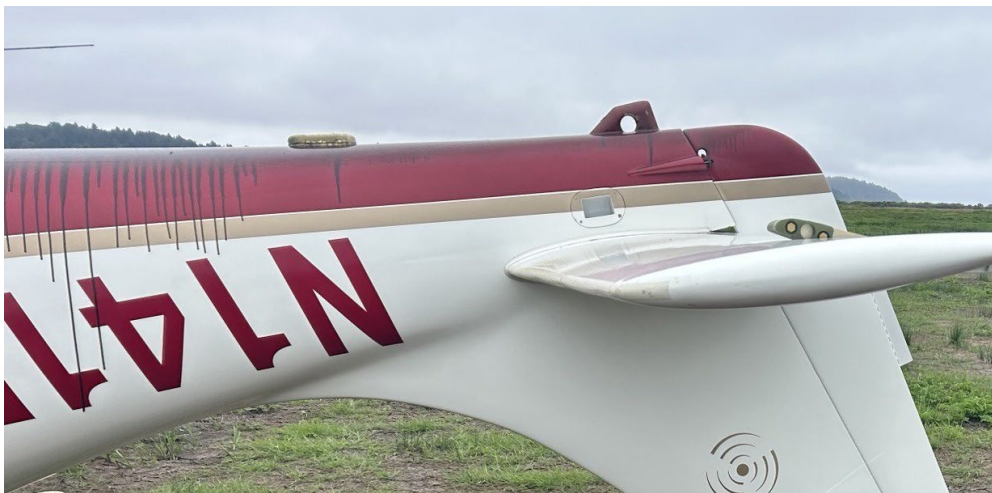
**Figure 2 - Oil on belly of airplane at the tail (photo courtesy of the pilot)**

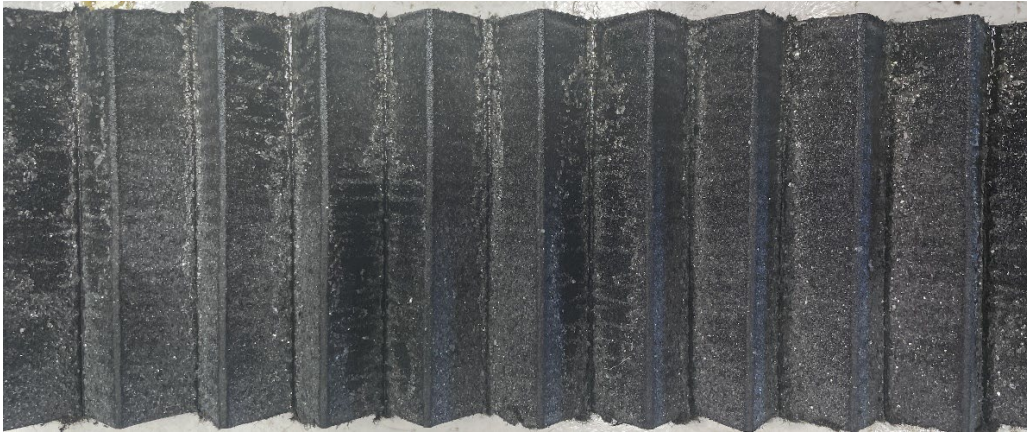
The oil filter was removed, and its paper element was covered in fine metallic particles (see figure 3). The engine breather tube behind the engine baffle appeared

**Figure 3 - Oil filter paper media with metallic particles**

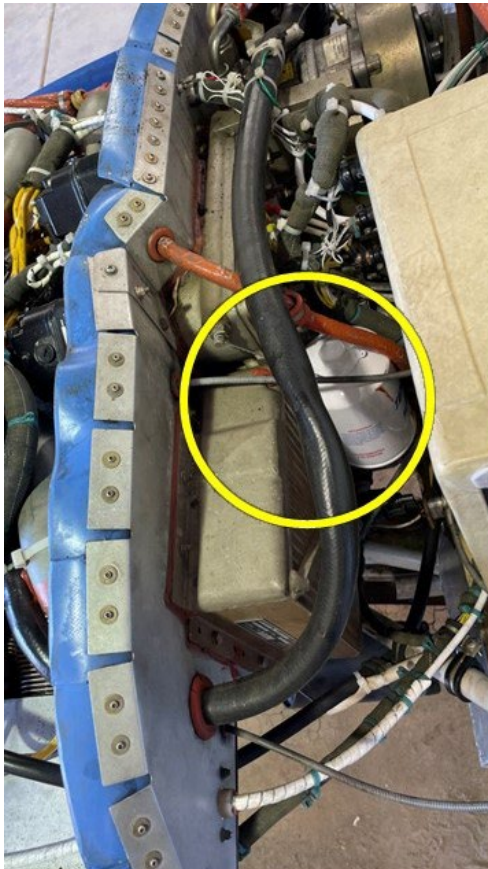
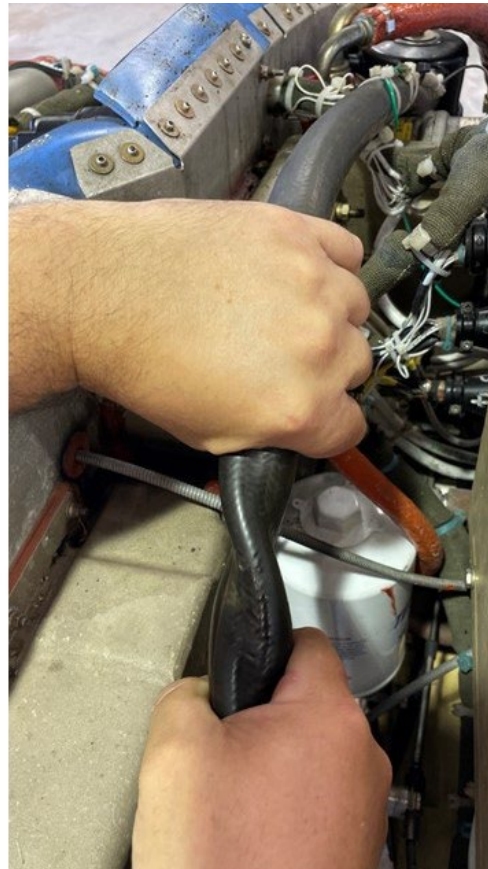
twisted and had a kink midspan. The tube was stiff but could be twisted to a blocked position by hand at the kink.

**Figure 4 - Oil breather tube with kink circled on left and twisted closed on right.**

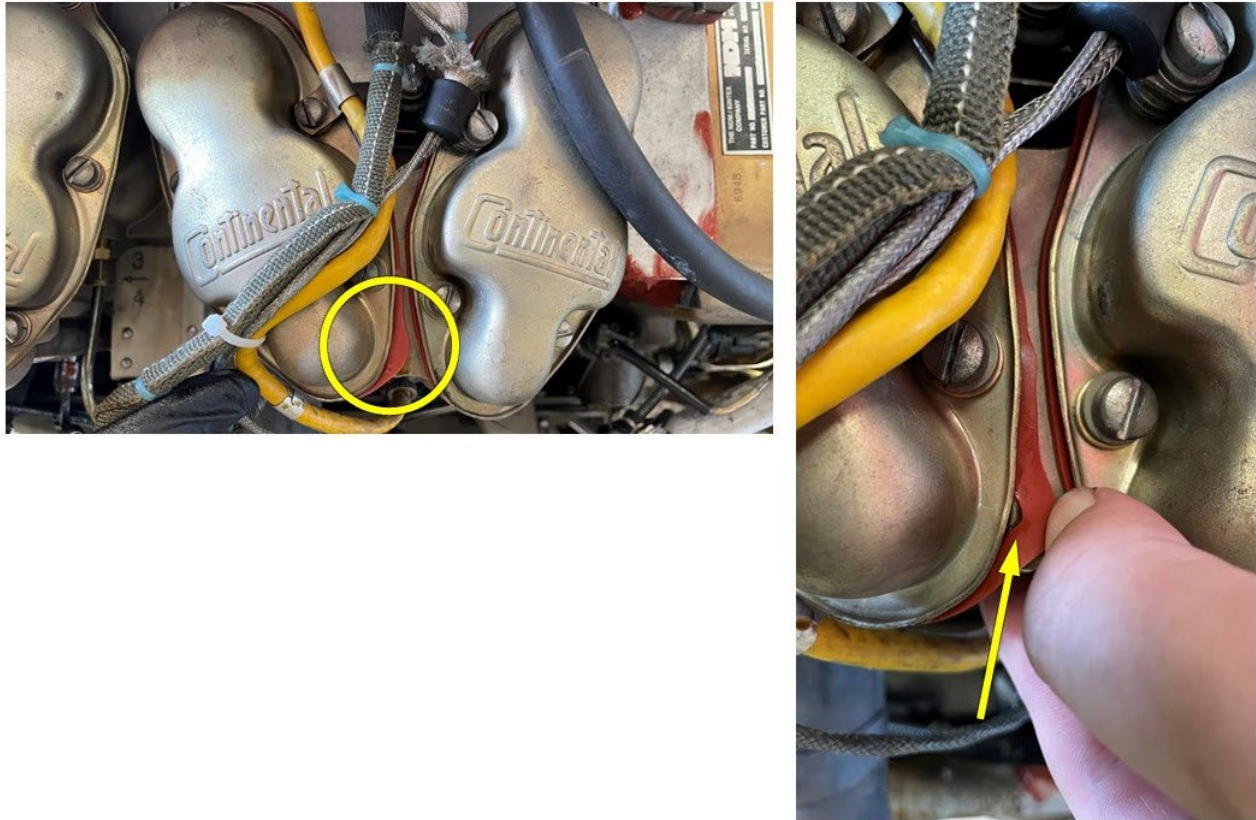
The airplane had lost most of its engine oil in flight, with only 1 quart remaining. The limited oil resulted in a partial seizure of the engine. Examination revealed that the number 2 cylinder rocker cover gasket was misaligned and not providing an adequate seal, this was allowed oil to escape from the engine. No other anomalies were noted to the engine that would have precluded normal operation.

Examination of the rocker covers revealed that the gasket for the exhaust rocker for cylinder number 2 was misaligned and out of place in the lower right hand corner, such that a gap between the rocker cover and cylinder head was present (see figure 5). The rocker cover and milled gasket contact area of the cylinder head were flat.

**Figure 5 -Left shows the misaligned gasket of exhaust rocker for cylinder number 2, and on the right a gap in the gasket seal.**

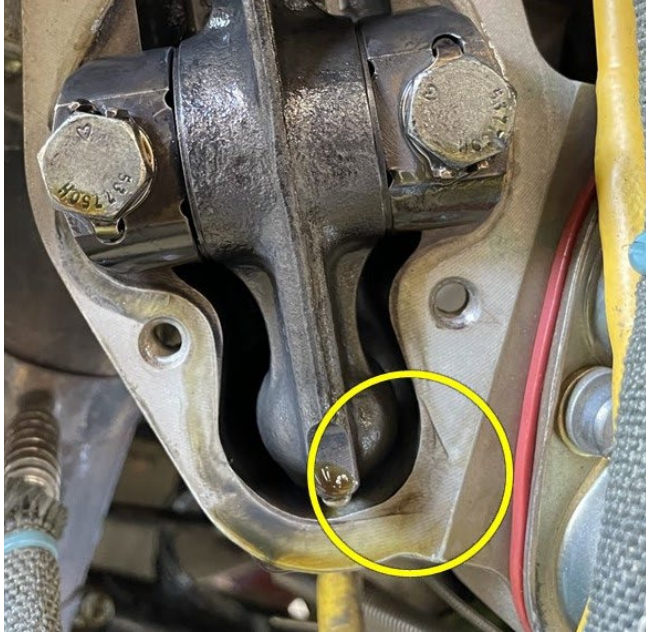
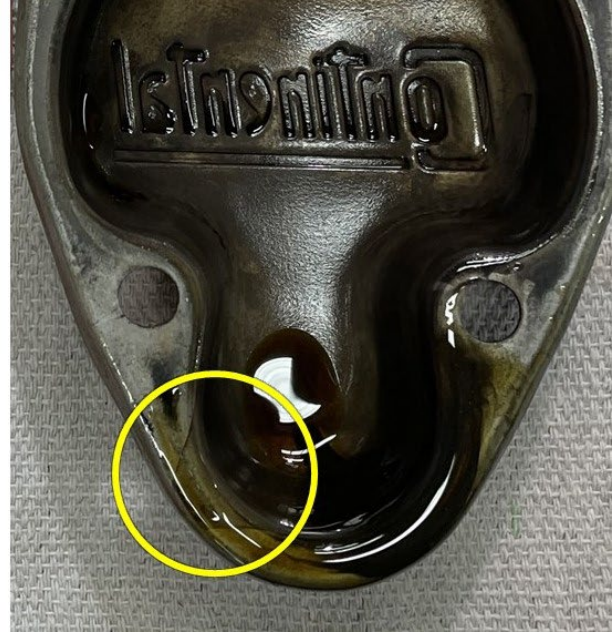
The surrounding area, including the adjacent lower left cowling (see figure 7) was coated in a light sheen of oil. The rocker cover was removed, and a dark stain was present in the face of the gasket mating surface on both the rocker and cover, which mirrored the misalignment of the gasket (see figure 6).

**Figure 6 - Witness mark of misaligned gasket.**

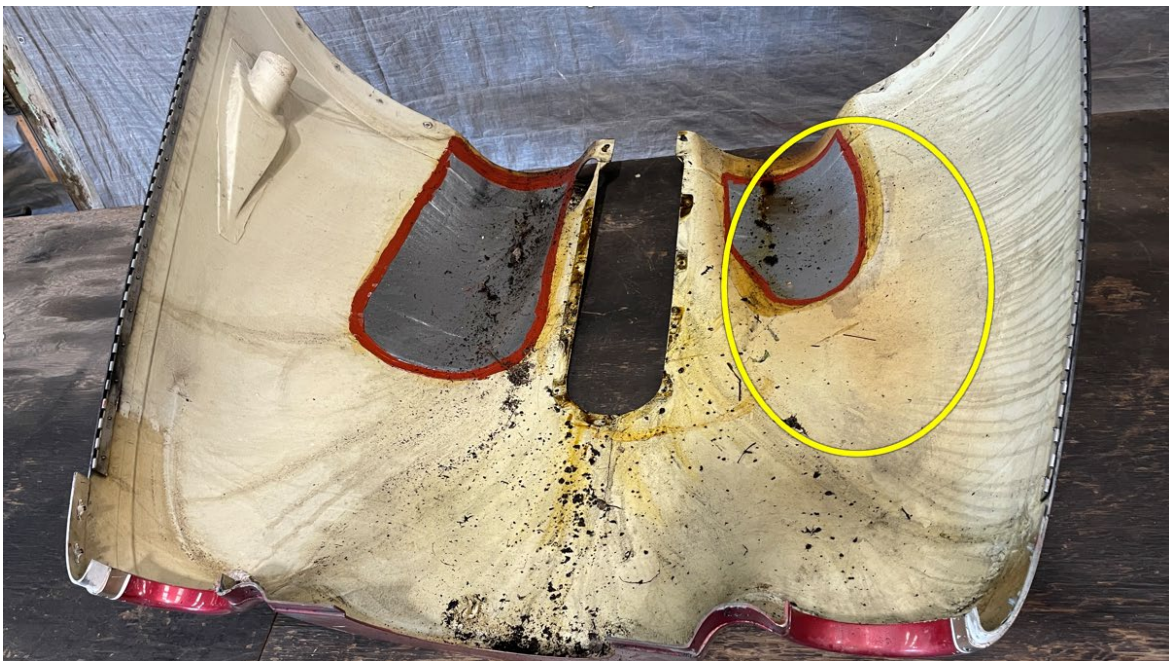
**Figure 7 - Oil predominantly in lower left of cowling adjacent to cylinder 2.**
