# National Transportation Safety Board

WPR24LA214

## **AIRFRAME AND ENGINE EXAMINATION REPORT**

Location: Pleasant Grove, California  
Date: June 25, 2024  
Time: 0600  
Airplane: N6793K, Grumman Aircraft Engine Corporation- Schweizer, G-164B

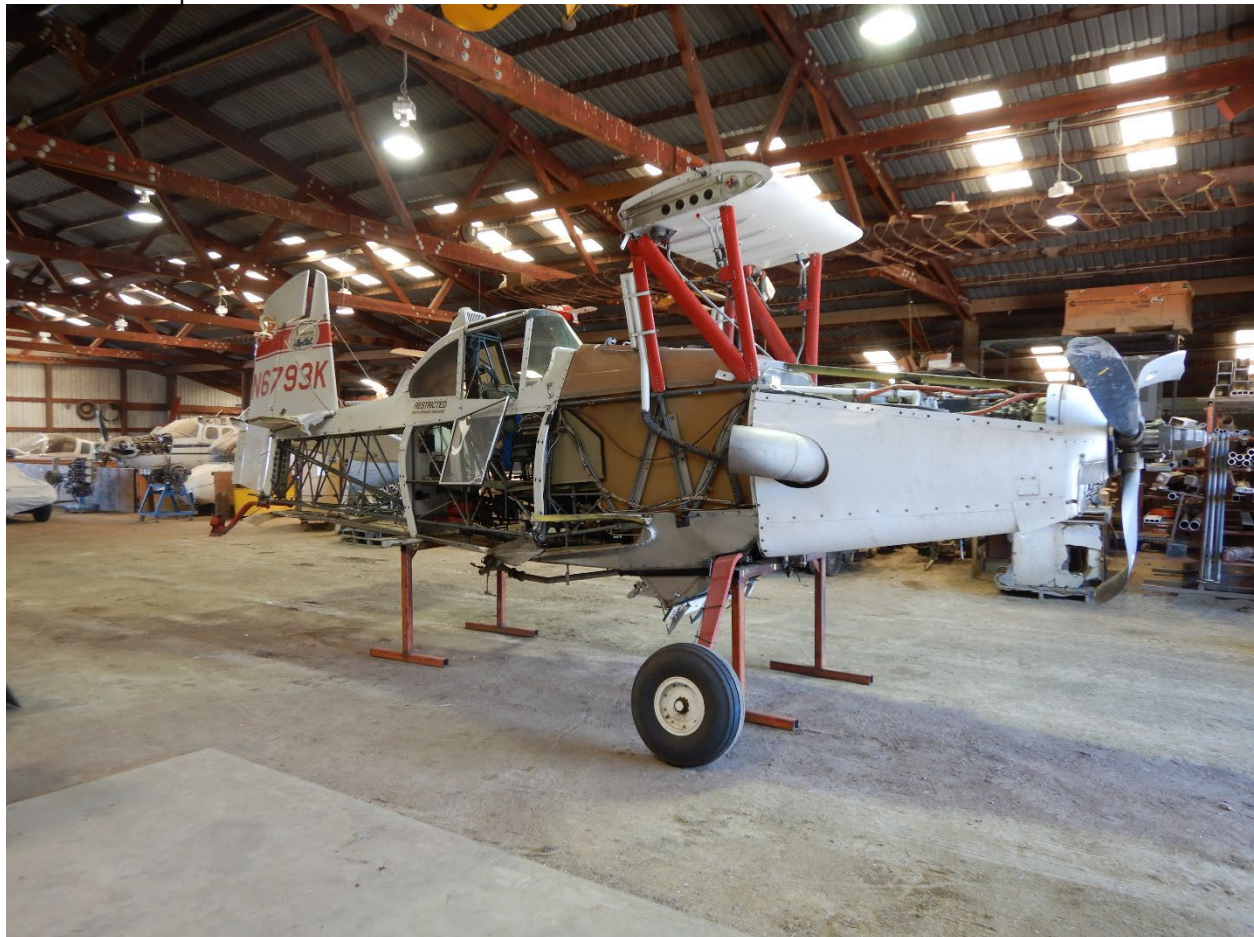
The fuselage was substantially damaged at the root end of the empennage and exhibited breaks in the metal tubing and twisting of the fuselage structure near the tail wheel. Additional substantial damage was located near the left main landing gear attachment point.

**Figure 1. N6793K at the recovery site.**

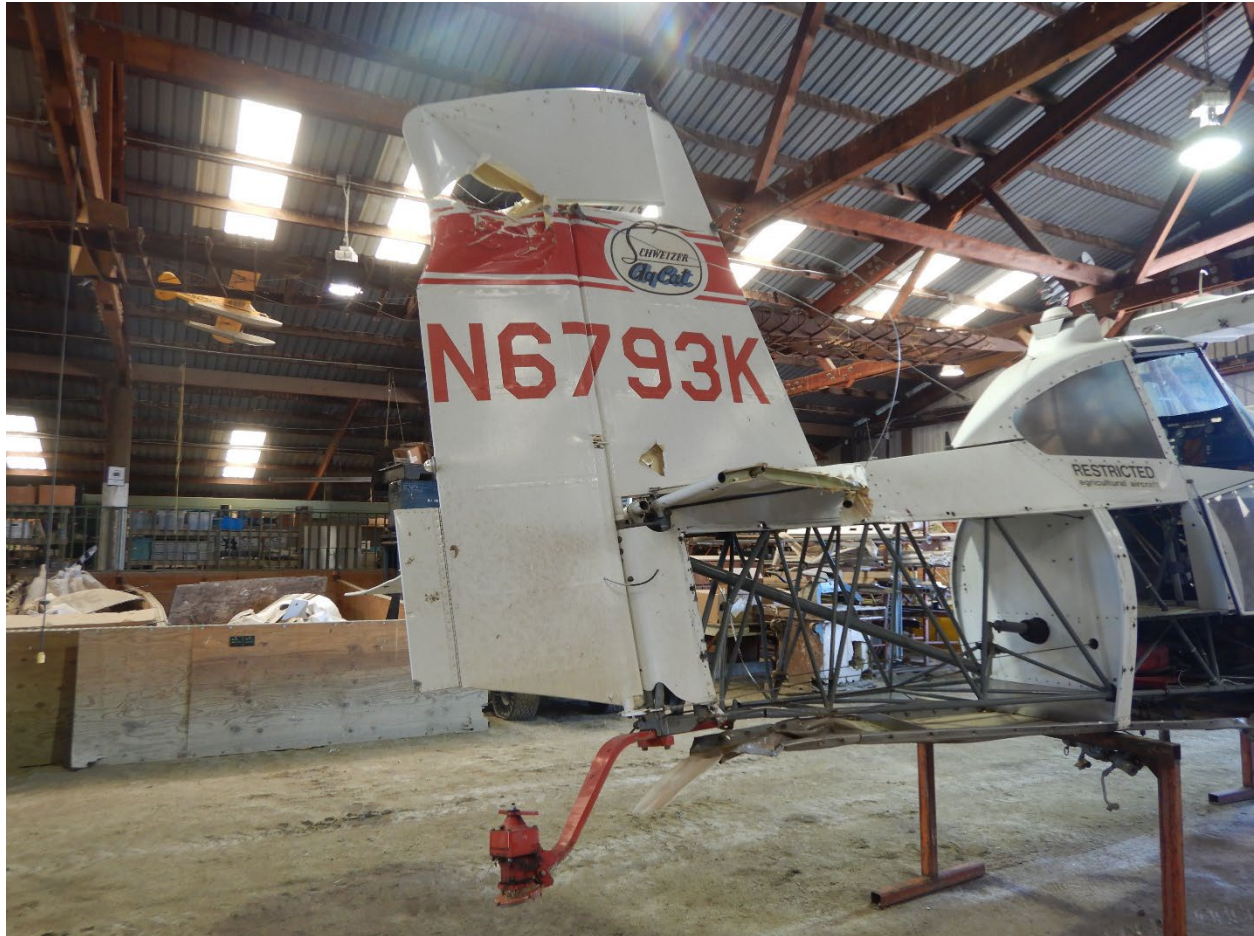
The vertical stabilizer received minor damage. The rudder exhibited substantial damage with tears in the fabric skin and bending of the structural tubing. The left and

right horizontal stabilizer and elevators were all substantially damaged with breaks and bends to the structural tubing and tears to the fabric skin. The right horizontal stabilizer and elevator were substantially damaged with separated components, bent structural tubing, and tears to the fabric skin.

**Figure 2. Empennage damage.**

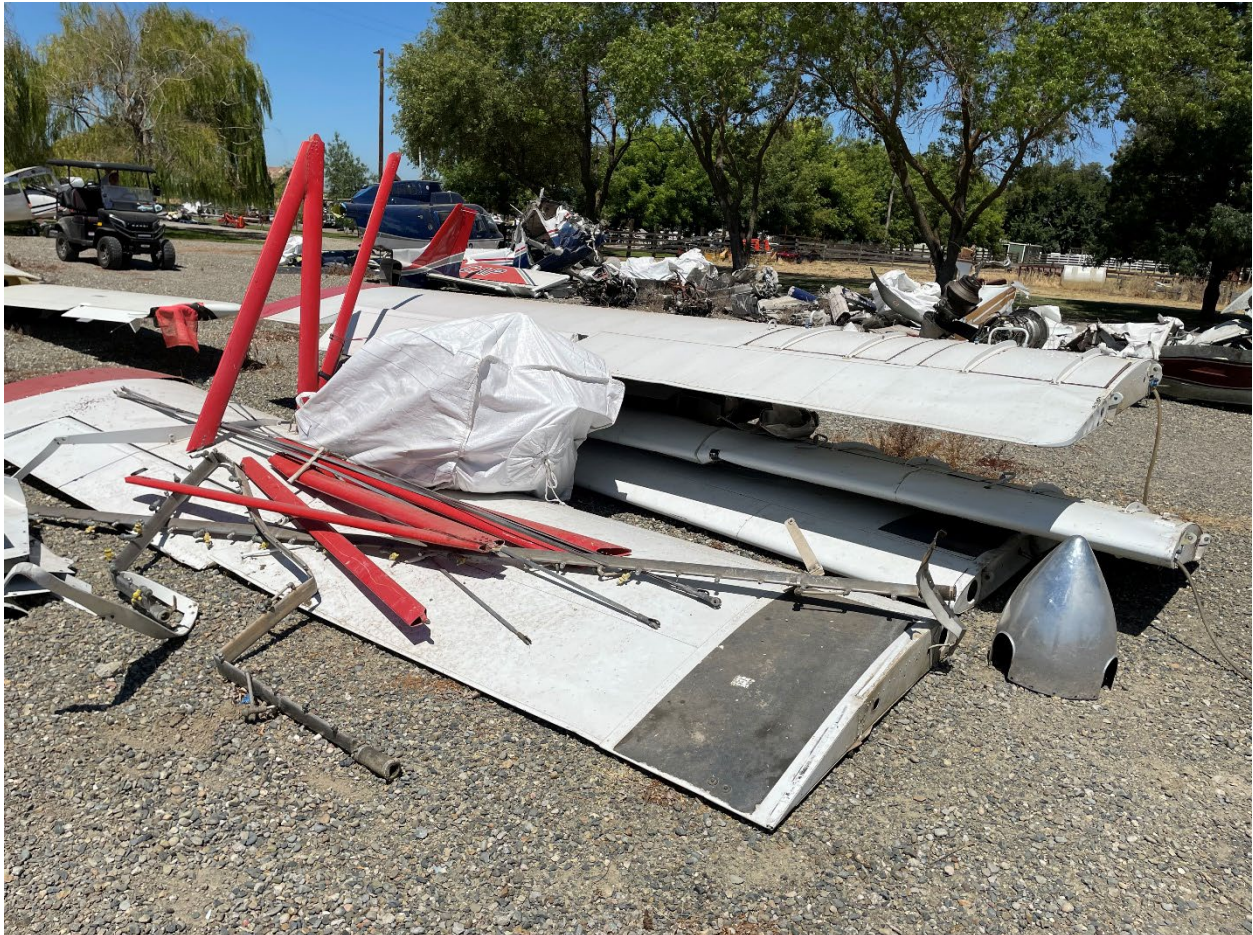
The upper right wing remained attached to the upper fuselage at the wing supports, and exhibited considerable downward bending of the leading edge. The lower right wing remained attached to the fuselage and exhibited crumpling at the tip to about four to five ft inboard. The wing-to-wing support (struts) remained attached to both the upper and lower right wings. The wing support cables were slack.

The left upper and lower wings exhibited less damage than the right pair. The upper left wing remained attached to the upper fuselage at the wing supports and exhibited

minor damage. The lower left-wing remained attached to the fuselage and exhibited damage to the trailing edge components. All wings were removed for recovery and stacked at the secured facility.

**Figure 3. Wings stacked at the recovery site.**

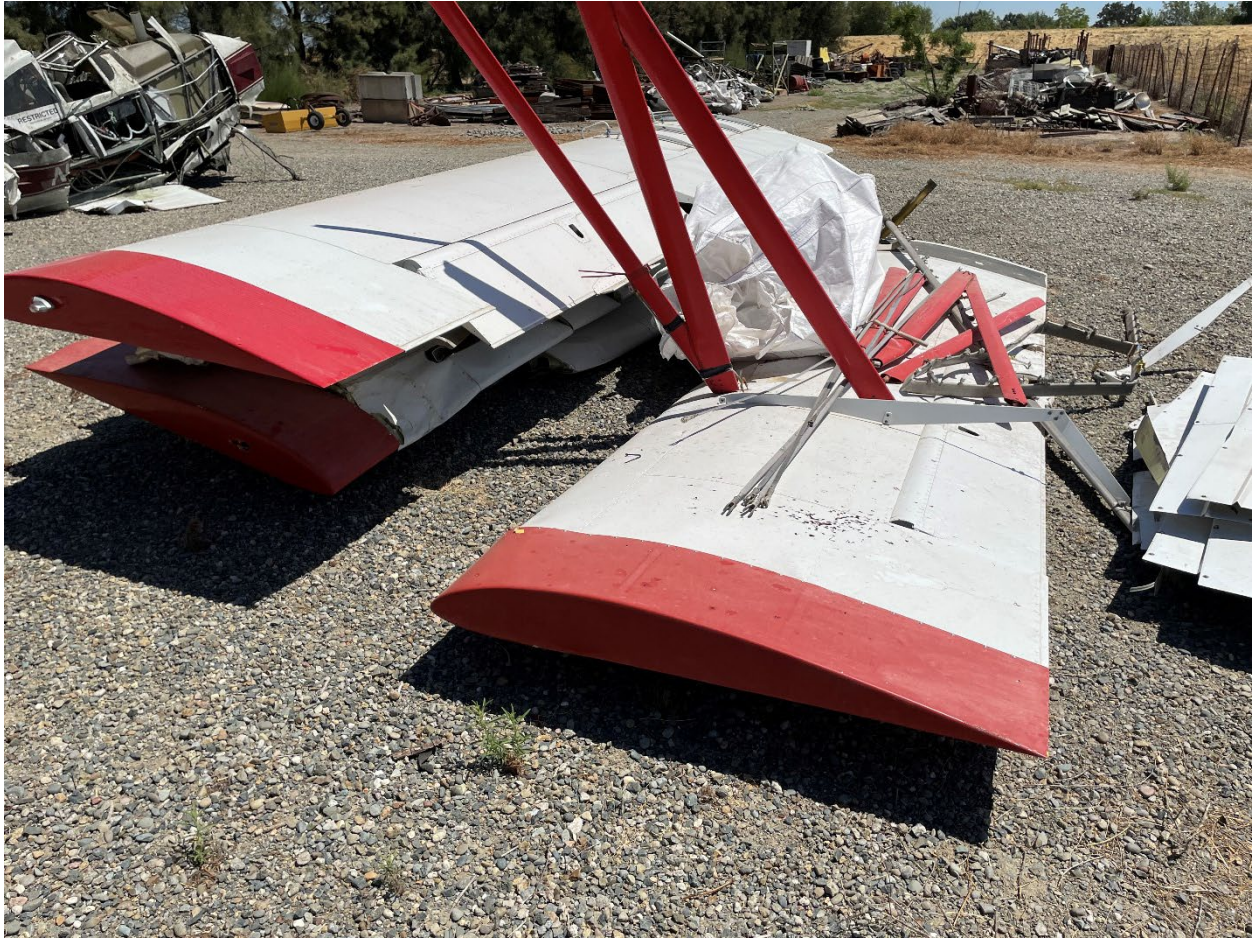
**Figure 4. Second view of wings stacked at the recovery site.**

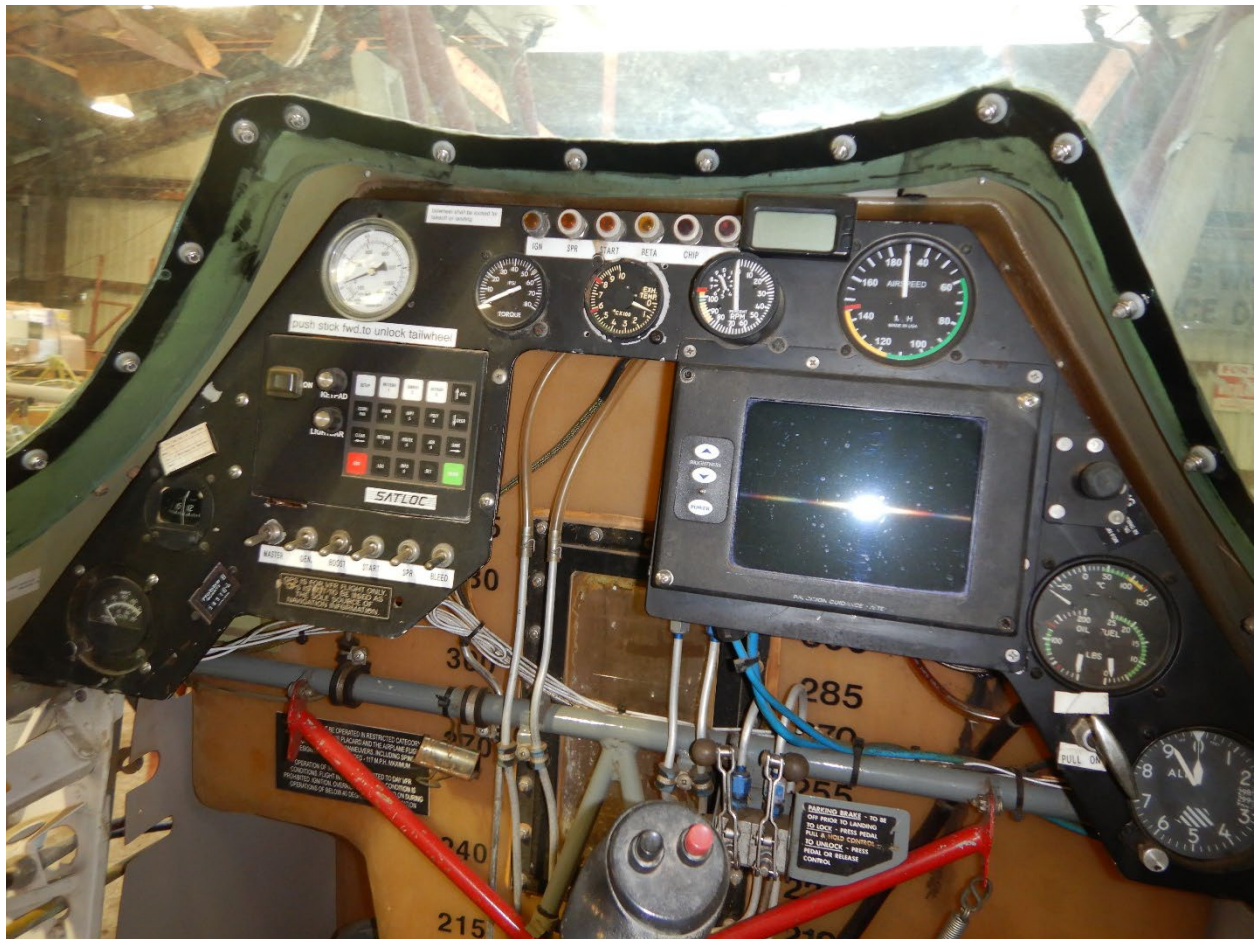
The cockpit received minor damage.

**Figure 5. Image of the cockpit.**

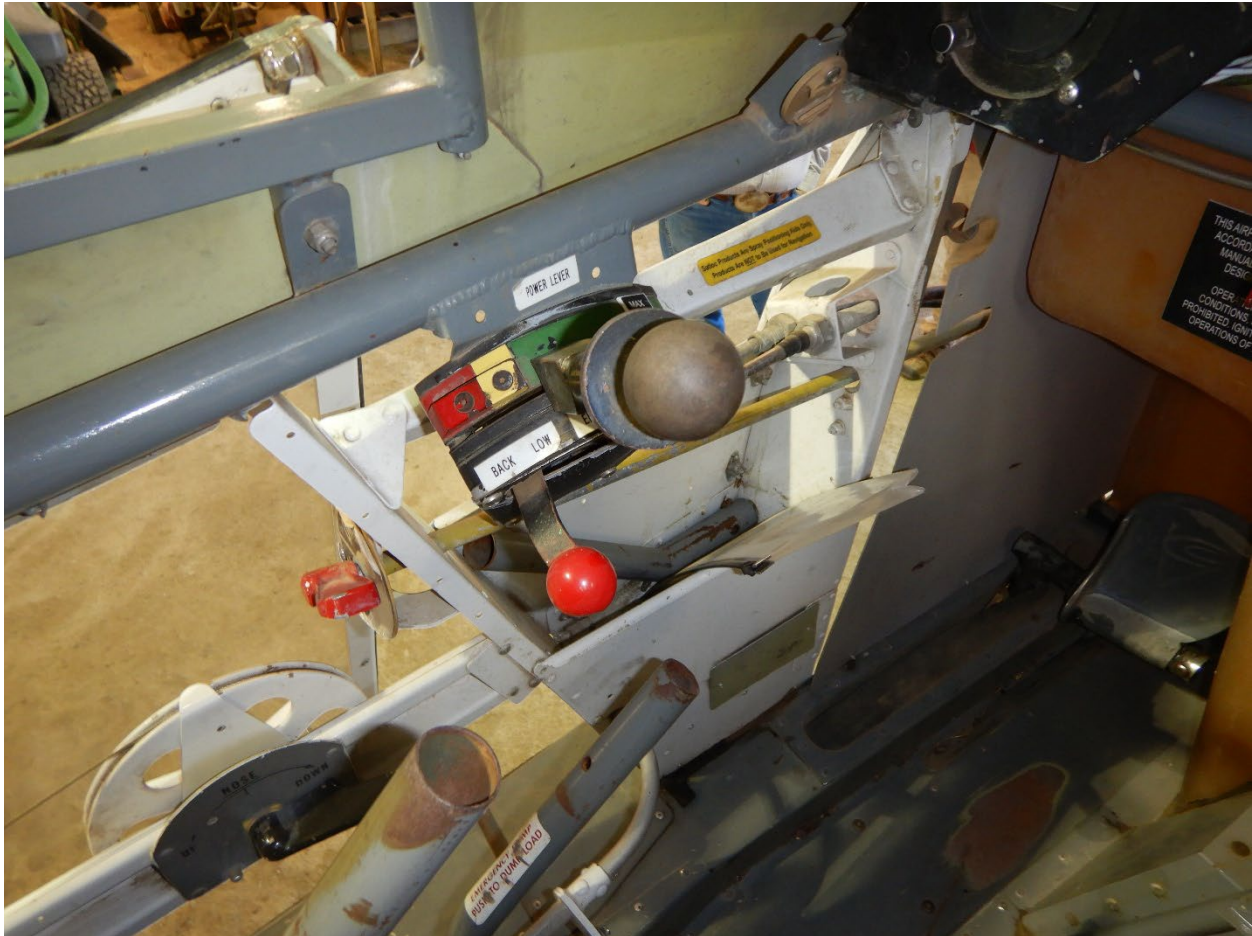
**Figure 6. Image of the throttle quadrant.**

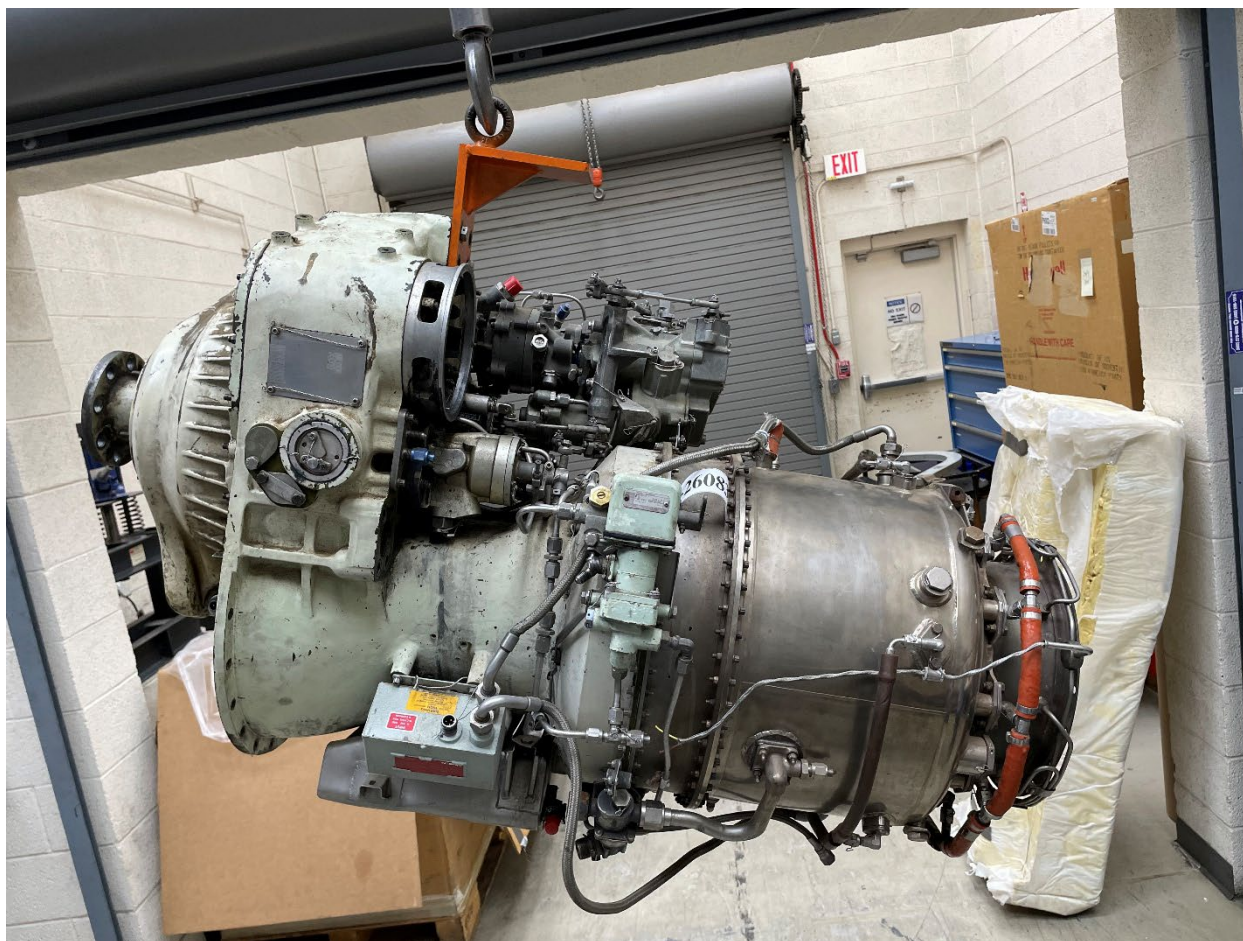
- The engine remained installed to the airframe at the undamaged engine mount.
- The engine power lever remained attached to the engine and was in the bottom of the green arc, against the gate position in the cockpit.
- The PLA lever remained attached to the engine and was in the BACK position at the cockpit.
- All B-nuts for the pneumatic lines to the engine were at least finger-tight.
- The Fuel Control Housing had fractured and partially separated from the Fuel Pump Housing at the interface flange.
- The engine was removed from the airframe and placed in a shipping container for shipping to HAT for further examination.

- Torque Sensor and Direct Drive Fuel Control Gear Train. All components were intact and appeared undamaged.
- Compressor Section.
  - The torque shaft was broken at the aft bushing land, consistent with torsional overload.

- The first-stage compressor impeller shroud was intact and had light rotational scoring at the exducer area of the shroud for a full 360°.
  - The first-stage impeller was intact, had earthen debris adhering to all blades, exhibited damage to the leading edges of all blades, and had light rotational scoring on all the blades at the exducer.

- The second-stage compressor impeller was intact and exhibited silt like debris on the inner bore, metallic deposits on the back face, rotational scoring with bluing at the exducer of all blades with corresponding damage to the second-stage impeller shroud. The second-stage compressor impeller also had rotational scoring at the inducer with corresponding damage to the second-stage impeller shroud.

**Figure 7. Image of the engine at the examination site.**

- Light damage to the leading edge of the primary and secondary compressor impellers, consistent with contact with the respective nozzles.
  - Light metal spatter on most second and third stage turbine wheels.
  - Some thermal cracks on two, but not all first stage nozzle vanes.
- Some thermal cracks on four, but not all the second stage nozzle vanes.
- Damage to the mounting flanges of the fuel pump
  - Torsion shaft fractured in half
  - Diaphragm Assembly: Damage to the Helical cam gear and hydraulic torque sensor, consistent with a propeller strike.

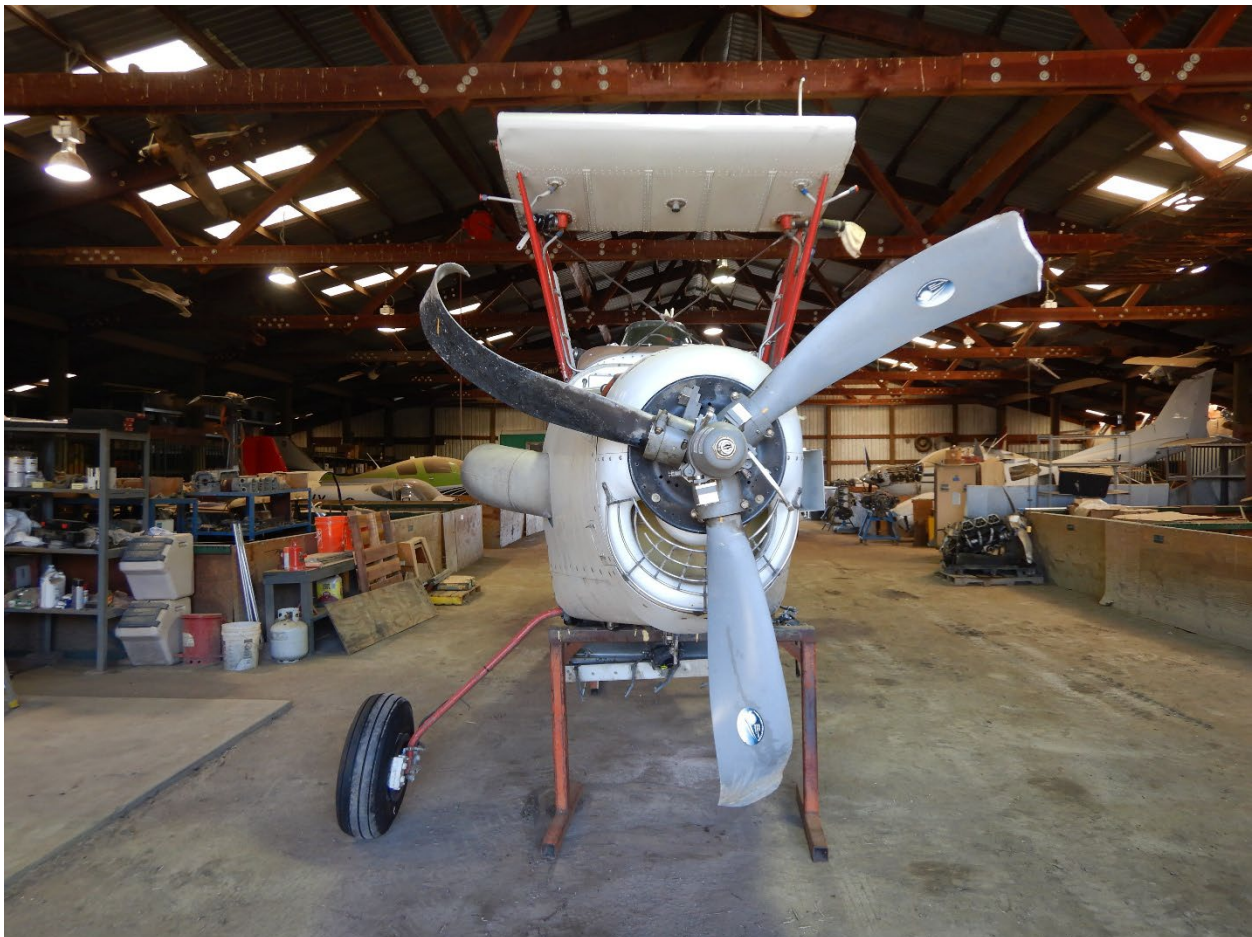
- The aluminum, three-bladed, constant speed propeller exhibited damage to all three blades and the hub components.
- Blade A remained installed in the hub and the alignment tabs matched. The blade exhibited an aft bend about mid span. The tip exhibited chord-wise and span-wise striations at the outboard end. The tip of the blade was fractured and separated. The tip was not present to be examined. The fractured end exhibited a dull rough and uniform appearance. The leading edge exhibited gouging near the outboard end that reduced in severity toward the root. The aft side of the blade exhibited pitting in the paint near the outboard end.

- Blade B remained installed in the hub and the alignment tabs matched. The blade exhibited a sharp near 90° forward bend with chordwise striations at the aft side of the outboard end. The tip fractured and separated from the blade. The tip was not present to be examined. The fractured end exhibited a dull rough and uniform appearance. The leading edge exhibited

gouging that reduced in severity toward the root. The B-blade counterweight was lodged into the spinner plate.

- Blade C remained installed in the hub and the alignment taps did not match. The blade rotated in the hub toward the high RPM direction. The blade exhibited a forward bend about mid-span and a fracture separation of the blade at the bend site. The fractured end exhibited a dull rough and uniform appearance. The outboard section of the blade was not examined. The blade exhibited chordwise and spanwise striations at the outboard end.
- The hub remained installed on the propeller flange and exhibited damage to two of the blade pitch control rods. Pitch control rod A remained installed at both ends. Pitch control rods B and C remained installed at the hub and separated at the blade. The Beta rod was removed and exhibited no damage.

**Figure 8. Image of the propeller.**

- Blade tips fractured. Blade C is a mid-blade fracture (27" missing)
- Forward thrust direction bending
- Link screw holes in the link arms were stretched.
- Slip indicators indicate rotation towards high pitch.
- Link screw fractured from clamp.
- Face-side chord-wise direction scoring. (Blades B and C)
- Blade A was bent aft but had Face-side Chordwise directional scoring

Impact marks indicate a blade angle between 15 to 30 degrees. Above the flight idle blade angle.
