Grant Mills  
Air Safety Investigator  
Western Pacific Region

**Subject:** WPR24LA218, Summary of Airframe Examination

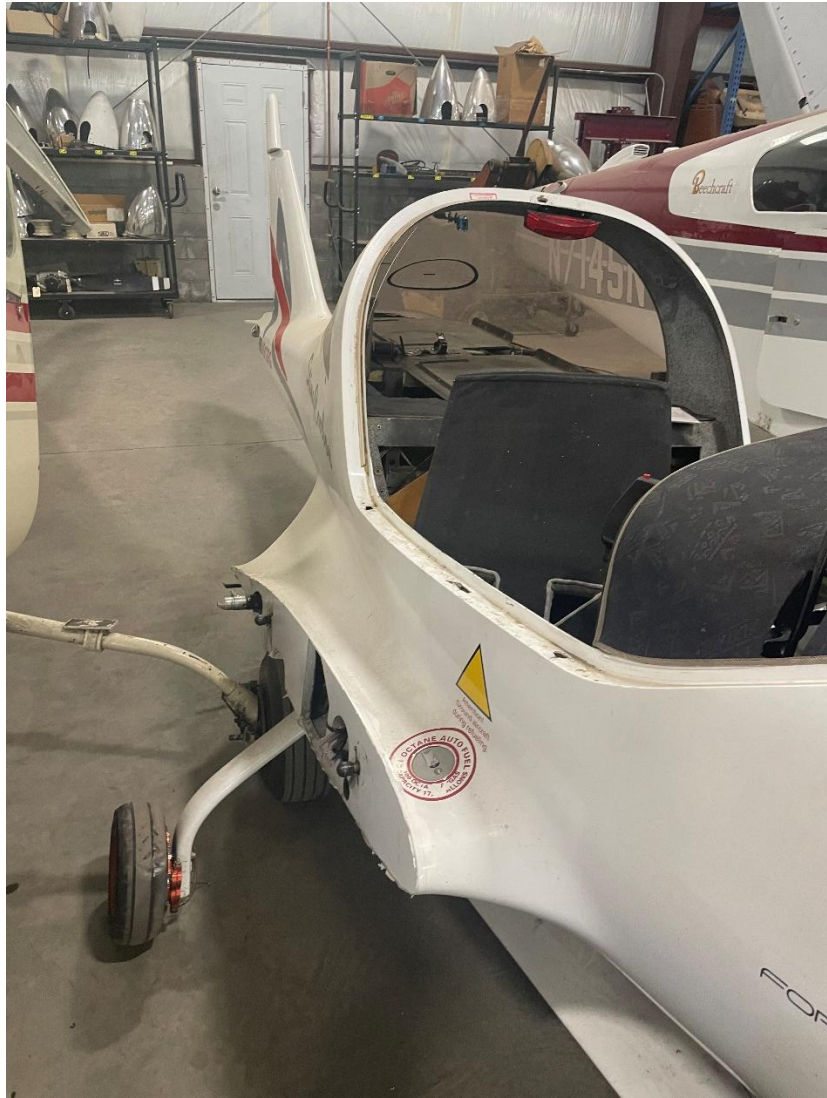
Examination of the recovered wreckage revealed that the airplane, an experimental amateur built Sting RG, N912RG, had recently been sold and was in a partial state of disassembly. The wings and horizontal stabilizer, as well as the cockpit instruments and wiring, had been removed.

**Photograph 1: View of fuselage**

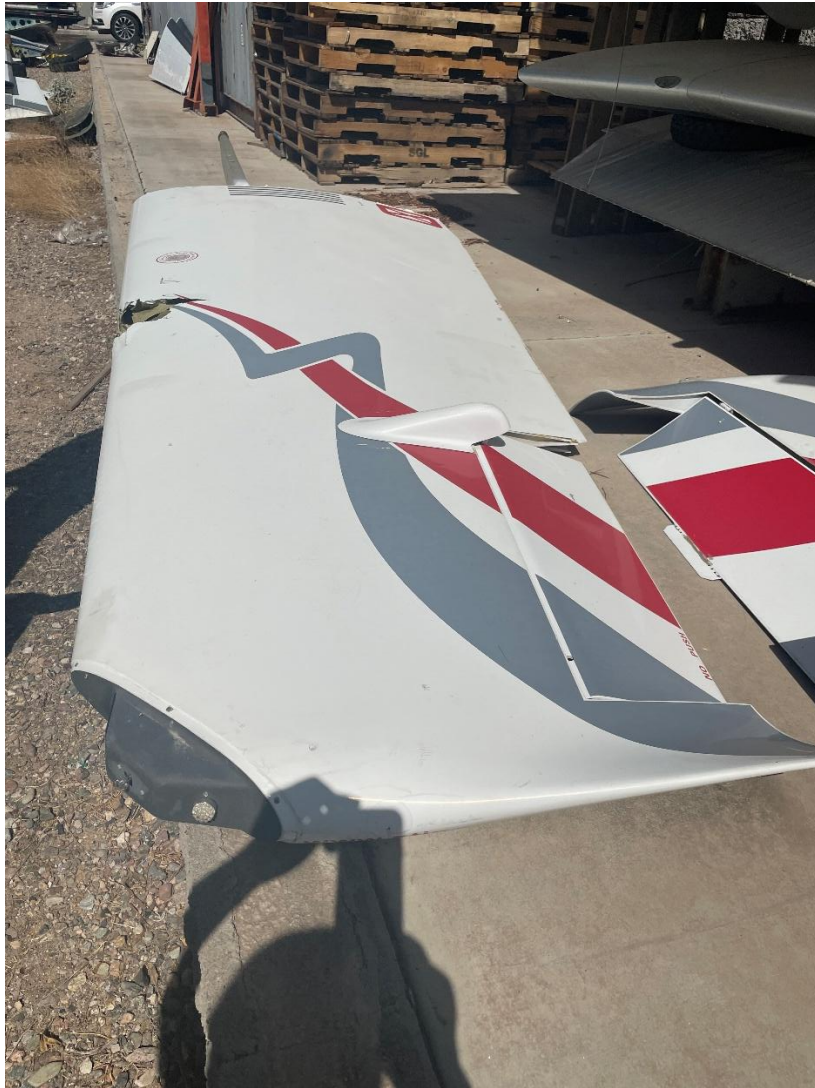
**Photograph 2: View of left wing**

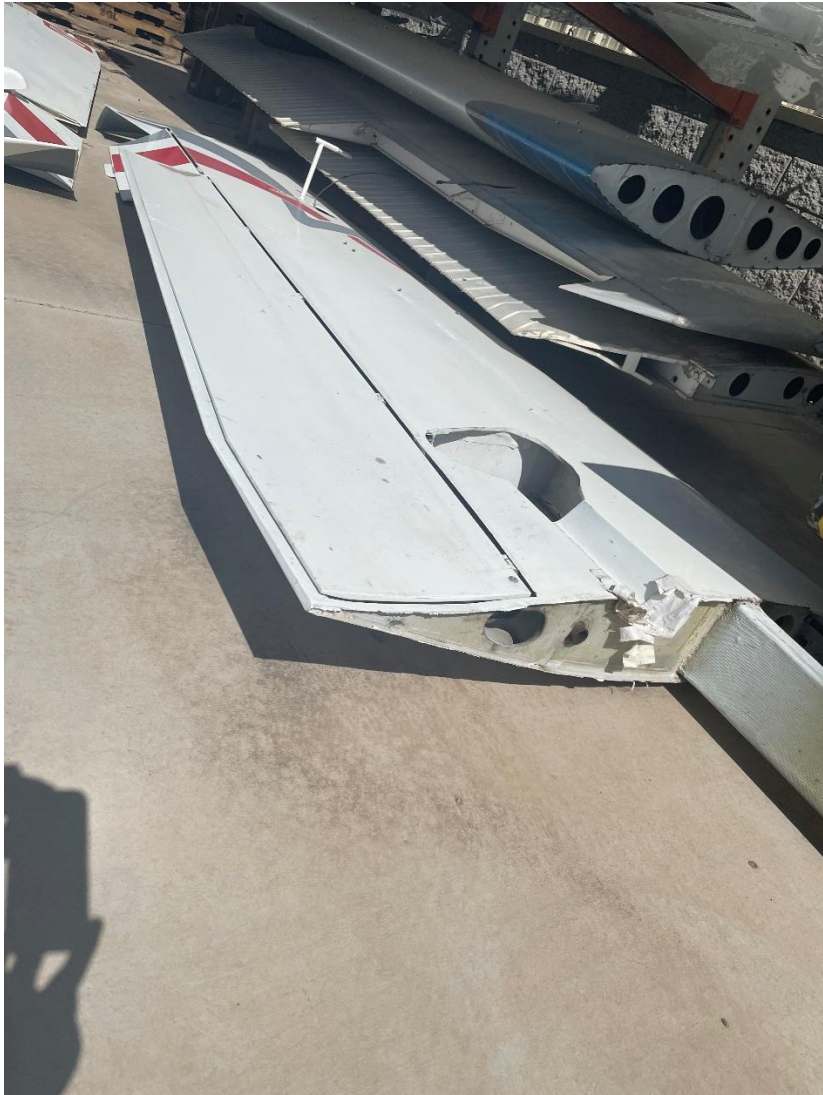
**Photograph 3: View of right wing**

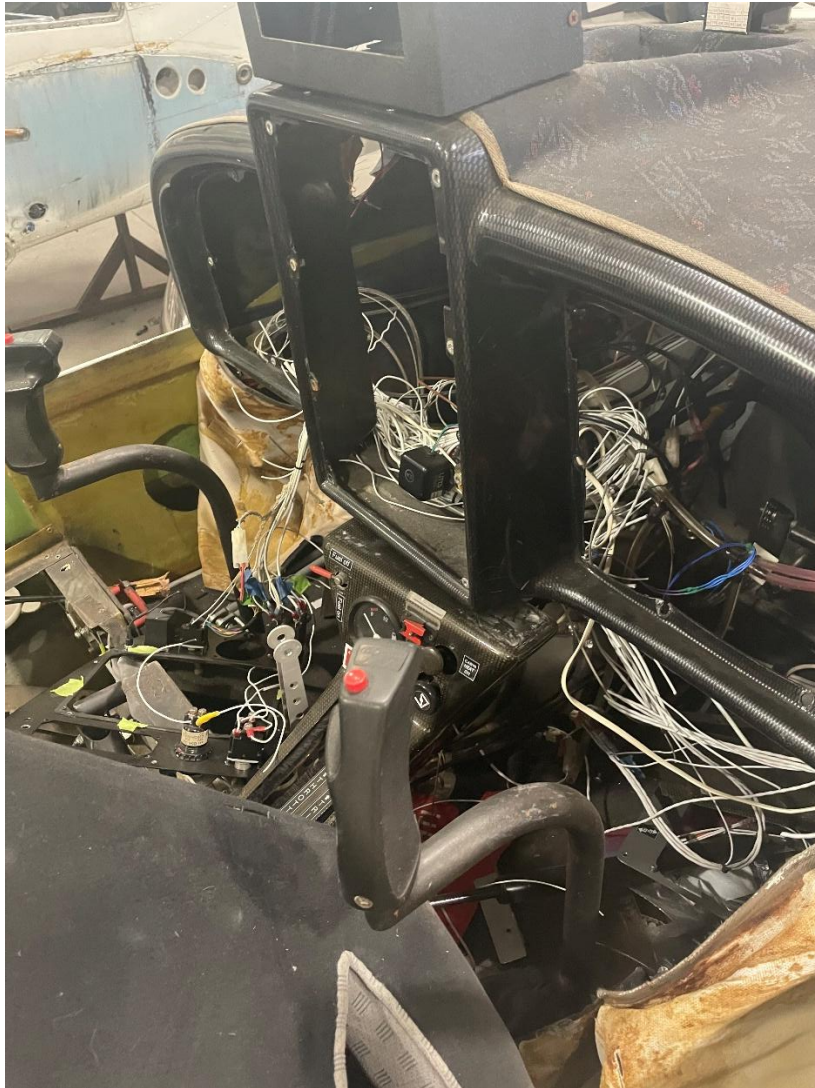
**Photograph 4: View of cockpit**

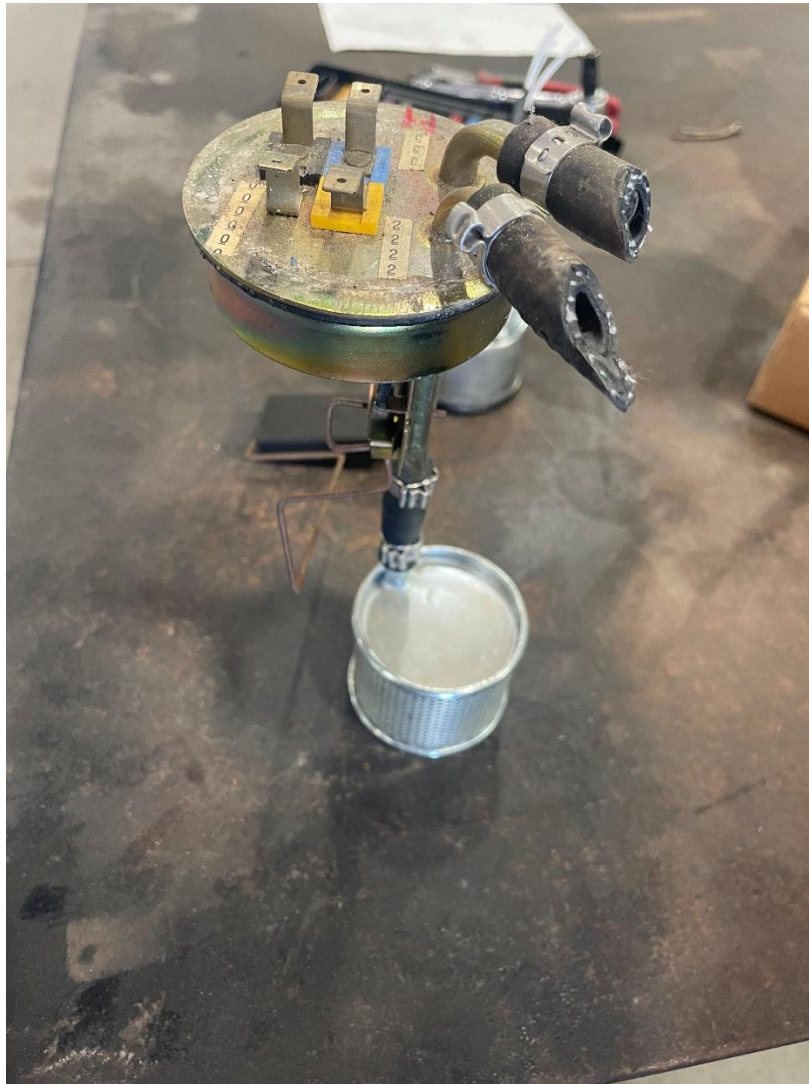
The fuel floater assembly was found disconnected at the fuel hose and breather hose. The fuel floater assembly was removed for further examination. Examination of the fuel floater assembly revealed that the fuel sensor arm was intact, with a float attached at the end, and was able to move freely by hand. The fuel floater assembly was connected to an external battery source. With the battery source connected, the fuel low level light would illuminate, but the fuel quantity indicator would not move despite manually moving the fuel sensor arm. An ohmmeter was used to check the fuel floater assembly contacts and it would register ohms; however, the ohm reading remained fairly consistent when manually moving the fuel sensor arm between the empty and full quantity levels.

**Photograph 5: View of fuel floater assembly**

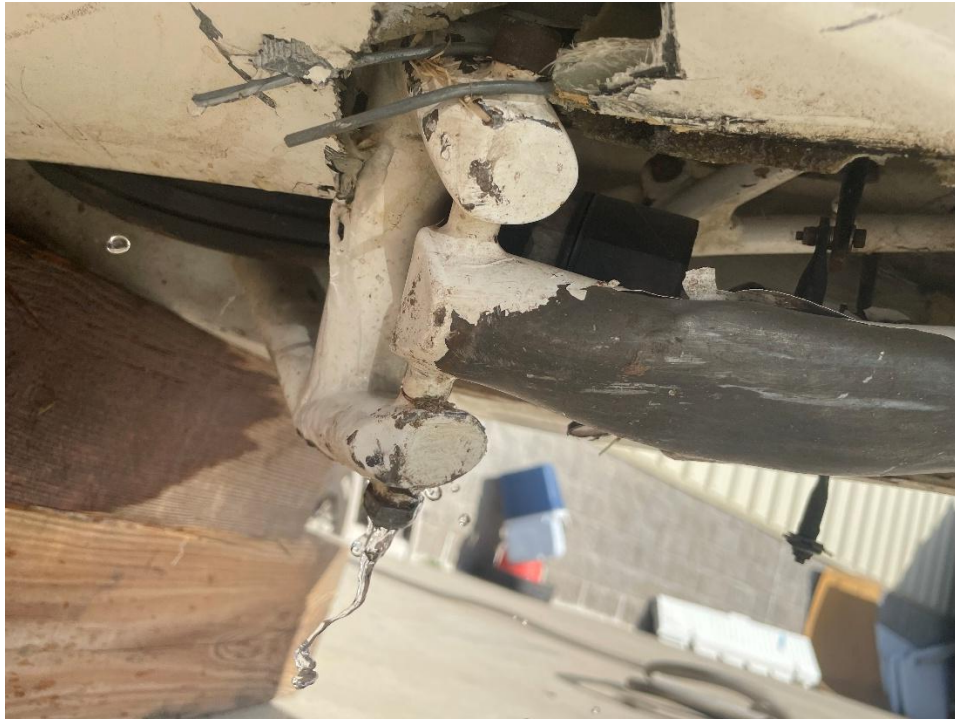
About 5 gallons of water was added to the main fuselage fuel tank. The water was observed leaking out of the area by the nose landing gear assembly close to where it collapsed into the bottom of the fuselage, consistent with impact damage to the tank.

**Photograph 6: View of water leak from fuel tank, nose landing gear**
