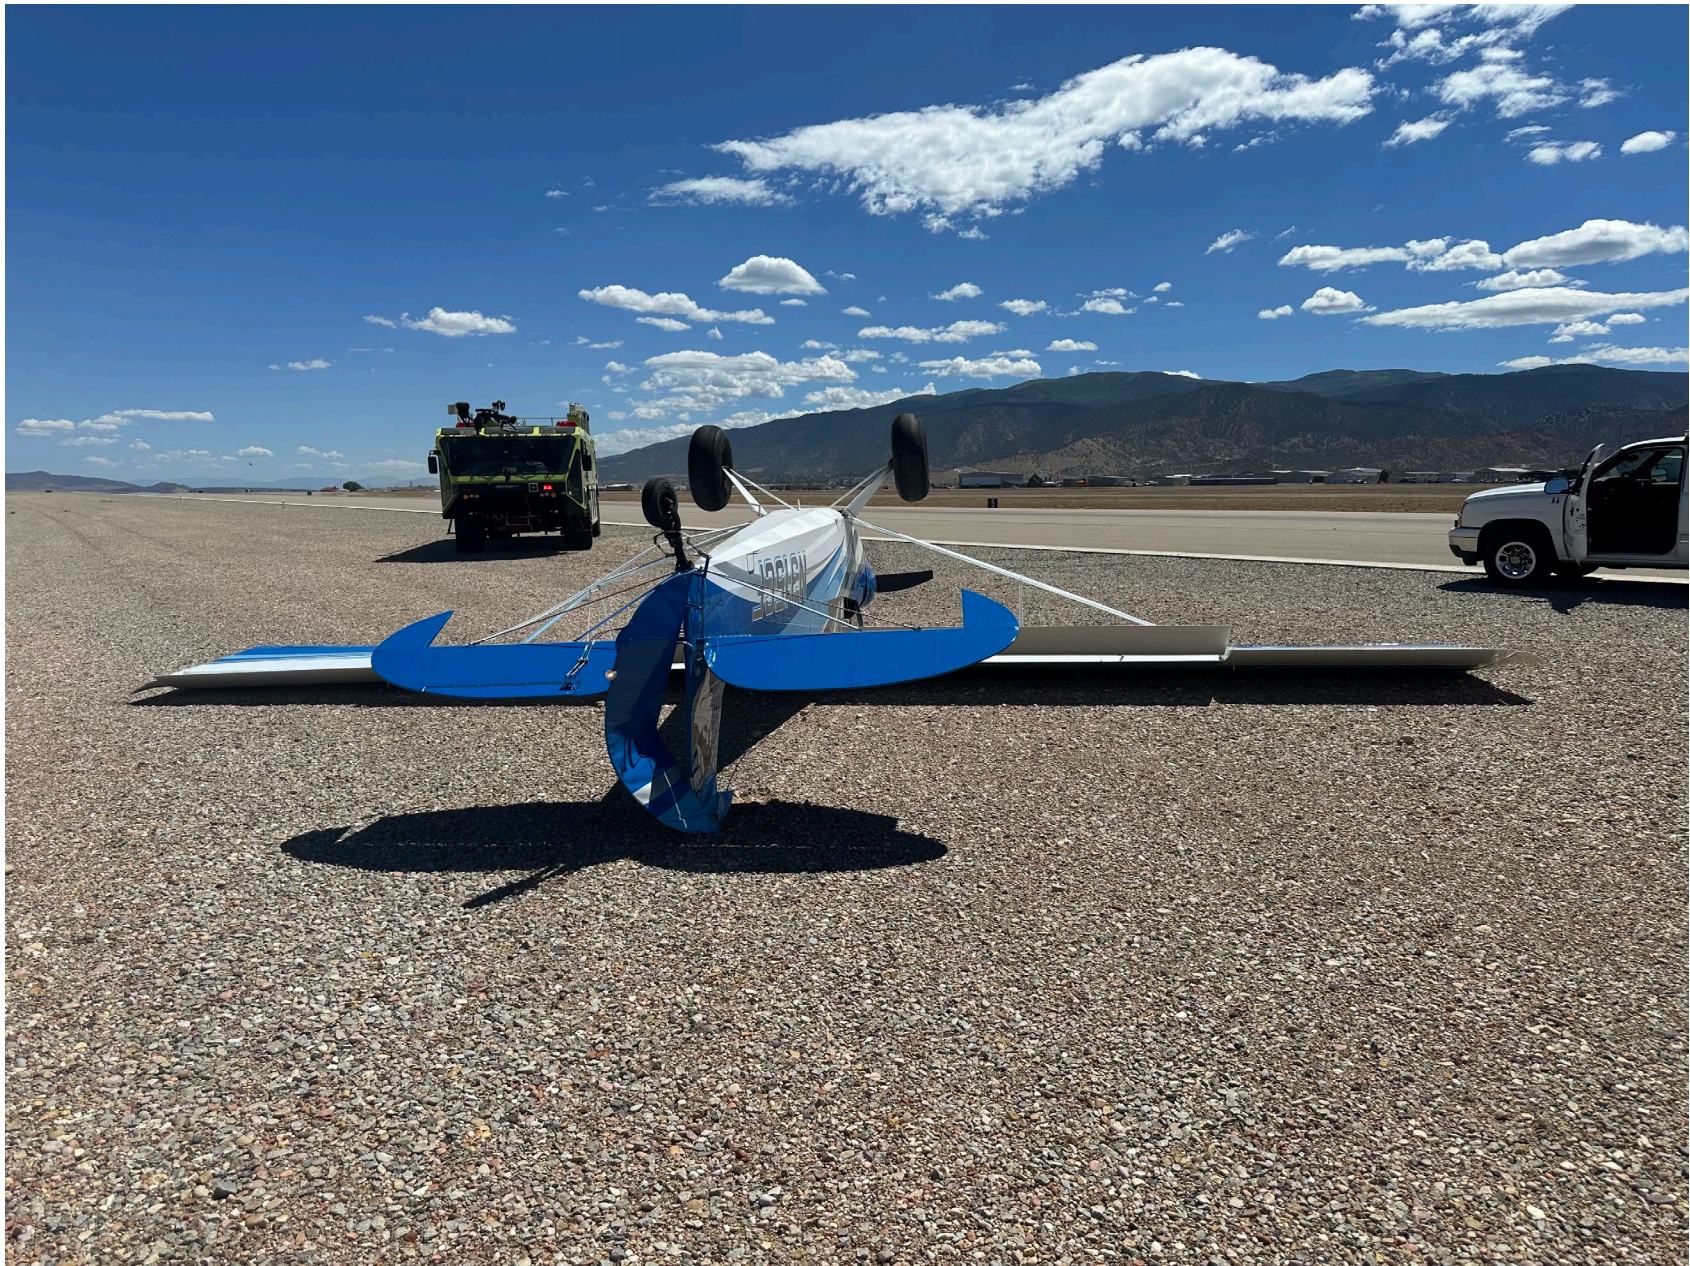
**Photo 1 – View of damage to vertical stabilizer, rudder, and right wing lift strut. (Courtesy airport ops)**
