# National Transportation Safety Board

WPR24LA230

## **AIRFRAME AND ENGINE EXAMINATION REPORT**

Location: Reno, Nevada  
Date: June 13, 2024  
Time: 2024  
Airplane: Cessna P210 / N36RW

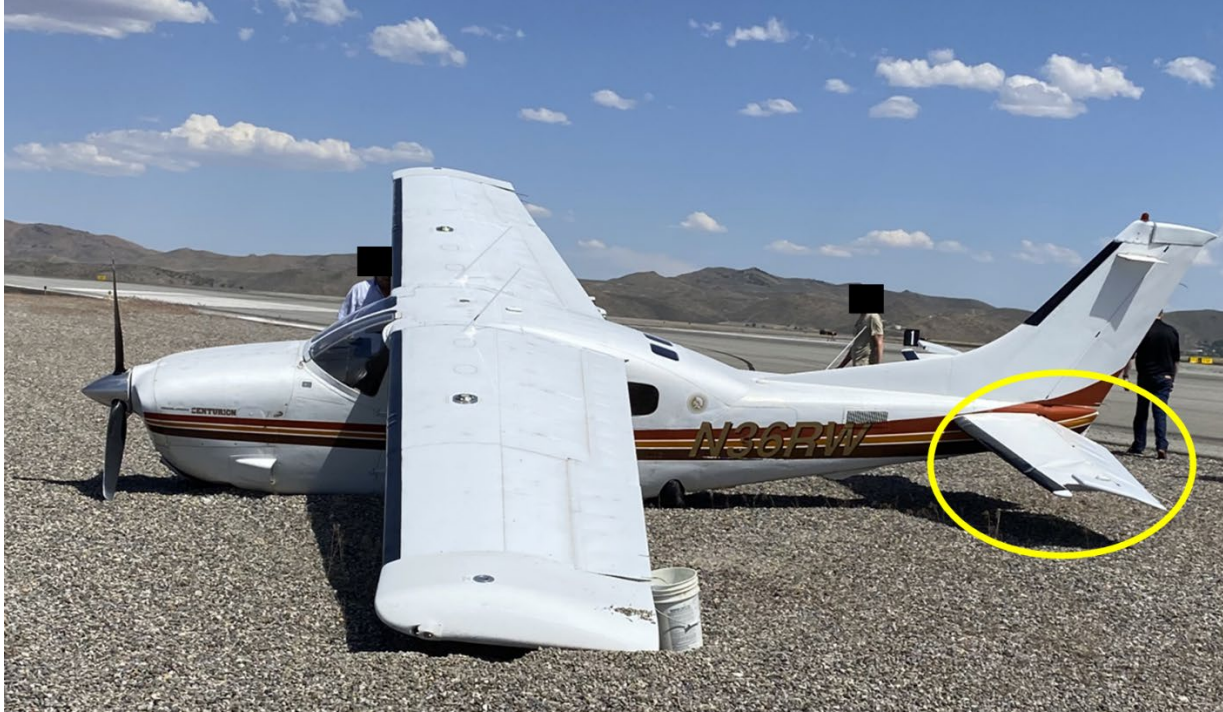
The fuselage was minimally damaged with only the left horizontal stabilizer and elevator exhibiting damage. The wings, horizontal stabilizers and elevators were removed for recovery. The airplane was upright on the main landing gear and the nose was supported by a metal frame.

**Figure 1. Photo of N36RW showing substantial damage to the left horizontal stabilizer and elevator (Photo courtesy of the pilot).**

The vertical stabilizer and rudder remained installed on the fuselage and exhibited minimum damage. The left horizontal stabilizer and elevator were displaced upward and exhibited wrinkles in the sheet metal.

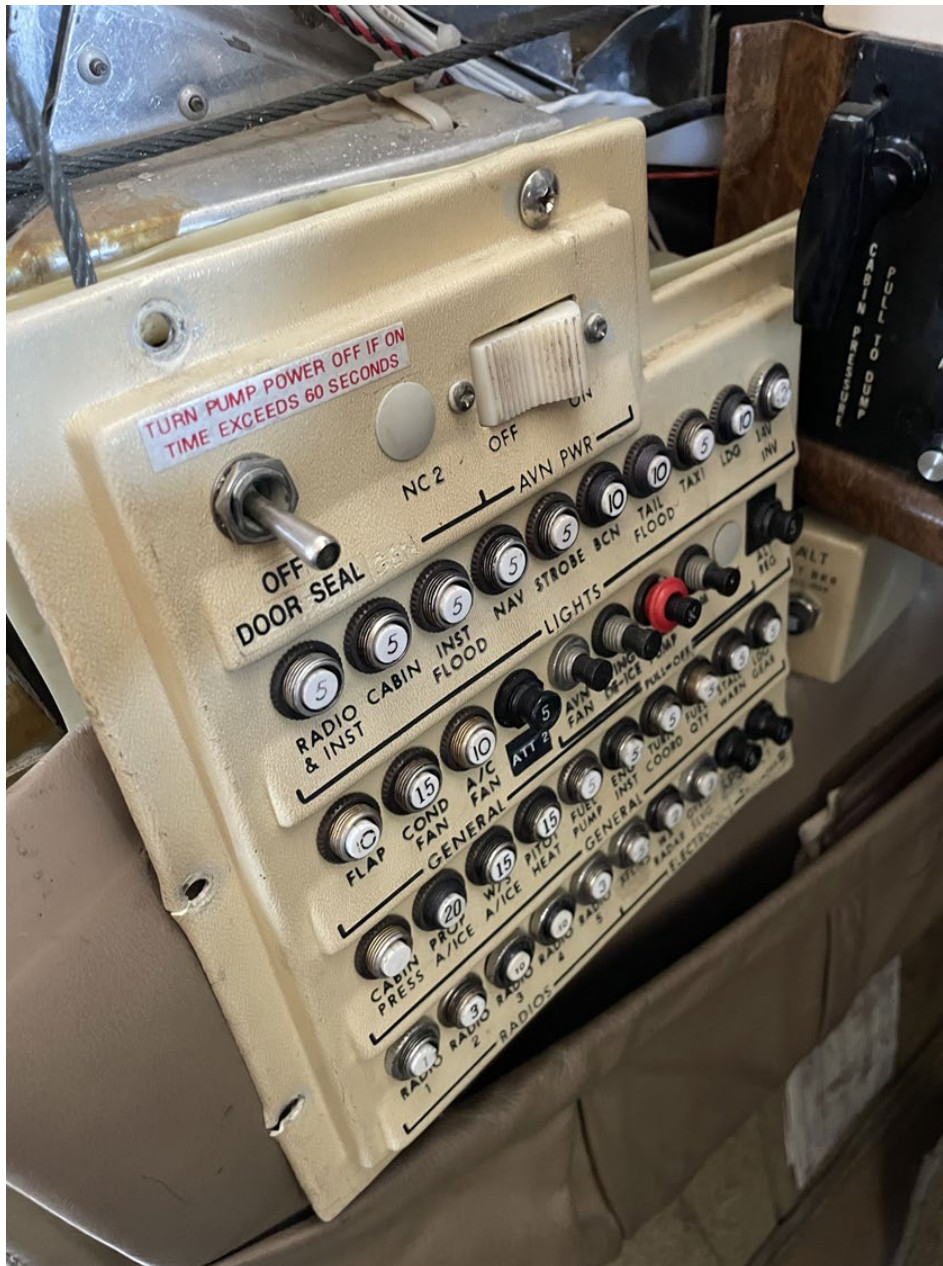
The circuit breaker panel was secured, and all circuit breakers were properly installed in the panel. Not loose wires were observed. No evidence of any electrical faults or anomalies was observed.

Figure 2. Circuit breaker panel.

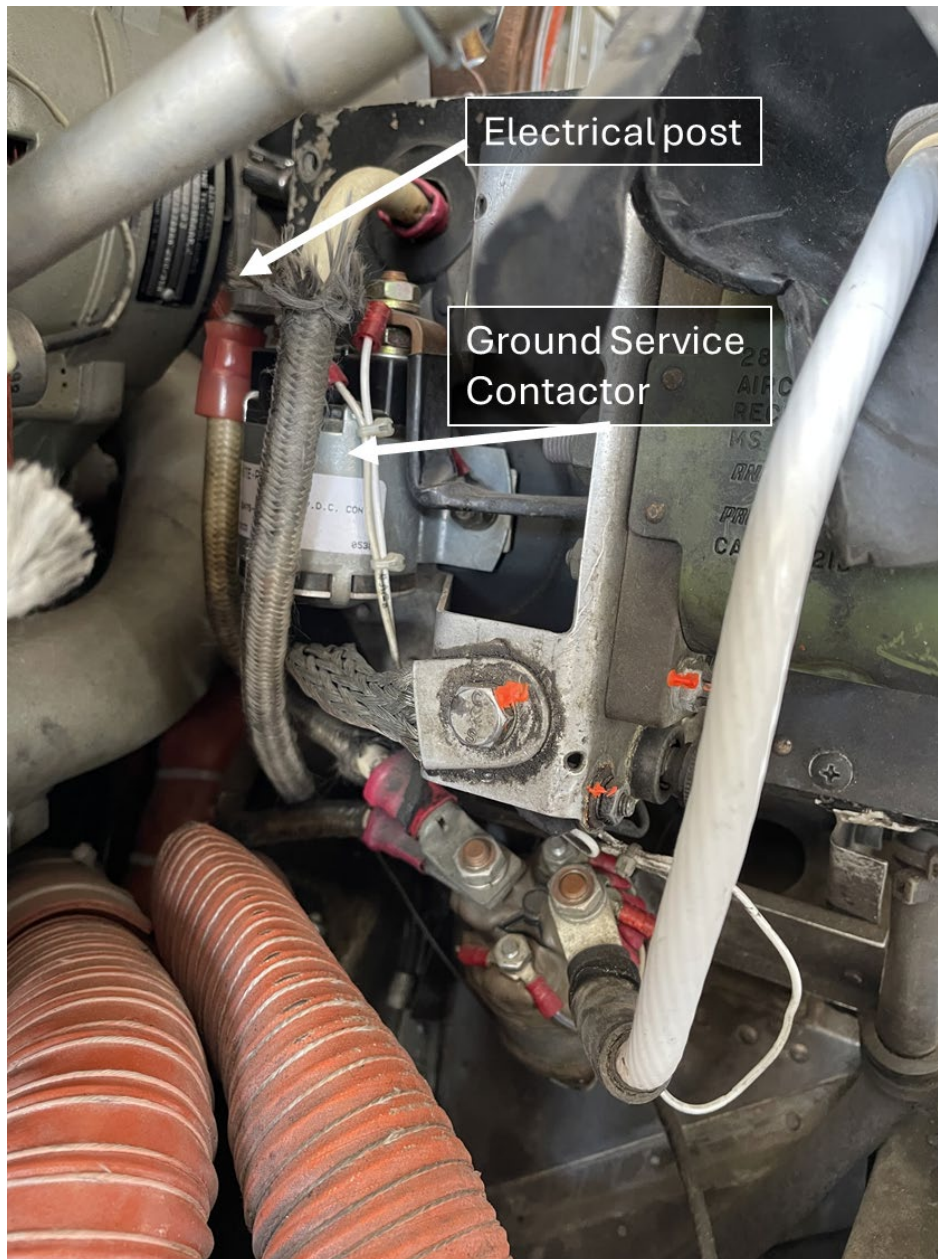
One electrical lead to the ground receptacle unit exhibited a loose attachment and could be moved with minimal hand force.

**Figure 3. Ground service contactor.**

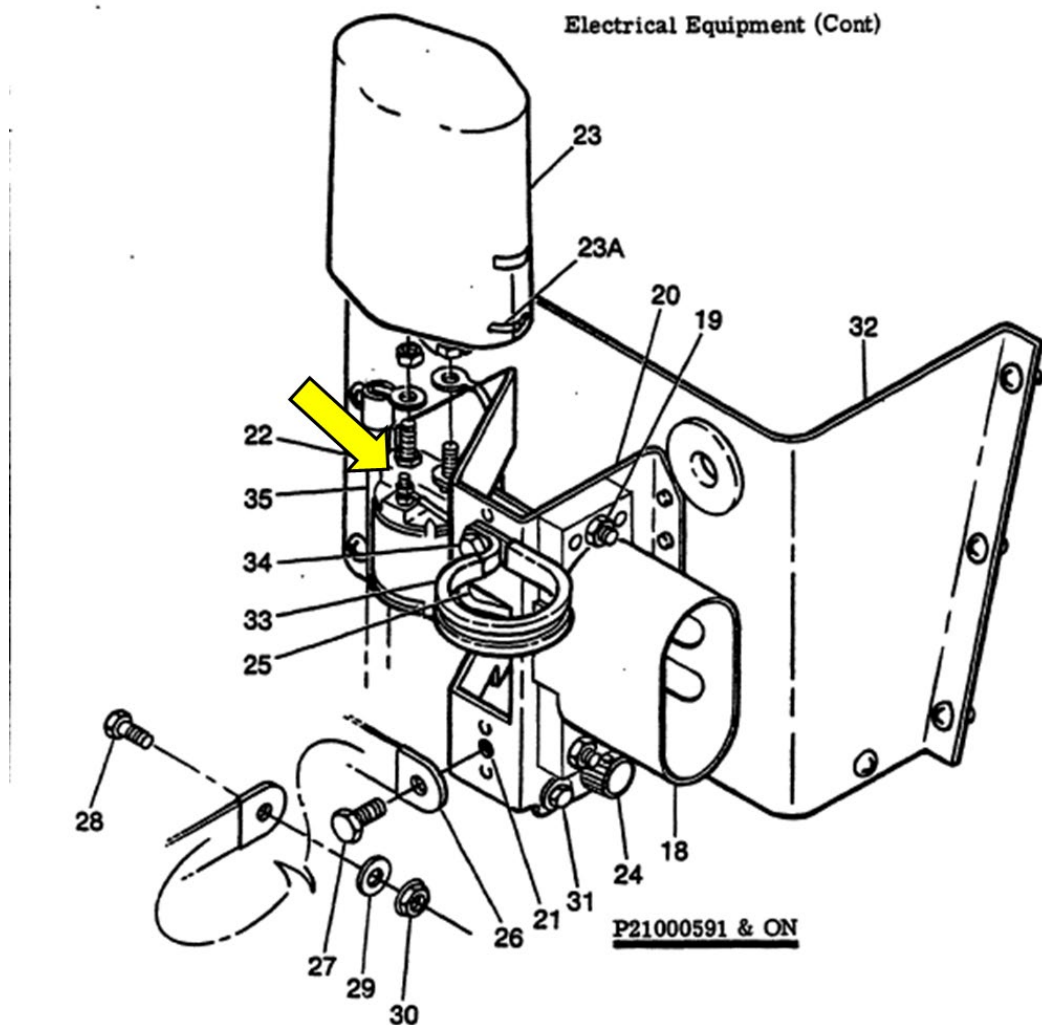
**Figure 4. Illustrated parts catalog image showing the ground service contactor.**

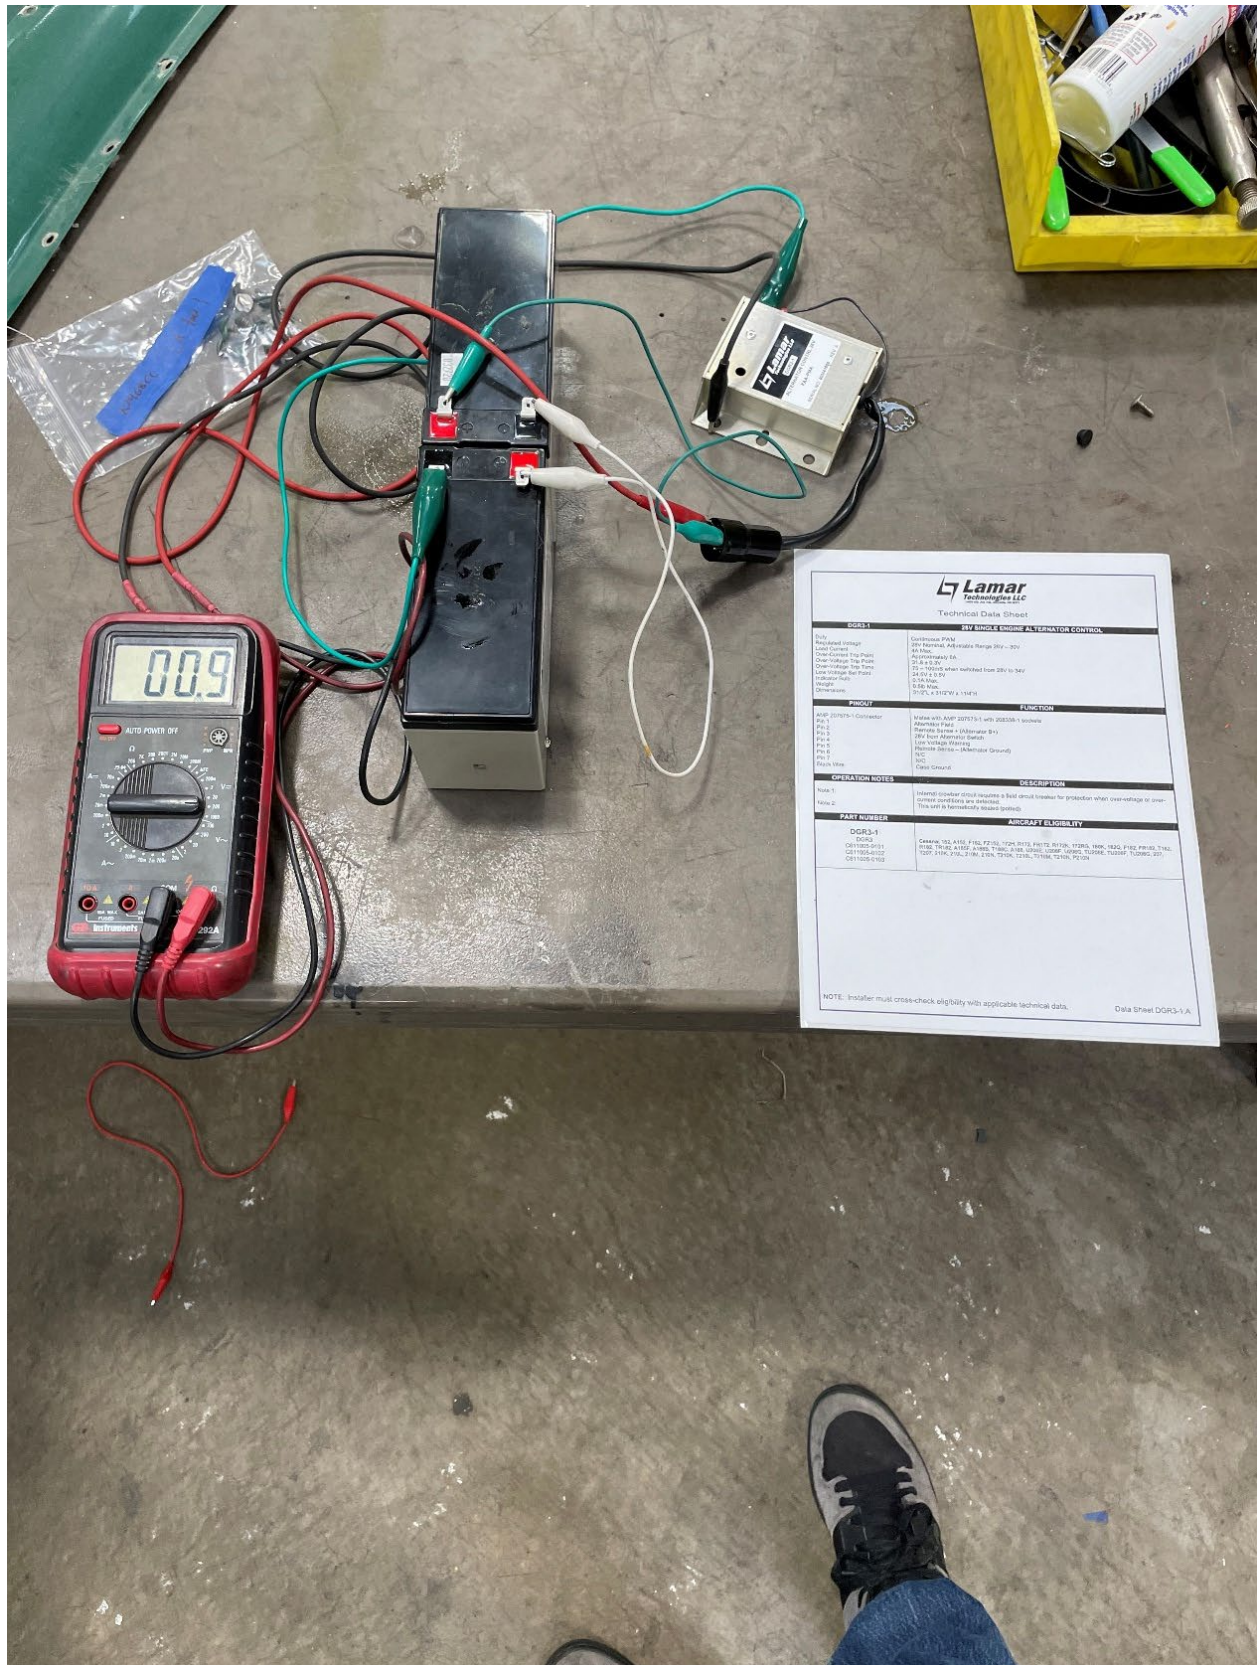
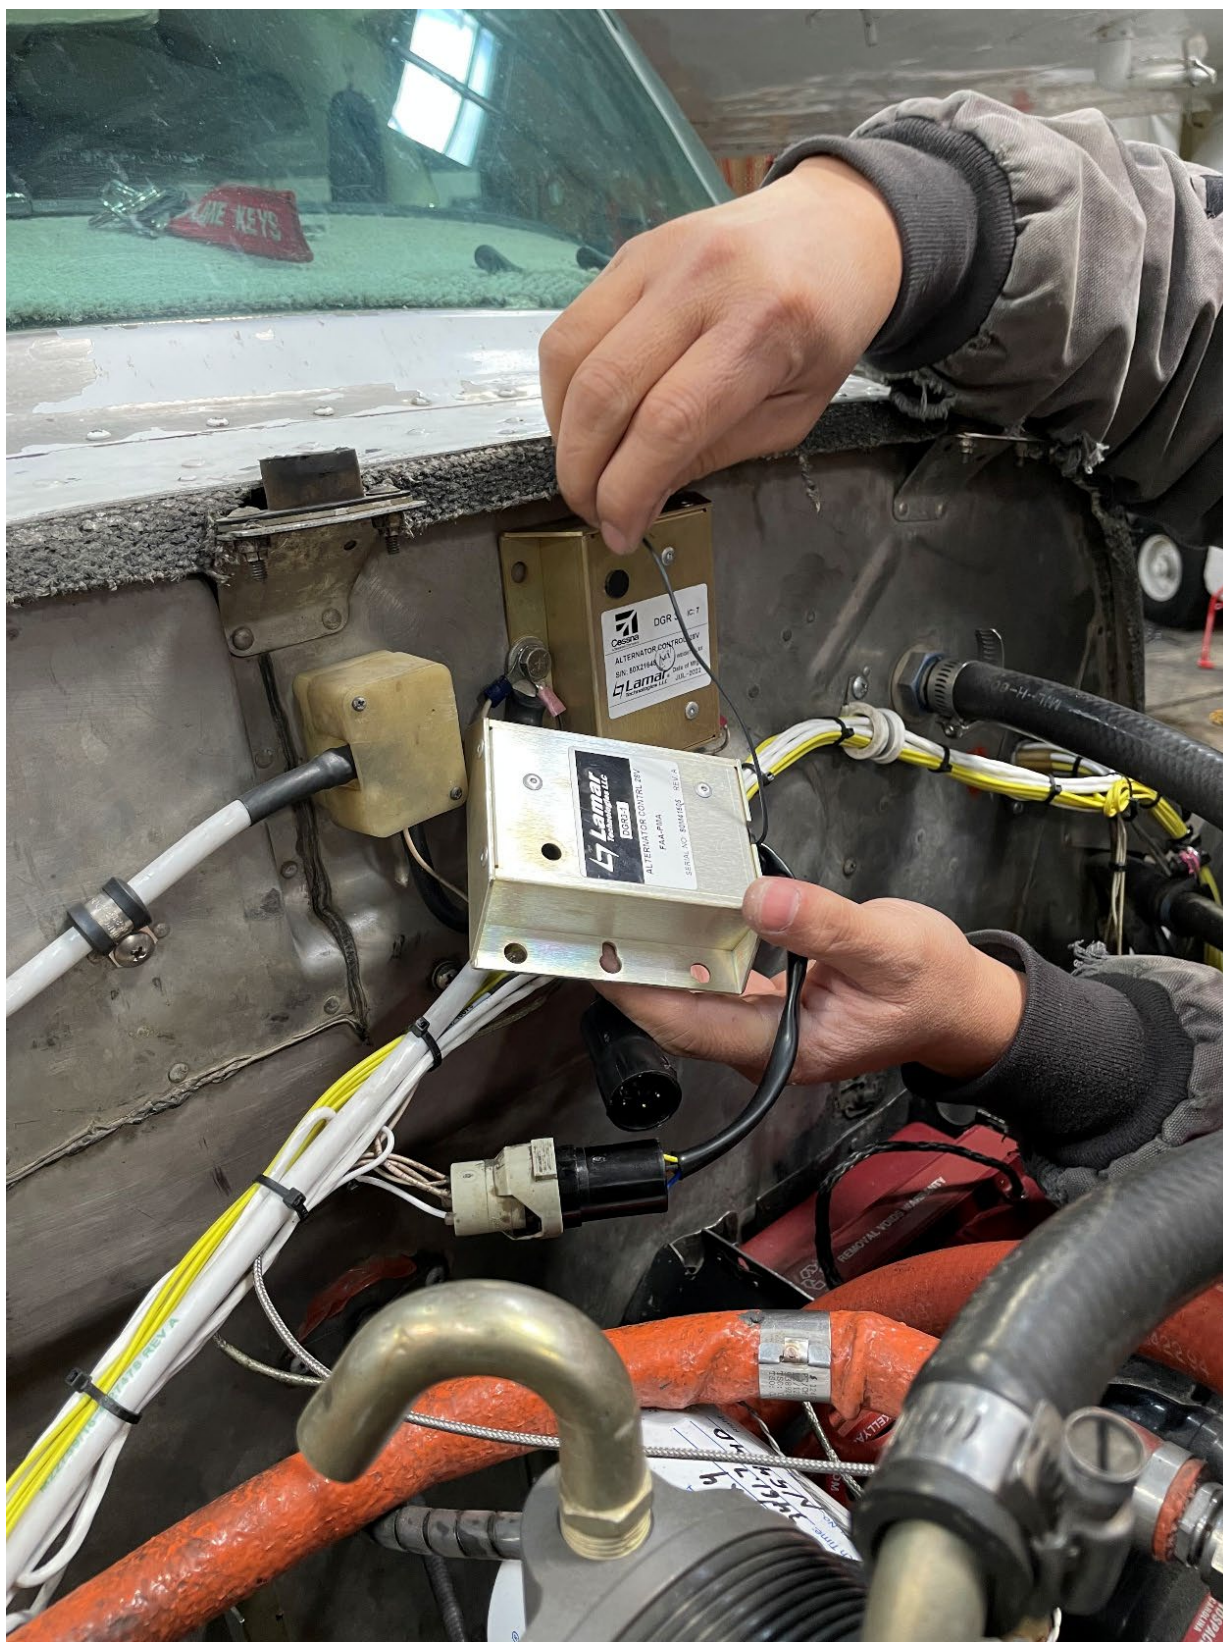
The voltage regulator (alternator controller, serial number: 80M41505), was removed from the inside-firewall for further examination. The unit was tested in accordance with the manufacturer's Technical Data sheet and found to be within the specifications. The unit was then installed onto an airplane with a normally functioning electrical system. Application of power to the accident unit revealed normal indications on the airplane's instrumentation.

**Figure 6. Accident voltage regulator alongside the exemplar voltage regulator.**

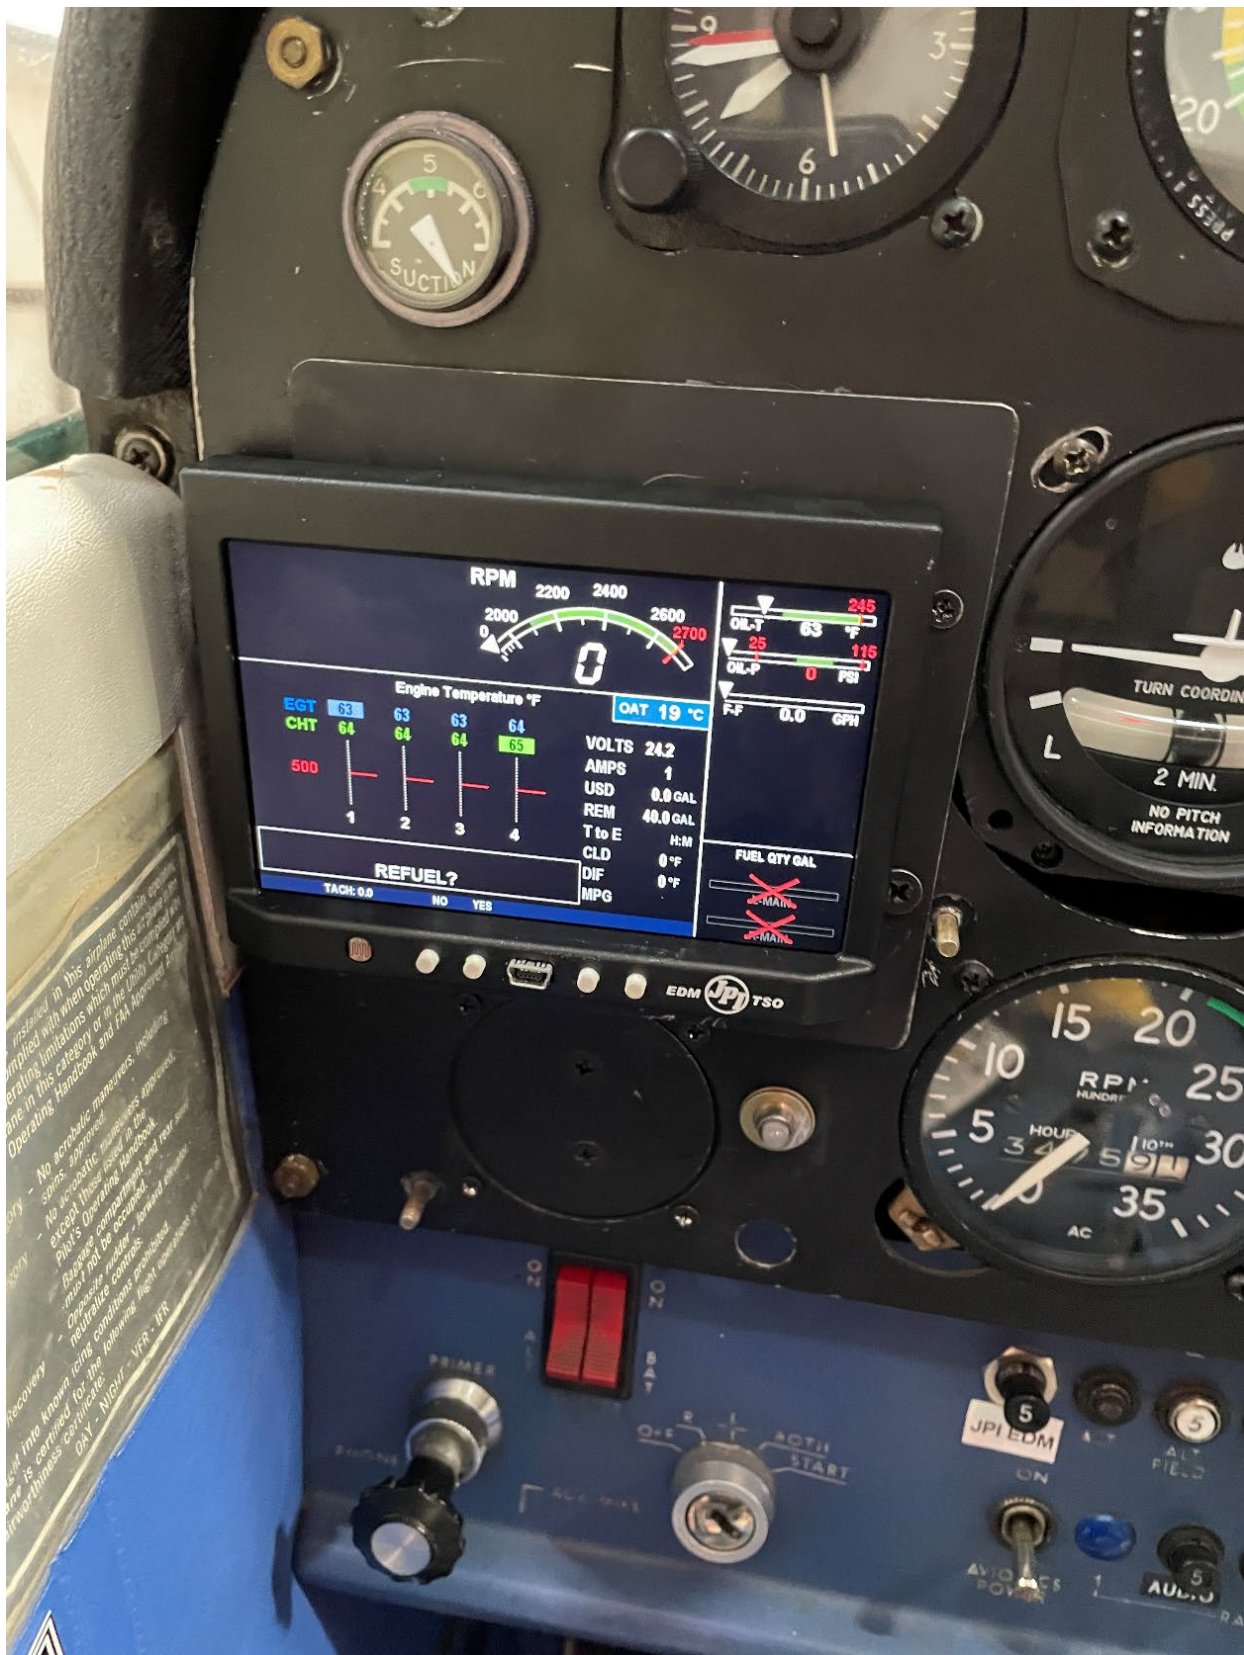
**Figure 7. Exemplar electrical system with accident voltage regulator showing 24.2 volts.**

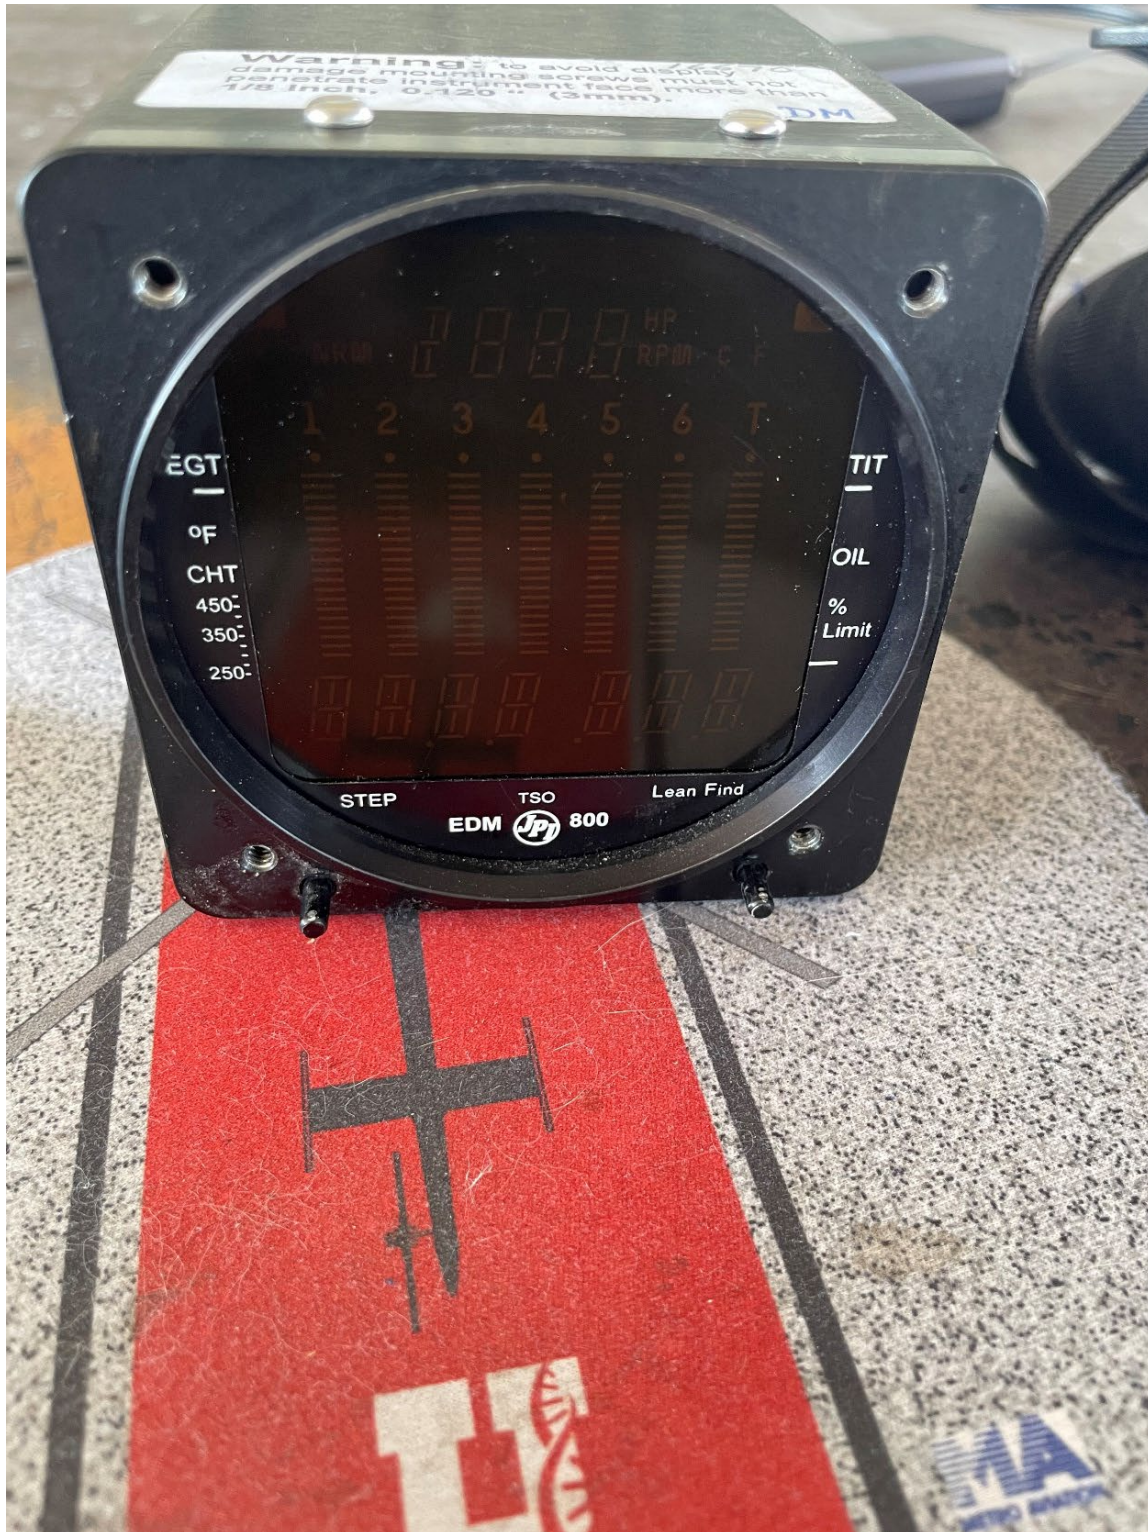
The JP Instruments, EDM-800, serial number: 23670, was removed for download of non-volatile memory. Figure 8 is a graph showing data from the accident flight.

**Figure 8. Image of the JPI EDM-800.**

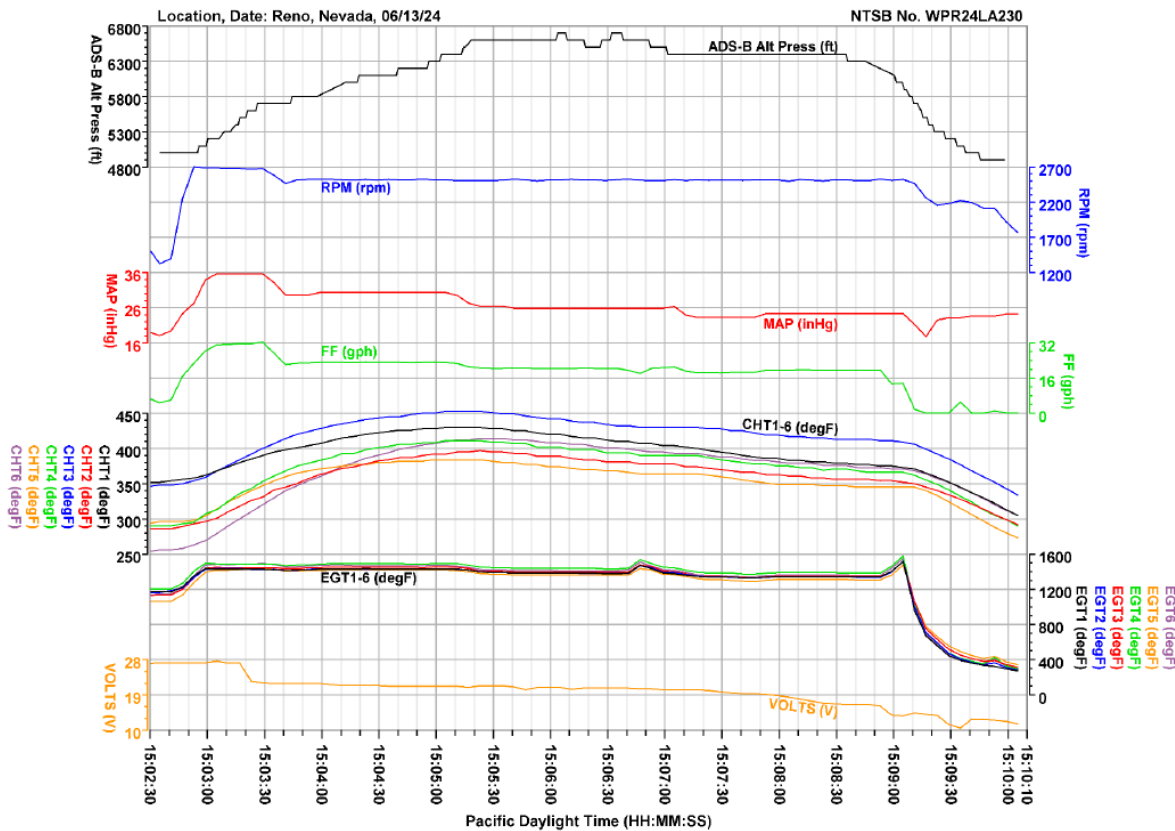
**Figure 9. EDM-800 Graphic data for the accident flight.**
