# National Transportation Safety Board

WPR24LA240

## **WRECKAGE EXAMINATION SUMMARY**

Location: Soldier, ID  
Date: July 13, 2024  
Time: 07:50 MDT  
13:50 UTC  
Airplane: 1959 Cessna 182B (SN: 51917)

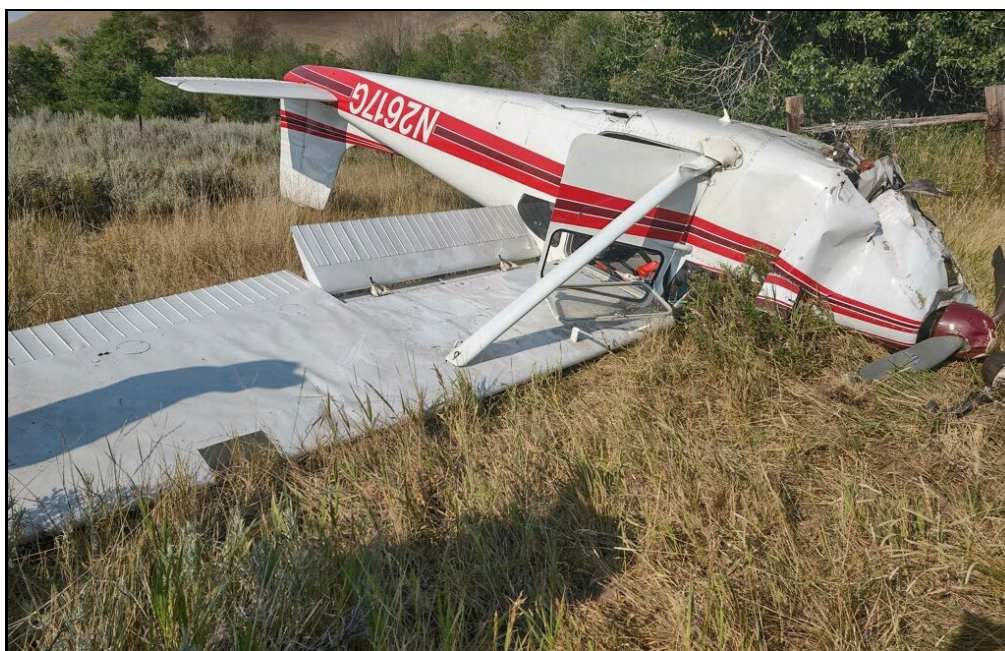
**Figure 1:** View of inverted accident airplane at the accident site

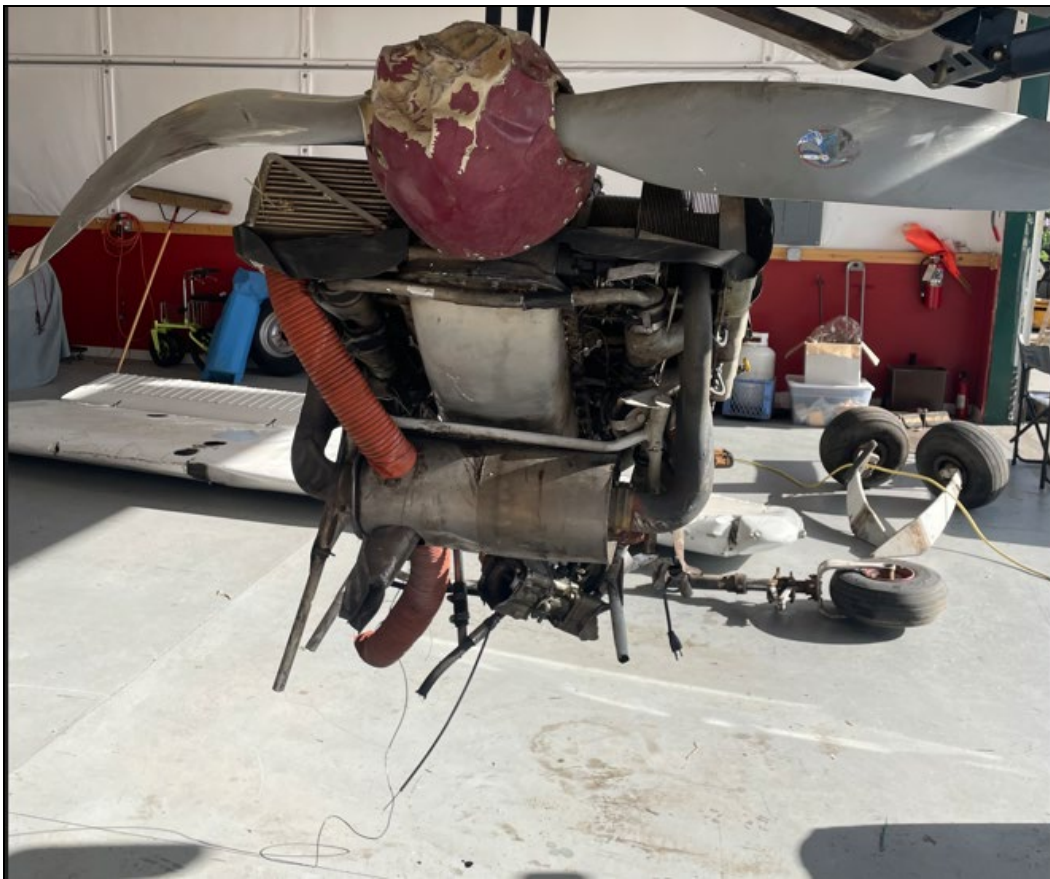
**Figure 2:** View of the accident engine separated from the airframe

Examination of the six cylinder, naturally aspirated piston engine, was observed with both propeller blades bent aft toward the fuselage, the spinner sustained impact damage, and the propeller hub remained attached to the propeller flange. The propeller could not be rotated through. Upon first appearance, each of the six cylinders were unremarkable with top and bottom spark plugs tight to touch, and primer lines secure. Intake and exhaust fittings were attached and secure to their respective cylinders. The exhaust manifold sustained impact damage and connected to the heat shield.

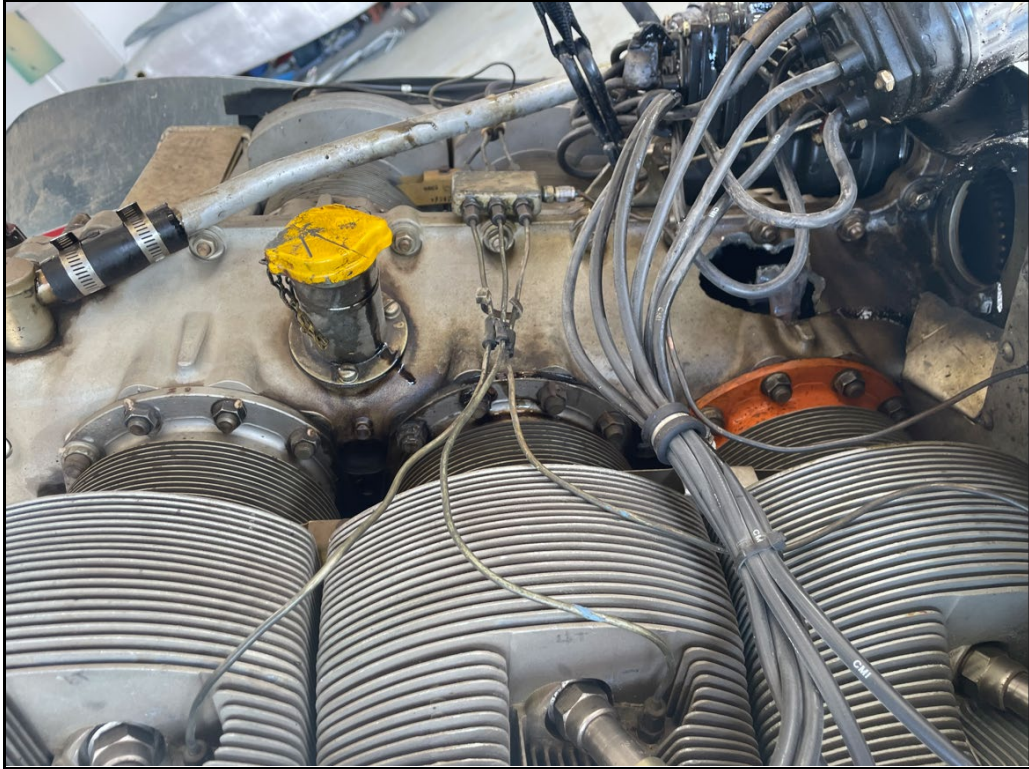
During a cursory overview of the engine after being separated from the airframe, about a 3-inch hole in the top of the crankcase was observed above the No. 2 cylinder. A lighted borescope was inserted into the spark plug orifice of each cylinder and revealed that the No. 1 cylinder piston was not present. Each of the cylinders were removed from the crankcase, and detonation signatures were observed throughout, in the form of cylinder head pitting, damage to the piston skirts, piston crown pitting, and shiny metallic fragments observed on the cylinder heads and piston crowns. Magenta to engine time was not confirmed due to impact damage to the left and right magneto.

**Figure 3:** View of hole in the crankcase above the No. 2 cylinder, and right separated magneto

The accessory case remained attached to the crankcase, except for the left and right magnetos which sustained impact damage. The right magneto remained partially attached, while the left magneto was completely separated from the accessory case. The carburetor sustained impact damage and was separated from the intake manifold. The engine sump remained intact and attached to the lower crankcase. The top of the crankcase, above the No. 2 cylinder, was breached by the No. 2 piston connecting rod. The top spark plugs were removed from each of the six cylinders, and a lighted borescope was used to assess the condition of the piston crowns, cylinder head, exhaust and intake valves, and cylinder walls.

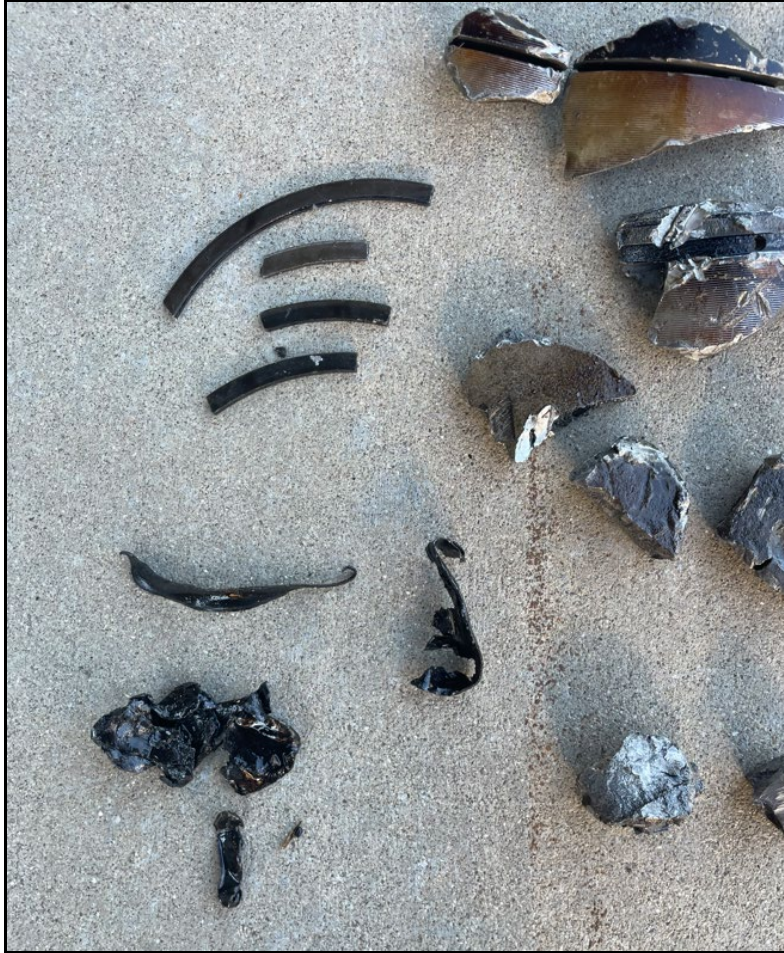
The top and bottom spark plugs were removed from each cylinder, and presented normal wear signatures, albeit the No. 1 cylinder top and bottom plugs contained melted, shiny metal fragments between the gaps. The engine oil sump was removed and contained multiple sections of the No.1 piston, and material from each of the damaged cylinder piston skirts. Each cylinder was removed, and the details are as follows:

**Figure 4:** View of the piston and cylinder material found in the engine oil sump

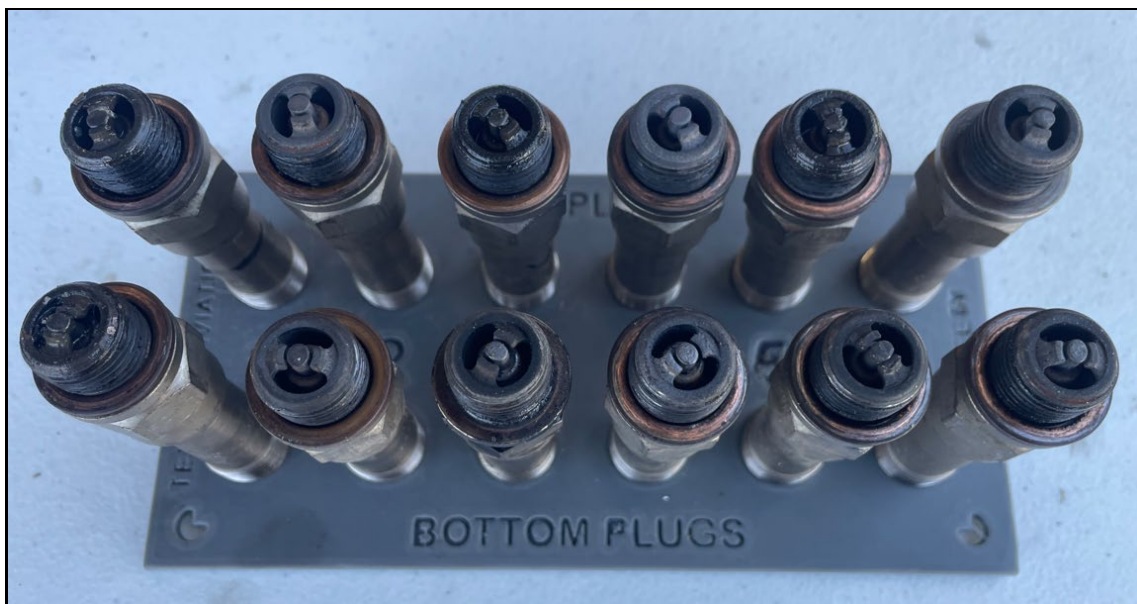
**Figure 5:** View of top and bottom spark plugs removed from each cylinder

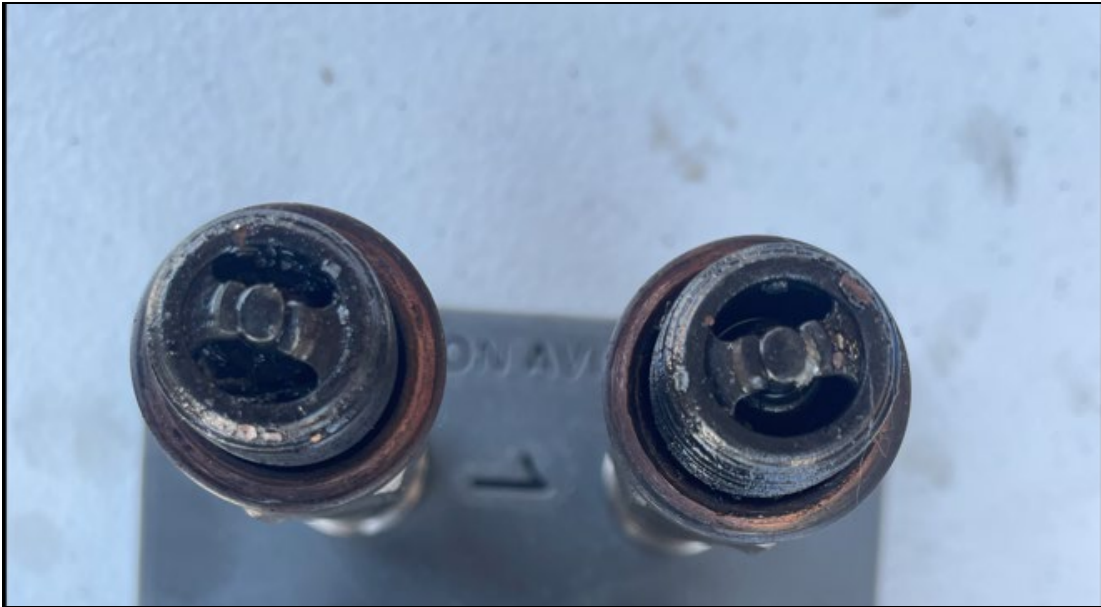
**Figure 6:** View of No. 1 cylinder top and bottom spark plugs with shiny metallic material between the gaps

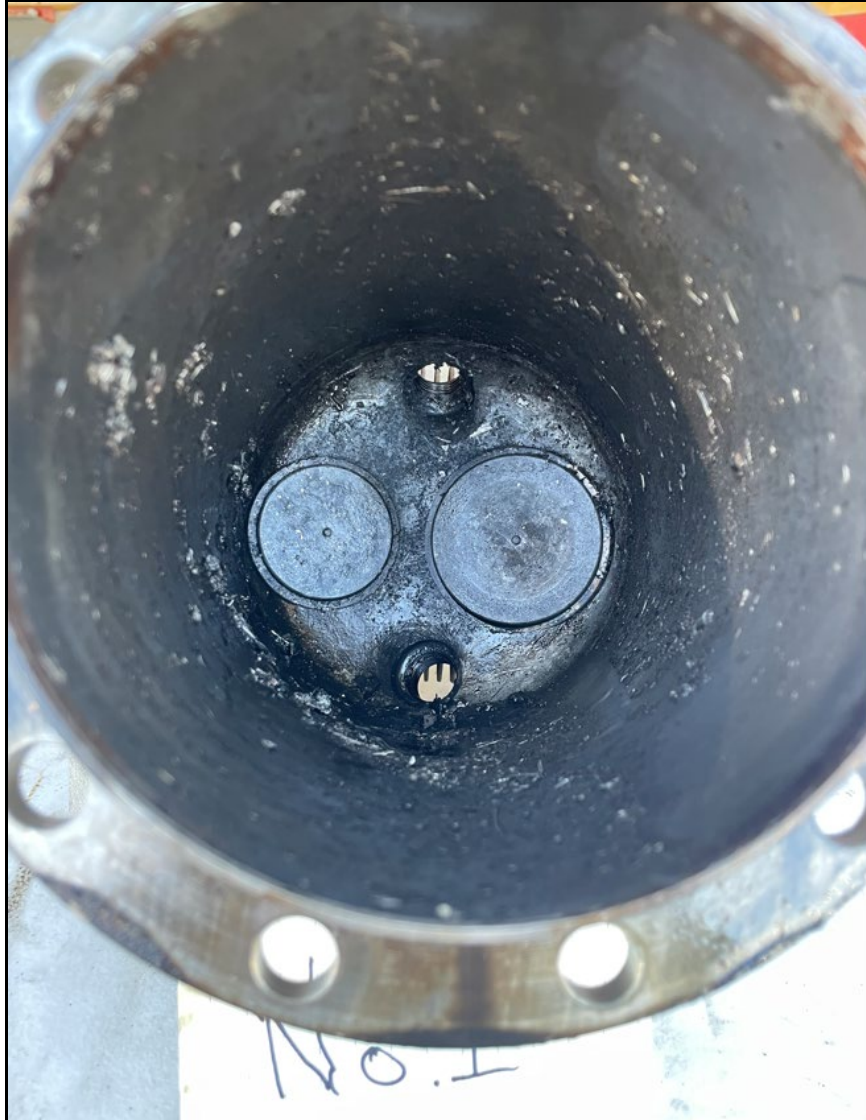
No. 1 piston was not observed in the cylinder. The connecting rod, bearings and cap were present and unremarkable. The wrist pin caps were present, deformed and conical in appearance. The cylinder head, exhaust and intake valves were present and sustained varying degrees of FOD ingestion. The intake and exhaust valve seats sustain varying degrees of FOD ingestion signatures but were grossly unremarkable. The cylinder walls were carbon coated with a noticeable level of metallic shavings throughout. The exhaust valve push rod was removed from the push rod housing and was deformed. The intake gasket was present and unremarkable. The intake and exhaust valve springs assemblies were present and unremarkable.

**Figure 7:** View of No. 1 cylinder barrel, head, exhaust and intake valves

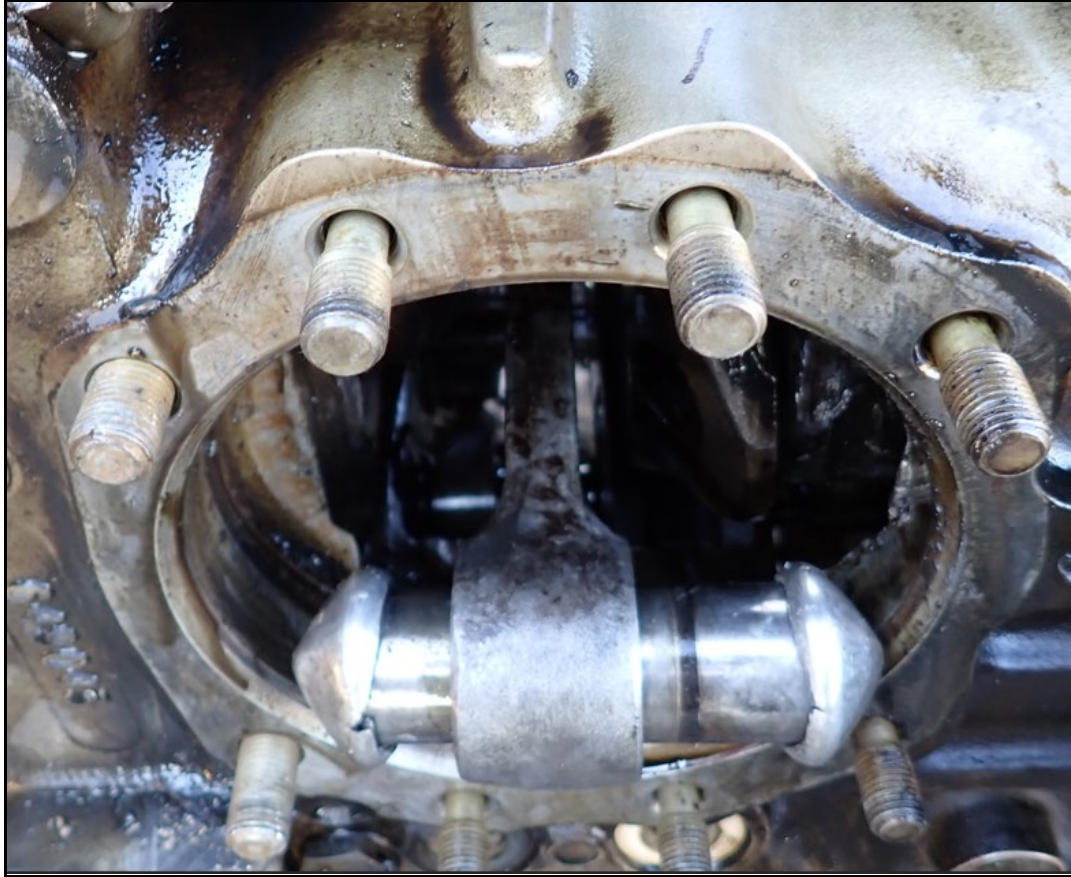
**Figure 8:** View of No. 1 connecting rod, wrist pin and end caps

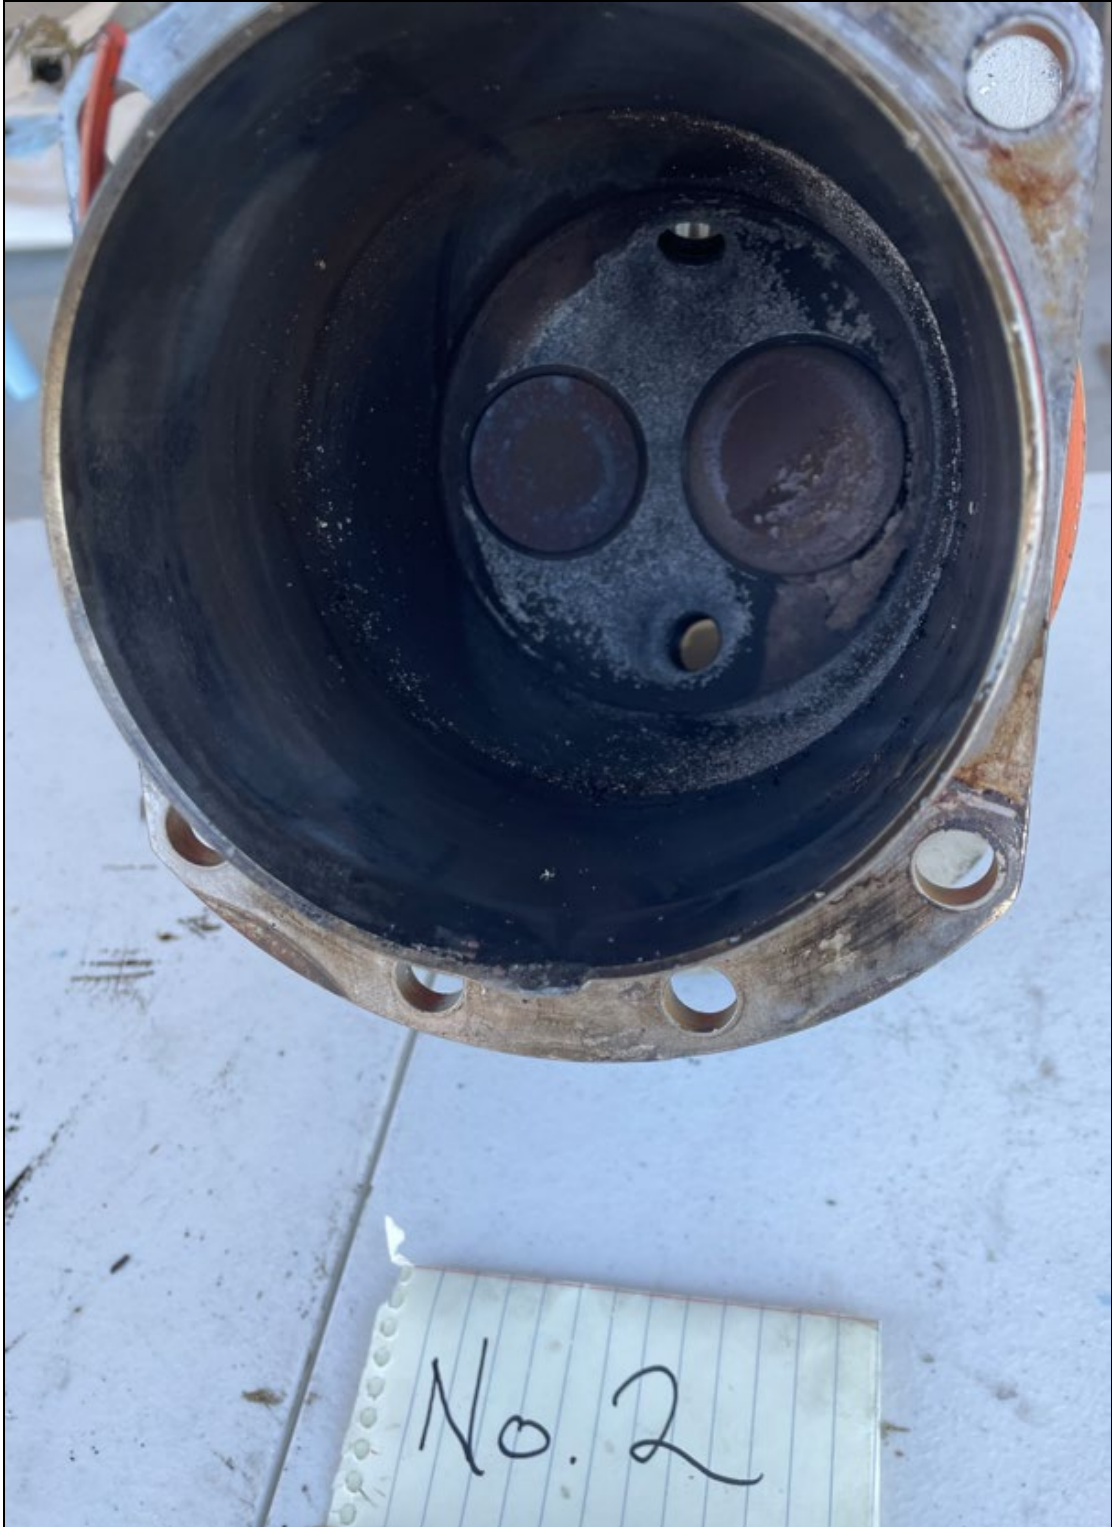
No. 2 piston was observed in the cylinder. The piston crown and edges were unremarkable. The oil retention rings, and oil scrapper rings were present and unremarkable. The piston skirt was missing several sections. The connecting rod and wrist pin were present and unremarkable. The connecting rod was separated from the bearings and cap, with the cap and bolts, and one nut deformed and affixed to the crankshaft. The cylinder head, exhaust and intake valves were present and unremarkable. The cylinder walls were carbon coated with a noticeable level of metallic shavings throughout. The exhaust and intake valve push rods were removed from their housings and unremarkable. The intake gasket was present and unremarkable. The intake and exhaust valve springs assemblies were present and unremarkable.

**Figure 9:** View of No. 2 cylinder barrel, head, exhaust and intake valves

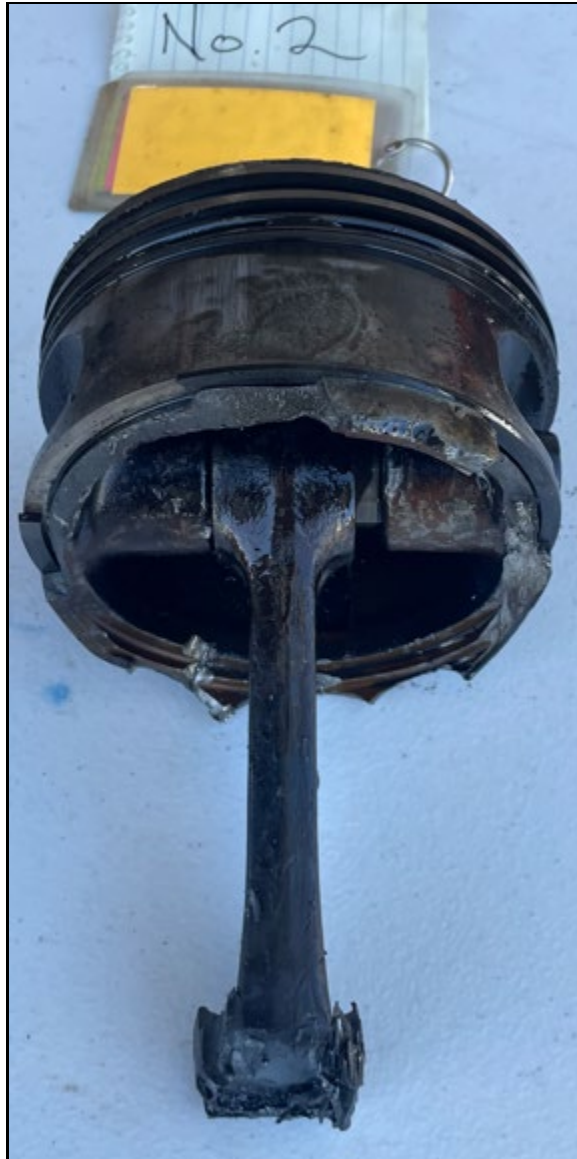
**Figure 9:** View of No. 2 connecting rod failure and piston skirt damage

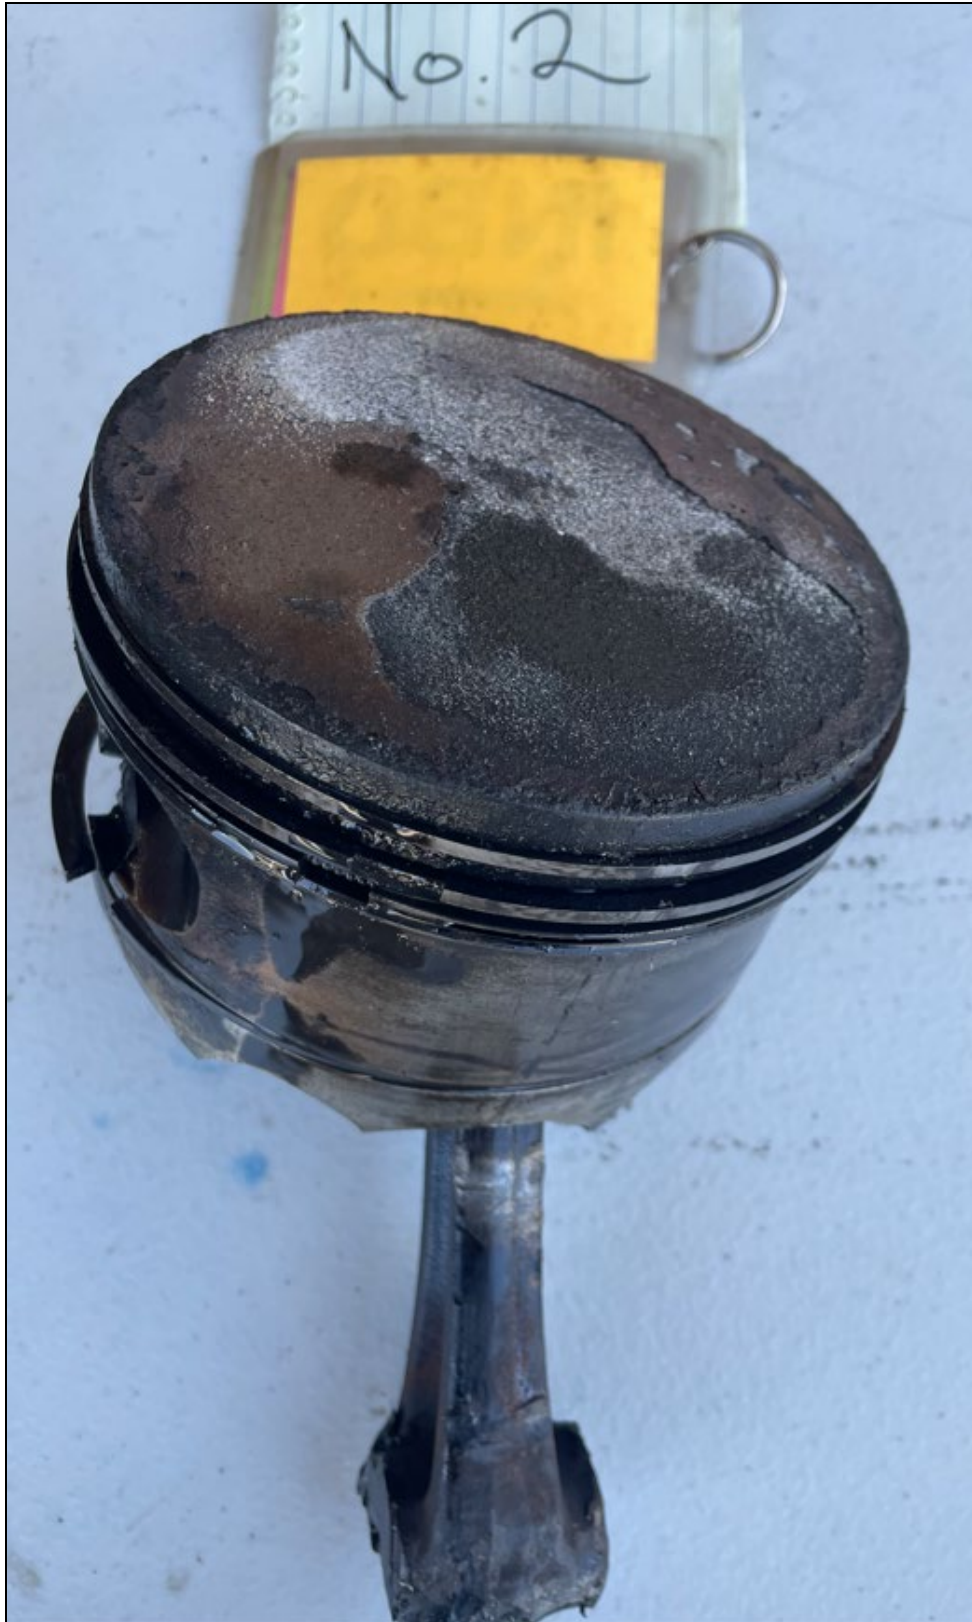
**Figure 10:** View of No. 2 piston crown and skirt

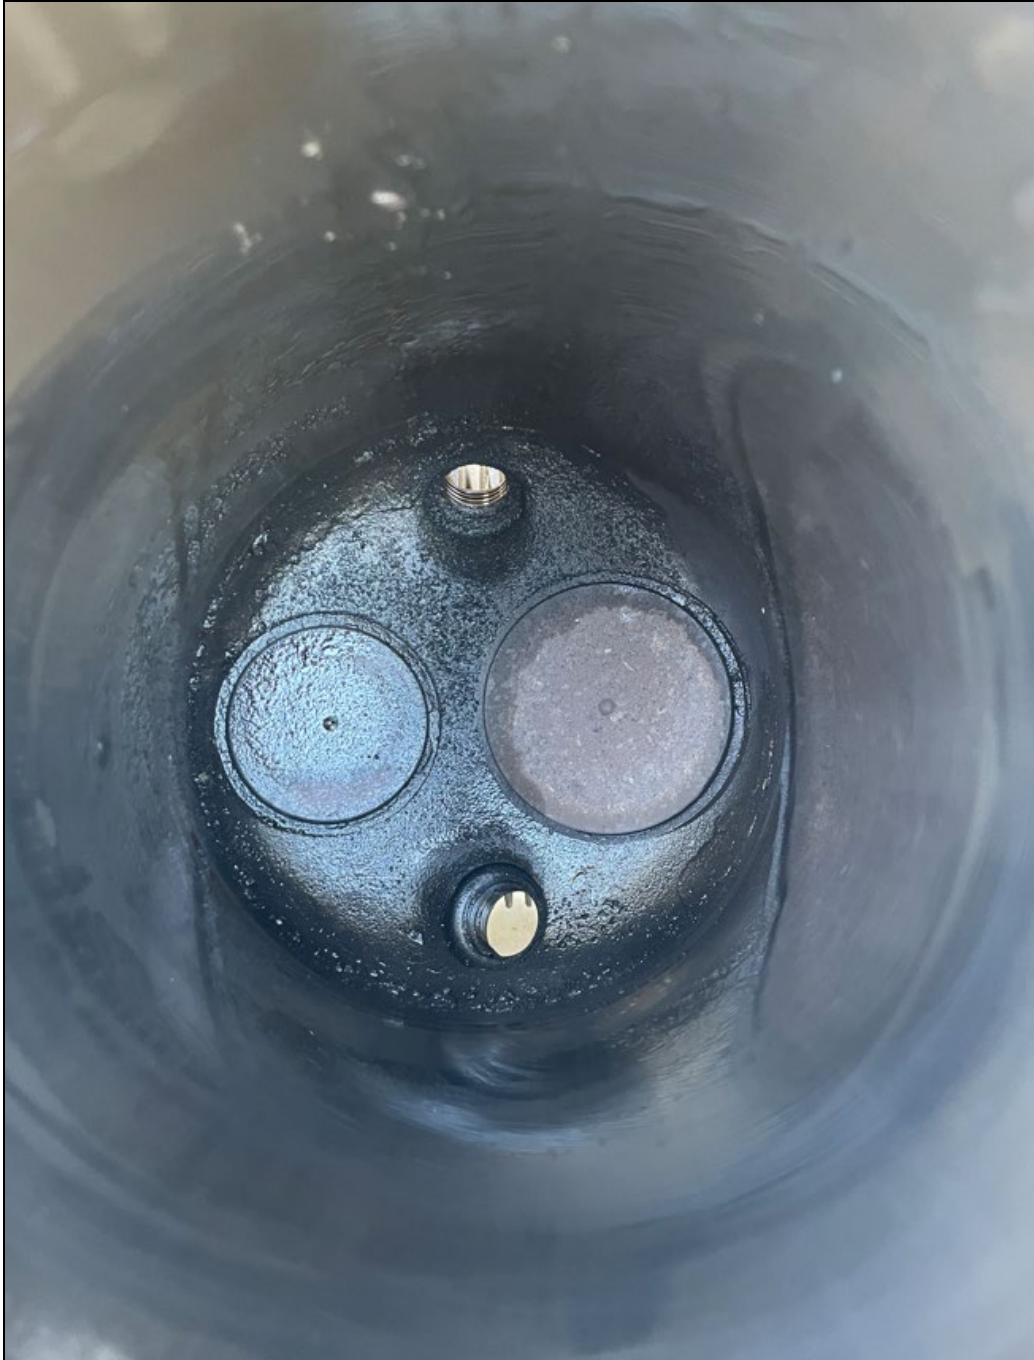
No. 3 piston was observed in the cylinder. The piston crown and edges were unremarkable. The oil retention rings, and oil scrapper rings were present and unremarkable. The piston skirt was missing several sections. The connecting rod and wrist pin were present and unremarkable. The connecting rod bearings and cap were rigid and unmovable by hand, with the bolts and retaining nuts present. The cylinder head, exhaust and intake valves were present and unremarkable. The cylinder walls were lightly carbon coated with a trace level of metallic shavings throughout. The exhaust and intake valve push rods were removed from their housings and unremarkable. The intake gasket was present and unremarkable. The intake and exhaust valve springs assemblies were present and unremarkable.

**Figure 11:** View of No. 3 cylinder barrel, head, exhaust and intake valves

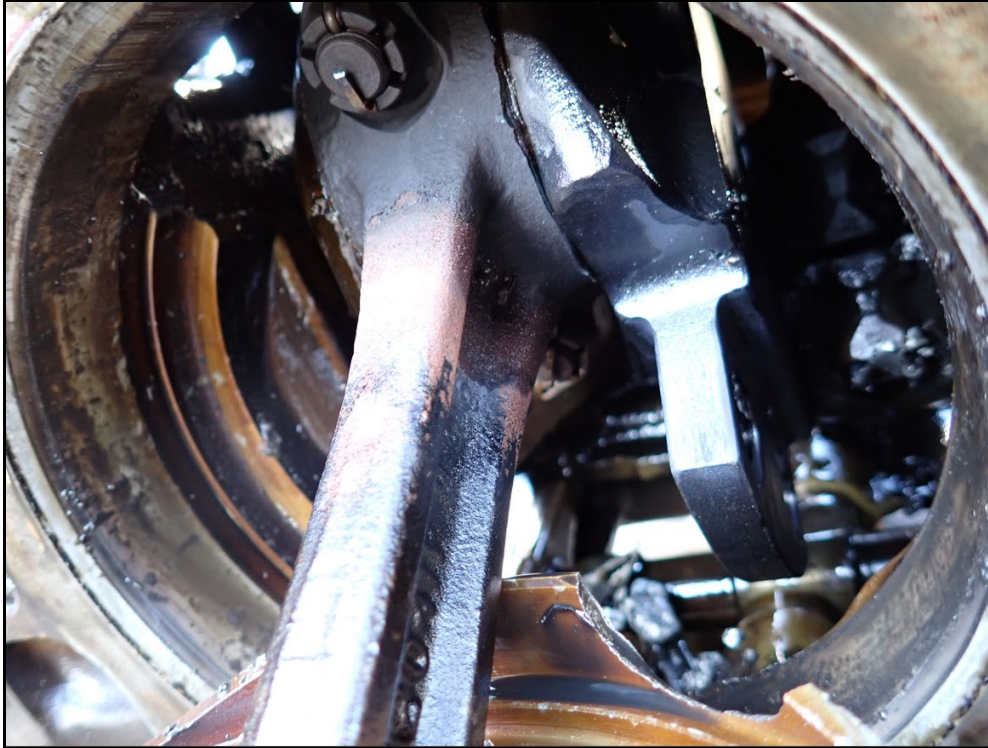
**Figure 12:** View of No. 3 connecting rod

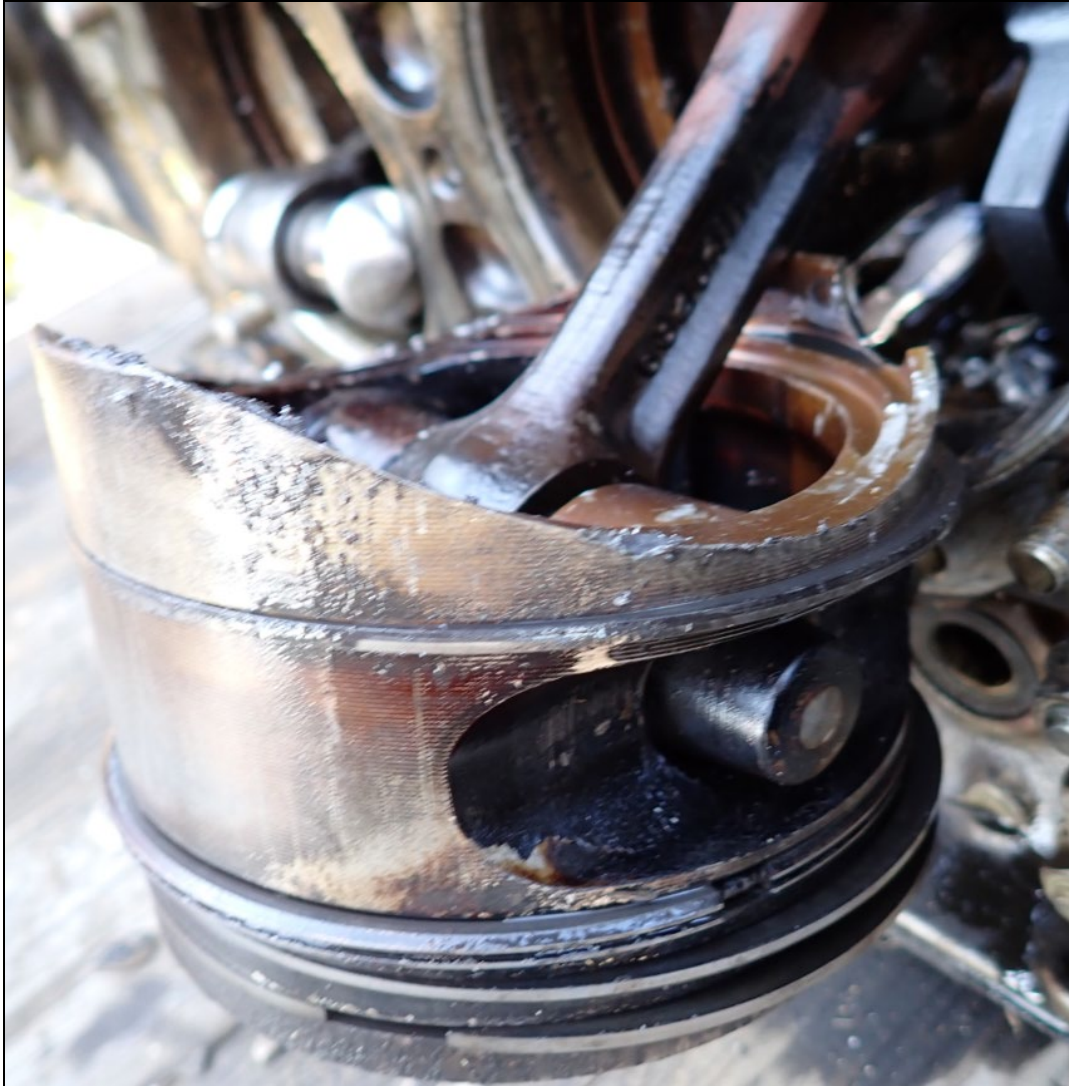
**Figure 13:** View of No. 3 connecting rod and piston skirt

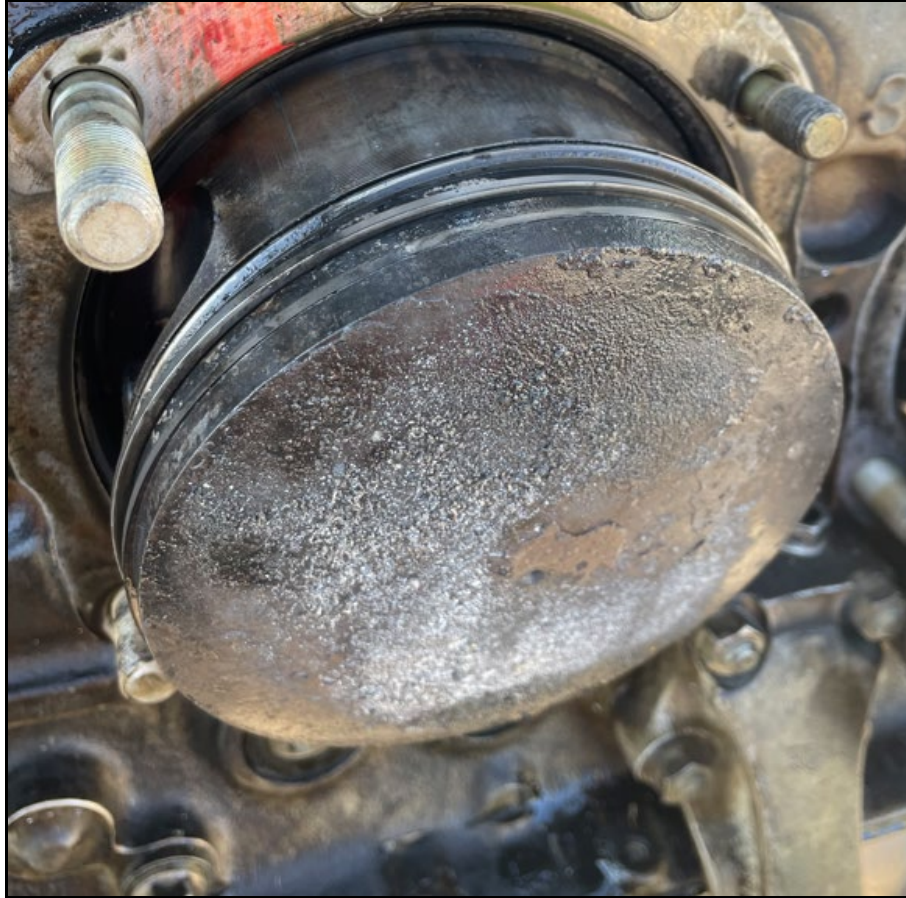
**Figure 14:** View of No. 3 piston crown

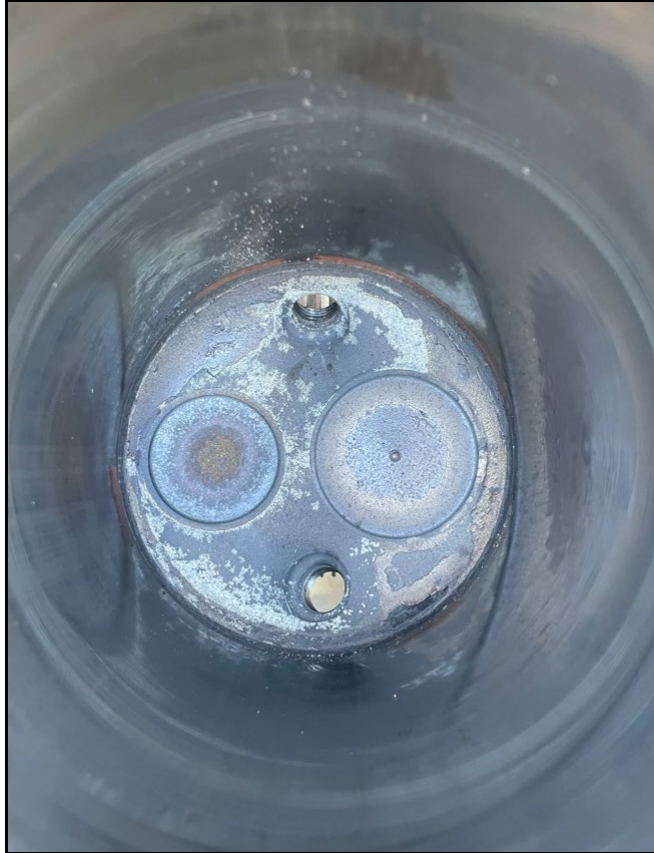
No. 4 piston was observed in the cylinder. The piston crown and edges were unremarkable. The oil retention rings, and oil scrapper rings were present and unremarkable. The piston skirt was unremarkable. The connecting rod and wrist pin were present and unremarkable. The connecting rod presented with reddish color, the bearings and cap were rigid and unmovable by hand, with the bolts and retaining nuts present. The cylinder head, exhaust and intake valves were present and unremarkable. The cylinder walls were lightly carbon coated with a trace level of metallic shavings throughout. The exhaust and intake valve push rods were removed from their housings and unremarkable. The intake gasket was present and unremarkable. The intake and exhaust valve springs assemblies were present and unremarkable.

**Figure 15:** View of No. 4 cylinder walls, head, exhaust and intake valves

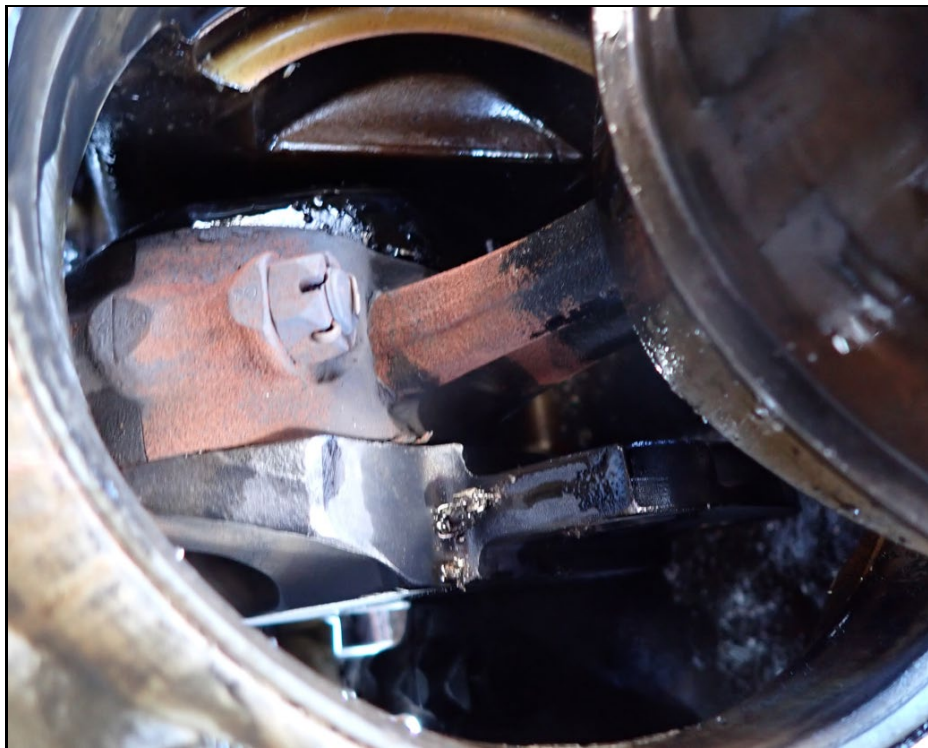
**Figure 16:** View of No. 4 piston connecting rod

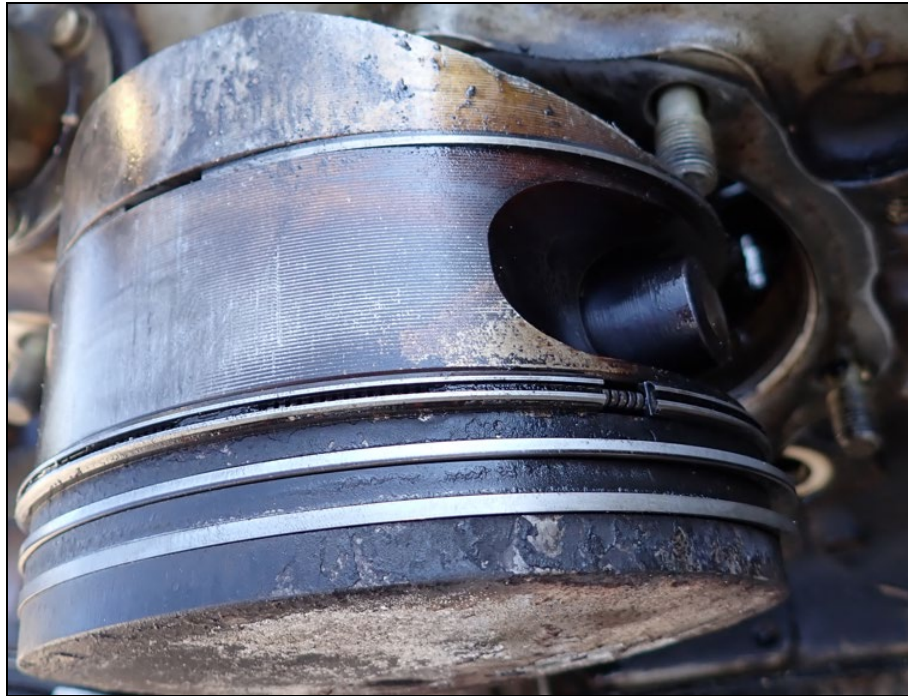
**Figure 17:** View of No. 4 piston skirt

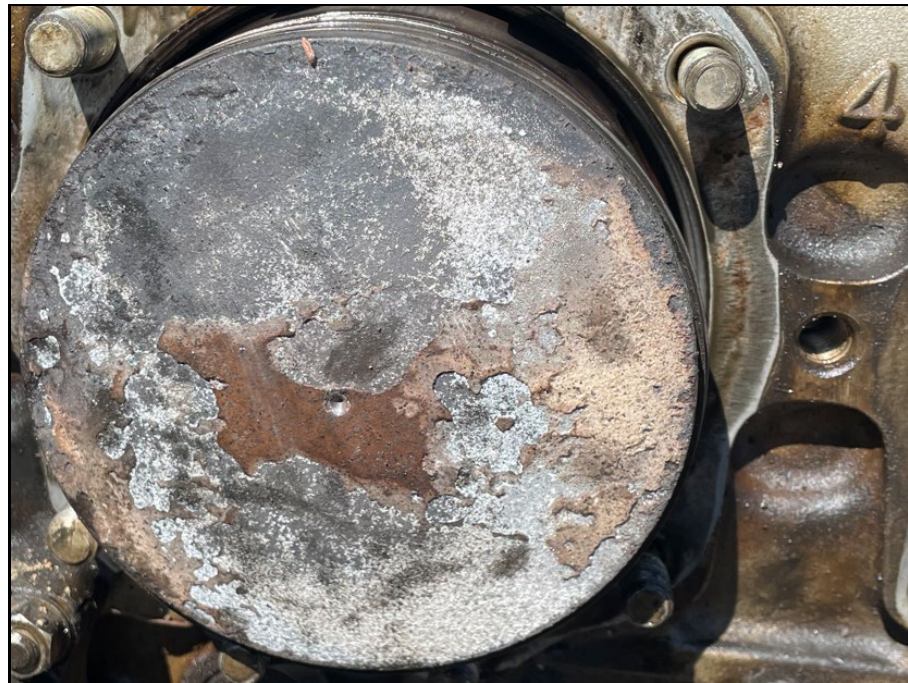
**Figure 18:** View of No. 4 piston crown

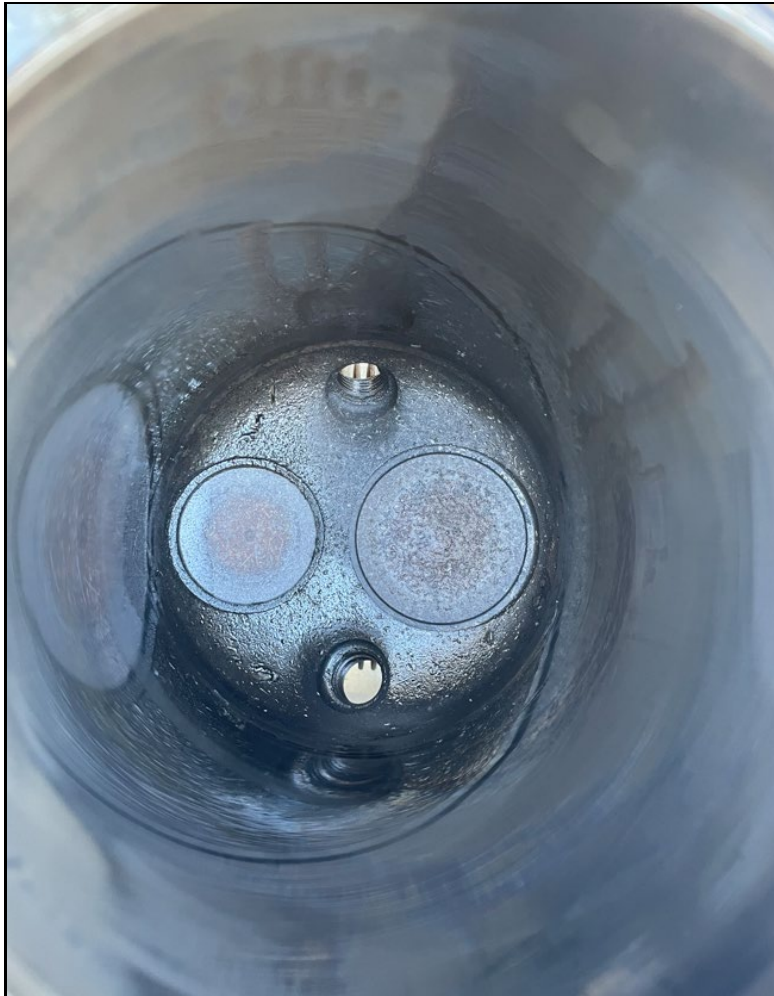
rod bearings and cap movable by hand, with the bolts and retaining nuts present. The cylinder head, exhaust and intake valves were present and exhibited FOD ingestion signatures. The cylinder walls exhibited rotational scoring signatures, with a trace level of metallic shavings throughout. The exhaust and intake valve push rods were removed from their housings and unremarkable. The intake gasket was present and unremarkable. The intake and exhaust valve springs assemblies were present and unremarkable.

**Figure 19:** View of No. 5 cylinder walls, head, exhaust and intake valves

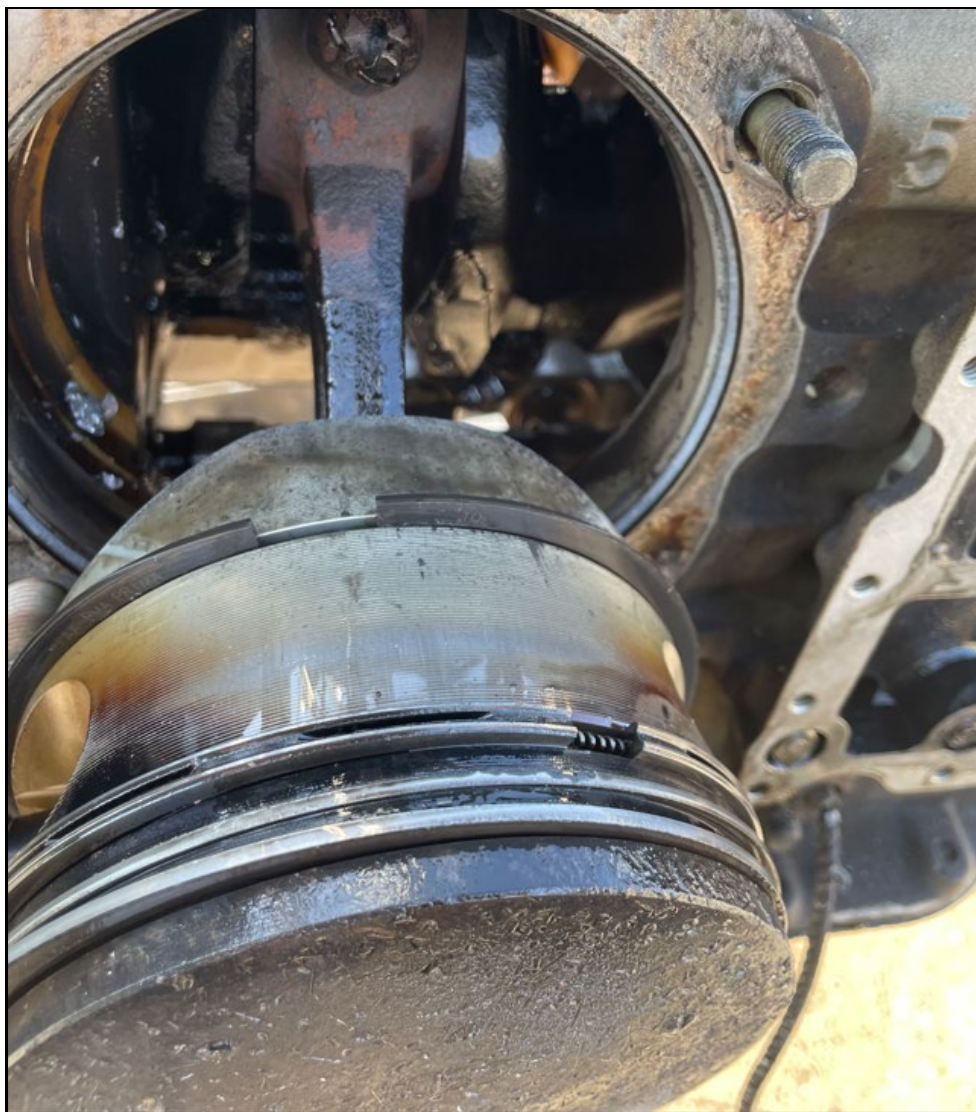
No. 5 piston was observed in the cylinder. The piston crown exhibited FOD ingestion signatures, and edges were unremarkable. The oil retention rings, and oil scrapper rings were present and unremarkable. The piston skirt was unremarkable. The connecting rod and wrist pin were present and unremarkable. The connecting

**Figure 20:** View of No. 5 piston and connecting rod

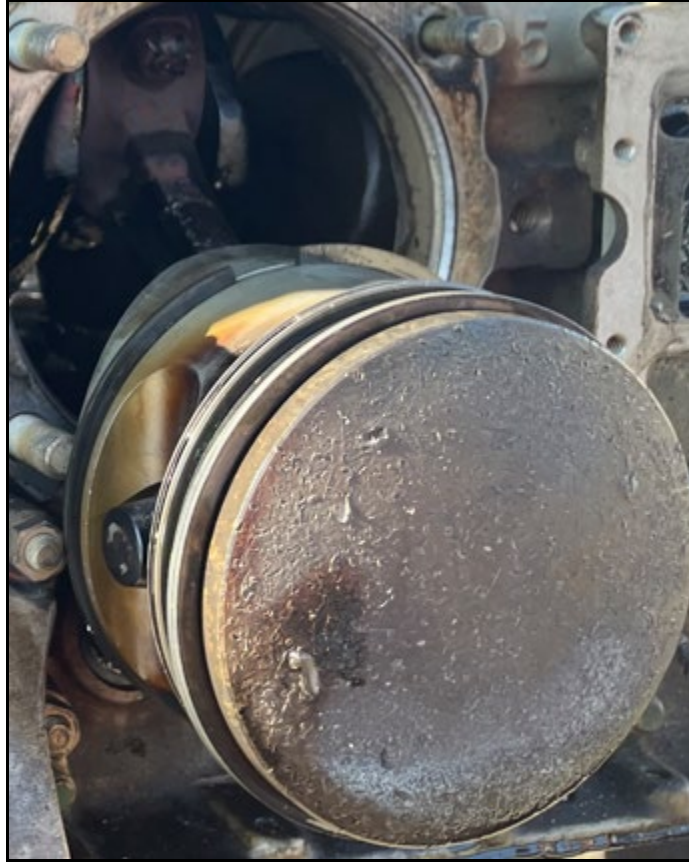
**Figure 21:** View of No. 5 piston crown

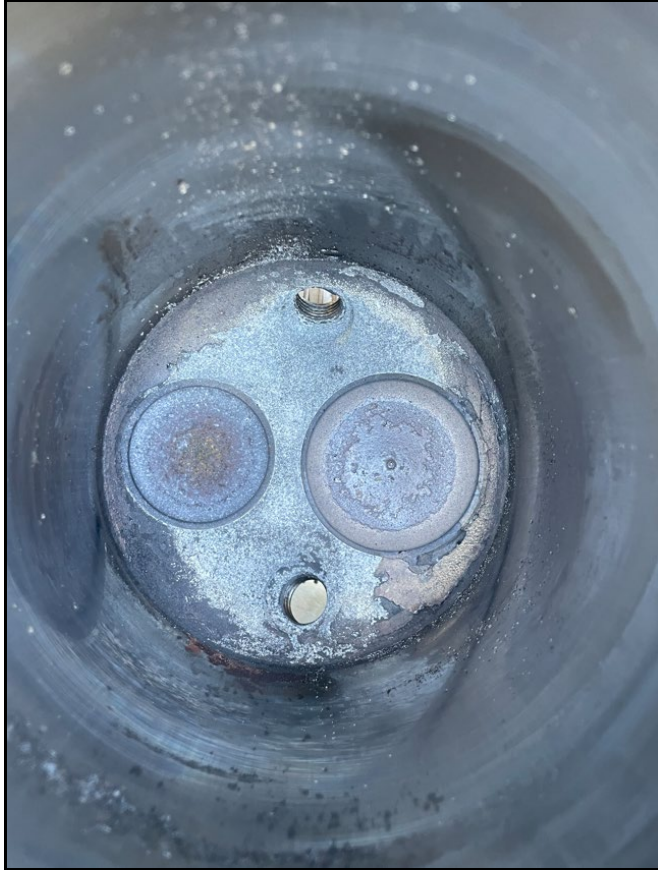
No. 6 piston was observed in the cylinder. The piston crown and edges exhibited an increased level of lead deposits. The oil retention rings, and oil scrapper rings were present and unremarkable. The piston skirt was present and exhibited a reddish appearance around the circumference. The connecting rod and wrist pin were present and not moveable by hand. The connecting rod bearings and cap were unremarkable, with the bolts and retaining nuts present. The cylinder head, exhaust and intake valves were present and unremarkable. The cylinder walls exhibited rotational scoring signatures, with a trace level of metallic shavings throughout. The exhaust and intake valve push rods were removed from their housings and unremarkable. The intake gasket was present and unremarkable. The intake and exhaust valve springs assemblies were present and unremarkable.

**Figure 22:** View of No. 6 cylinder walls, head, exhaust and intake valves
