# National Transportation Safety Board

WPR24LA240

## **WRECKAGE EXAMINATION SUMMARY**

Location: Soldier, ID  
Date: July 13, 2024  
Time: 07:50 MDT  
13:50 UTC  
Airplane: 1959 Cessna 182B (SN: 51917)

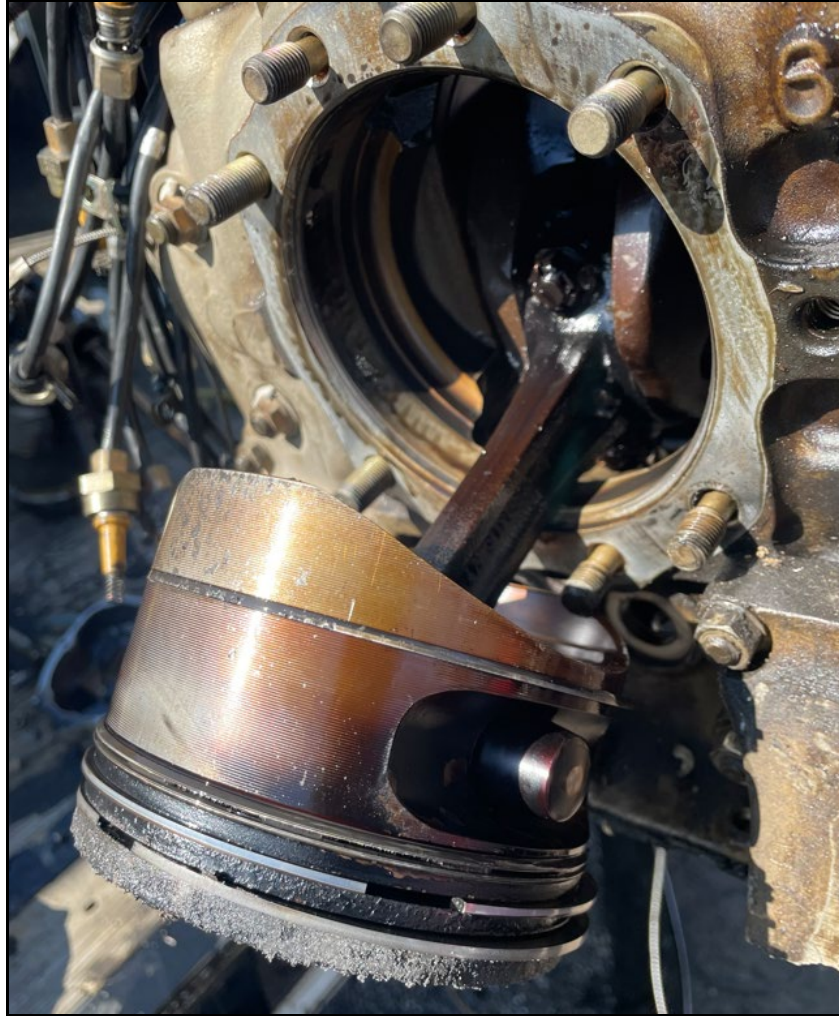
No. 6 piston was observed in the cylinder. The piston crown and edges exhibited an increased level of lead deposits. The oil retention rings, and oil scrapper rings were present and unremarkable. The piston skirt was present and exhibited a reddish appearance around the circumference. The connecting rod and wrist pin were present and not moveable by hand. The connecting rod bearings and cap were unremarkable, with the bolts and retaining nuts present. The cylinder head, exhaust and intake valves were present and unremarkable. The cylinder walls exhibited rotational scoring signatures, with a trace level of metallic shavings throughout. The exhaust and intake valve push rods were removed from their housings and unremarkable. The intake gasket was present and unremarkable. The intake and exhaust valve springs assemblies were present and unremarkable.

**Figure 23:** View of No. 6 piston and connecting rod

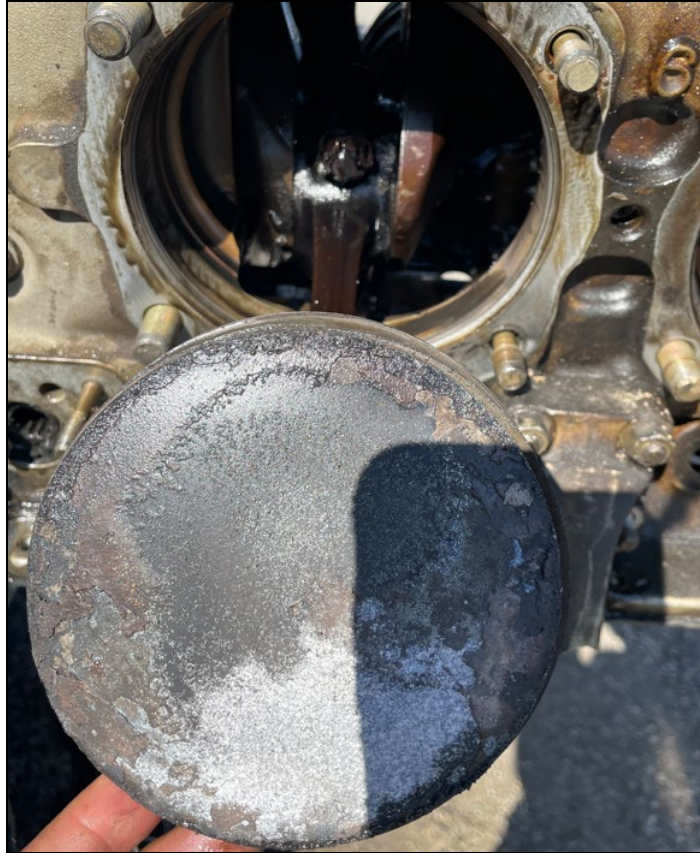
**Figure 24:** View of No. 6 piston crown

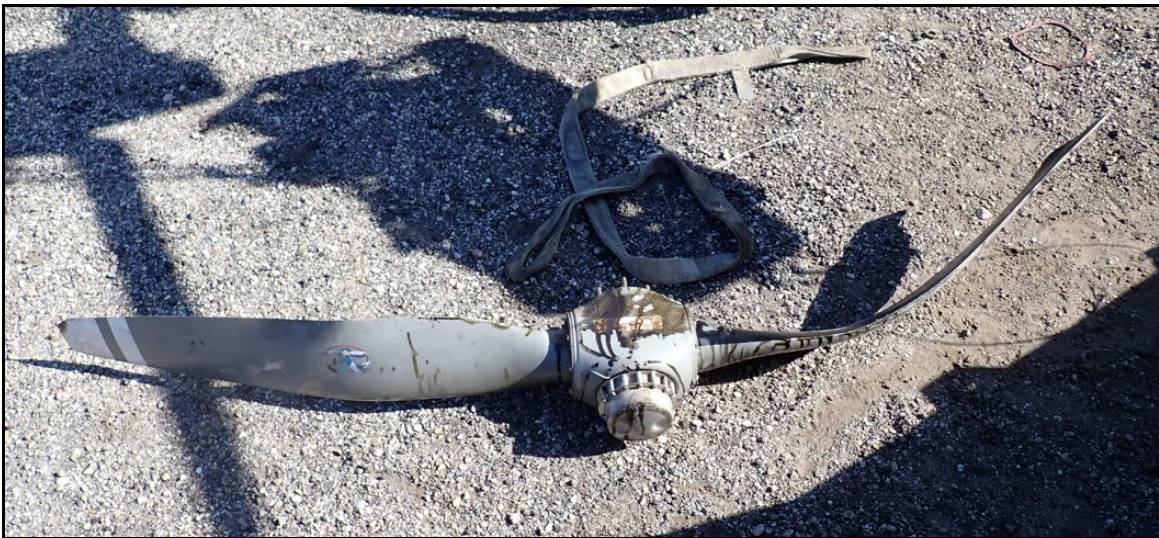
The 2-blade propeller sustained impact damage to both blades. There were no leading-edge gouges, or chordwise scratches observed on the propeller. The propeller blades remained attached to the hub, which remained attached to the propeller flange, which remained attached to the crankcase.

**Figure 26:** View of propeller removed from engine during engine exam
