WPR24LA240

**INVESTIGATION PHOTOGRAPH**

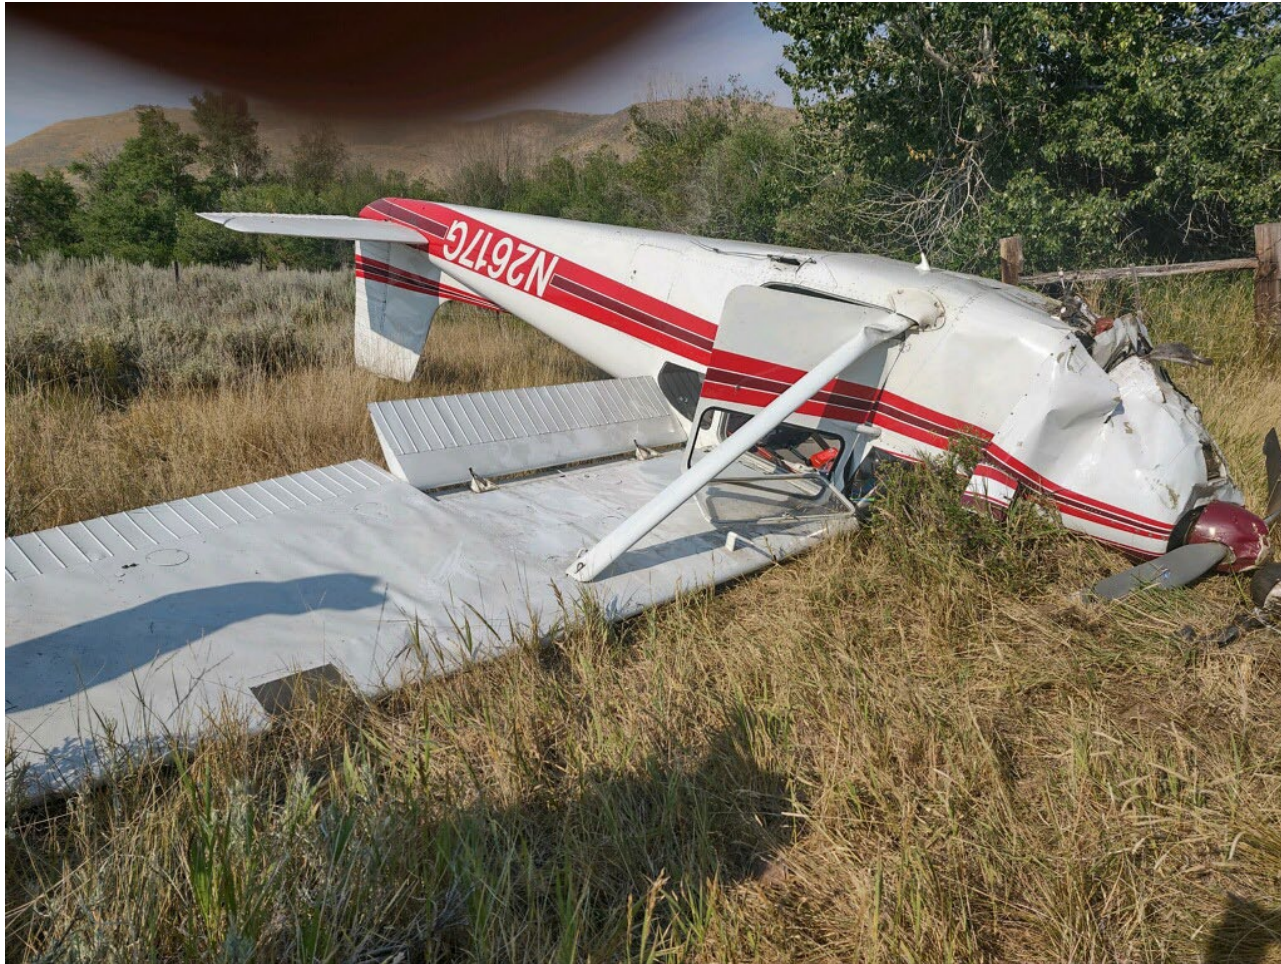
**Photograph 1 - View of substantial damage to the left wing lift strut and damage to the horizontal stabilizer (Courtesy of pilot)**
