# National Transportation Safety Board

WPR24LA241

## **AIRFRAME AND ENGINE EXAMINATION REPORT**

Location: Herriman, Utah  
Date: July 13, 2024  
Time: 1035 MDT  
Helicopter: Robinson R-44 II / N6960

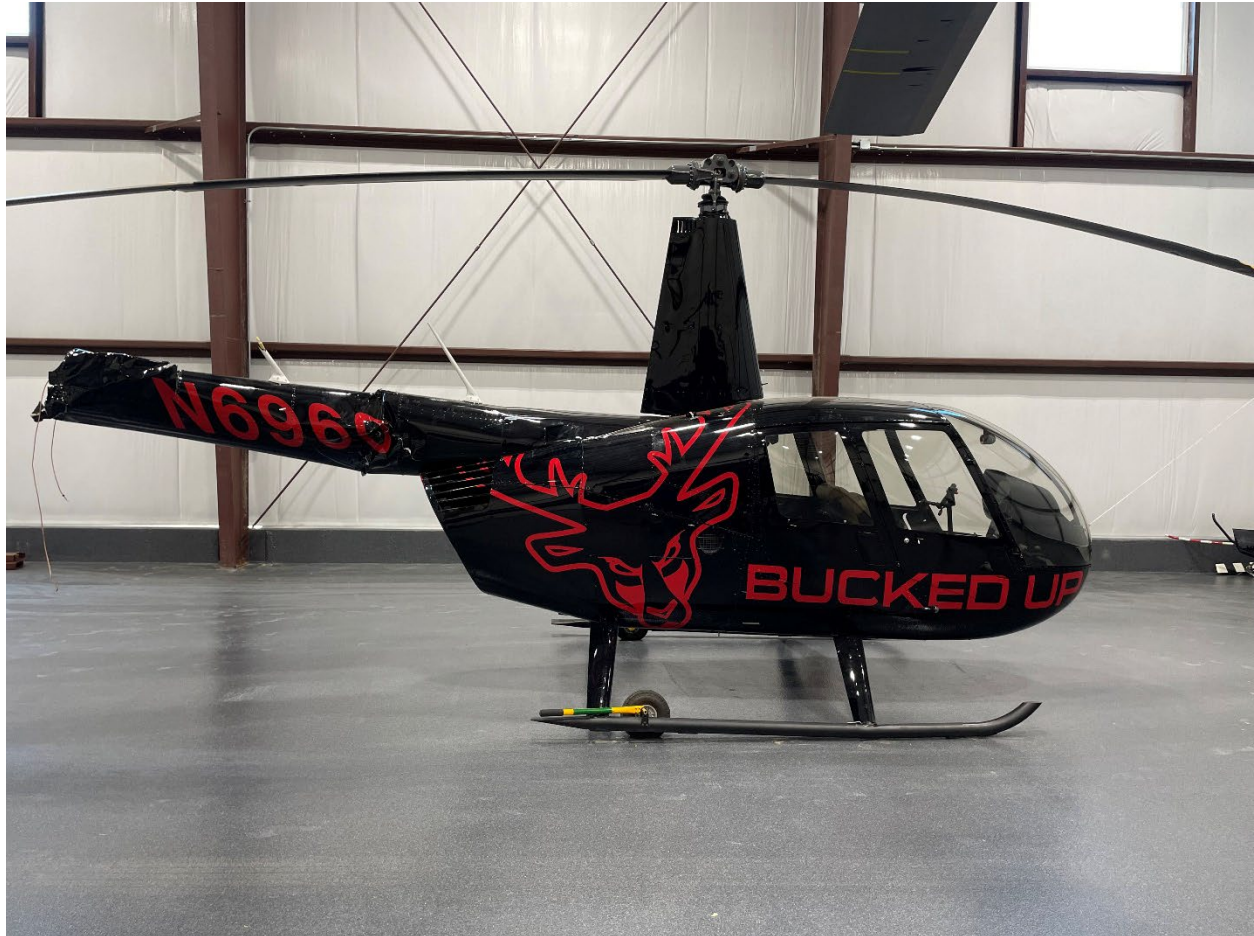
The fuselage exhibited a normal and non-damaged appearance except for slight squatting displacement at the rear crosstubes. The ground handling tires were difficult to install due to the displaced skids.

Figure 1. N6960 at the operator's hangar, right-side view.

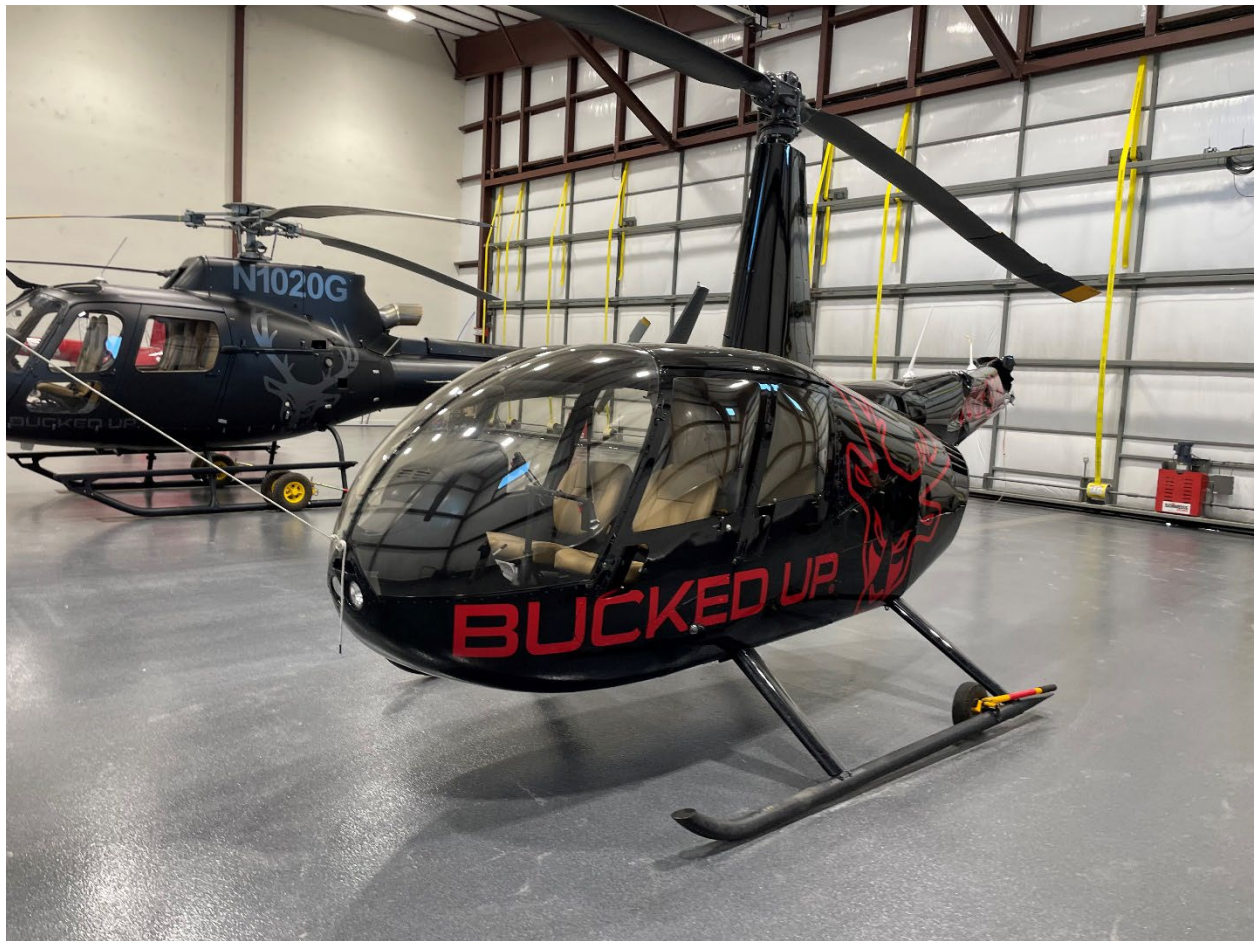
Figure 2. Left-forward view.

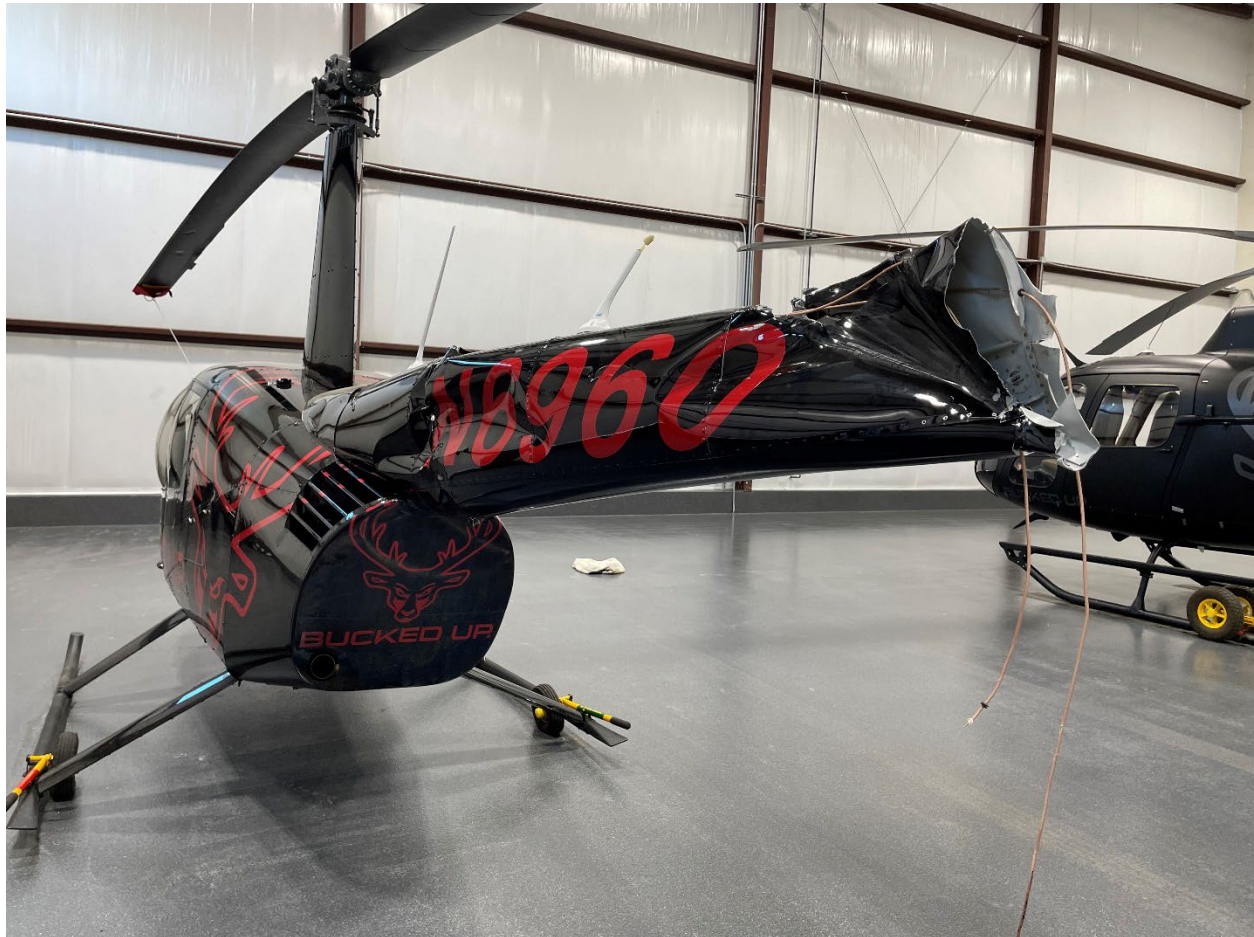
The tail cone remained installed to the fuselage but exhibited a separated about ten ft outboard of the base/root of the tail cone. The separated section was fractured into multiple sections. All sections were recovered and exhibited signs consistent with contact from the main rotor blades.

Figure 3. Rear view.

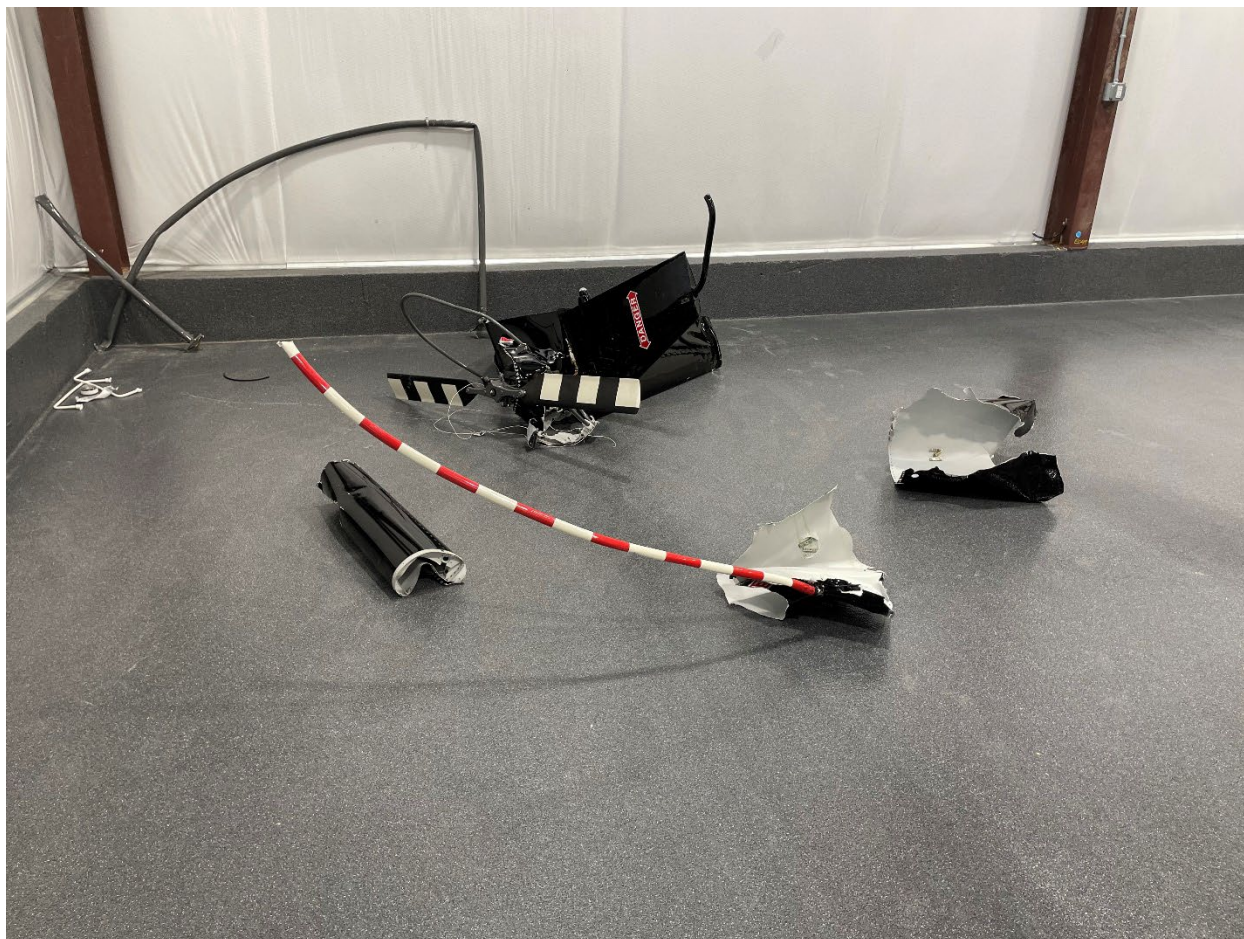
Figure 4. Aft tail cone components, tail rotor gearbox and tail rotor assembly.

The tail rotor drive shaft was separated from the tail cone, possibly during recovery. The driveshaft was fractured into a long section and a short section. The fractured area exhibited a flattening of the drive shaft and separation fractures consistent with the main rotor blade contact. Both ends of the driveshaft contained a damaged flex coupling.

The tail rotor gearbox remained installed at the end of the tail cone and exhibited no damage. The tail rotor hub remained installed at the tail rotor gear box and exhibited no damage. Both tail rotors blades (identified and blade 1, and blade 2) remained installed at the hub and exhibited minor damage. The tail rotor assembly articulated fully throughout its limits and was smooth with no binding. The tail rotor control rod was separated from the tail cone and exhibited multiple bends.

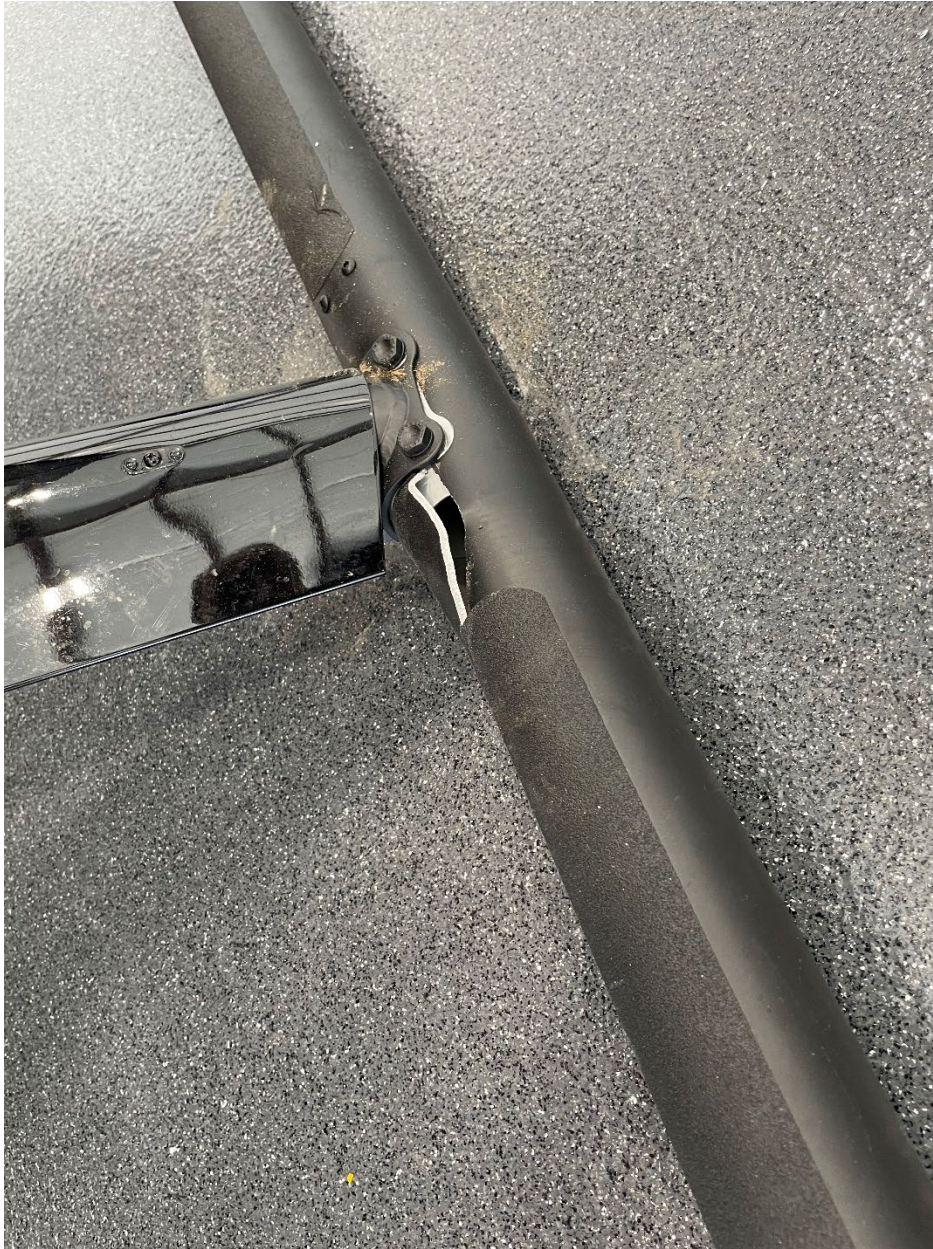
As mentioned earlier in this report, the rear struts exhibited a squatted, outward displacement. The forward struts appeared normal. The left skid exhibited a normal appearance. The right skid exhibited a fracture at the forward saddle area.

Figure 5. Fracture at the right skid near the forward saddle area.

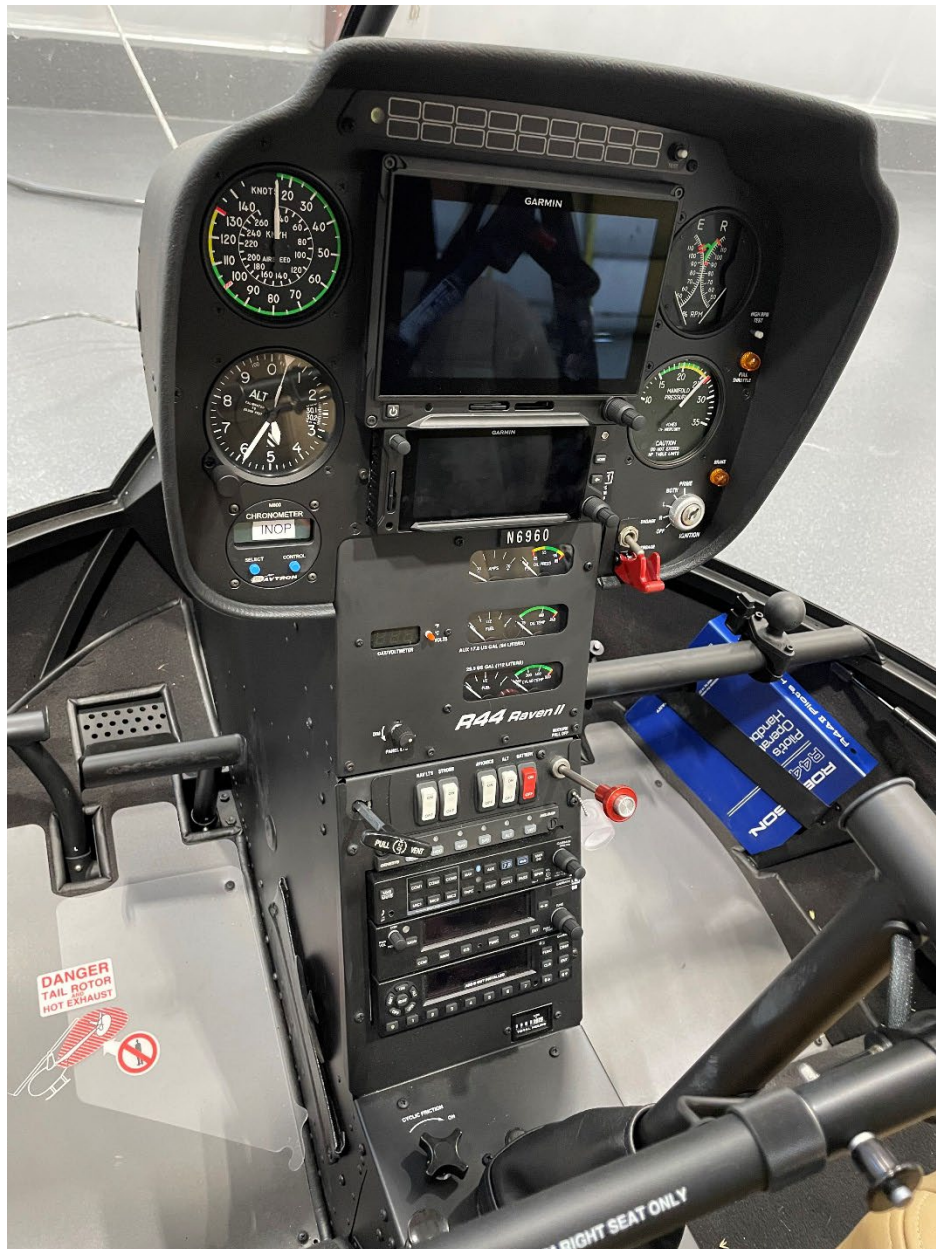
The cockpit exhibited a normal appearance with no damage. The instrument panel held two Garmin instruments. Both units held a data memory card. The memory cards were recovered for data download.

Figure 6. Instrument panel.

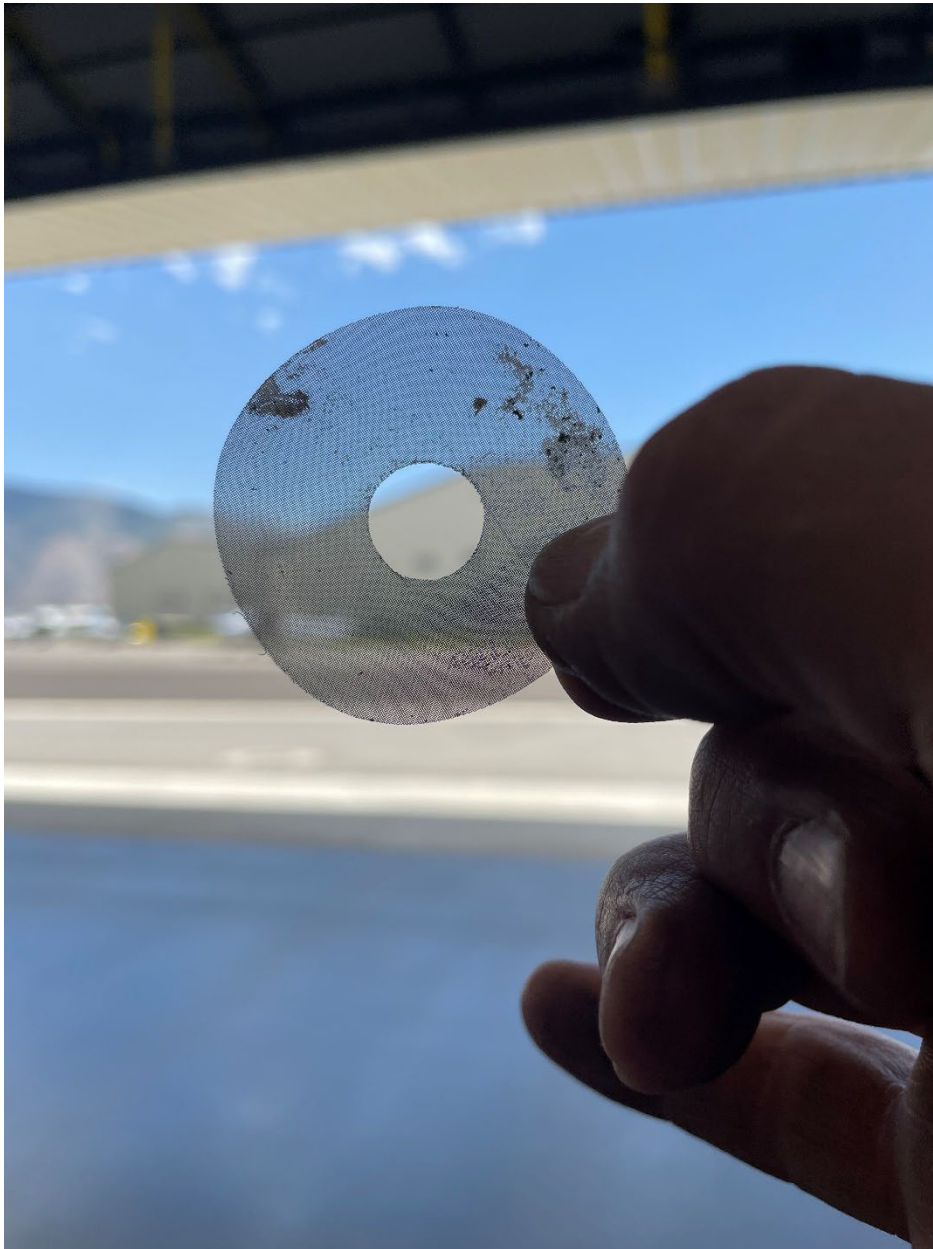
and held a full amount of fuel. The filter gascolator screen was clear. The electric fuel pump remained installed in the engine area and operated when the clutch engage switch was on. The mechanical fuel pump remained installed to the engine. The fuel servo remained installed to the engine. The throttle and mixture control assembly remained installed to the fuel servo and articulated throughout their full range. After the test runs, the mechanical fuel pump and the fuel servo were removed and recovered for further examination.

Figure 7. Gascolator filter

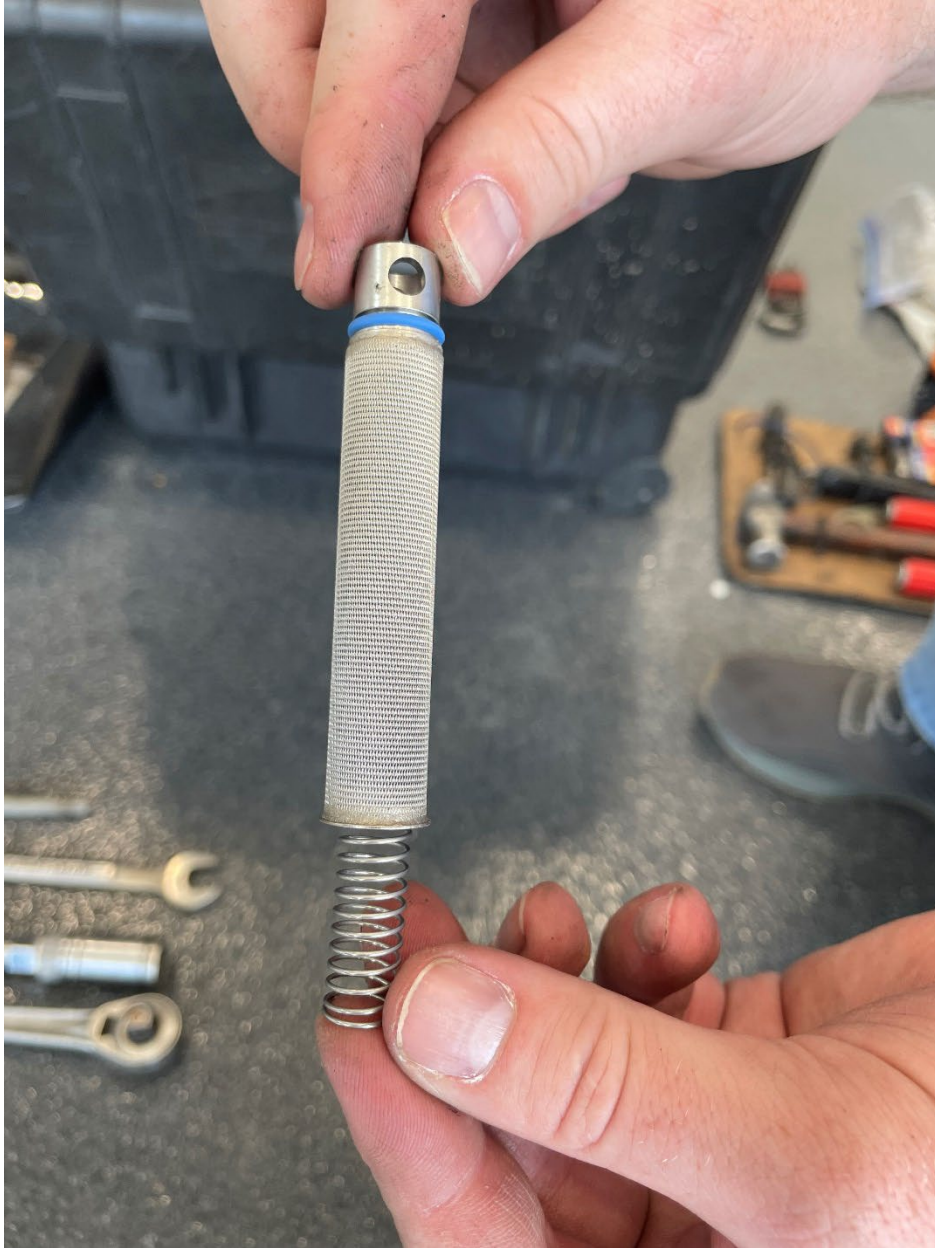
Figure 8. Fuel Servo filter screen.

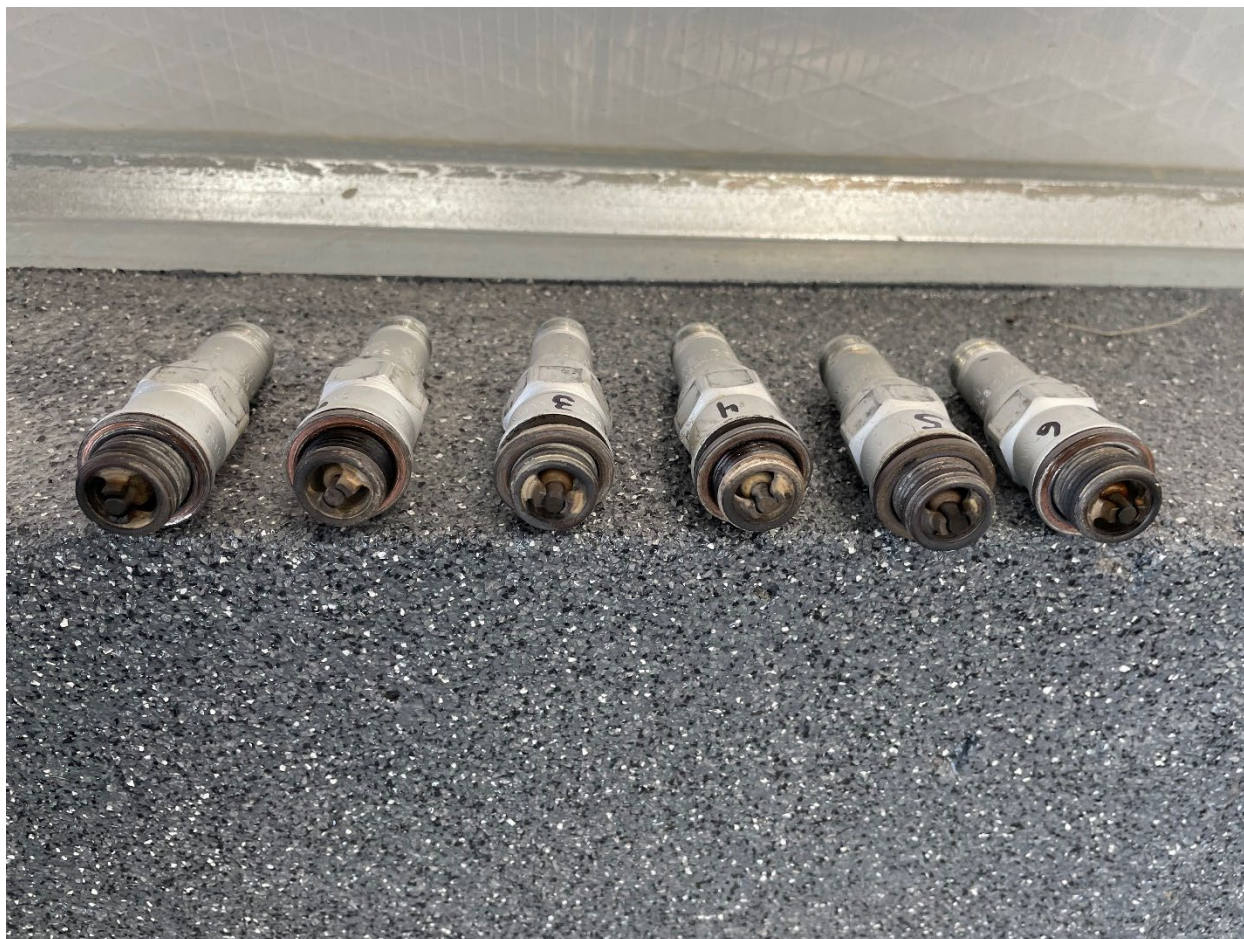
The engine remained installed to the airframe by the undamaged engine mounts. The engine exhibited very minor damage. The air filter was clean. The oil filter was not removed. All cylinders exhibited thumb force compression. The bottom spark plugs were removed, and all exhibited a slightly dark/rich appearance when compared to the Champion Check-A-Plug chart.

Figure 9. Lower sparkplugs.

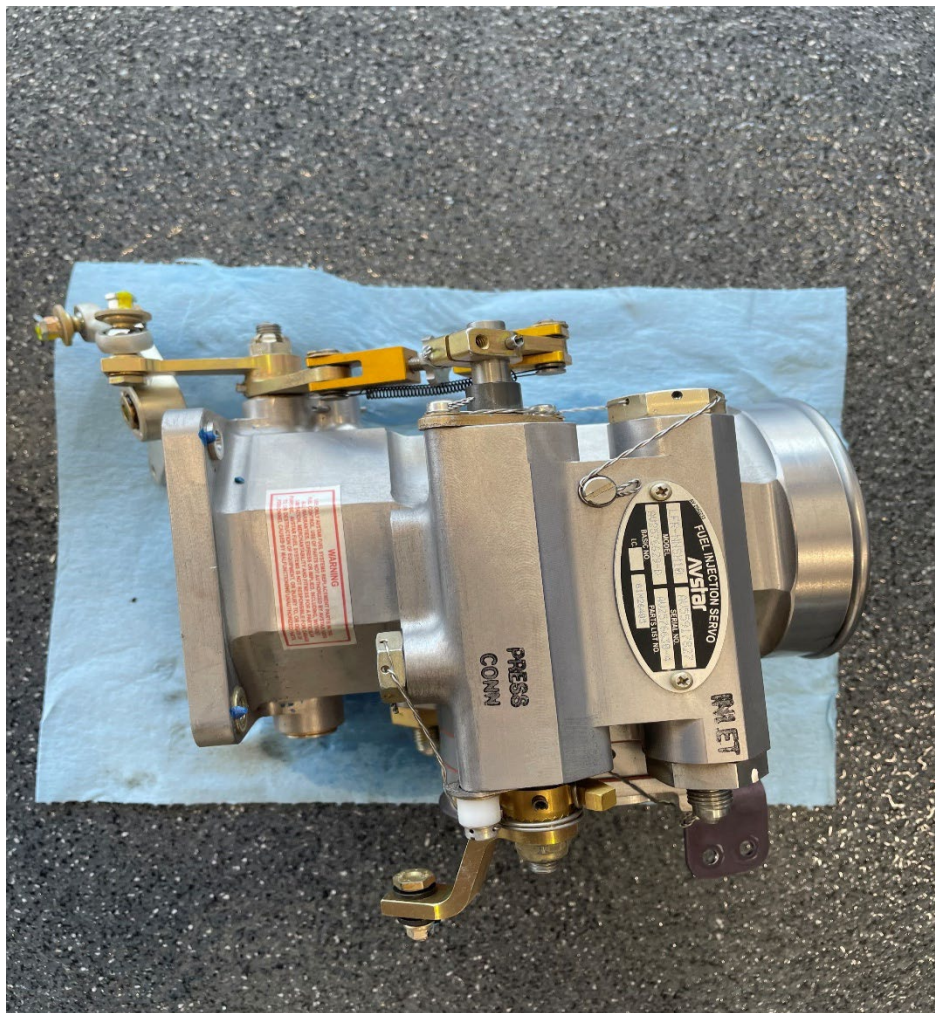
consistent with normal operation. The fuel servo was removed and exhibited no damage.

Figure 10. View of removed fuel servo

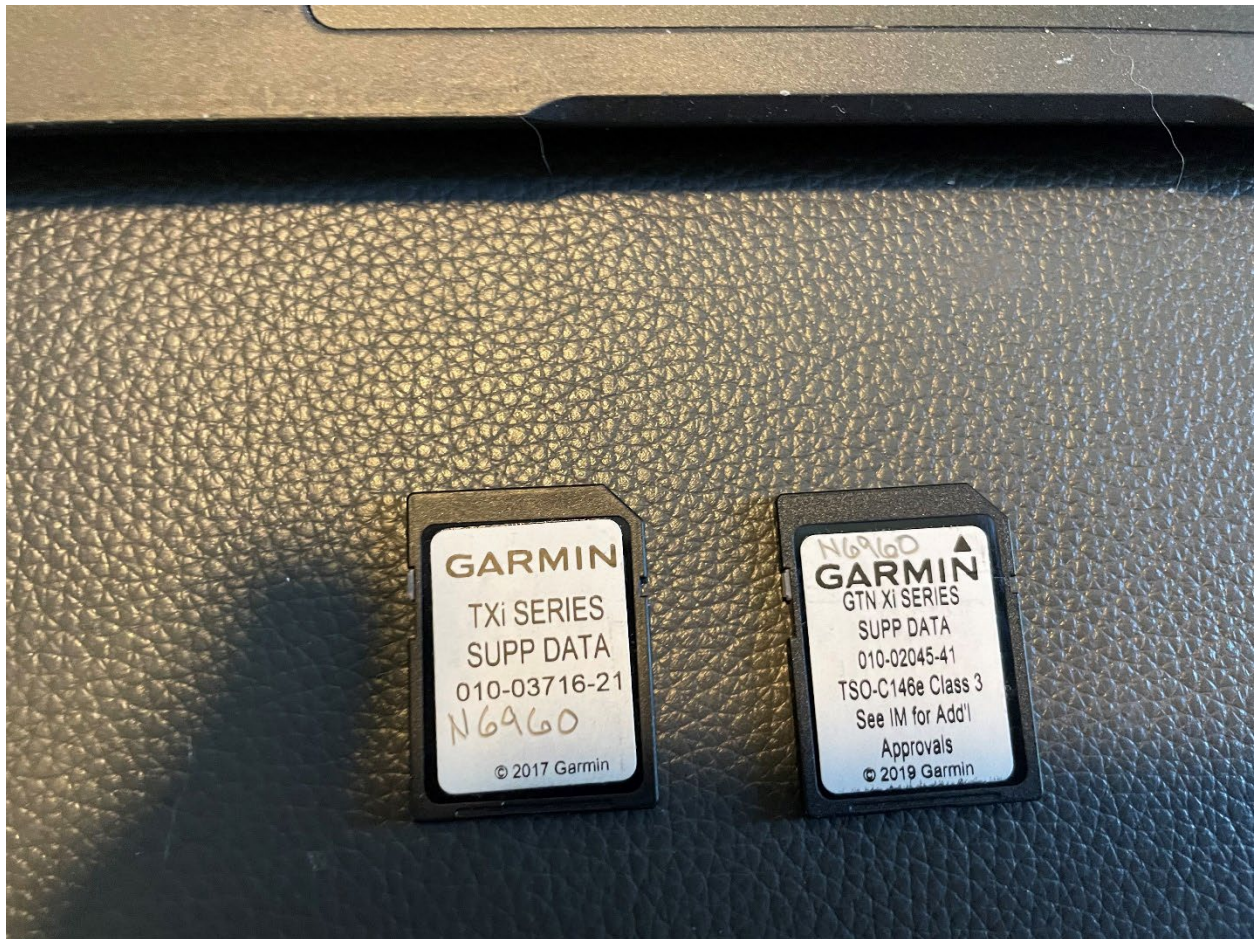
Figure 12. View of removed Garmin data cards
